Inspection Photos

API: 05-071-09062

Operator: ARP PRODUCTION COMPANY
WAPITI OPERATING LLC

Inspection Date: 7/19/2019

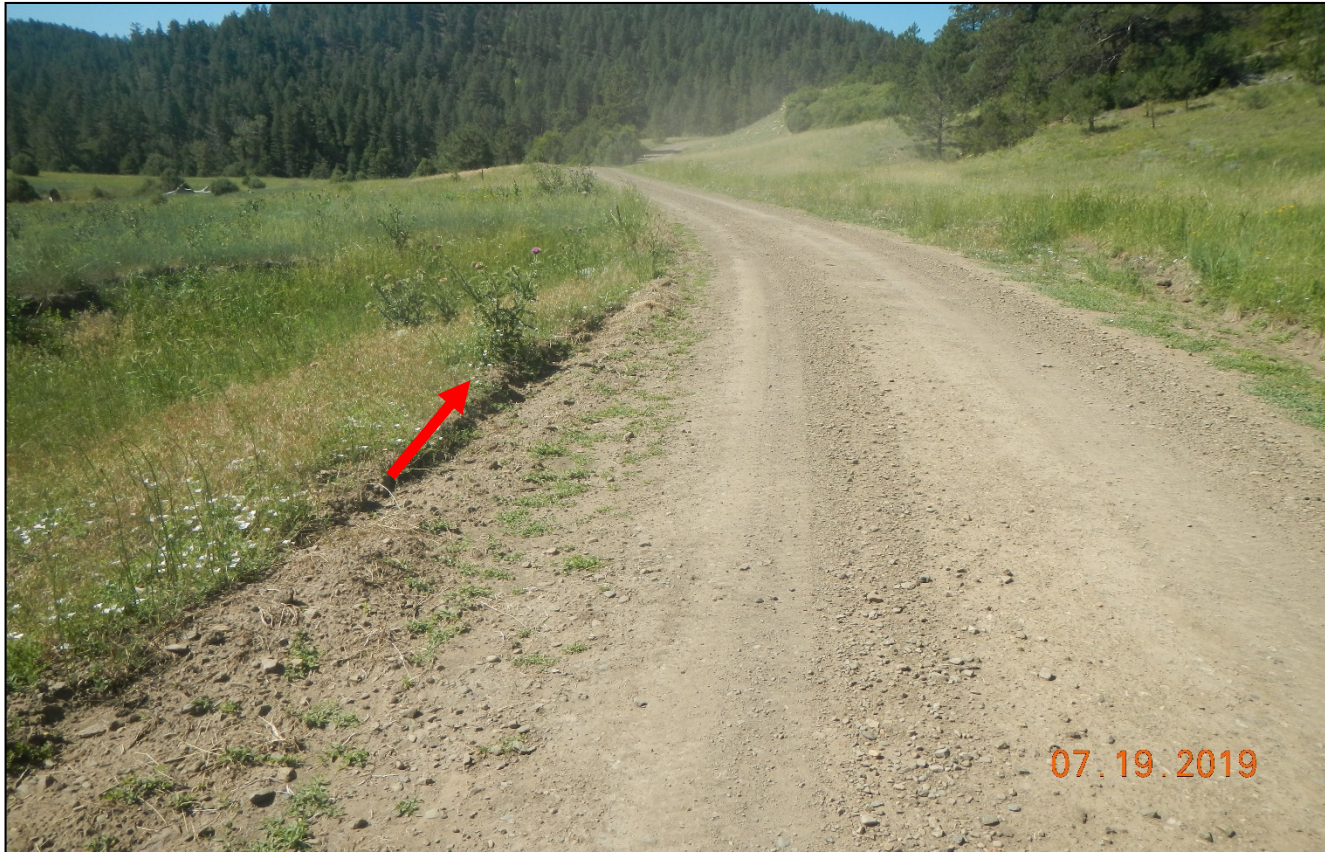
Photo 1. There is List B noxious weeds growing along the main & access road to the location. (Musk thistle shown in photo) There were a few weeds wilting but most were not treated. Corrective action was not completed since previous inspection.

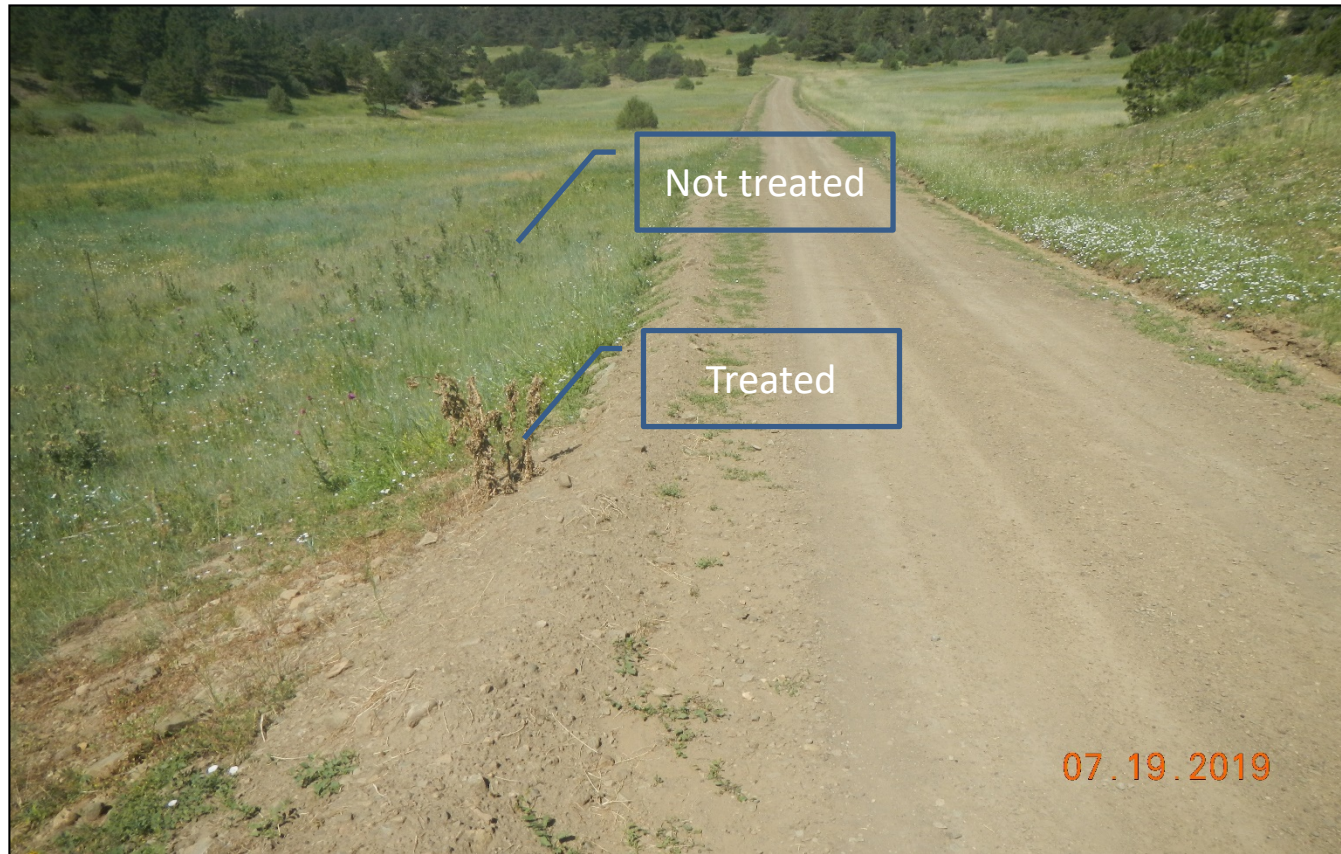
Photo 2. There is List B noxious weeds growing along the main & access road to the location. (Musk thistle shown in photo) There were a few weeds wilting but most were not treated. Corrective action was not completed since previous inspection.

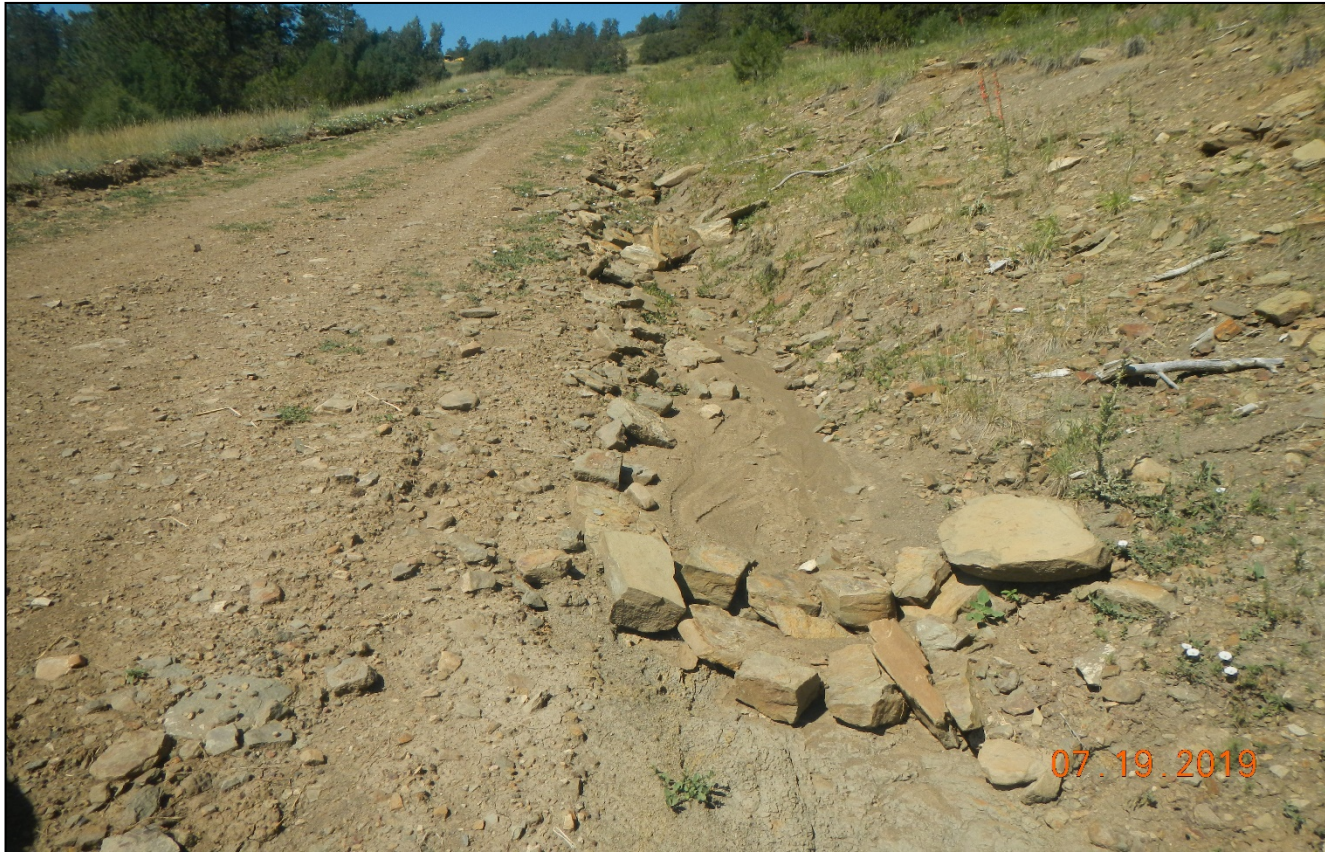
Photo 3. Rock check dams were installed along the side of the access road to the location. Sediment has filled in the check dams or stormwater is flowing around. Corrective action was not performed since previous inspection.

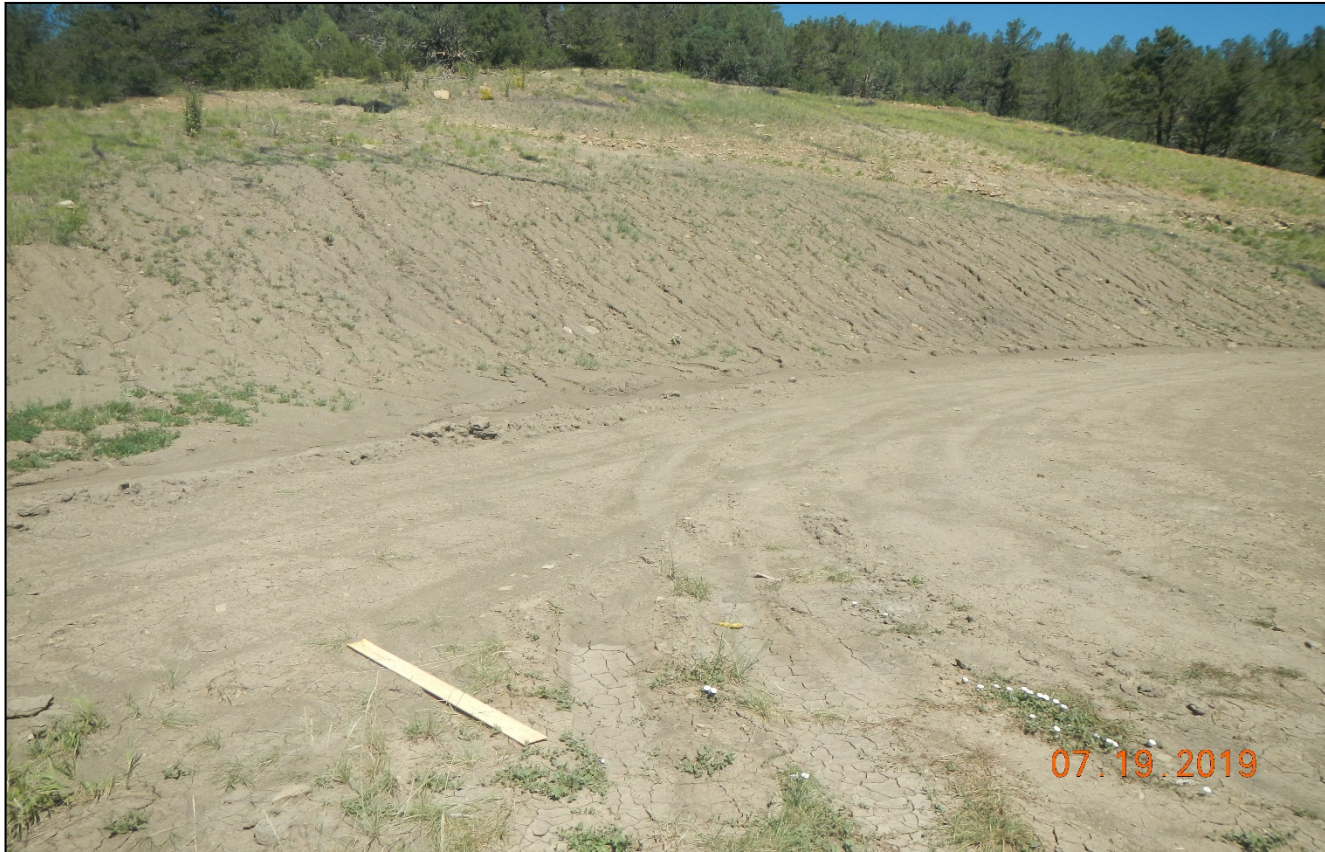
Photo 4. The cut slope is not stabilized and erosion is occurring. No vegetation is establishing. Corrective action was not performed since previous inspection.

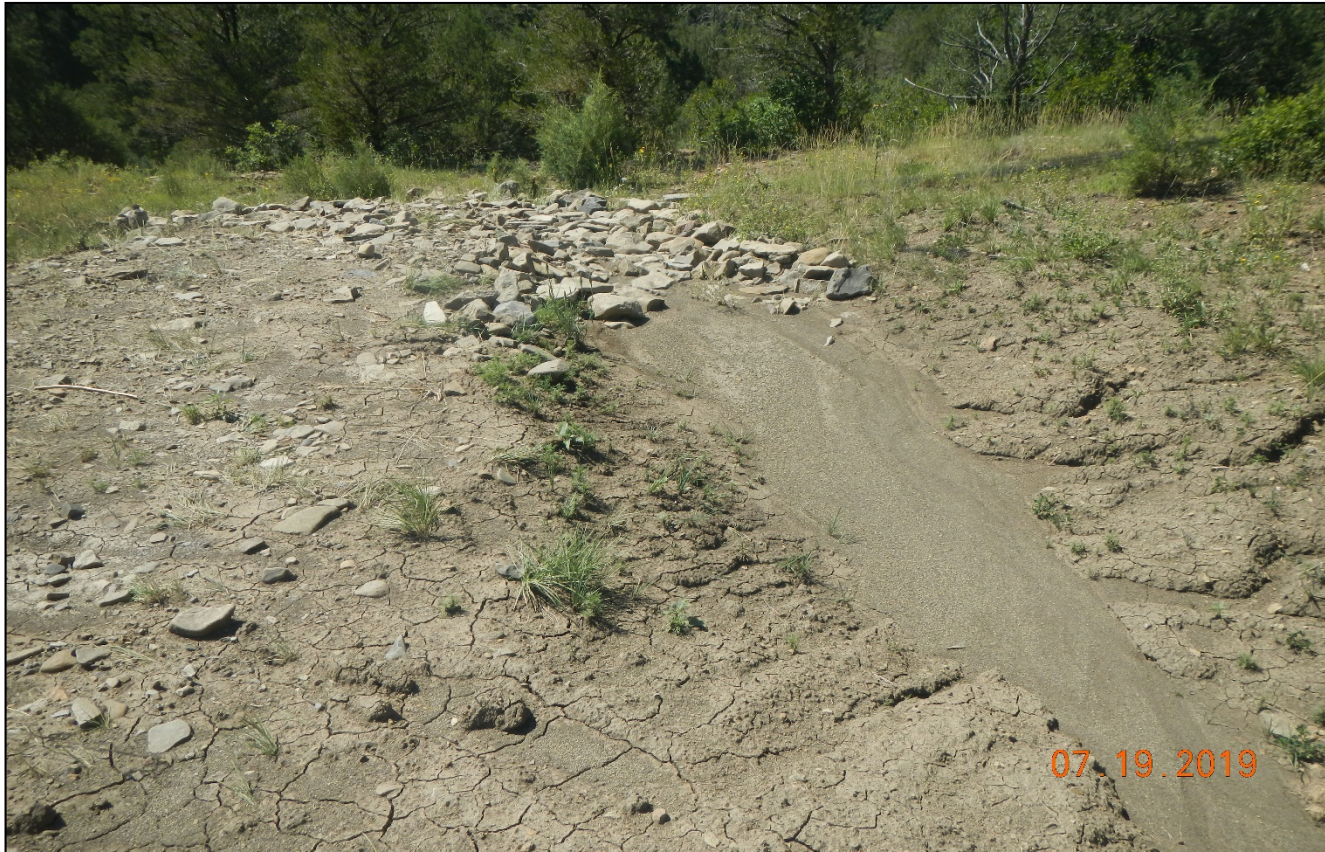
Photo 5. Rock rip/rap was installed at the end of the diversion ditch however, sediment has already filled in the diversion ditch from erosion of the cut slope.

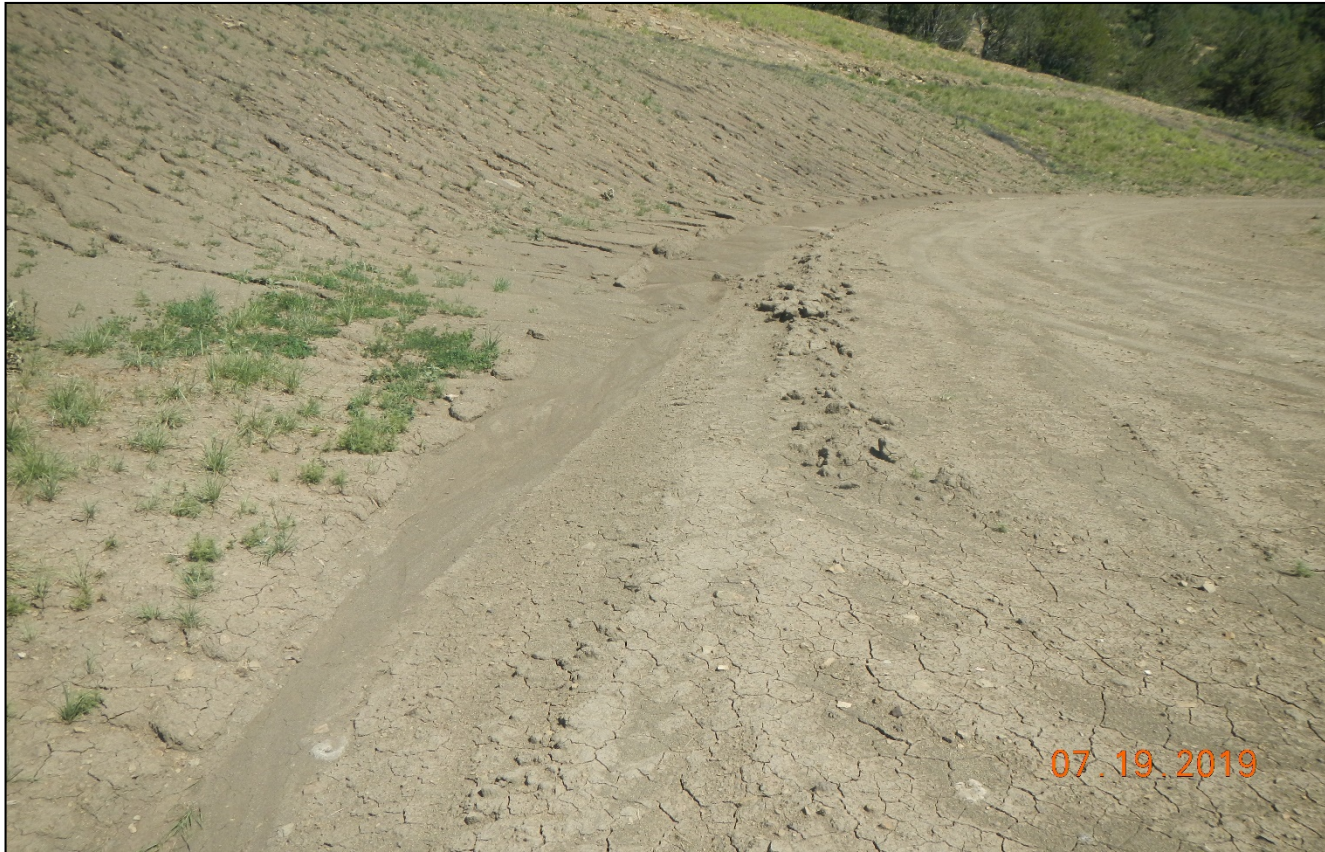
Photo 6. Sediment has already filled in the diversion ditch from erosion of the cut slope.

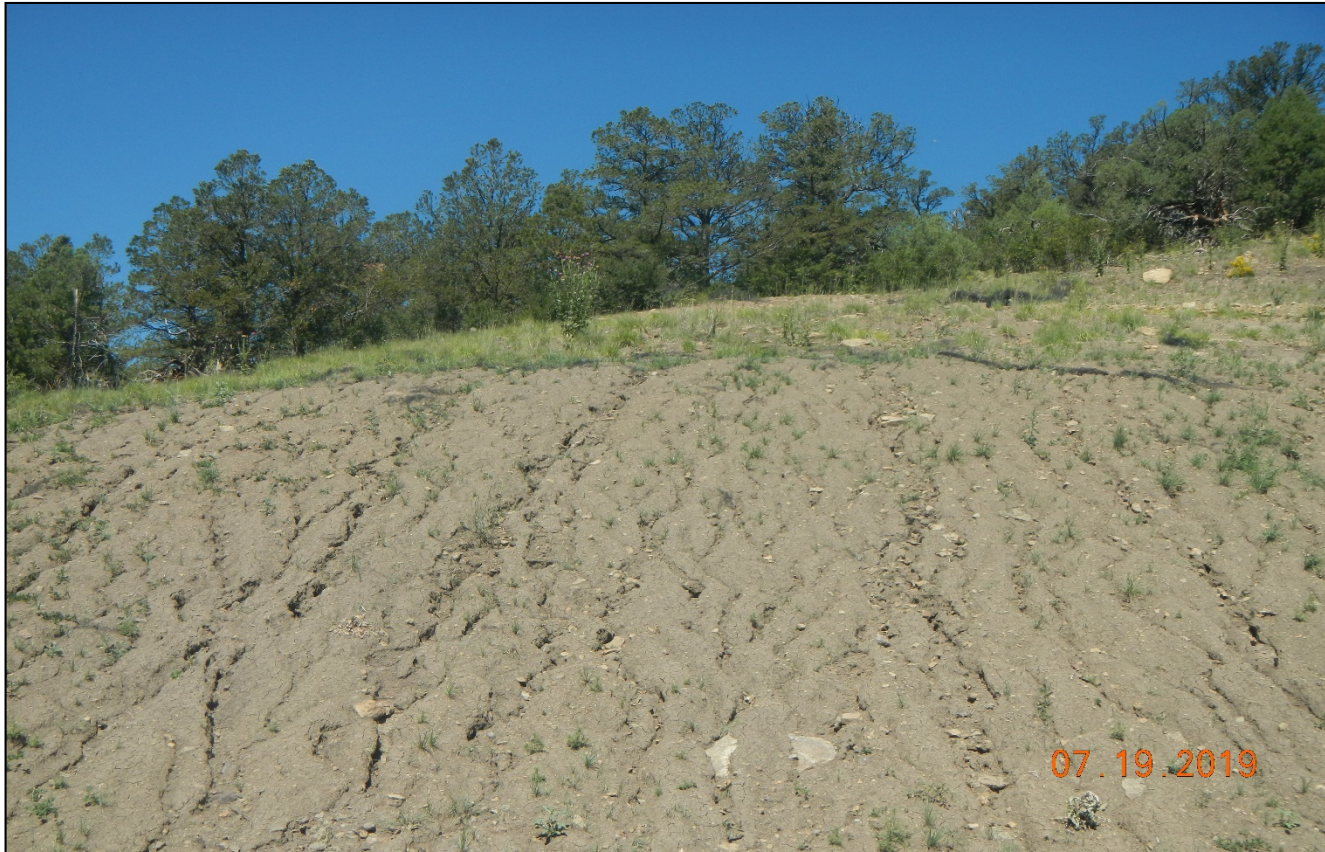
Photo 9. There are noxious weeds (CMusk thistle) growing at the top of the cut slope. Corrective action was not completed since previous inspection.
