Inspection Photos

API: 05-071-06094

Operator: AMOCO PRODUCTION COMPANY

Inspection Date: 7/22/2019

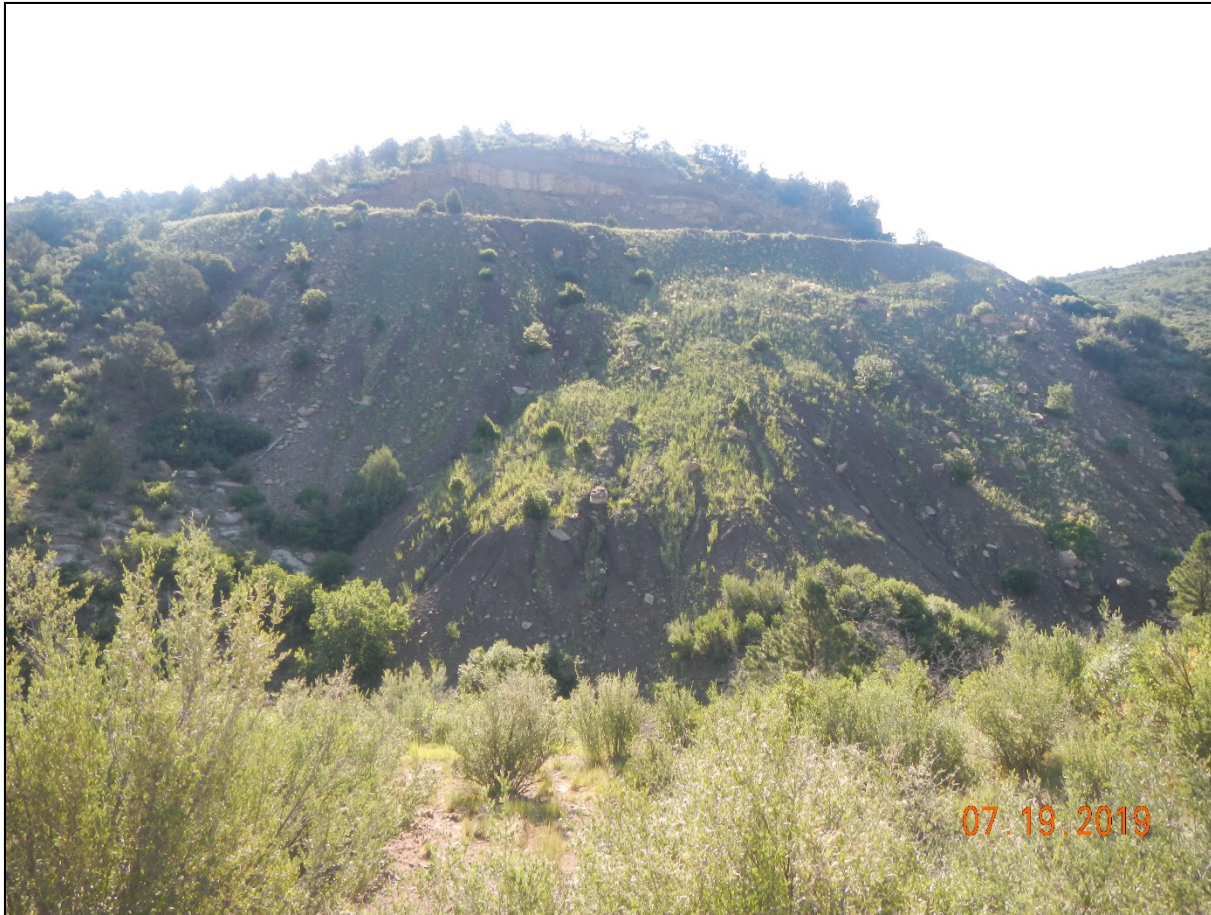
Photo 1. Facing east toward the location from across the canyon. Reclamation has not been performed.

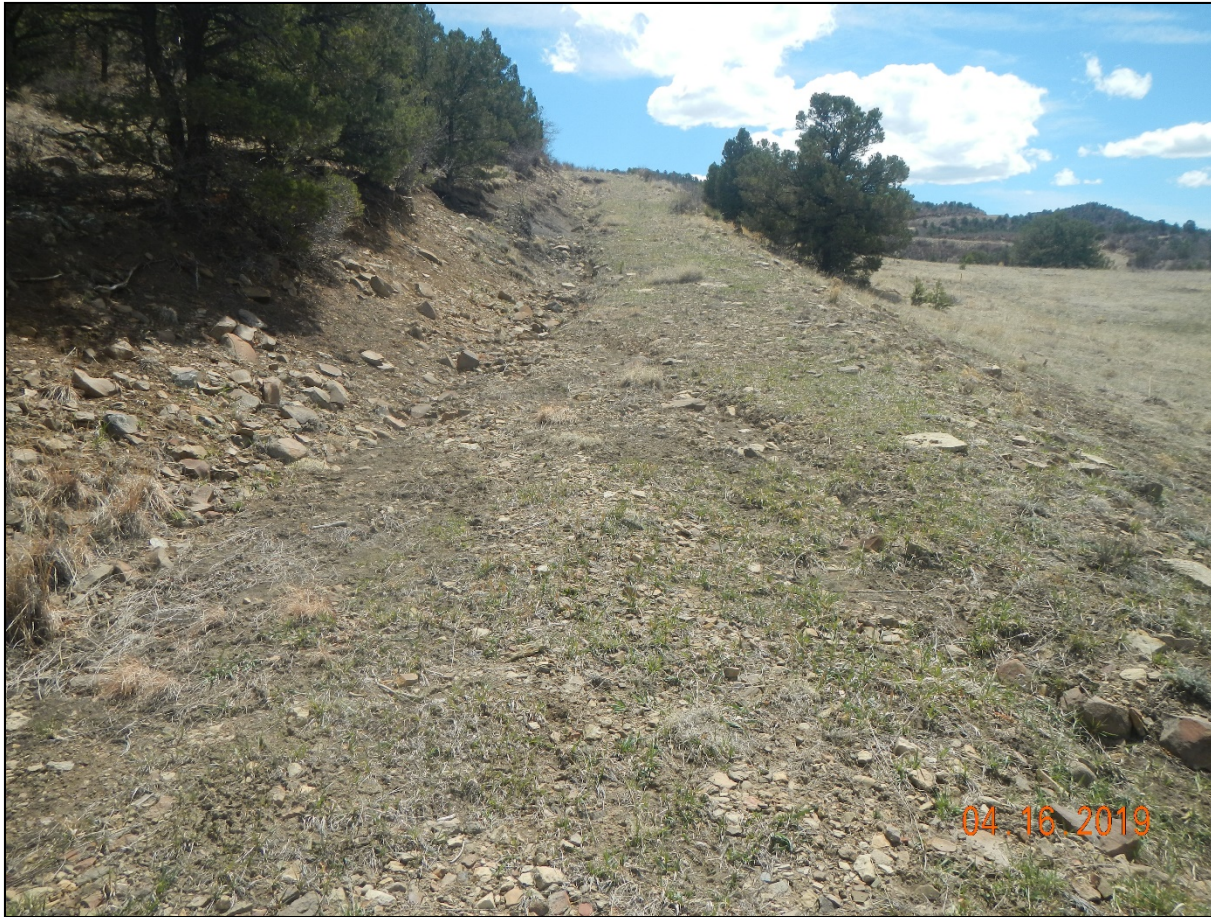
Photo 2. Facing south at the beginning of the access road.

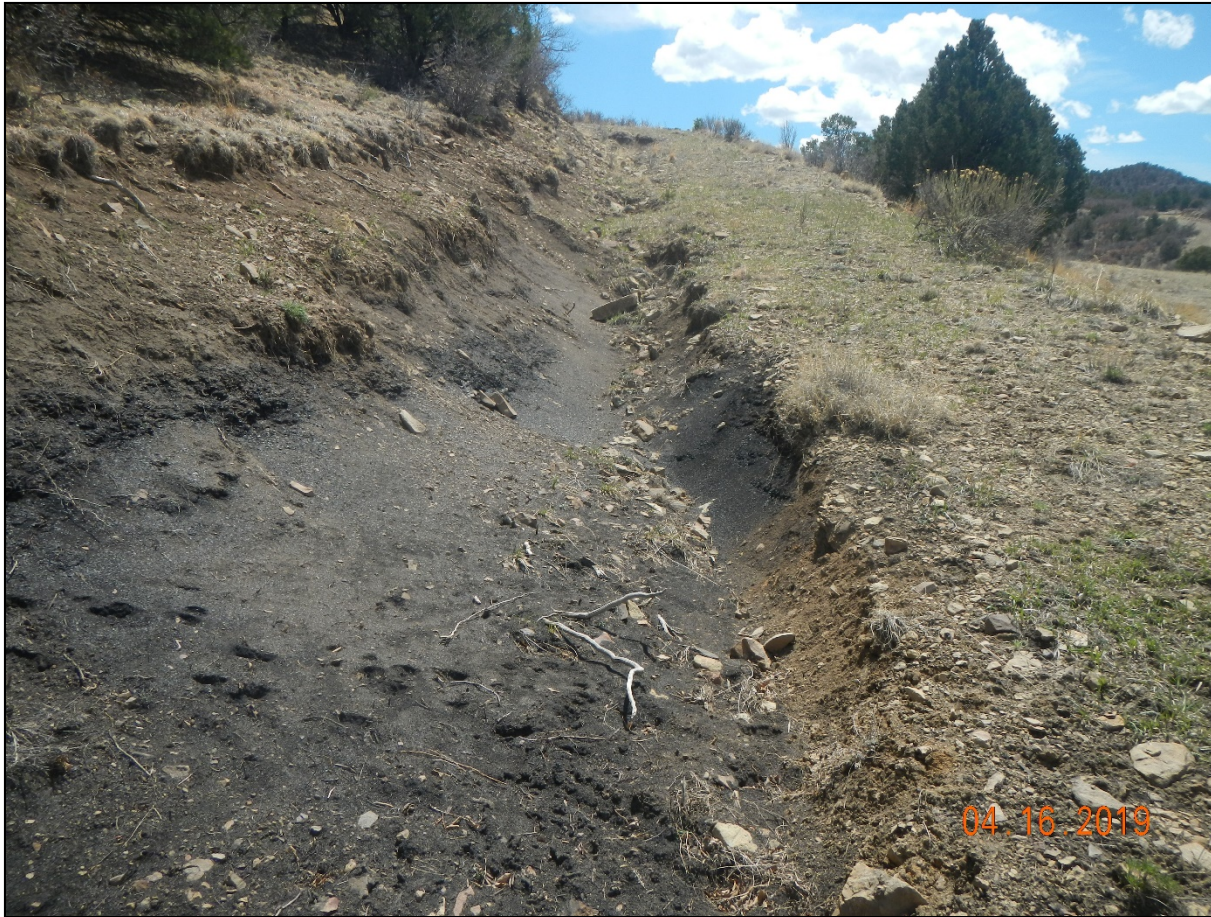
Photo 3. Photo shows erosion along the access road. Access road has not been recontoured and reclaimed.

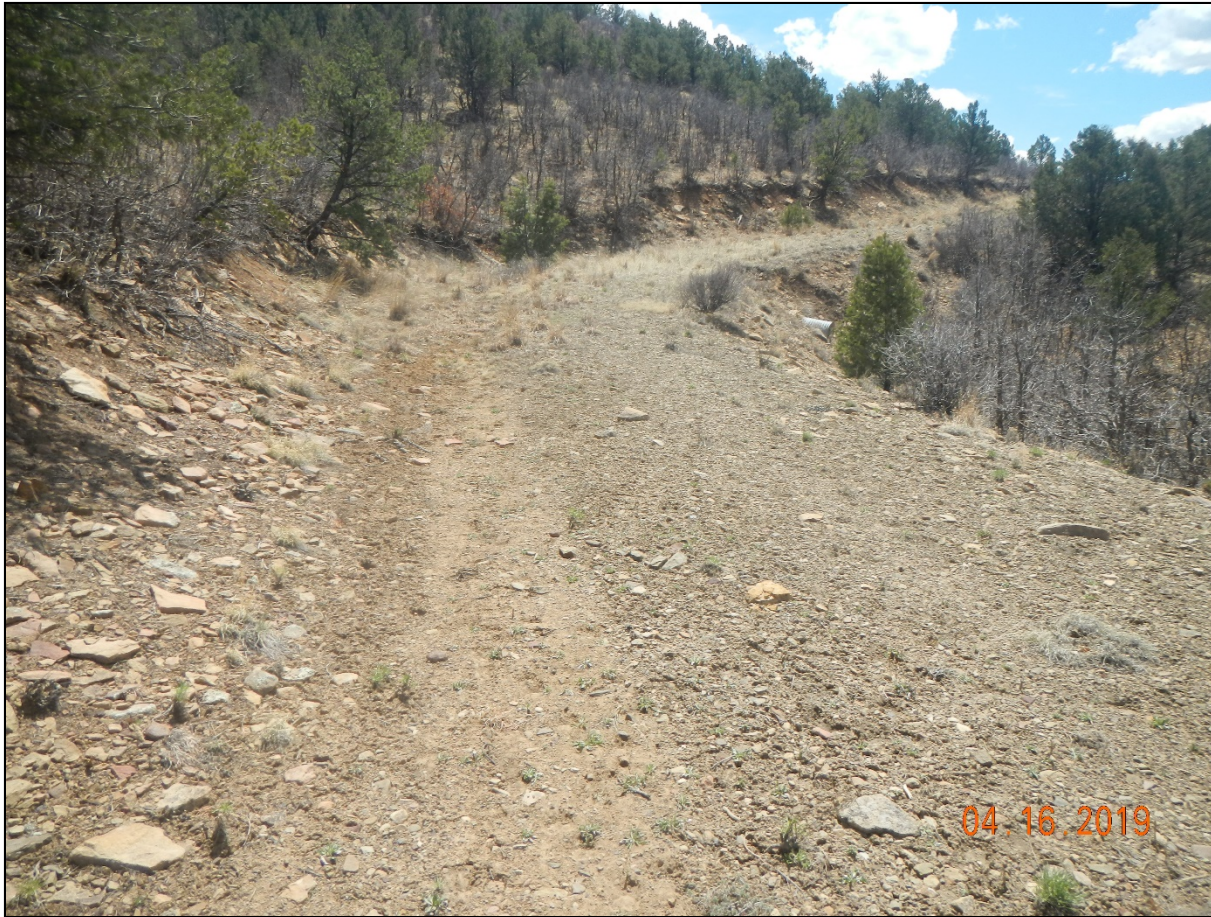
Photo 4. Further along the road. Access road has not been recontoured and reclaimed.

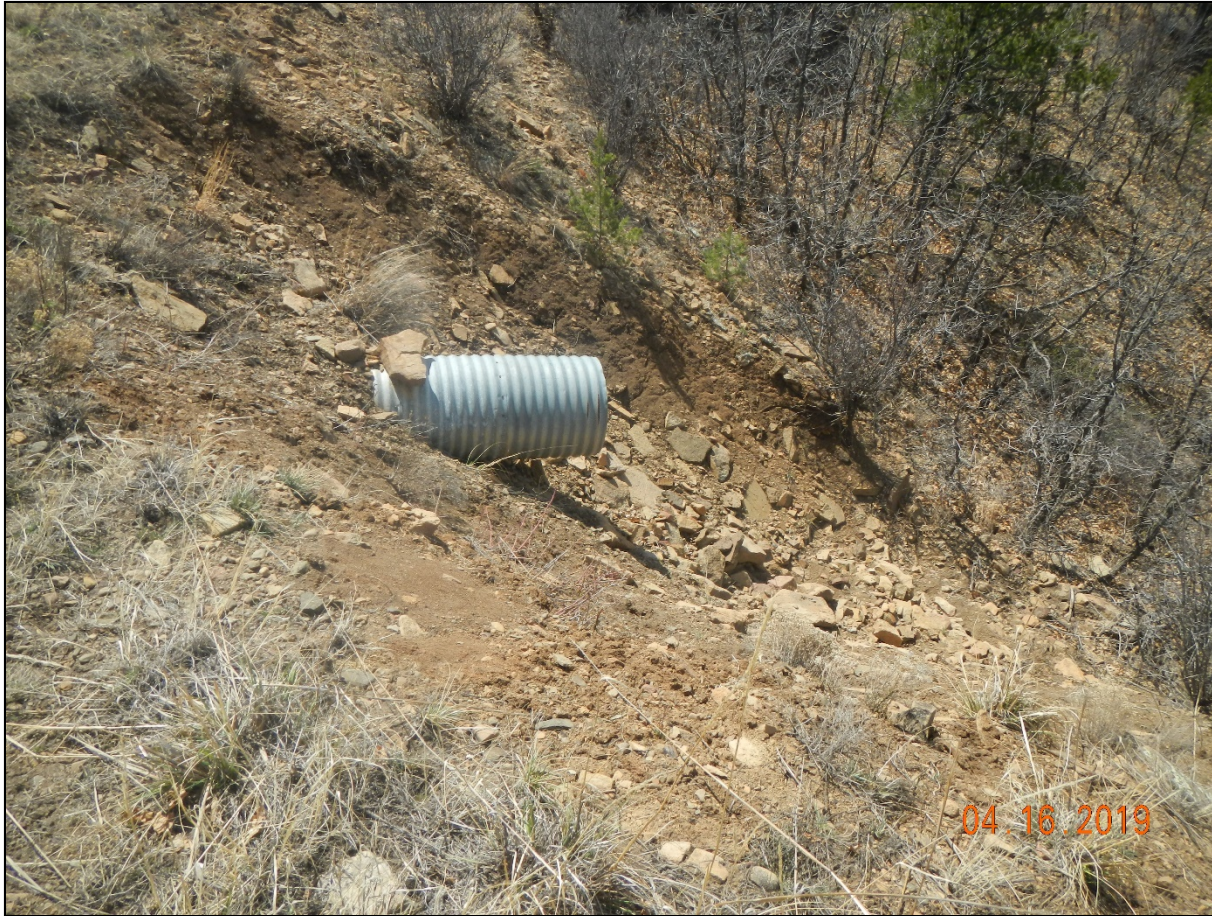
Photo 5. Culvert remains along the road. Erosion is occurring around the outlet.

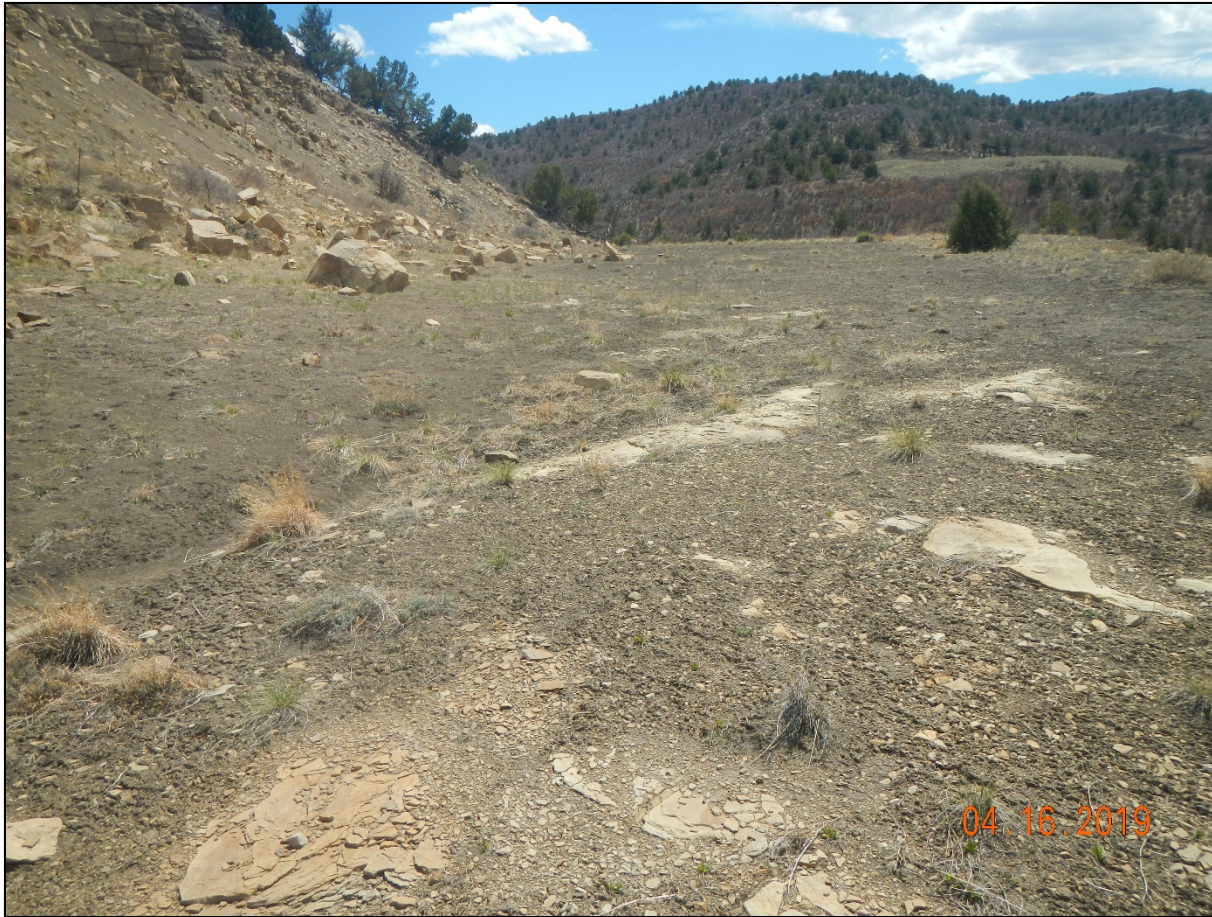
Photo 6. Facing southeast toward the location. The pad has not been recontoured.

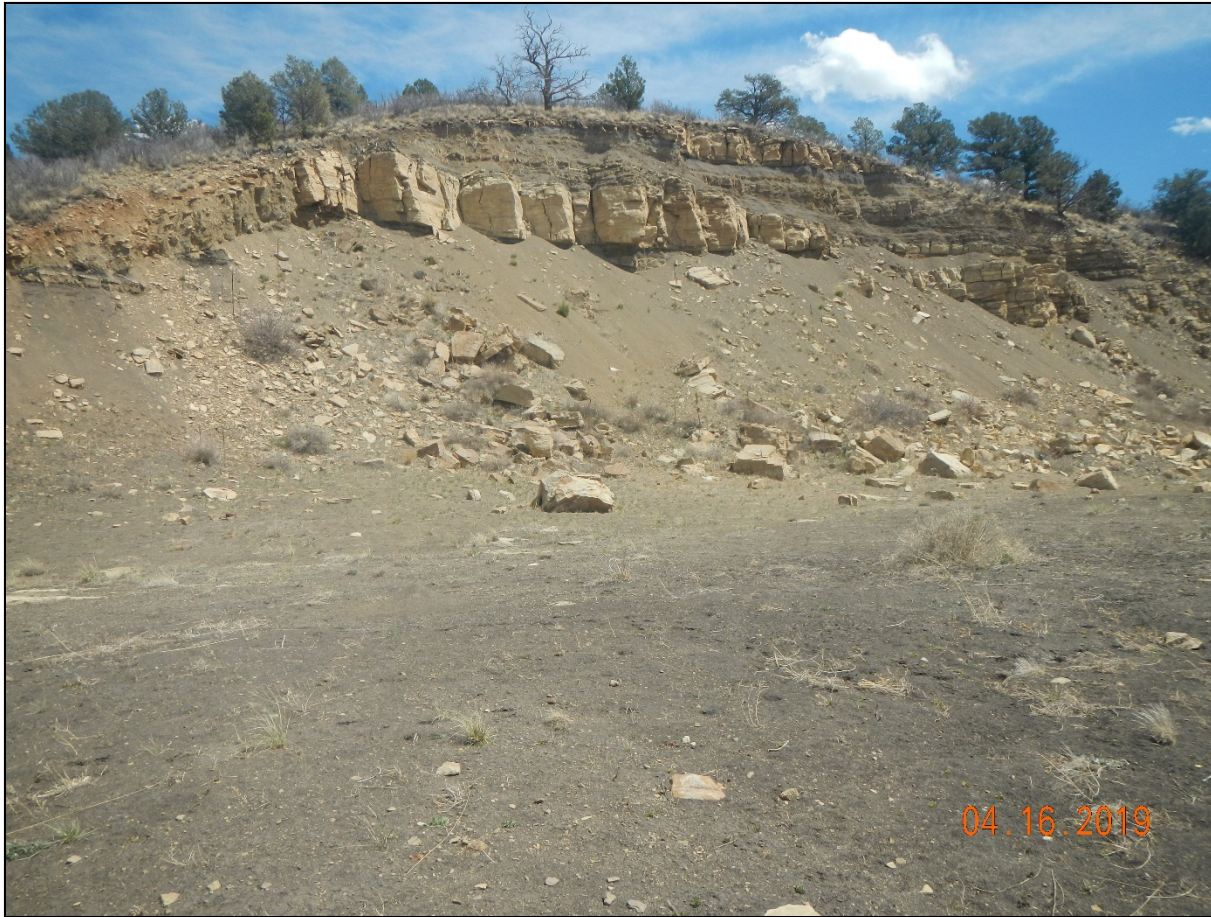
Photo 7. Facing towards the unstable vertical cut slope. Estimated to be 200' high.

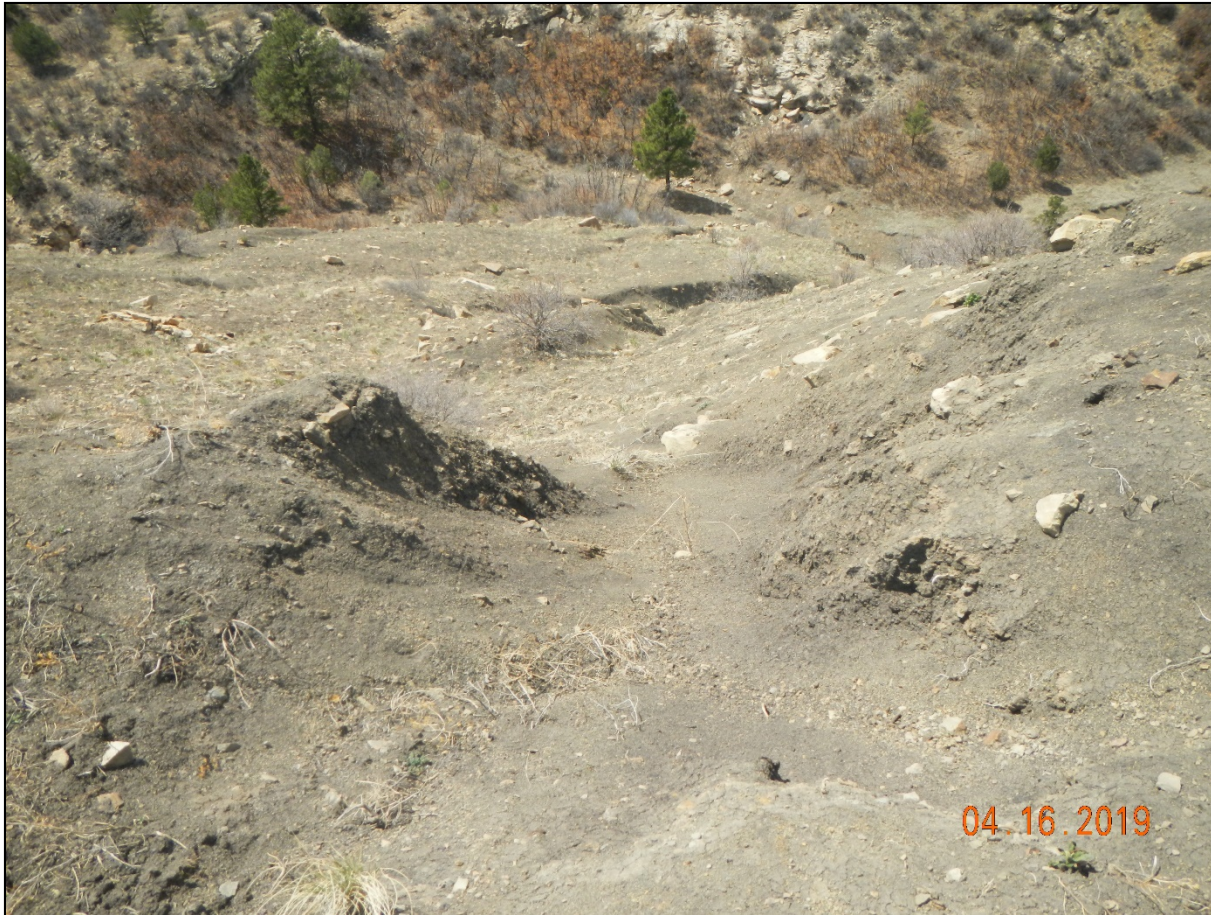
Photo 8. Facing down the fill slope shows signs of erosion.

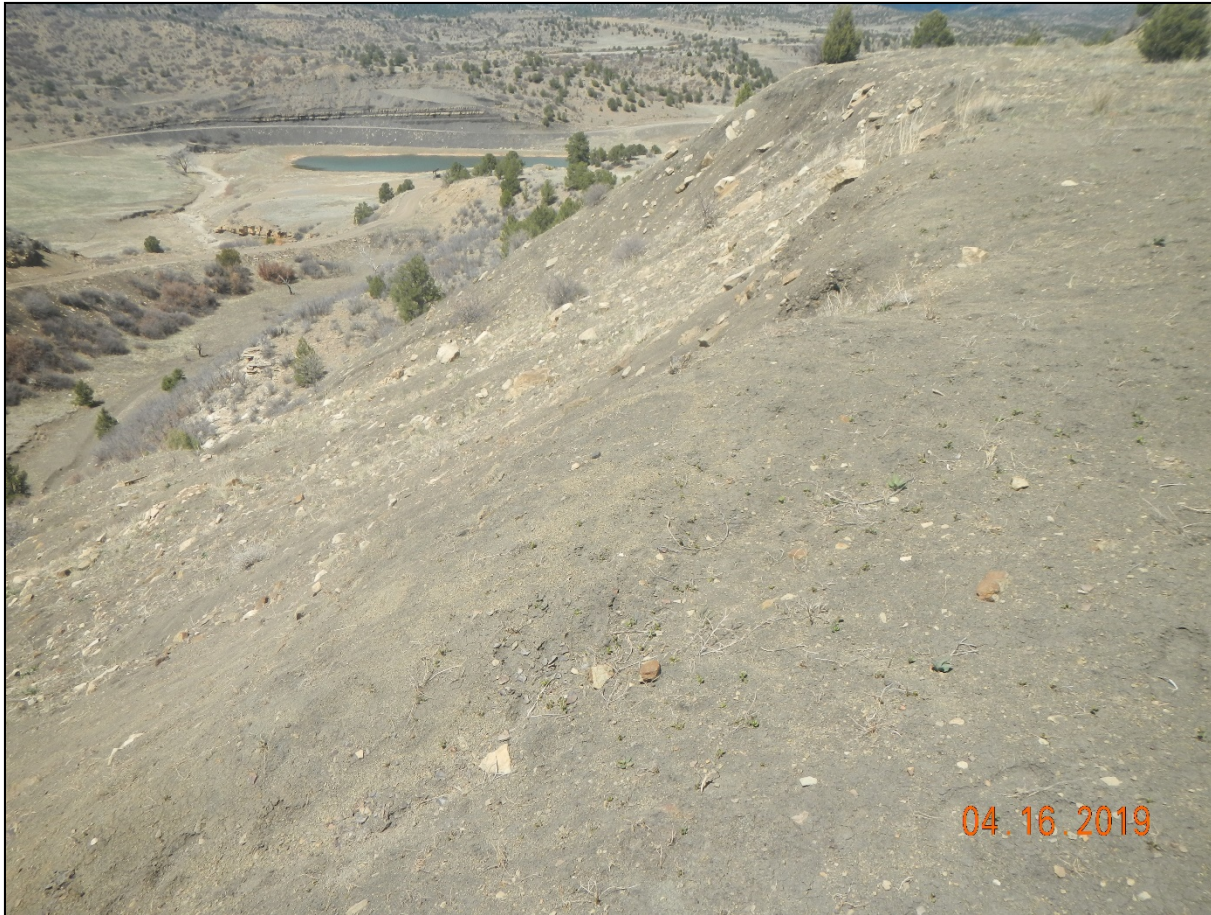
Photo 9. Facing toward the fill slope of the location.

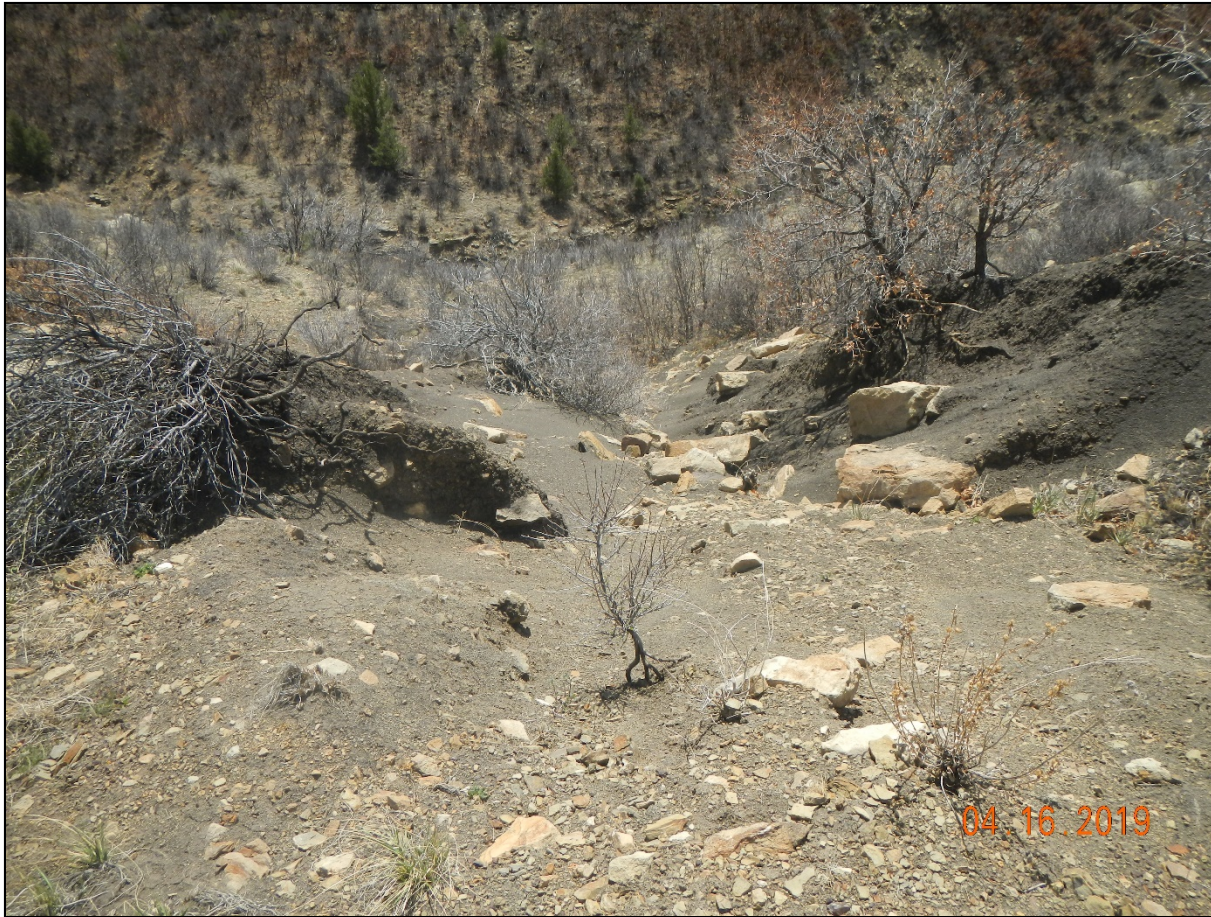
Photo 10. There is significant signs of erosion off the southeast fill slope.

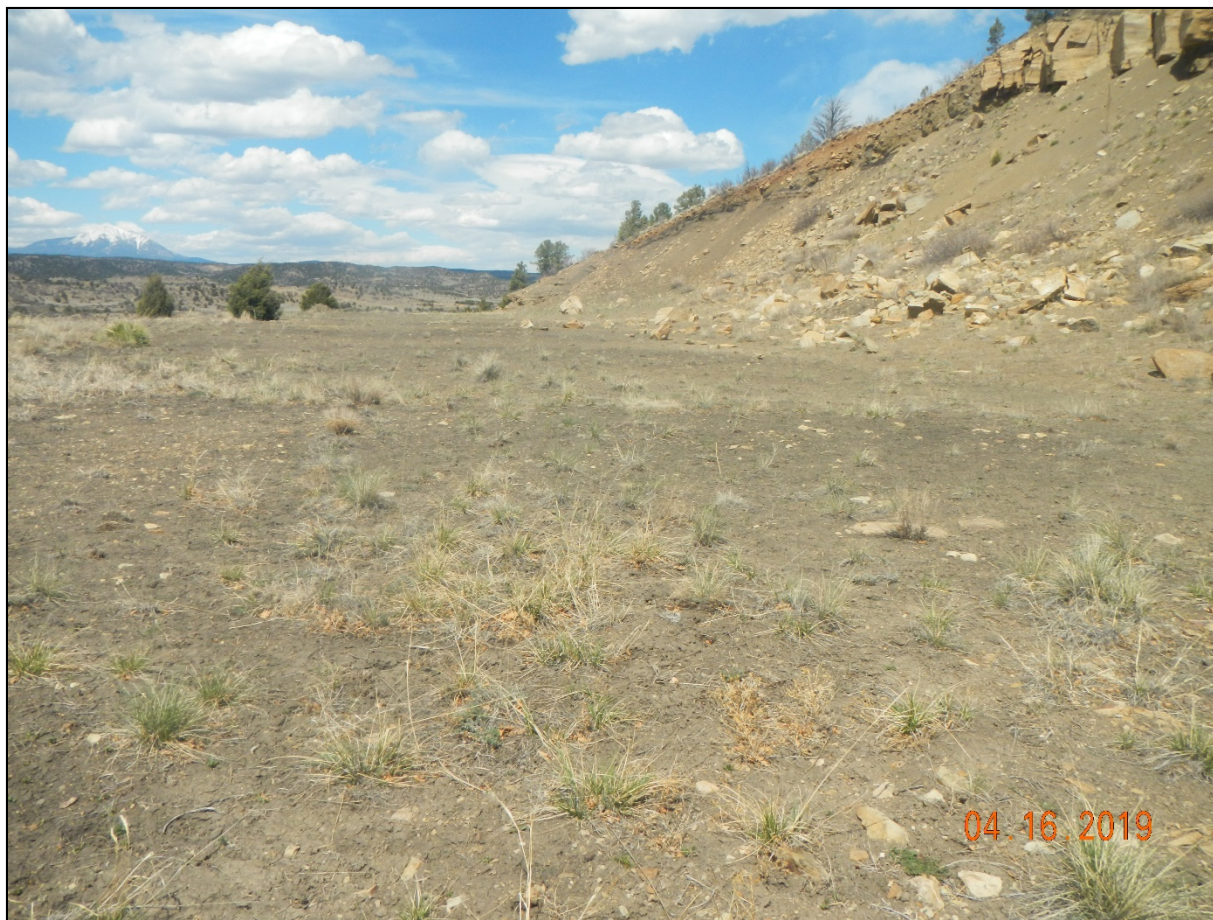
Photo 11. Facing north at the pad.

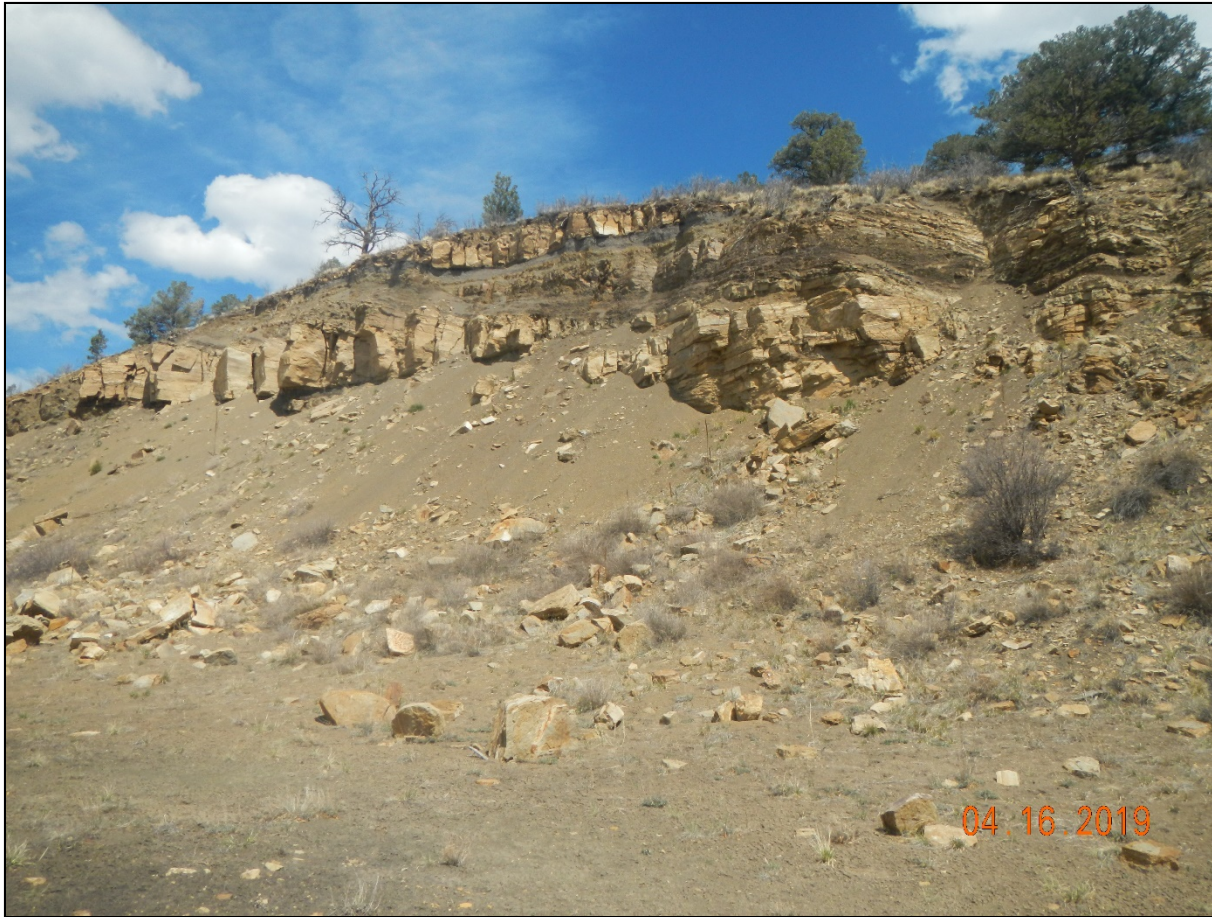
Photo 12. Facing towards the unstable vertical cut slope. Estimated to be 200' high.

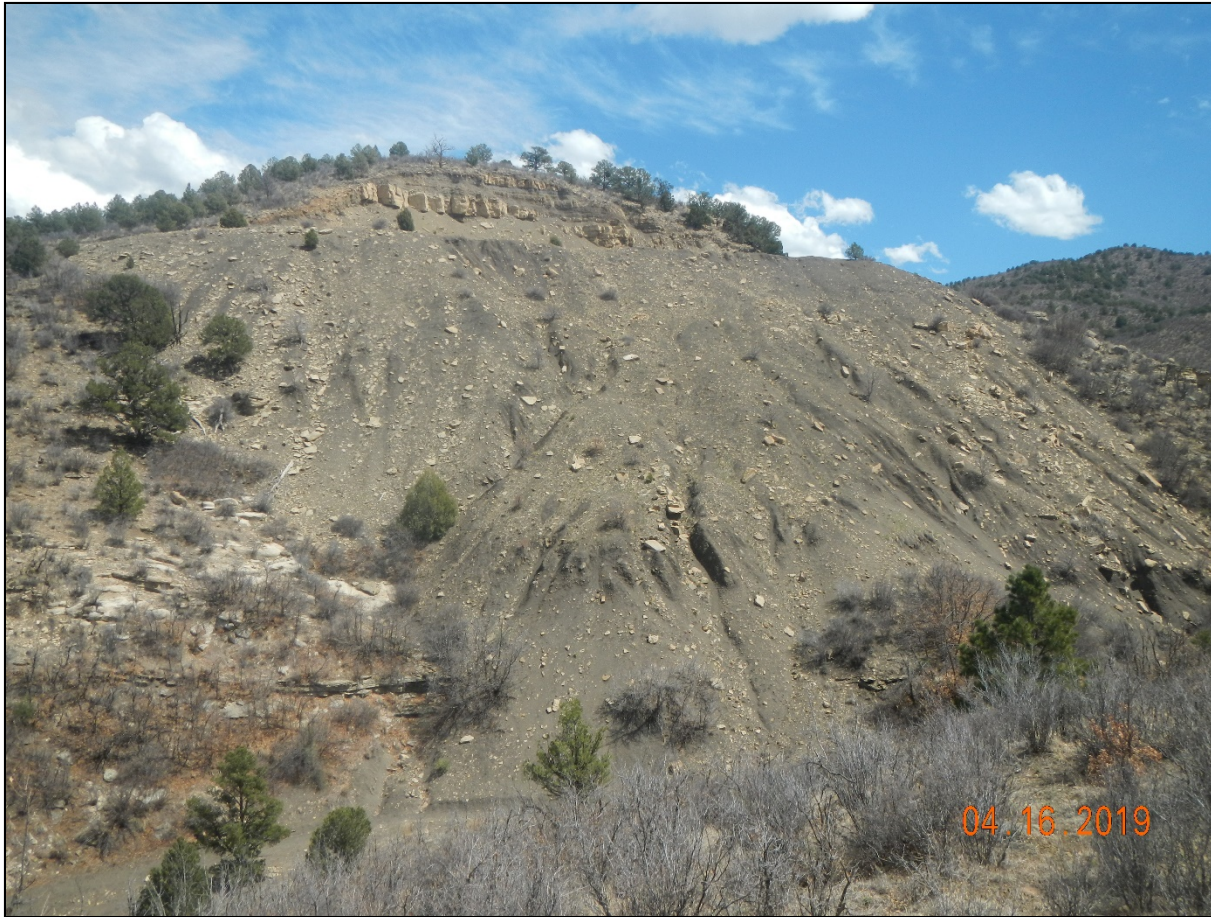
Photo 13. Facing east toward the location from across the canyon. The fill slope is not stabilized and shows signs of erosion. Location not recontoured.
