Inspection Photos
Location Name: Maylon Scow Pilcher #1
API: 05-083-06418

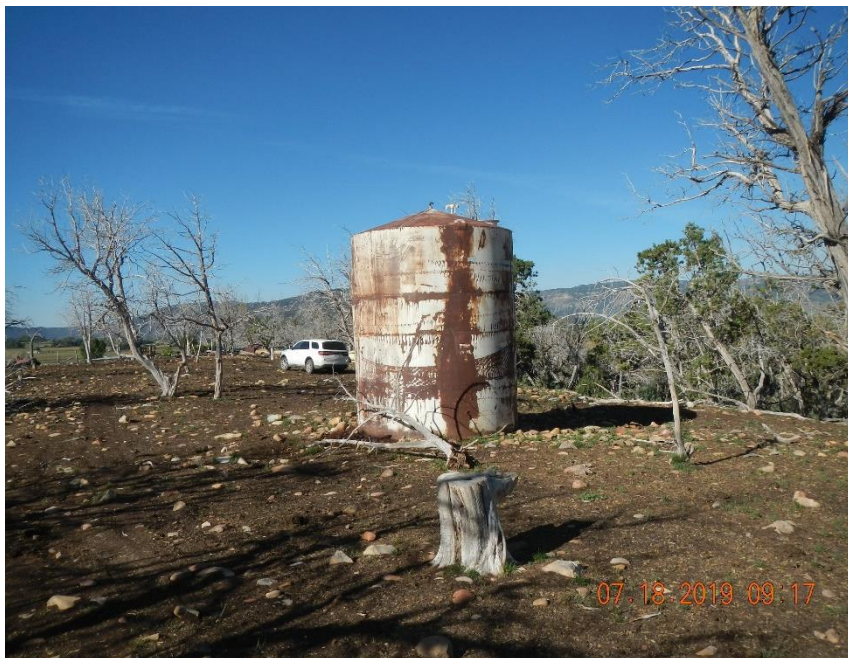
Location ID #393155 with 200 bbl. AST.

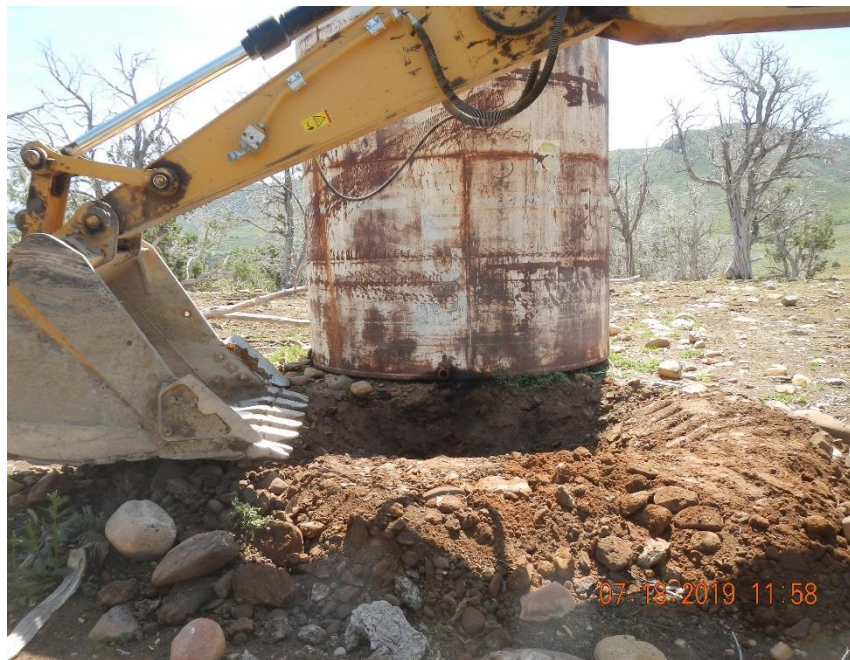
Track hoe excavating containment area.

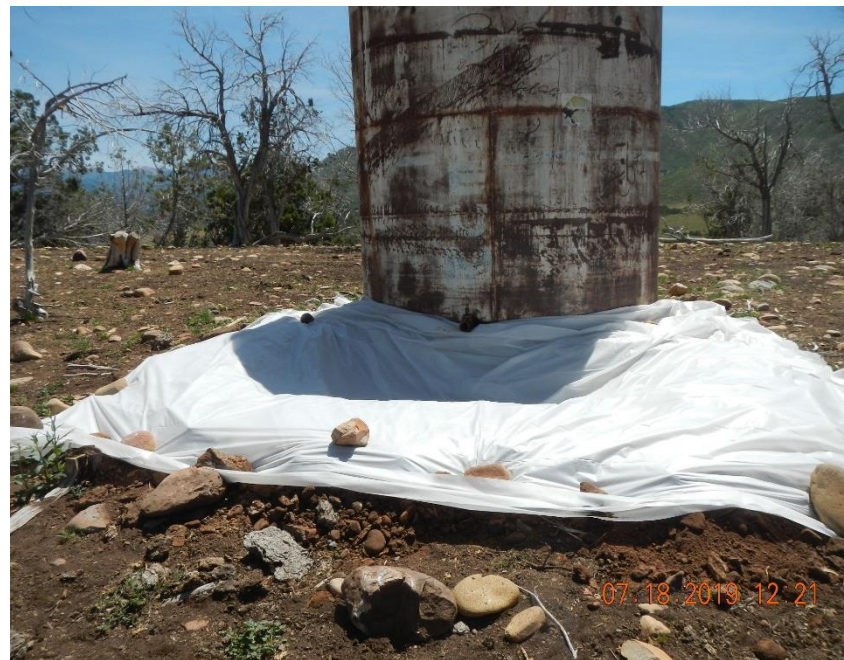
Containment area lined with plastic sheeting.

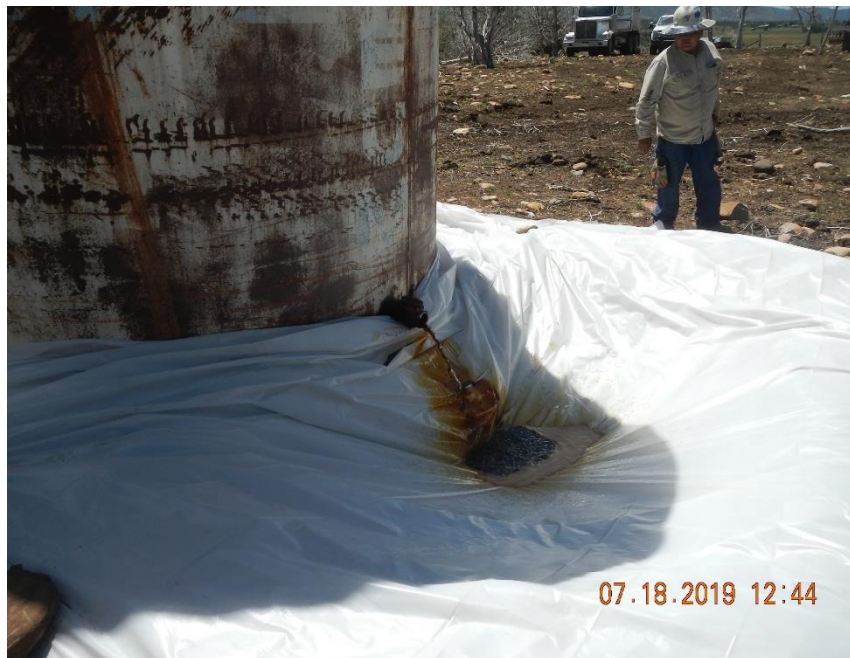
Load out valve opened.

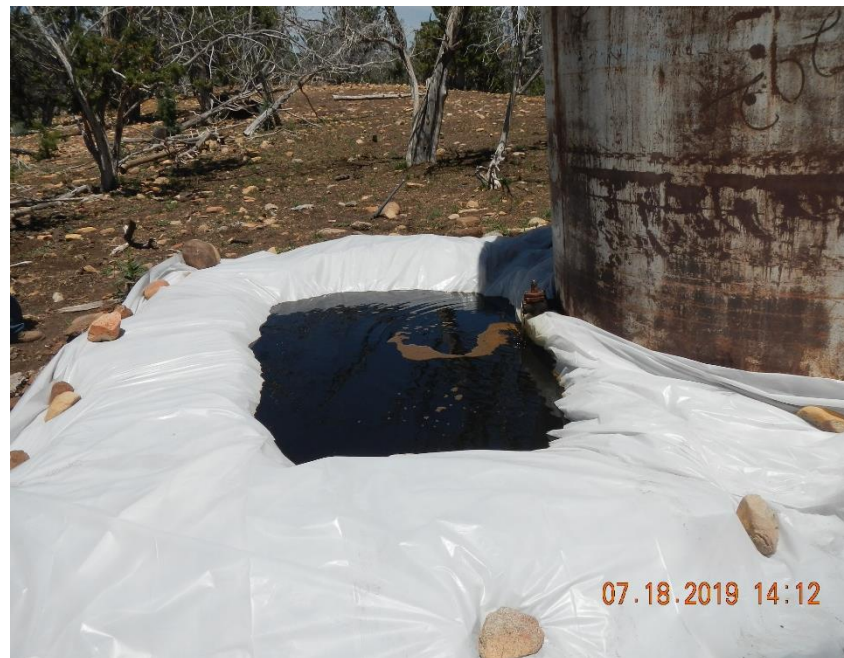
Fluids drained from AST.

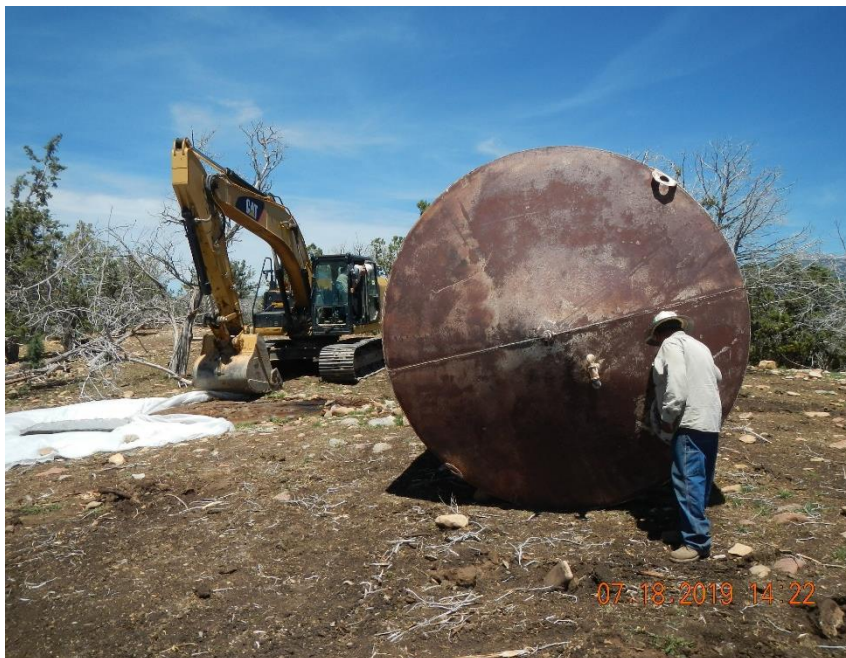
AST knocked over by track hoe.

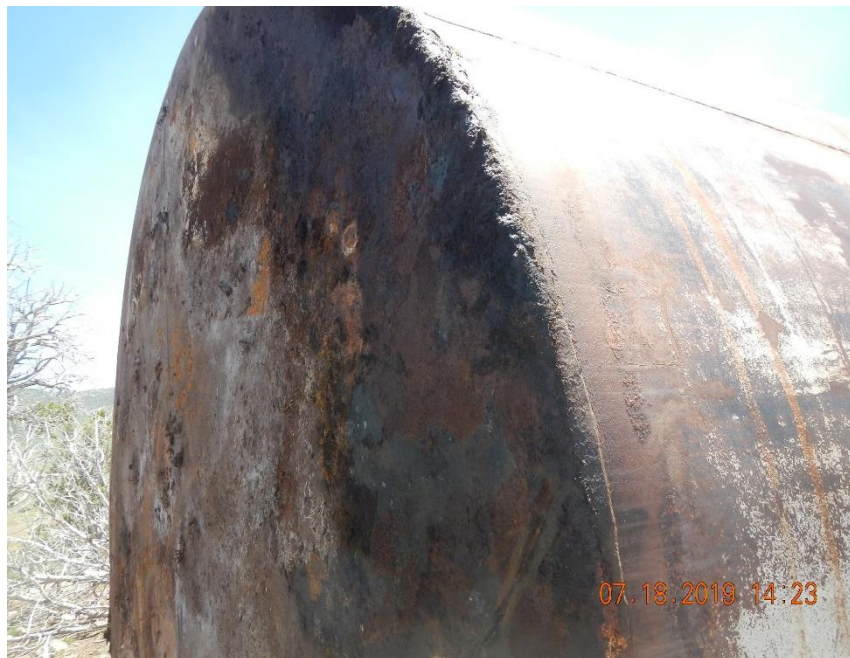
Corrosion along bottom seam of AST.

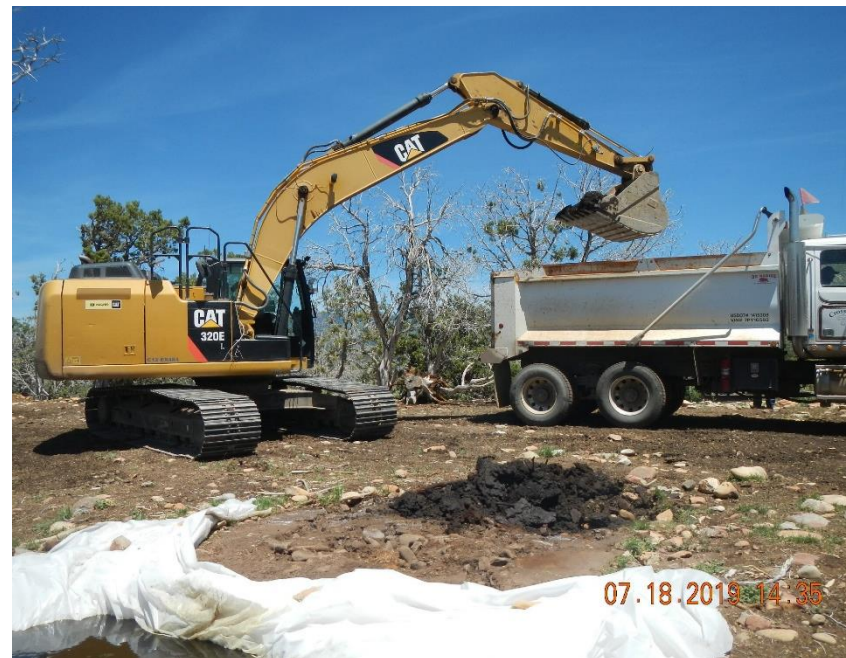
Excavating impacted material.

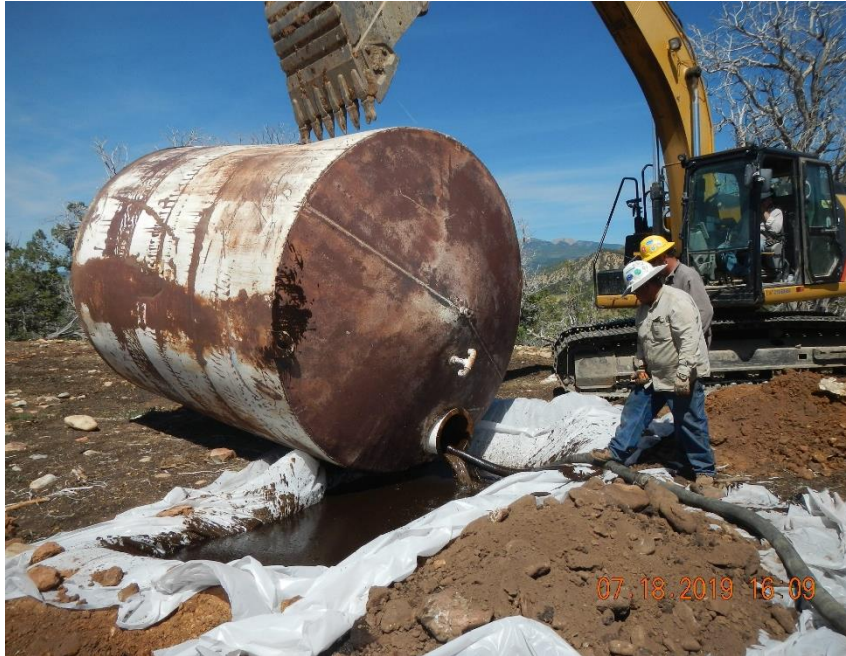
Flushing residue from AST.

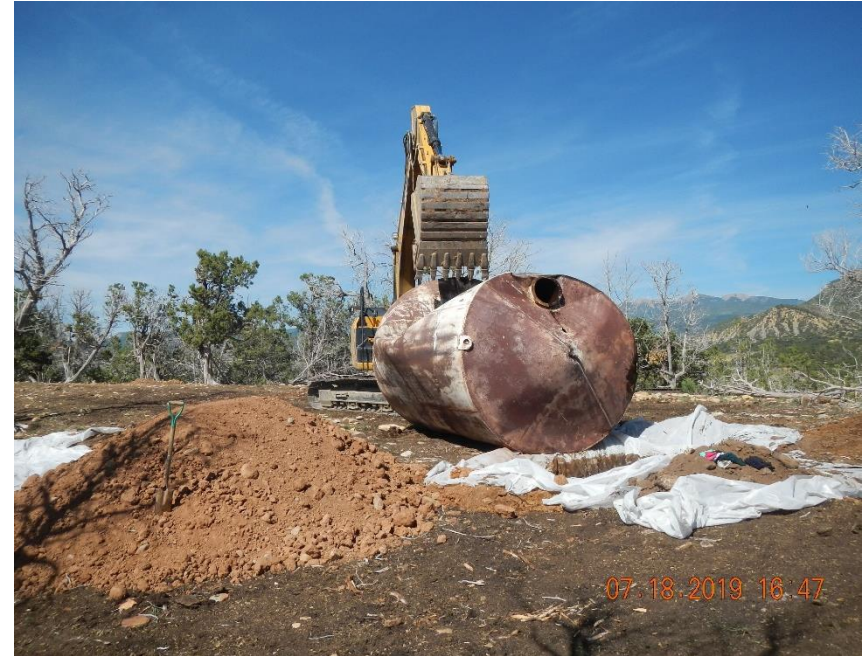
Track hoe demolishing AST.

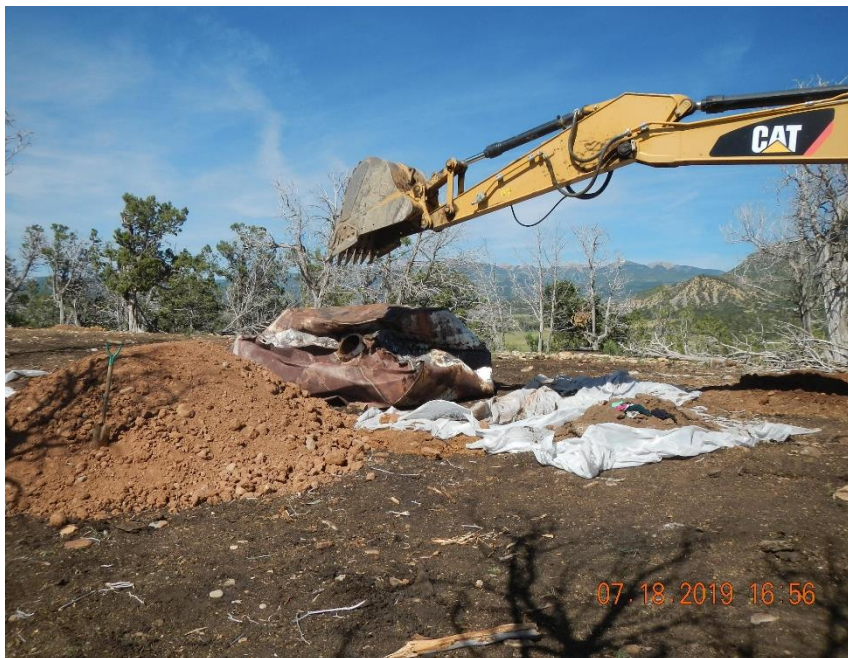
AST crushed into size to transport.

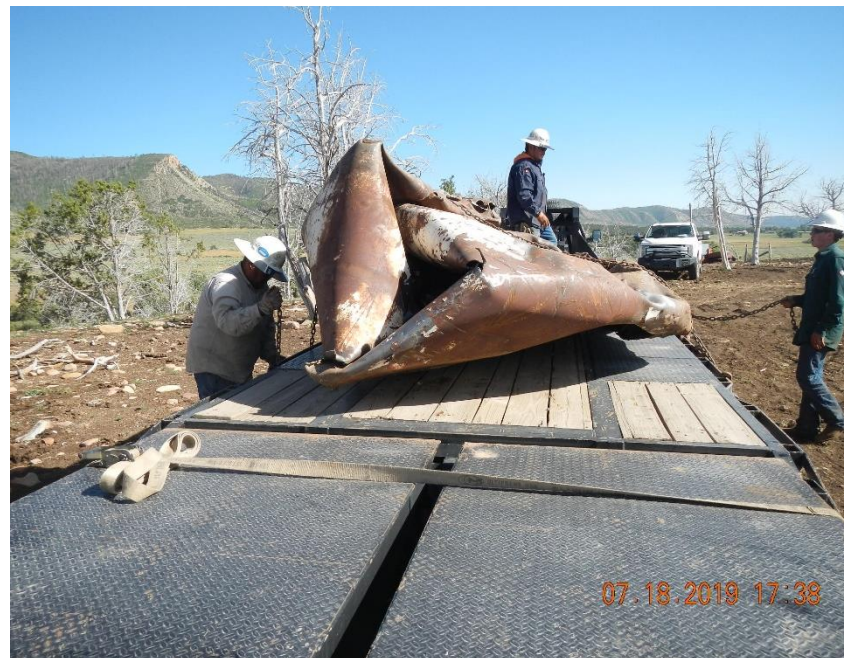
AST loaded onto flat bed trailer.

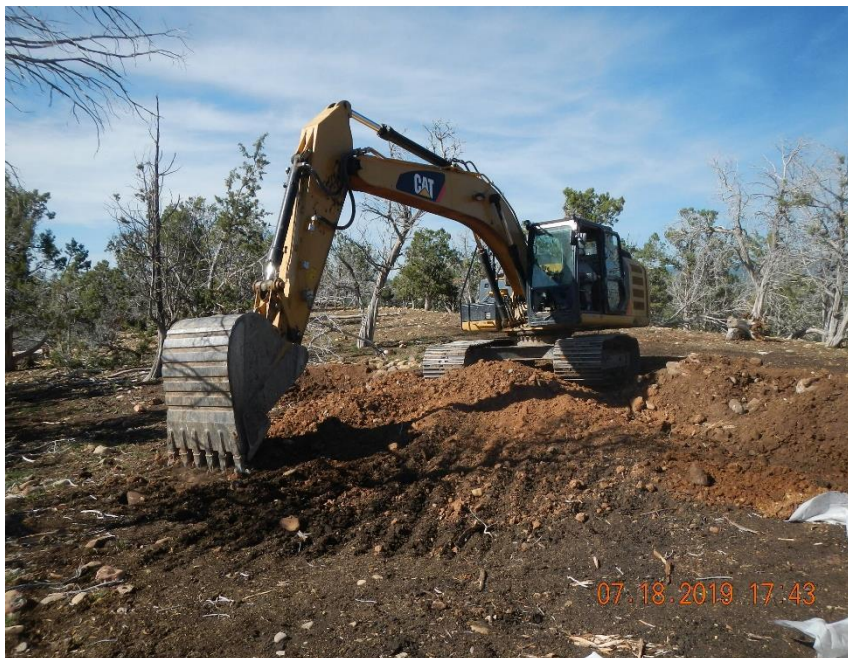
Excavated area backfilled with clean fill.

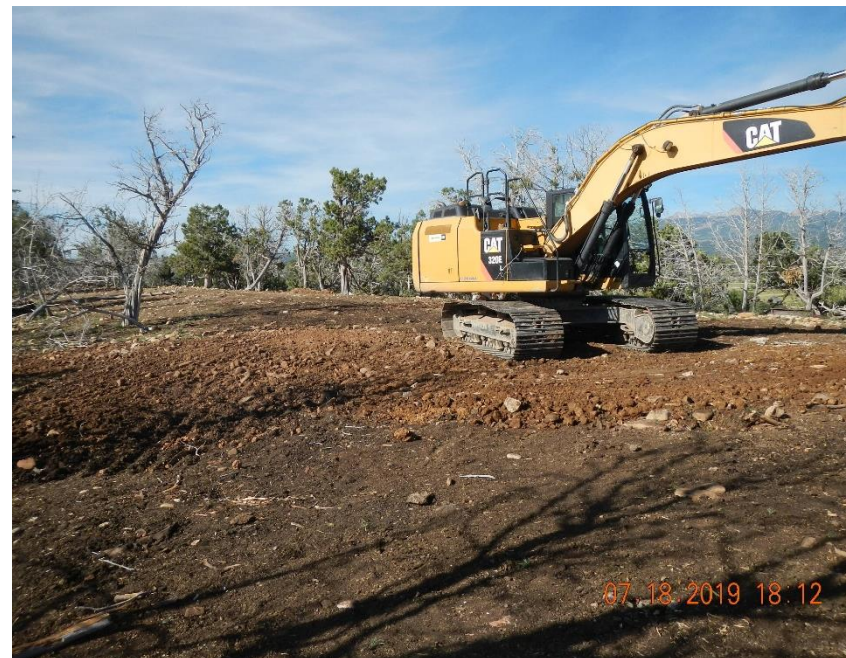
Project area returned to contour.
