**Inspection Photos**  
**Operator: Enduring Resources**  
**Location/API #: 067-08400**  
**Date: 7-18-2019**

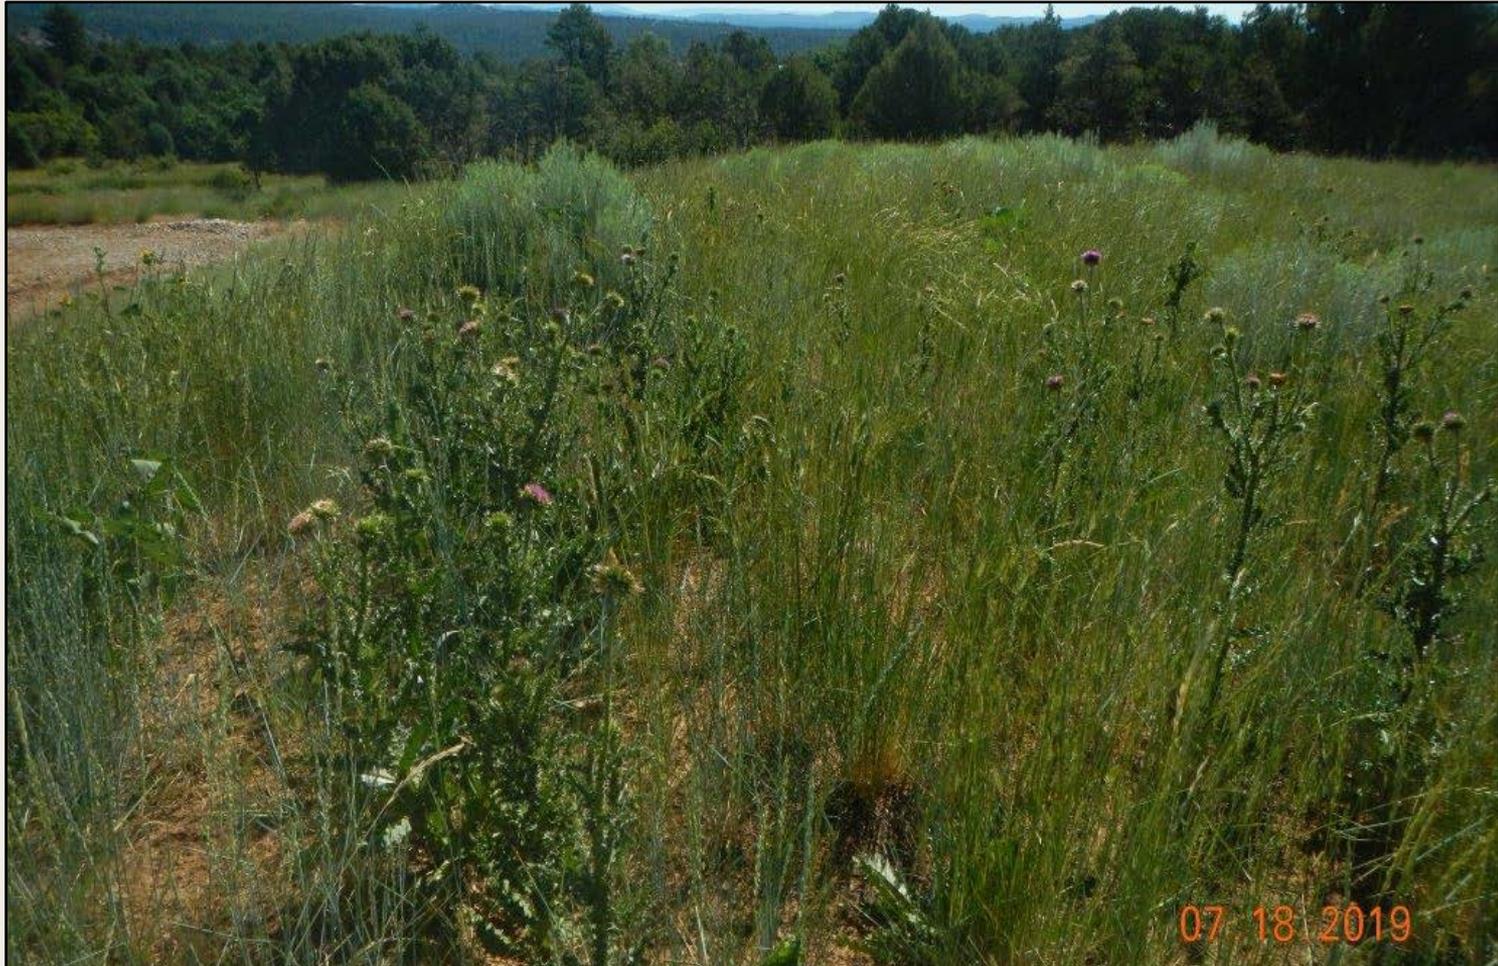
Photo 1. View of southern project area from the southwestern edge facing eastward. Hundreds of musk thistles (*Carduus nutans*) are blooming and need immediate control.

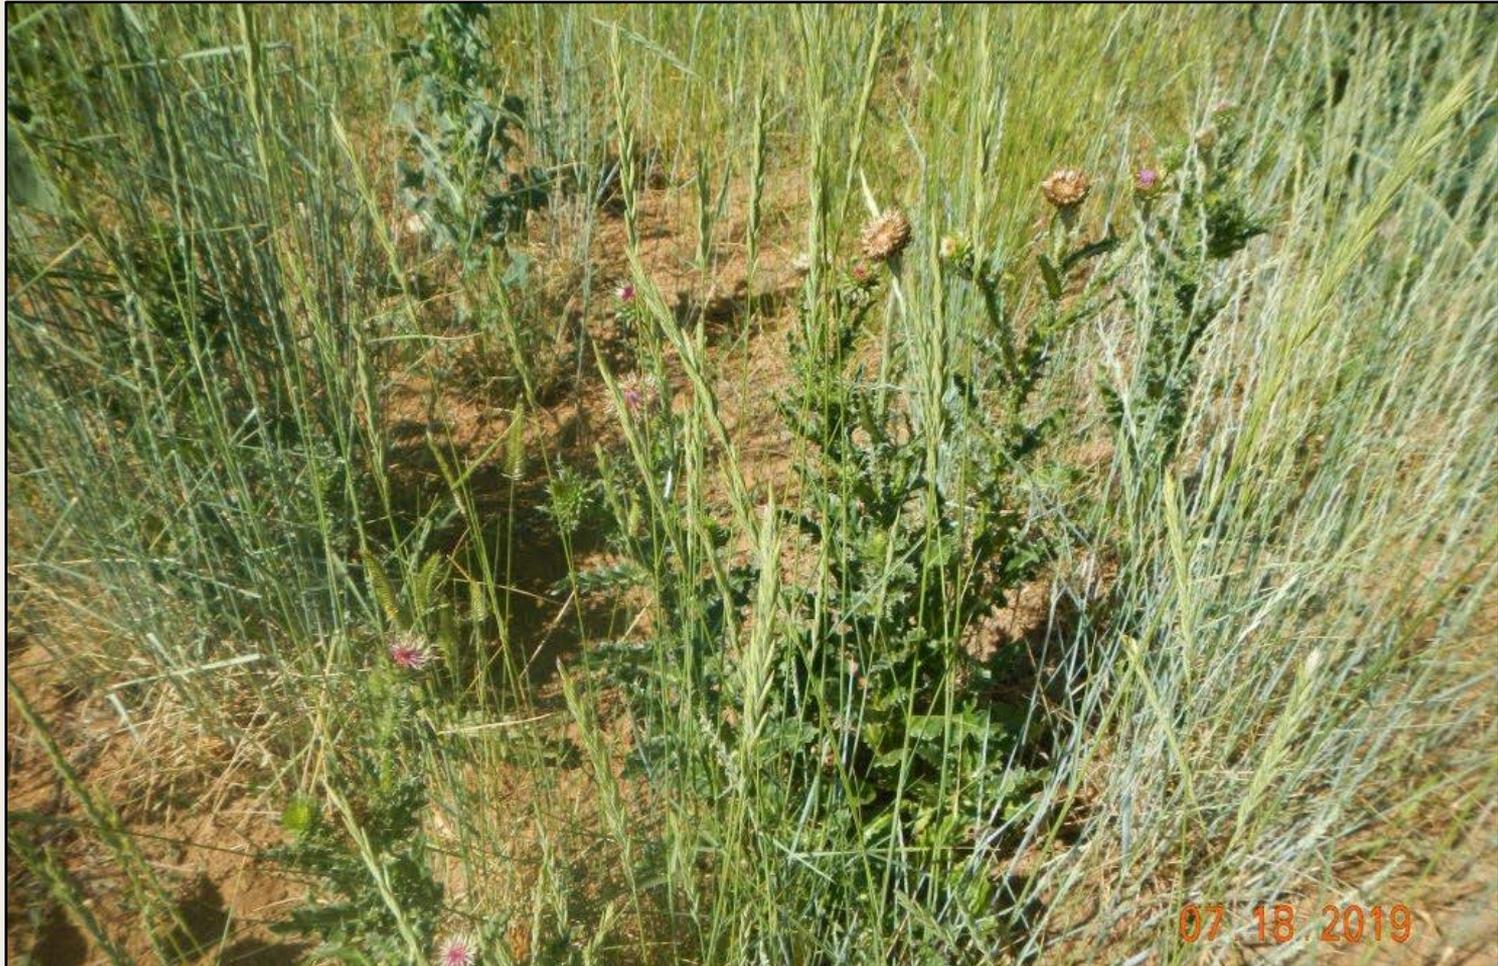
Photo 2. Closeup view of musk thistles within the southern project area.
