Inspection Photos

Operator: Enduring Resources
Location/API #: 067-07467
Date: 7-18-2019

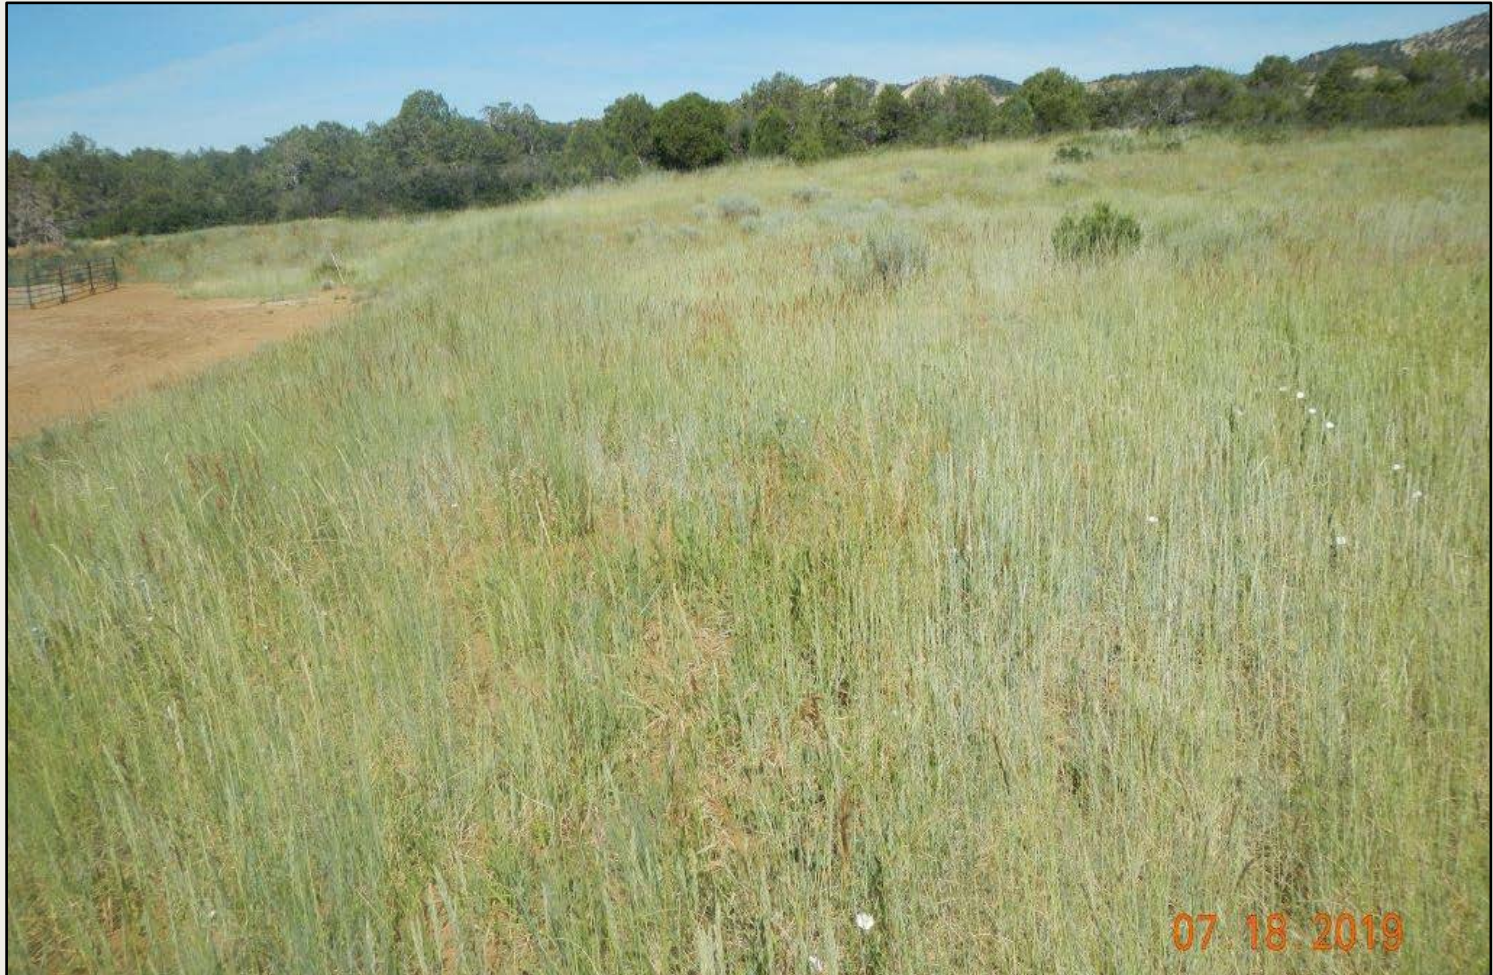
Photo 1. View of northern project area from the northeastern edge facing westward.

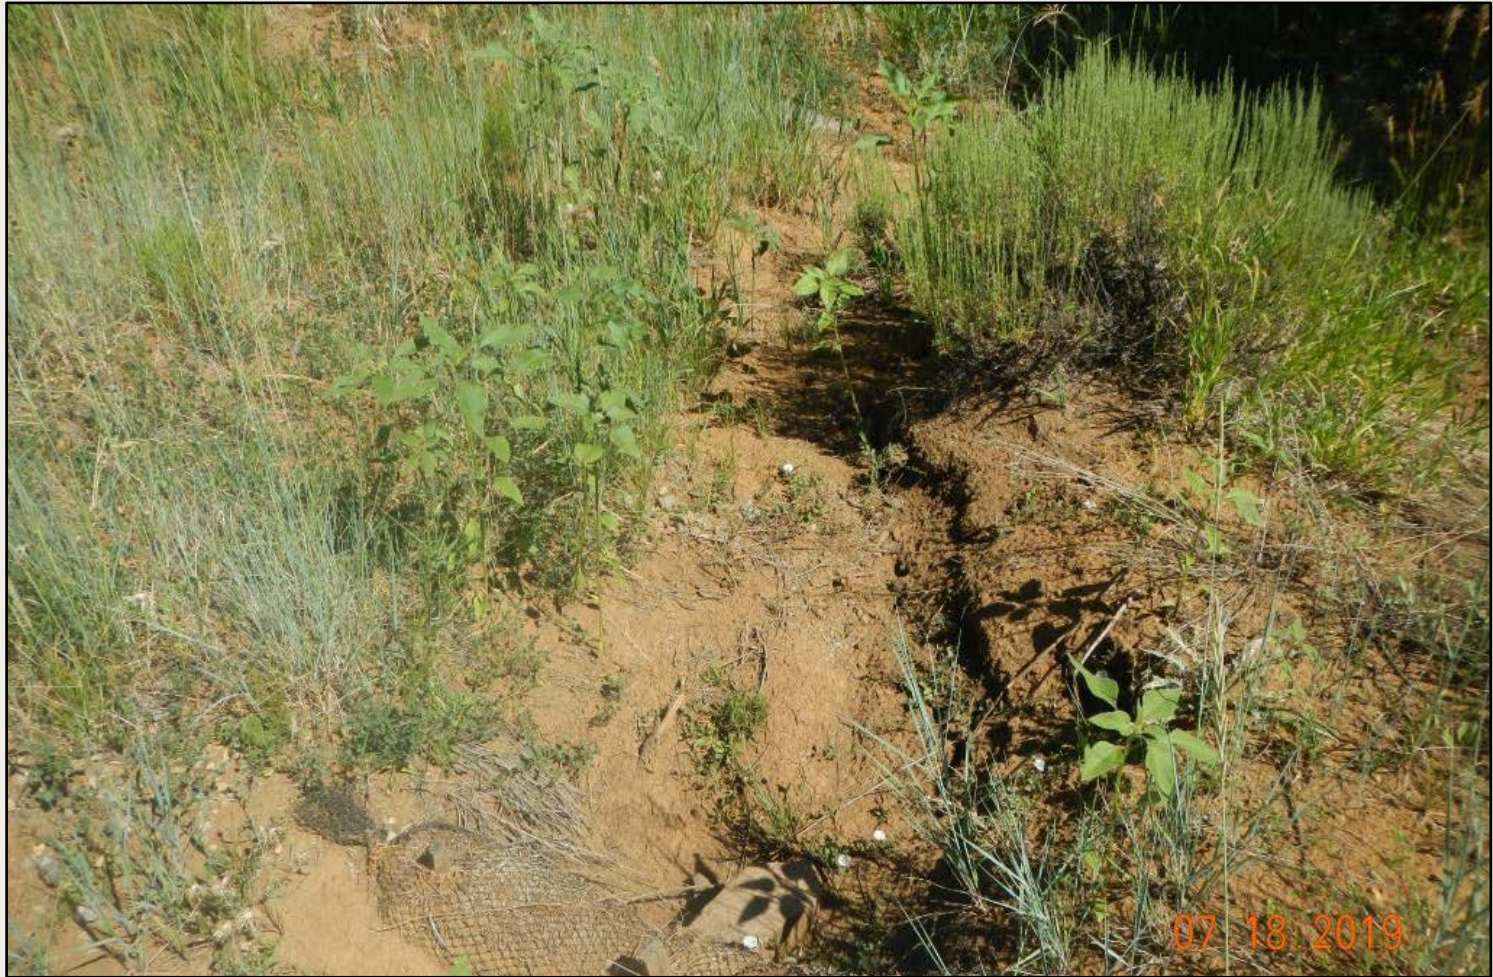
Photo 2. View of wattle full of sediment and erosional down-cutting downstream from culvert near well pad entrance.

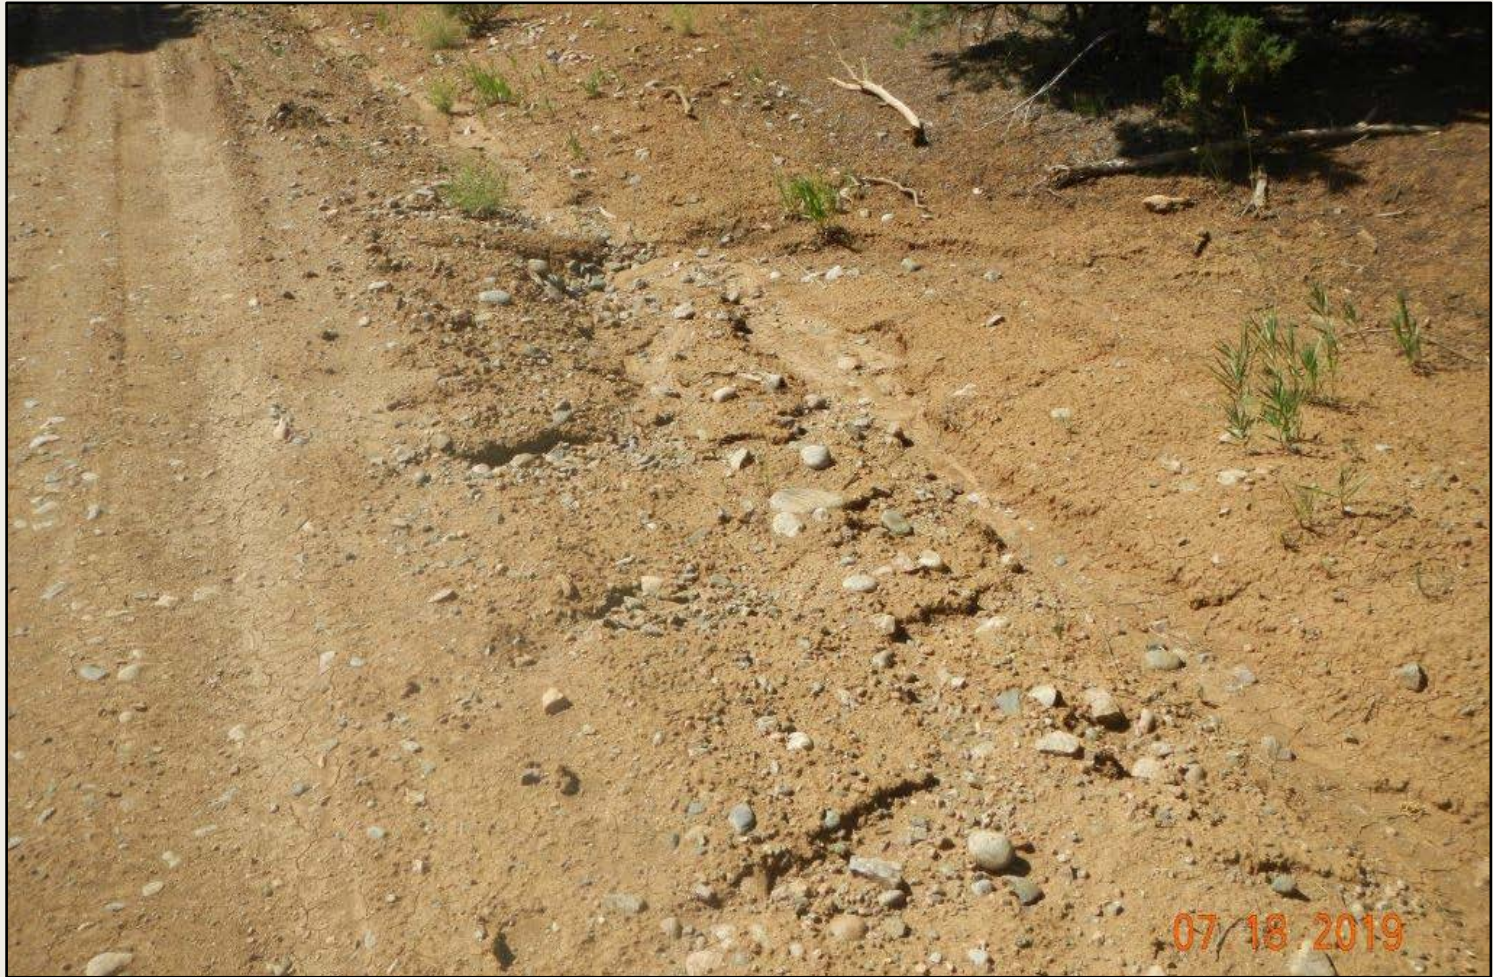
Photo 2. View of rilling and erosional down-cutting of bare soils along access road.

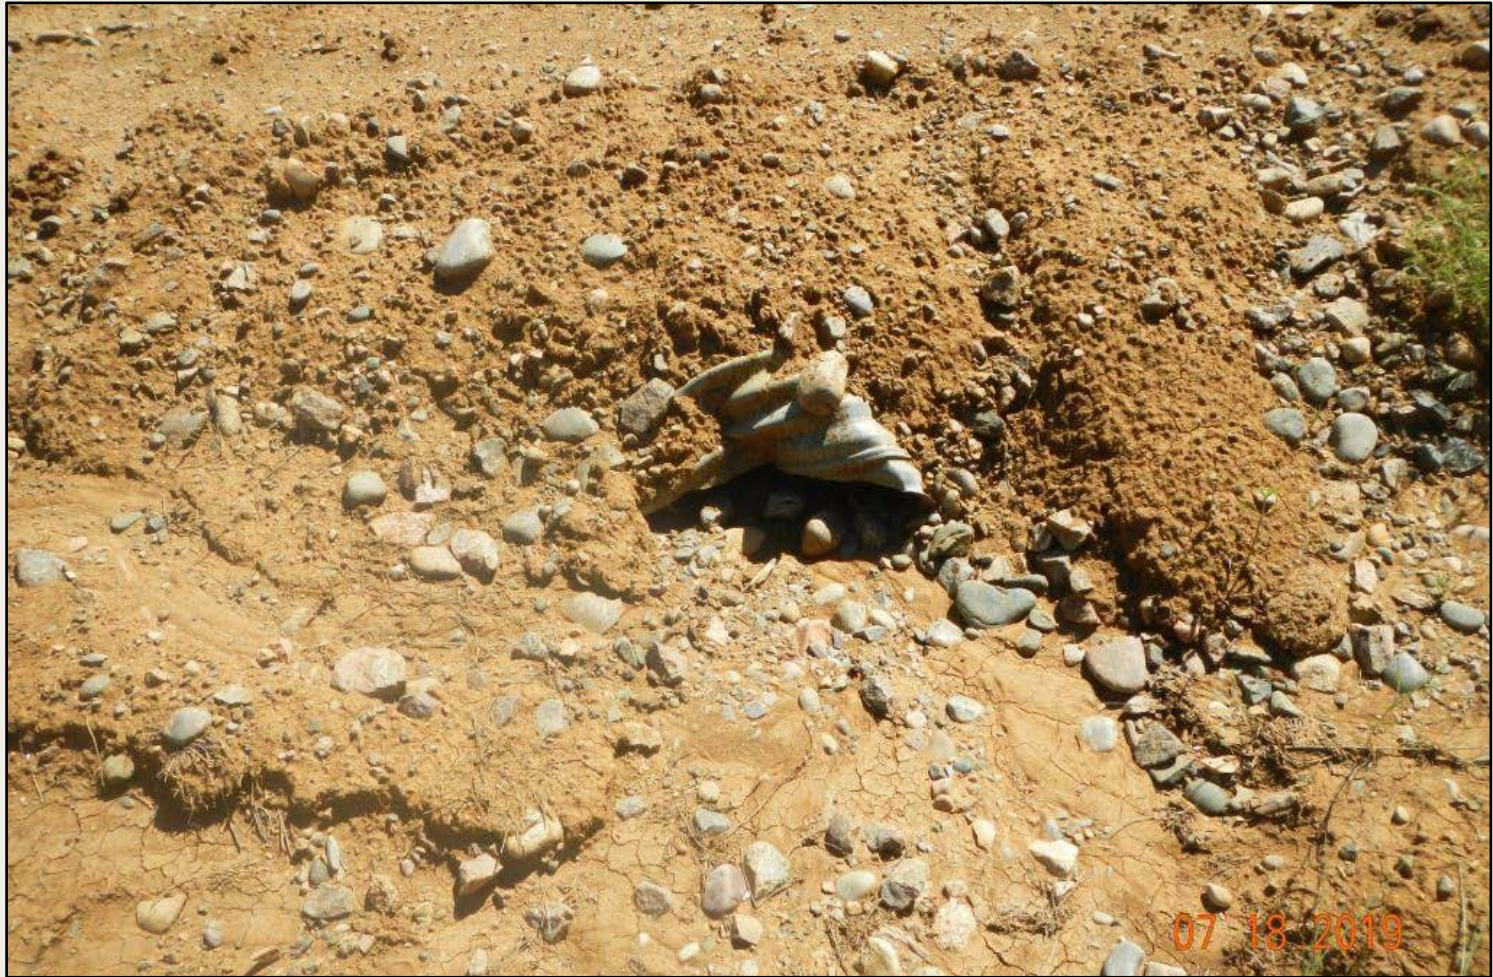
Photo 3. View of damaged culvert full of sediment and erosional rilling around culvert near the well pad entrance.
