Inspection Photos
Operator: Enduring Resources
Location/API #: 067-06894
Date: 7-18-2019

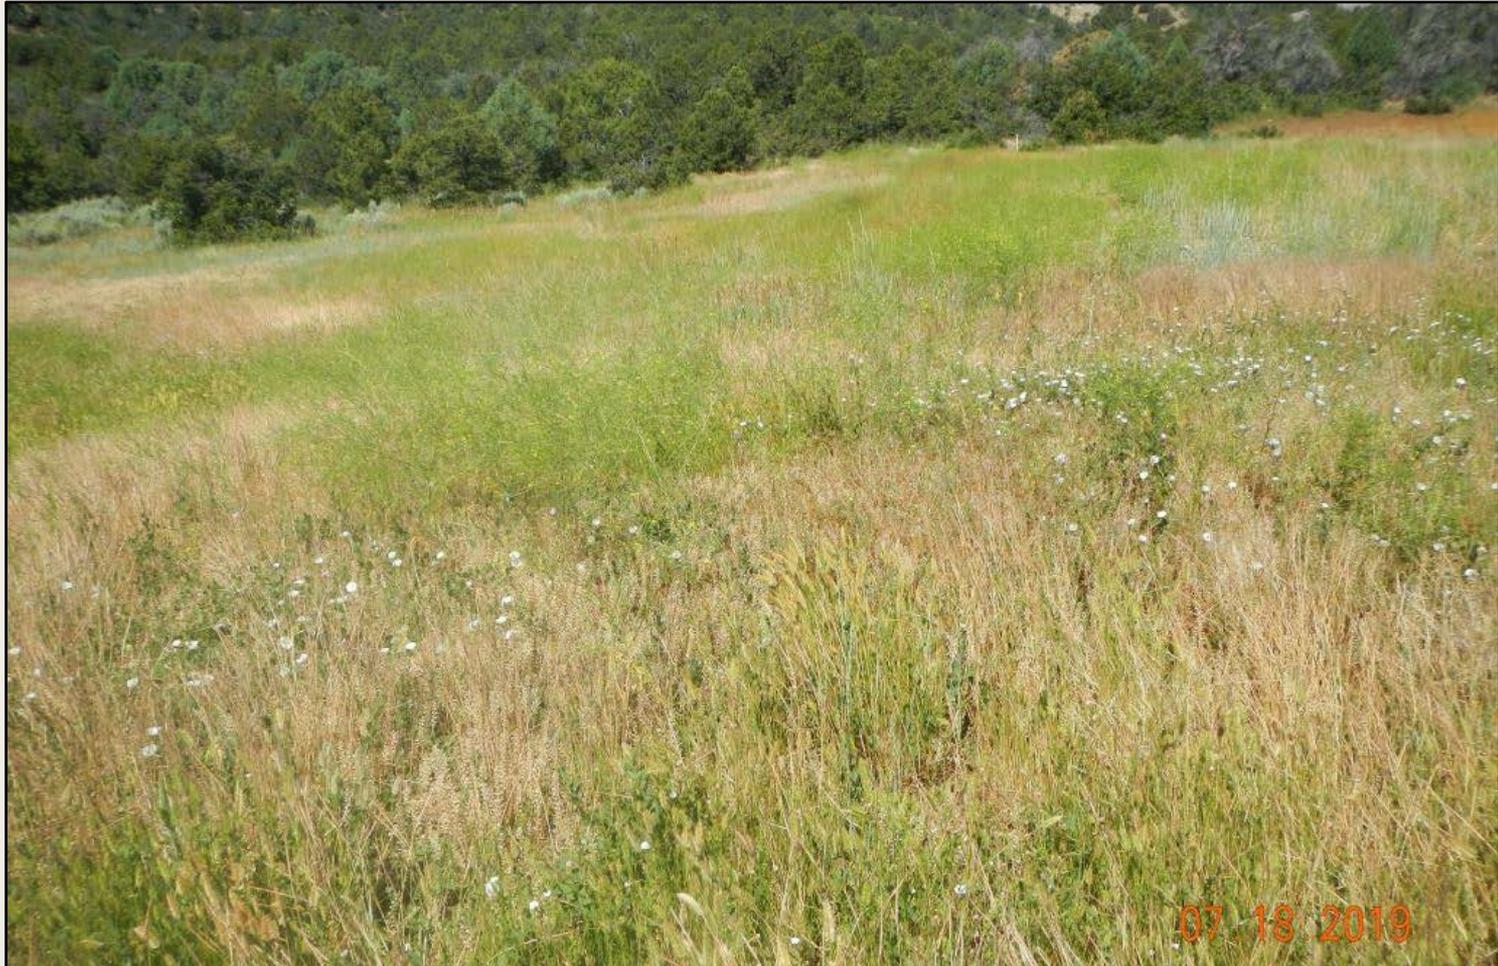
Photo 1. View of the southern project area from the southeastern edge facing westward.

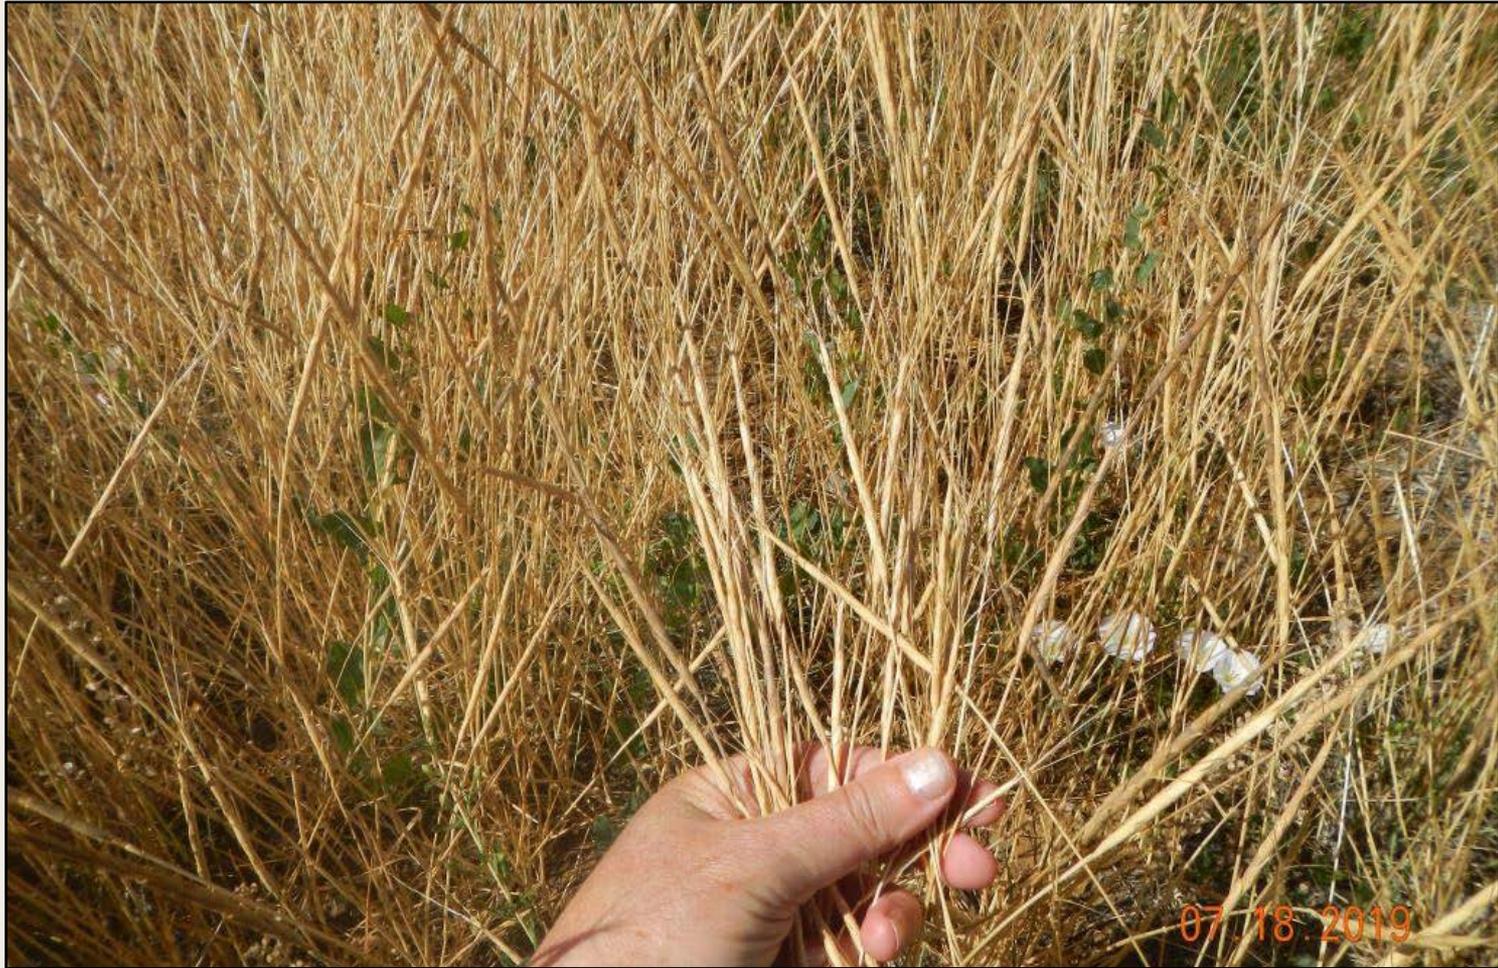
Photo 2. Closeup view of jointed goatgrass (*Aegilops cylindrica*) that is infested within the project area.

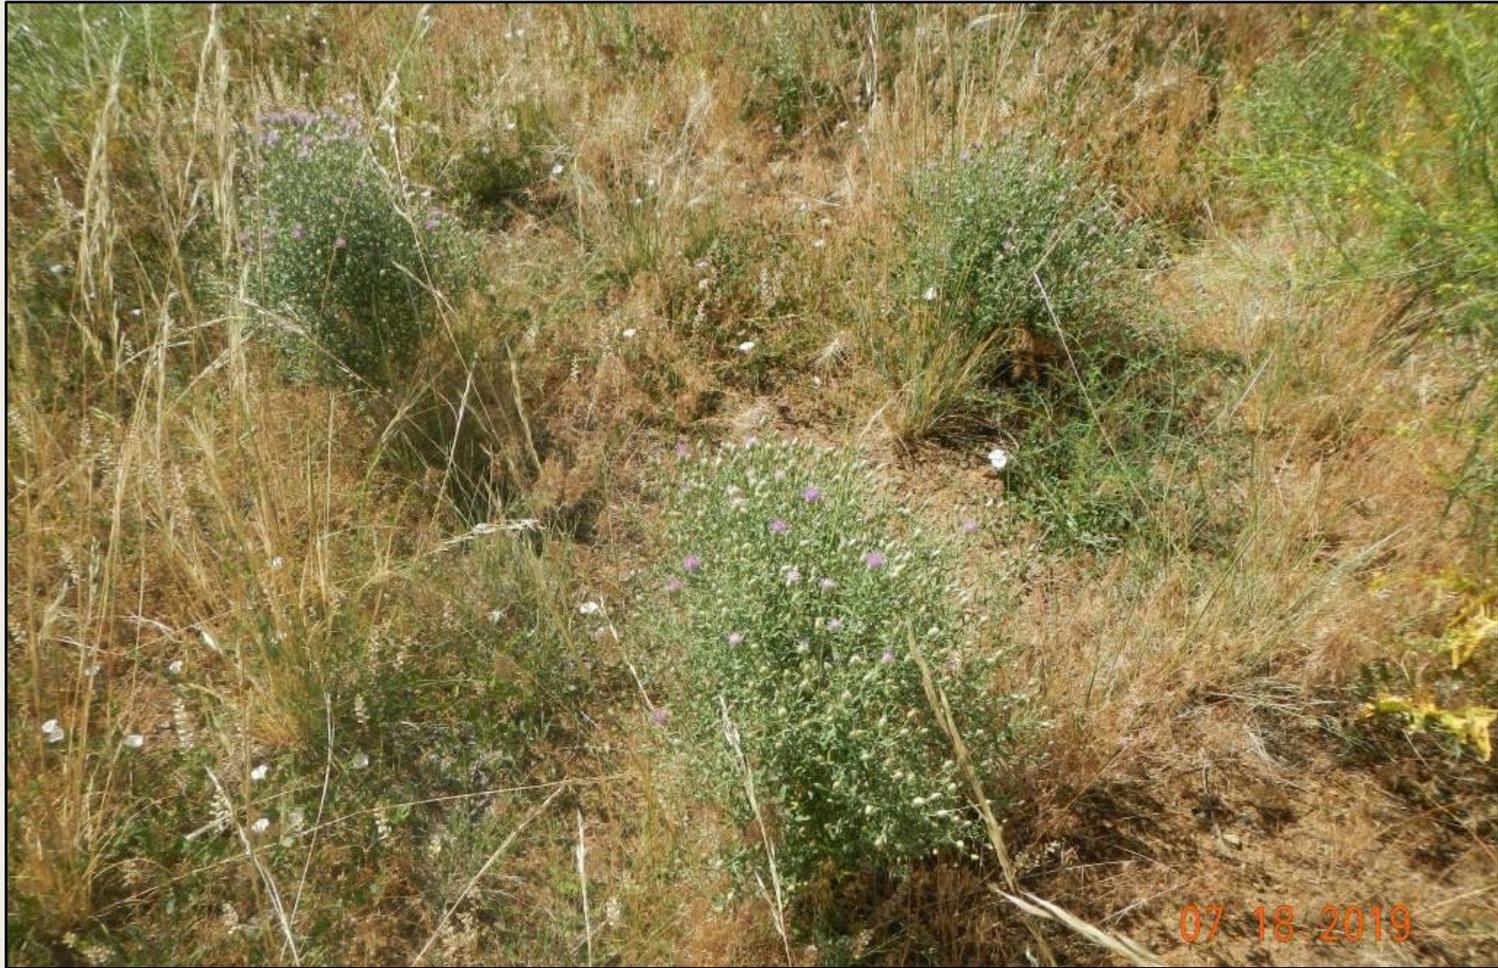
Photo 3. View of Russian knapweeds (*Rhaponticum repens*) within the southeastern project area.

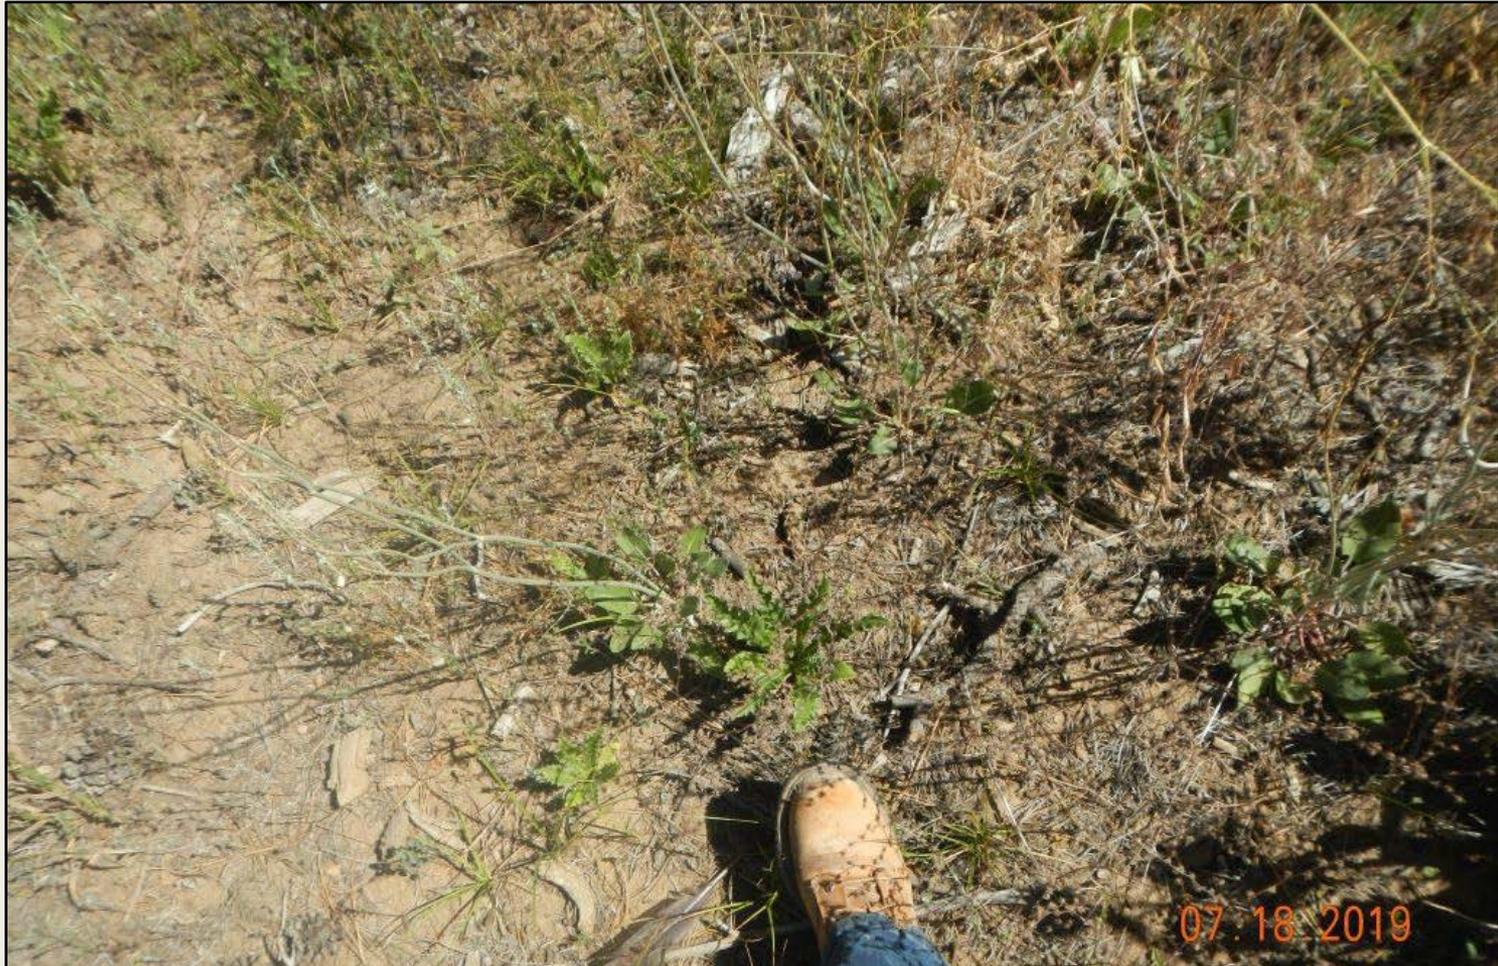
Photo 4. View of musk thistles (*Carduus nutans*) along the access road.
