Inspection Photos
Location Name: SUMMERS 21-19 TR
API#: 05-071-09149
INSP. #: 695101108

Location Name: SUMMERS 21-19 TR

API#: 05-071-09149

INSP. #: 695101108

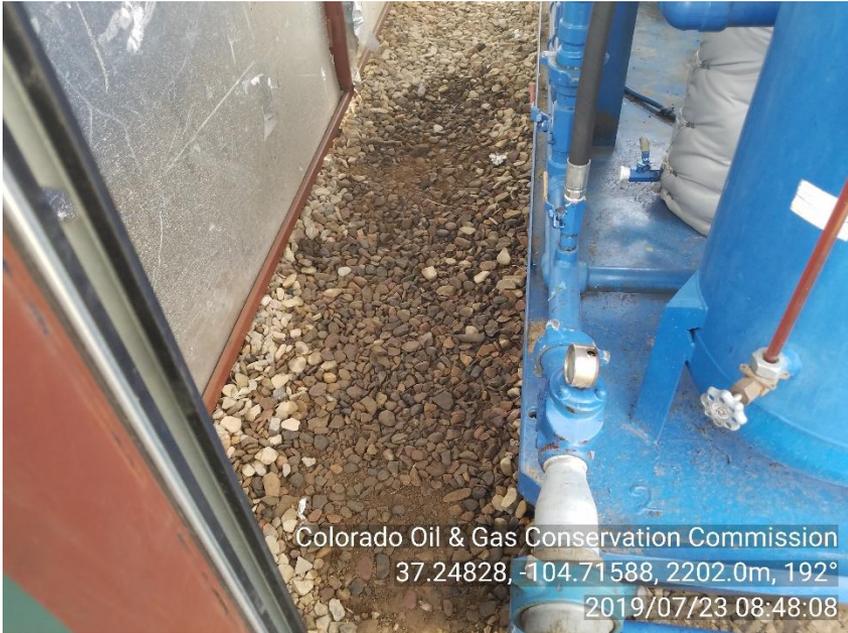
PHOTO 3: AREA OF IMPACTED SOIL INSIDE COMPRESSOR HOUSE APPEARS TO BE OIL STAINING FROM COMPRESSOR. Remove and dispose impacted material in approved manner, service and maintain equipment and self inspect to prevent recurrence of conditions per 1002.f(2) and 907. CA DATE 8/23.19.

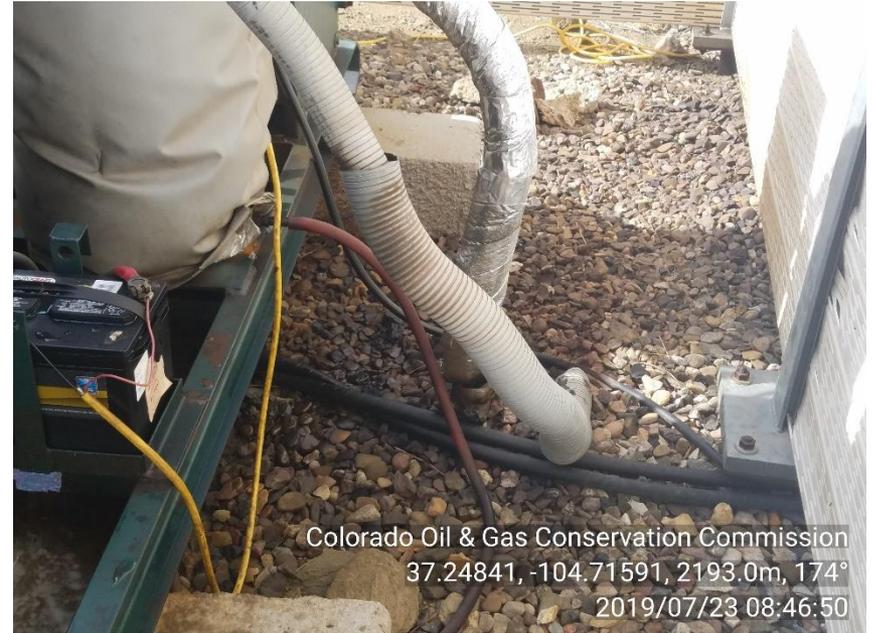
PHOTO 4: VALVE ON ENGINE SKID WAS LEAKING THERE IS AN AREA OF IMPACTED SOIL NEAR LEAKING VALVE. Increase frequency of maintenance and self inspection schedule of equipment to prevent impacting surface materials and mixing of wastes with precipitation. Securely fasten all valves, pipes, and fittings to ensure good mechanical condition, inspect at regular intervals and maintain in good mechanical condition per Rule 605.d. CA DATE 8/23/19.

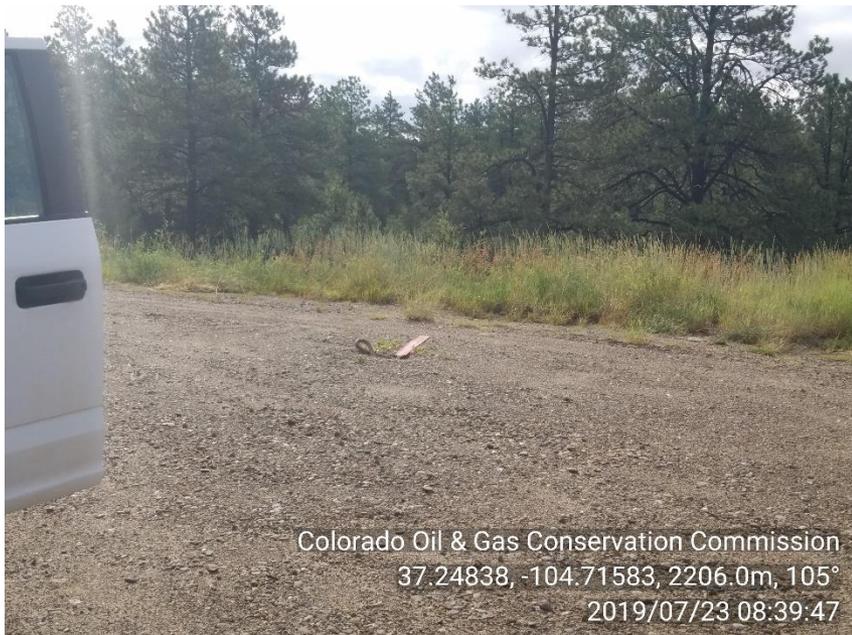
PHOTO 5: GUY LINE ANCHOR MARKER IS DOWN. REINSTALL GUY LINE ANCHOR MARKER. COMPLY WITH RULE 1003. CA DATE 8/23/19.

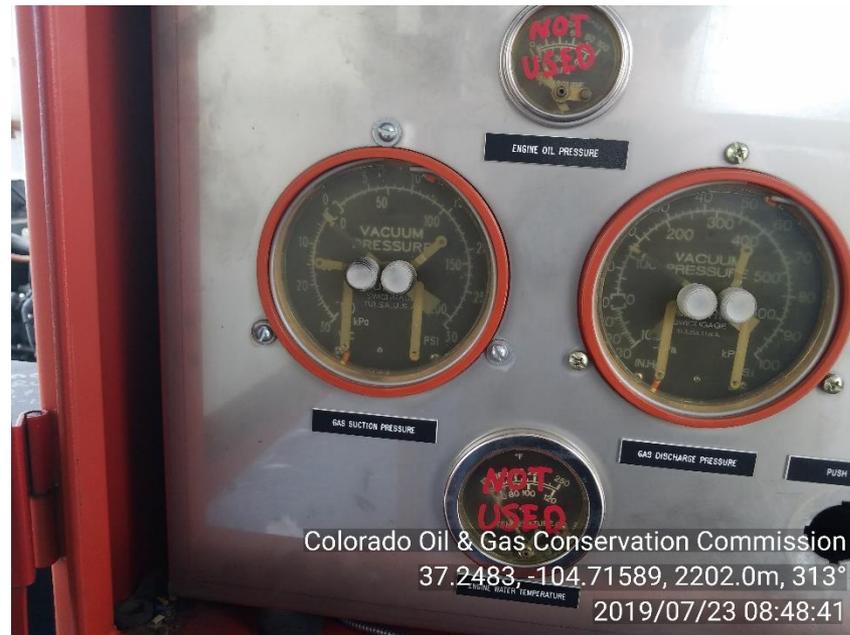
PHOTO 6: Vacuum pump observed on well without COGCC approval. Provide COGCC with documentation showing approval of use of vacuum pump. CA DATE 8/8/19.
