Inspection Photos
Location Name: UPRR 23 Pan Am D 2
Location ID: 319939

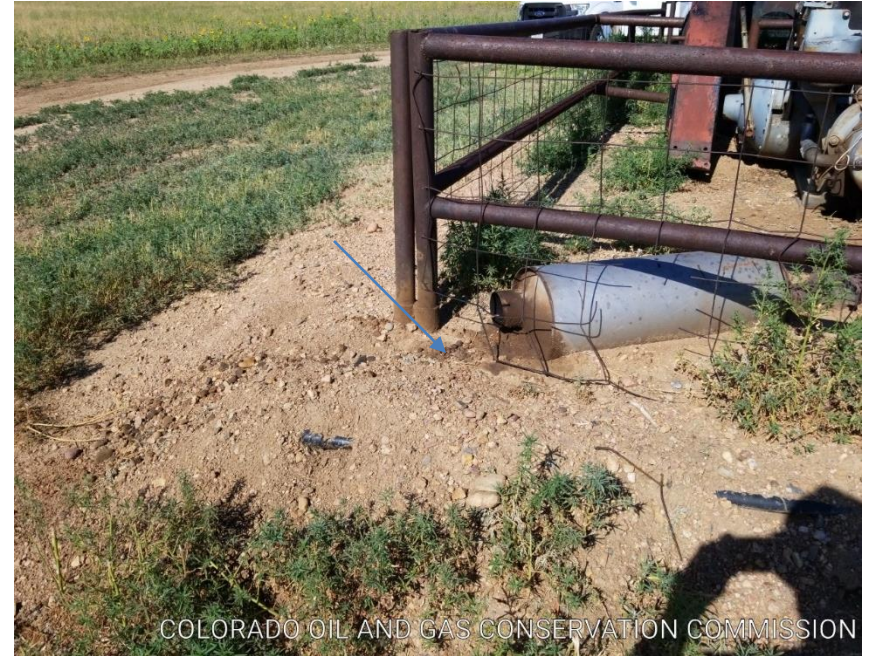
Pic 2 stained soil

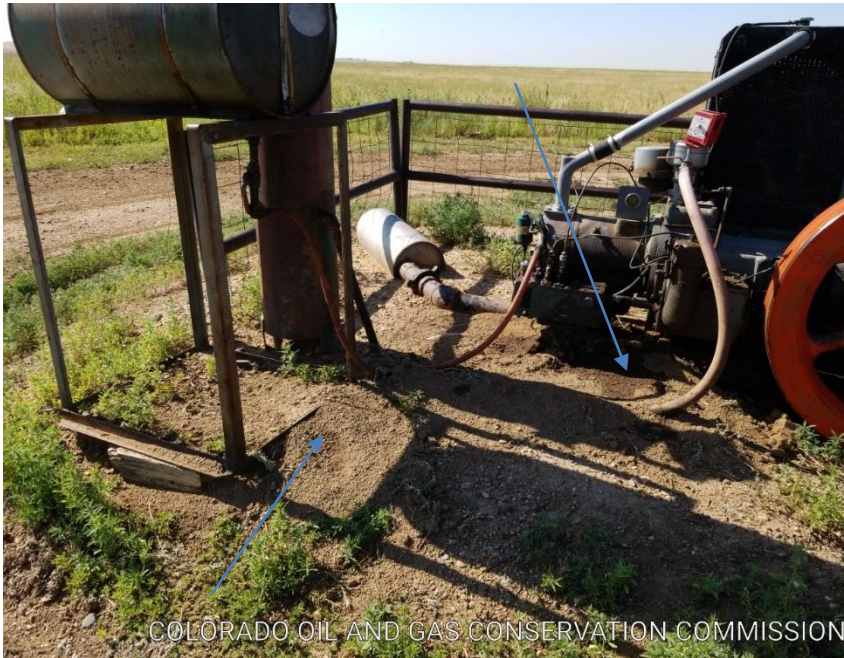
Pic 3 stained soil by motor, no BMP for chemical tank

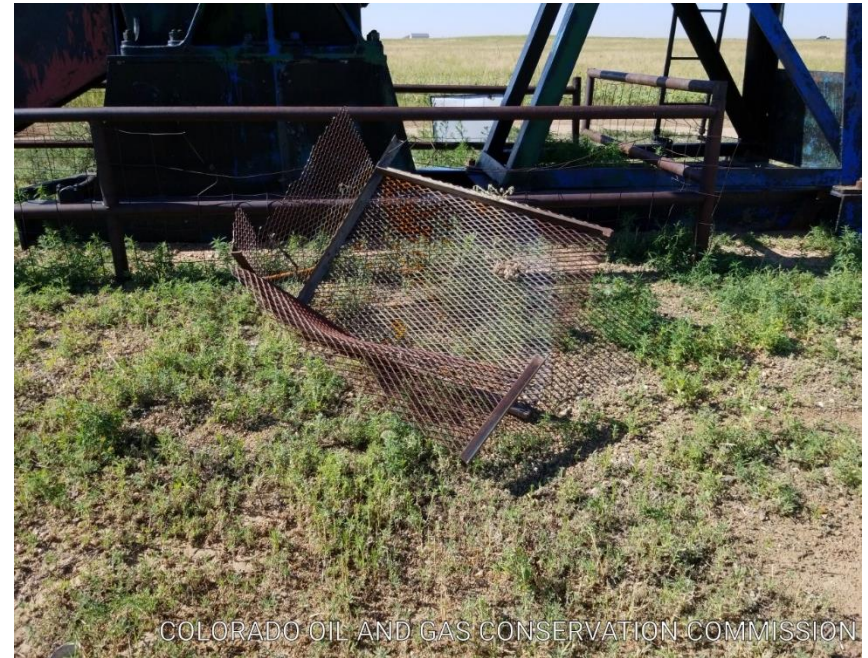
Pic 4 unused guard

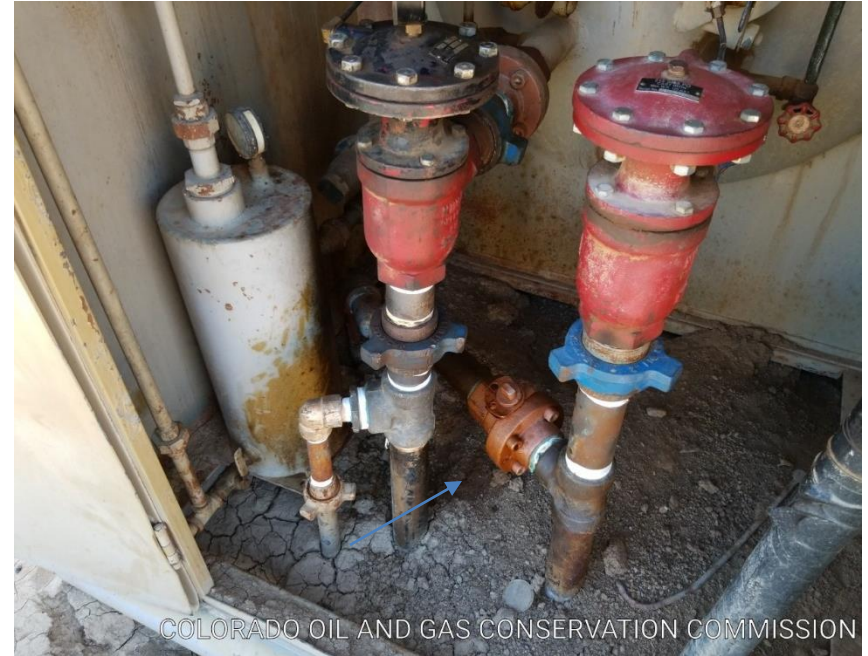
Pic 8 stained soil/mechanical issue in separator house

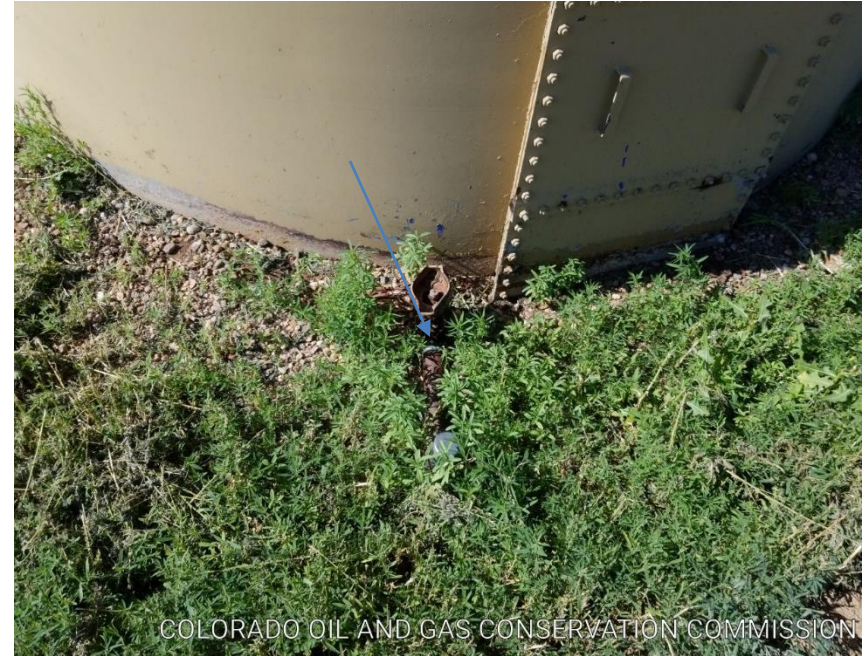
Pic 10 mechanical issue with valve on oil tank.
