Laramie Energy LLC
API # 05-077-08699
Inspection # 696600406

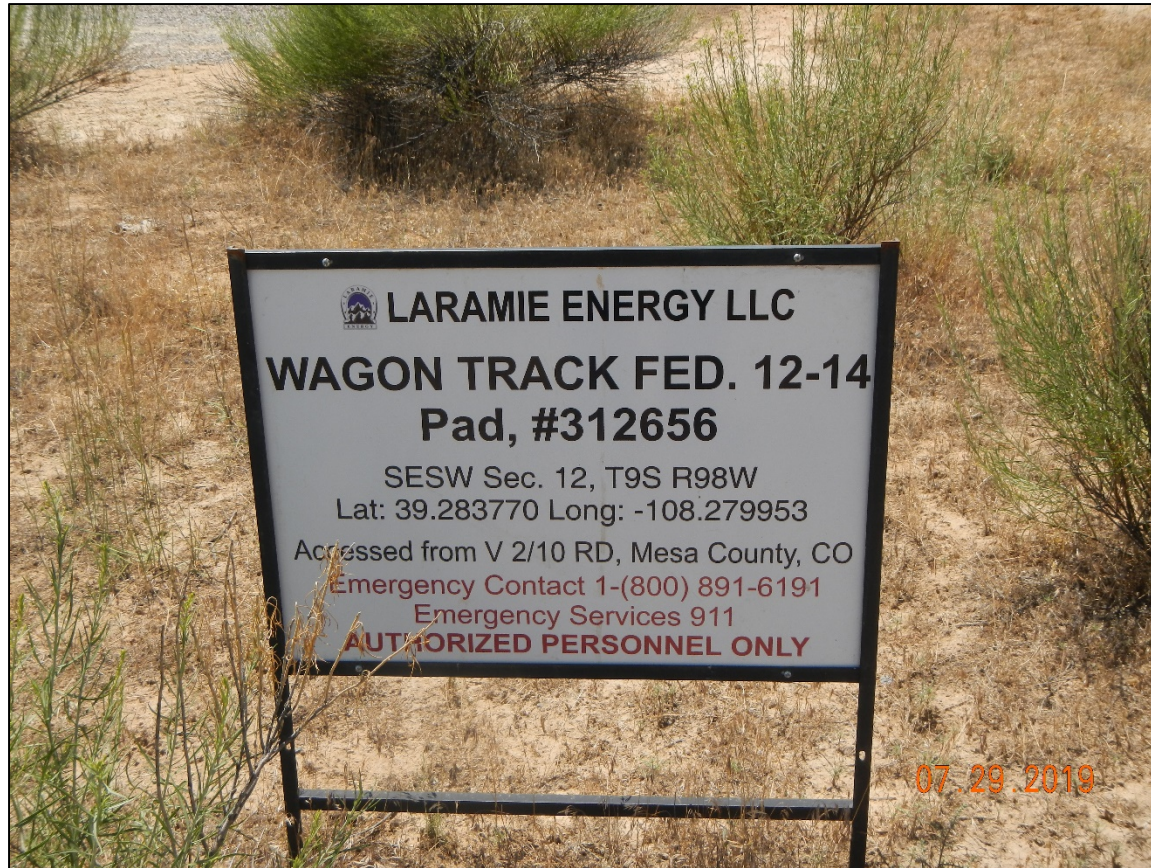
Battery sign at entrance of location.

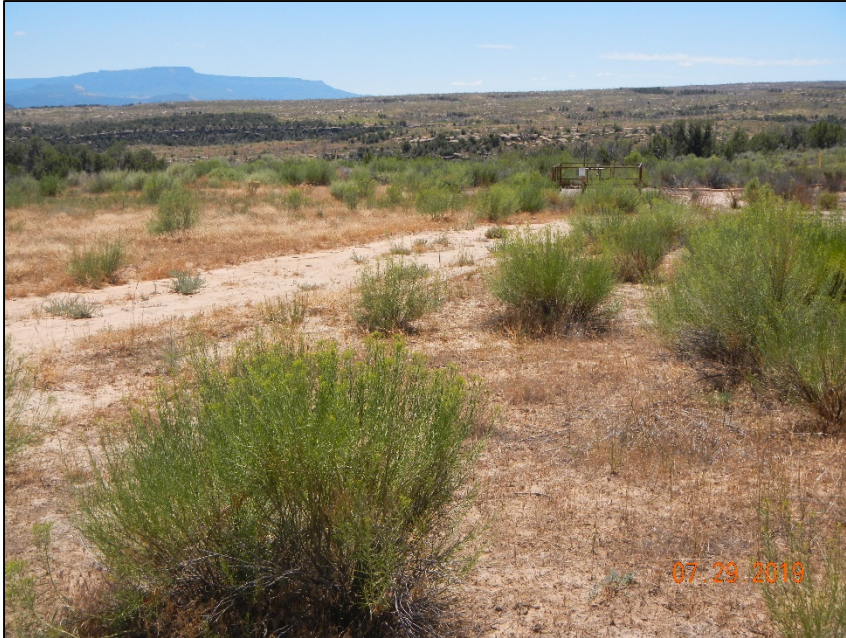
Photo #1 Photo at entrance of S side of location .

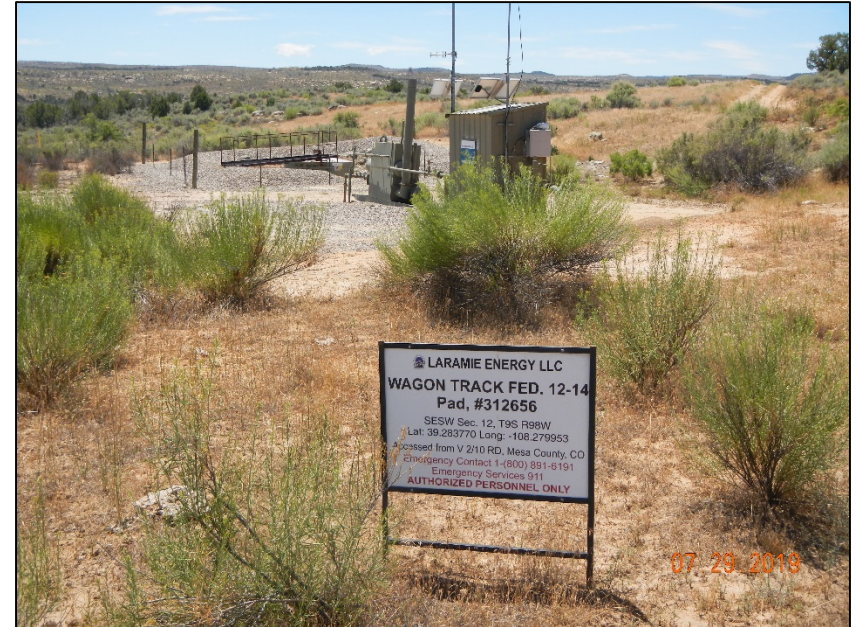
Photo #2 Photo at entrance of West location side of location

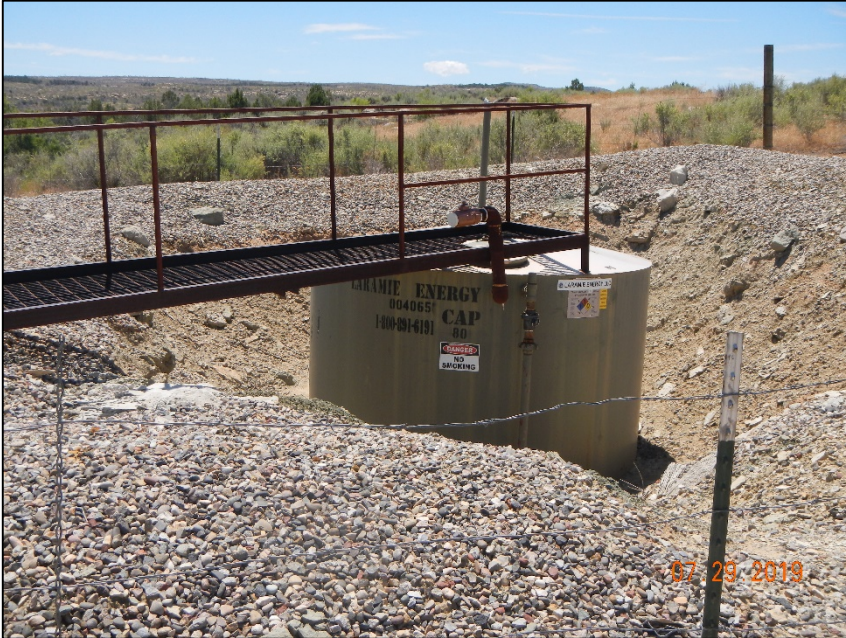
Photo #3 Photo of tank battery

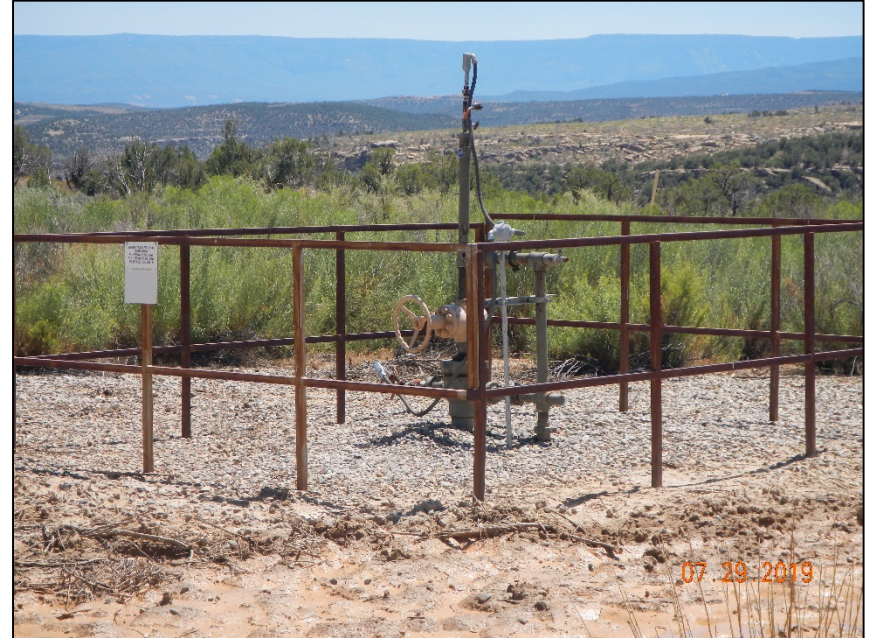
Photo #4 photo at wellheads

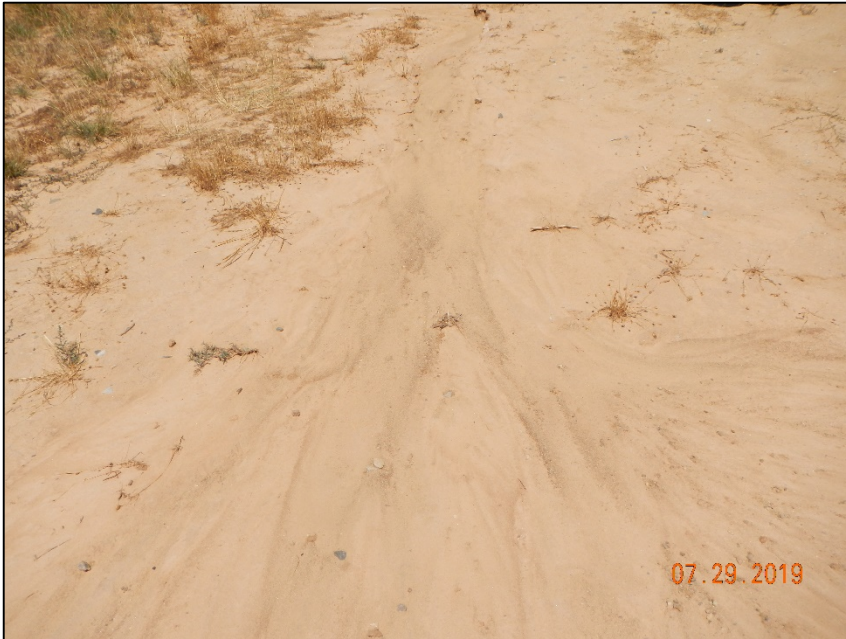
Photo #5 Photo of sediment moving south across location

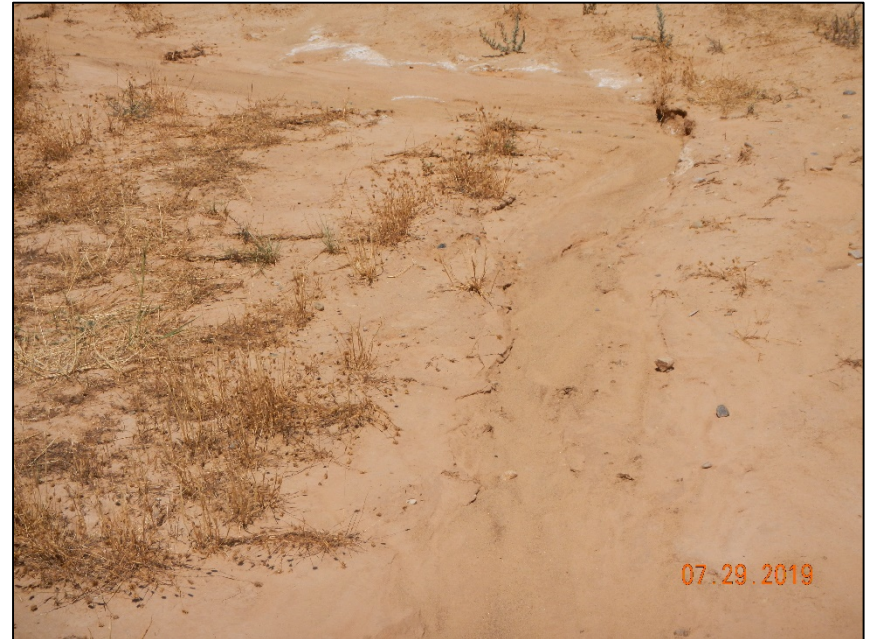
Photo # 6 Photo of sediment moving south across location

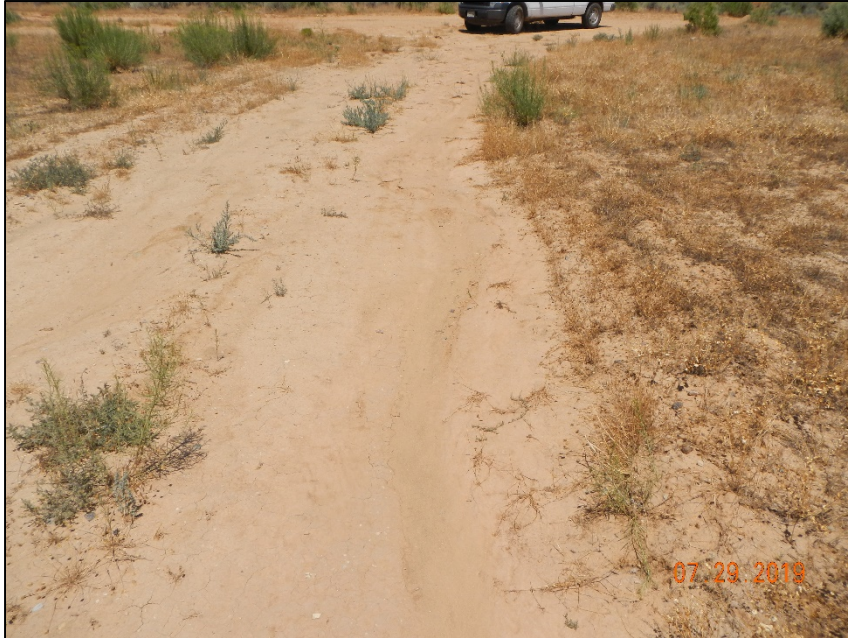
Photo #7 Photo of sediment moving south across location

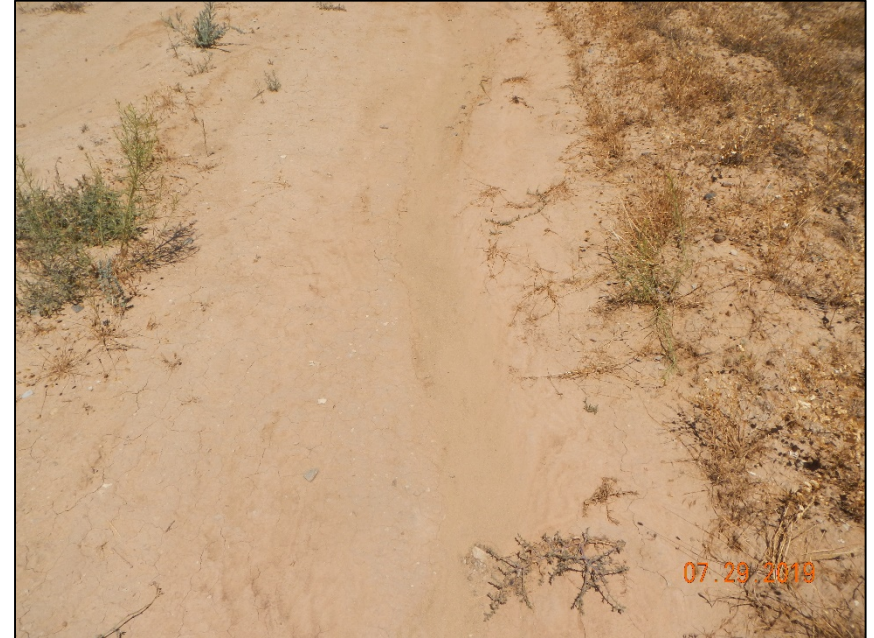
Photo #8 Photo of sediment moving south across location

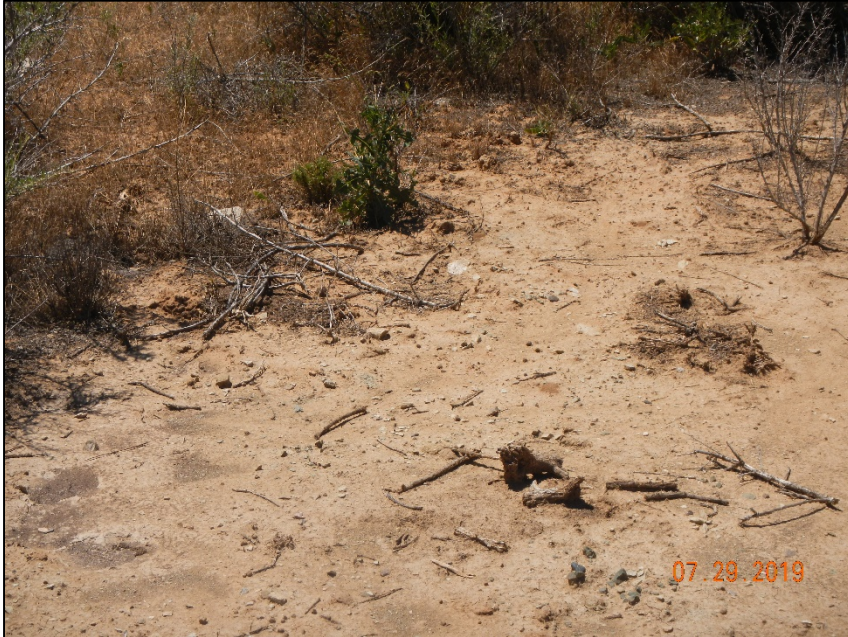
Photo #9 Sediment moving off location on the south side of tank battery, choking out possible vegetation

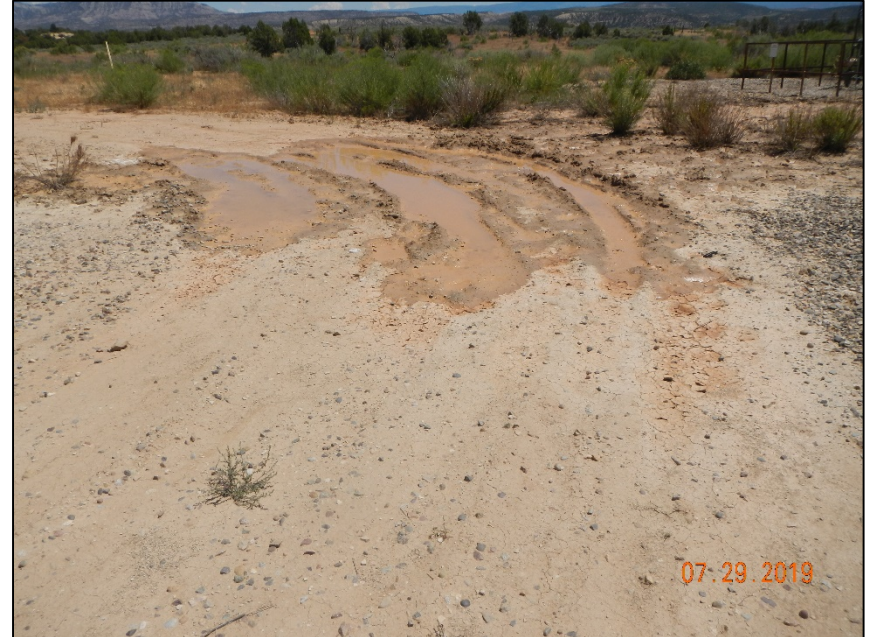
Photo #10 Location has lost compaction by wellhead and tank battery

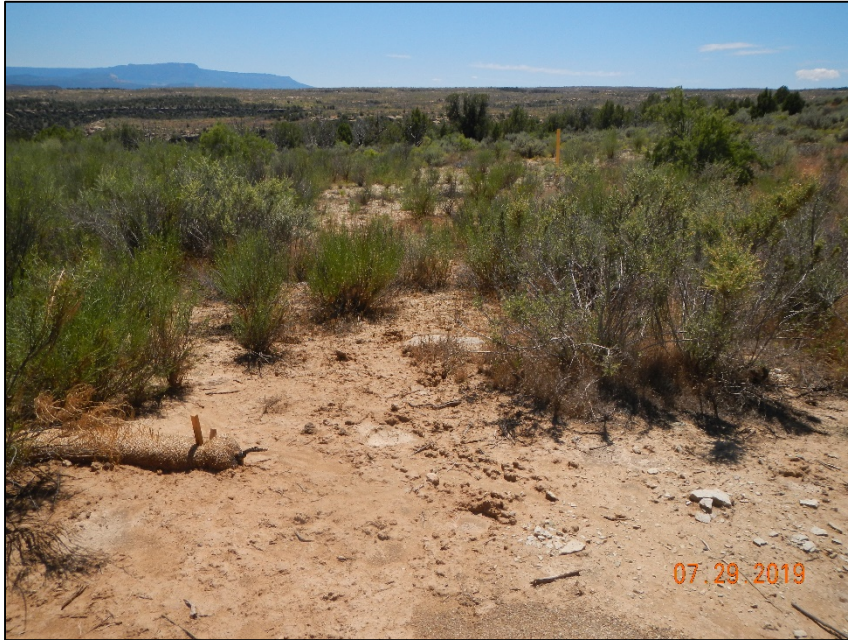
Photo #11 Photo of BMP that was recently put in place, allows erosions sediment to move around the waddle, letting sediment move south off location, choking out vegetation.

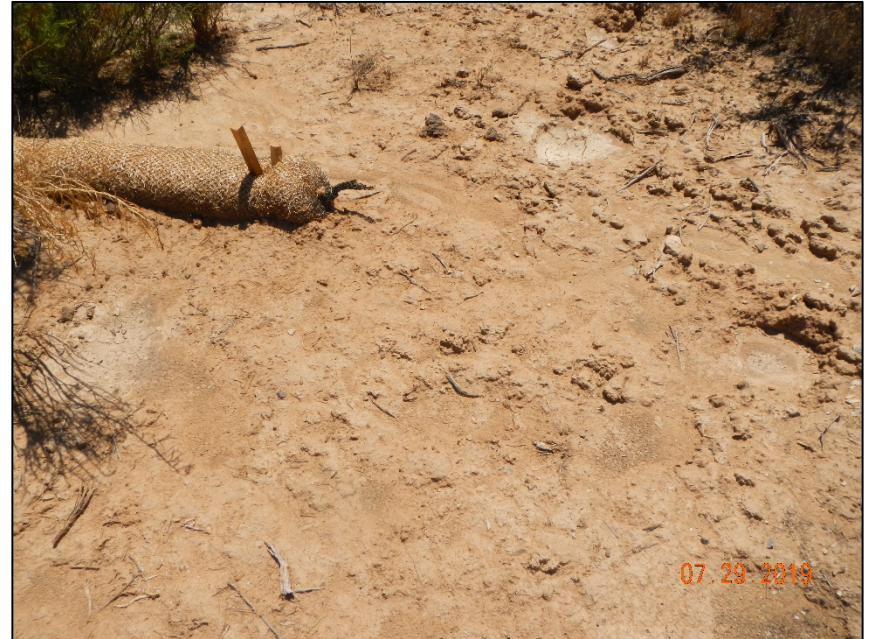
Photo #12 Photo of BMP that was recently put in place to stop erosion, allows erosions sediment to move around the waddle, letting sediment move south off location, choking out vegetation.
