Construction and Stormwater Inspection

July 29, 2019

Operator: CCRP OPERATING INC- 10665

Location Name: Salt Ranch Fee /18 East

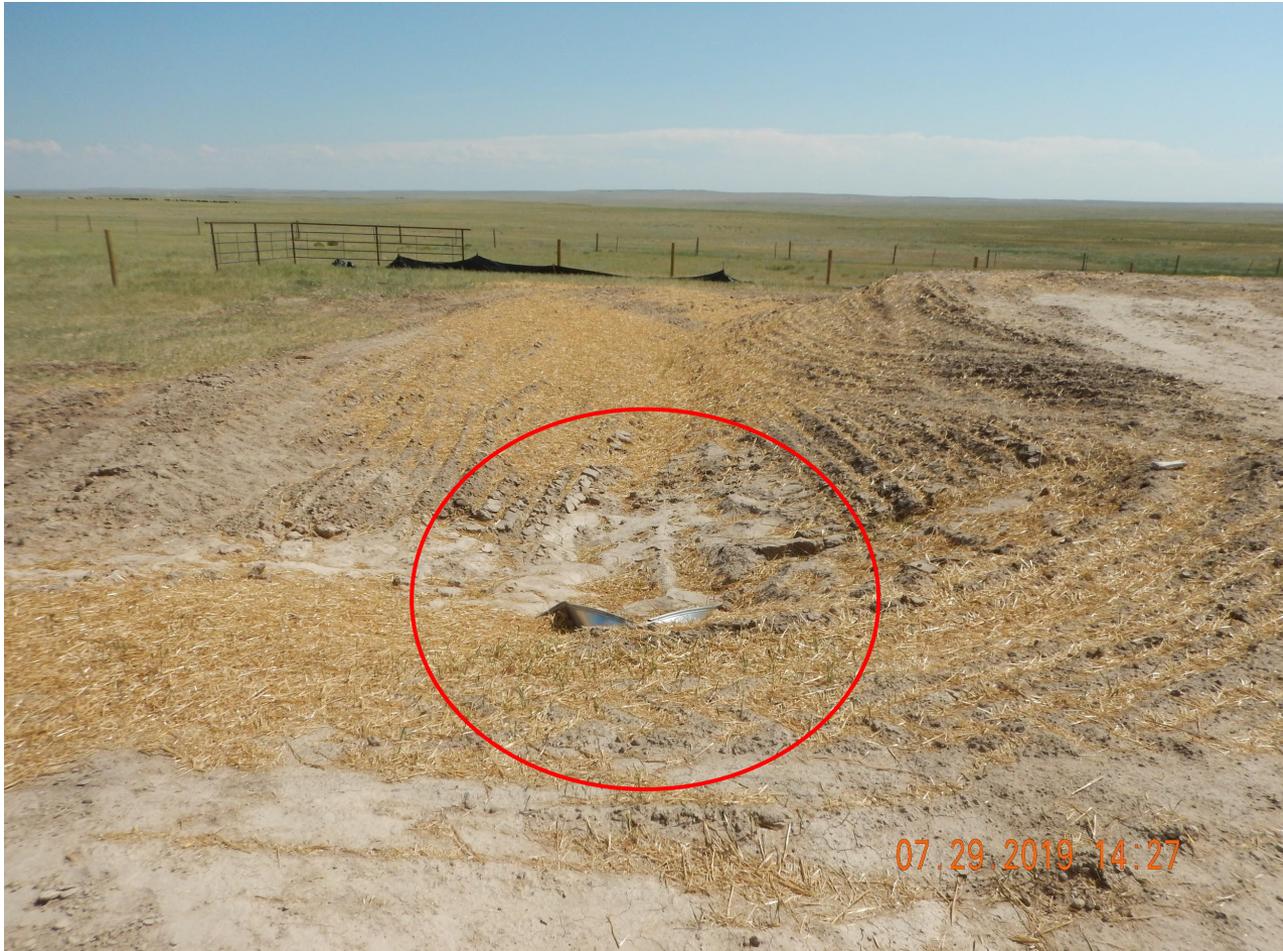
Photo 1. Photo taken from the entrance of the location, facing South. Operator has installed a ditch which is directed to a retention area. Ditch area has been seeded and mulched. Inlet and outlets of culverts still need to be stabilized. Silt fence BMP was used as the initial stormwater BMP and will be removed.

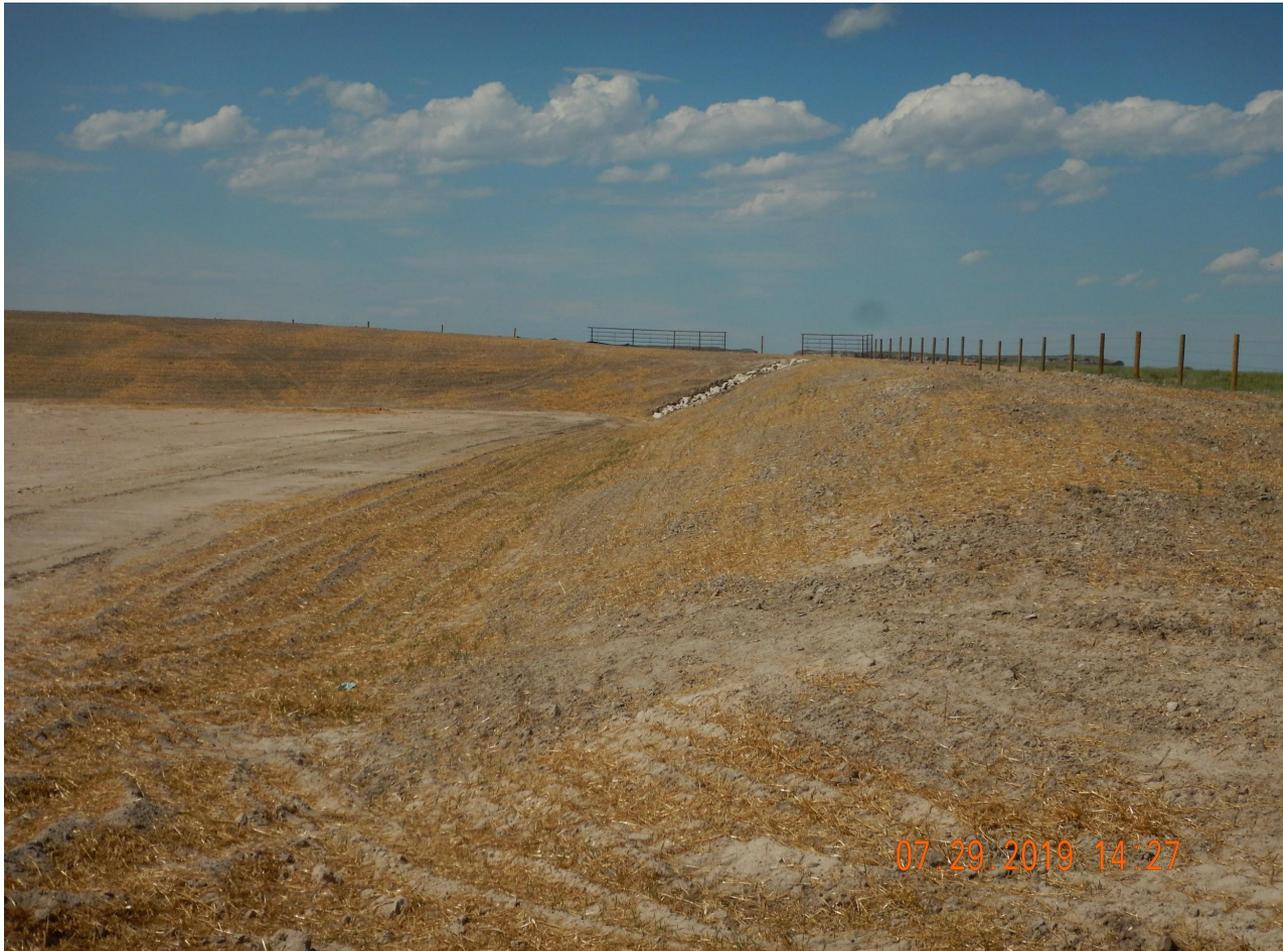
Photo 2. Photo taken from the entrance of the location, facing North. See comments under Photo 1.

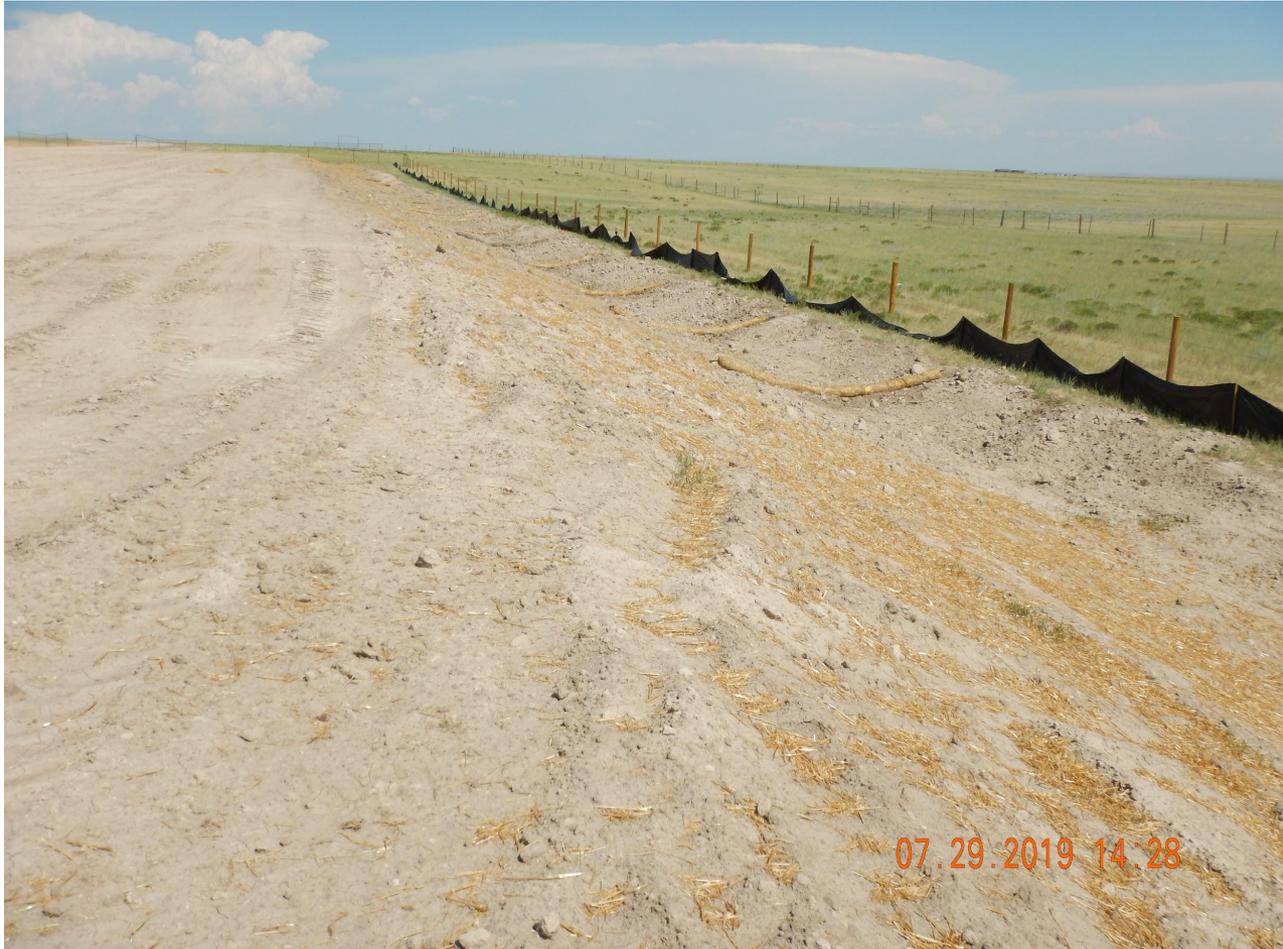
Photo 3. Photo taken from the southwestern location, facing East. Operator has installed straw wattles along portions of the ditch. Portions of the ditch may need to be

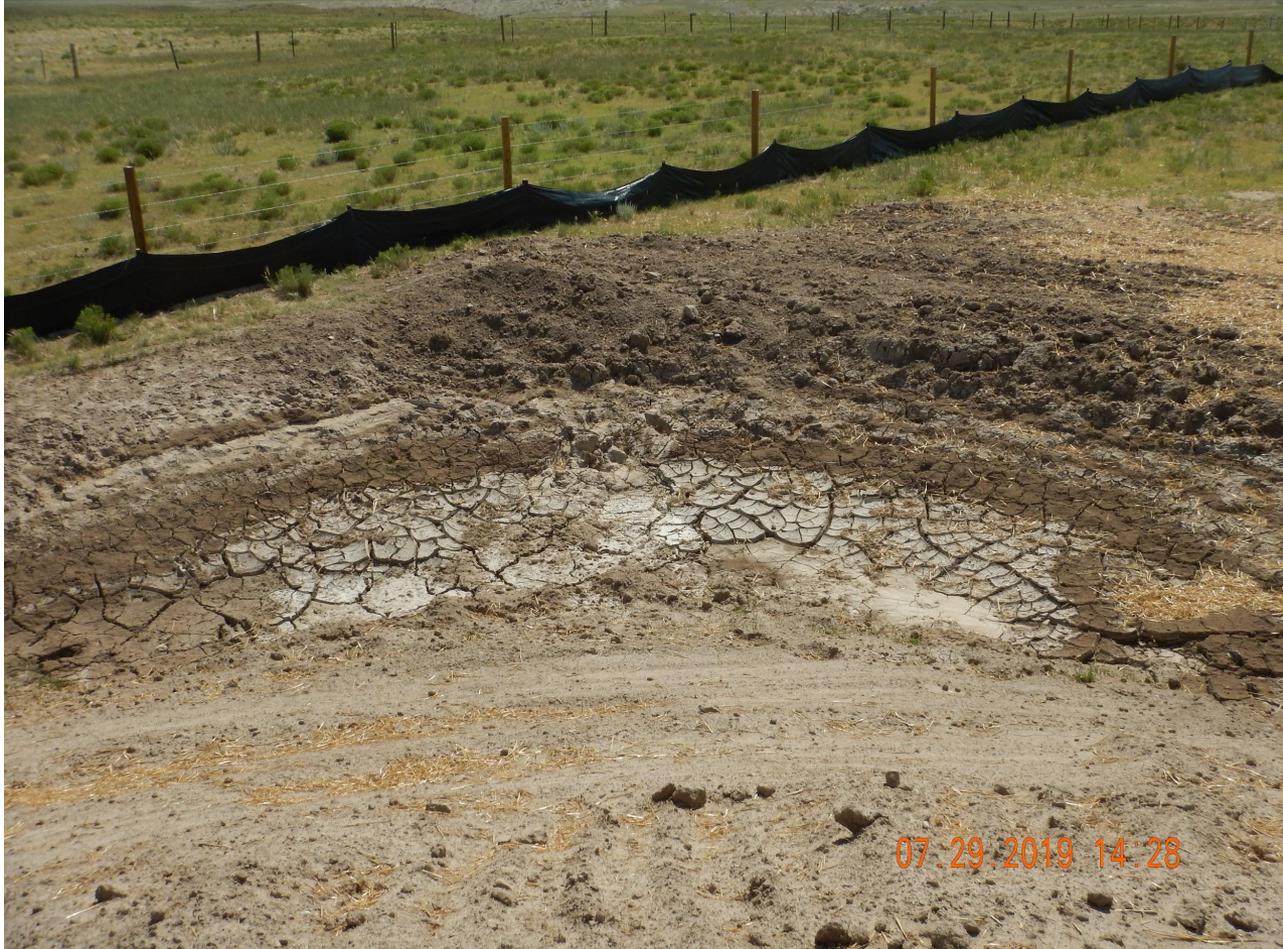
Photo 4. Photo taken from the southwestern perimeter of the location, facing South. Operator failed to installed a retention area.

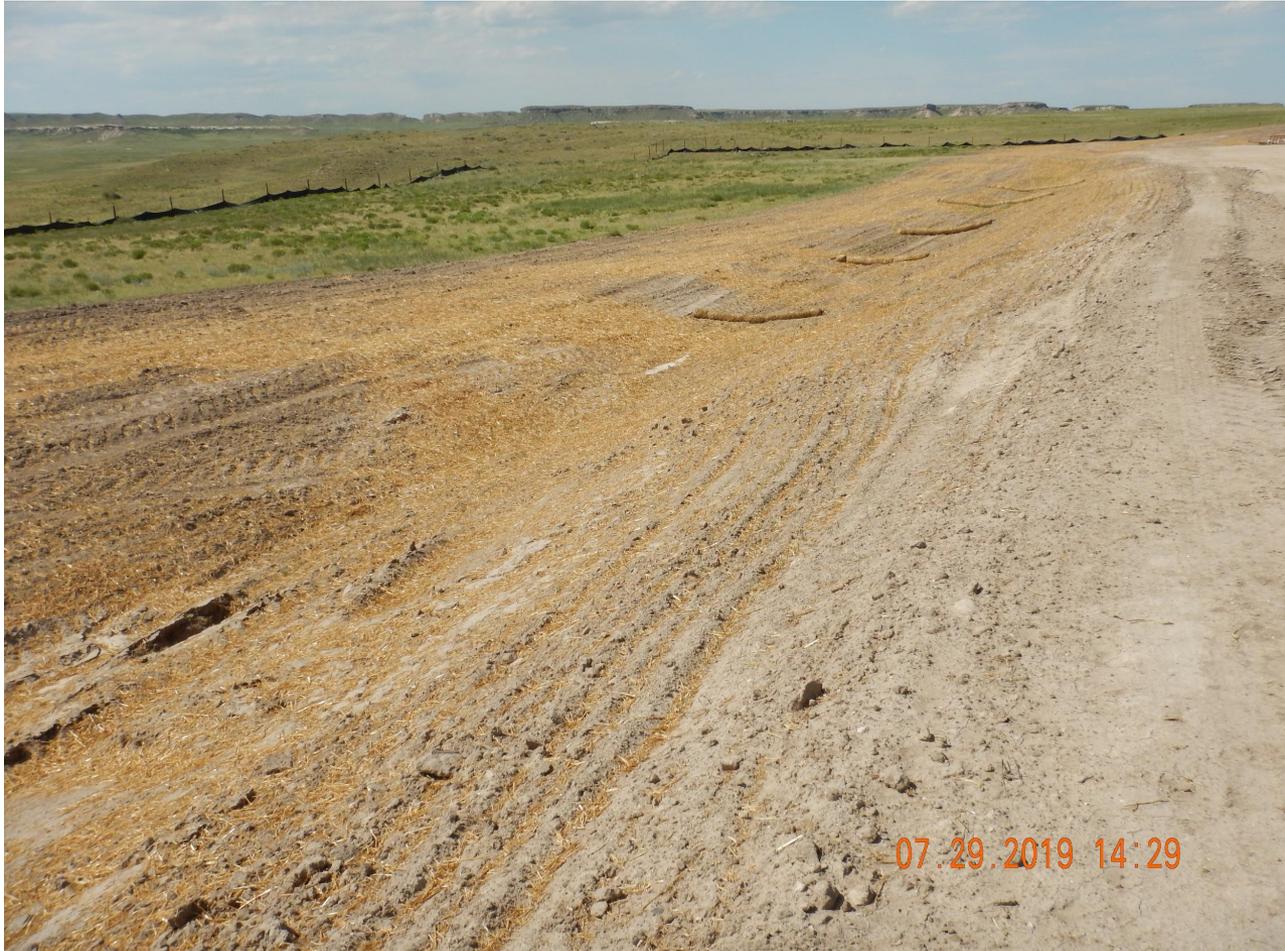
Photo 5. Photo taken from the southwestern perimeter of the location, facing North.
See comments under Photo 1.

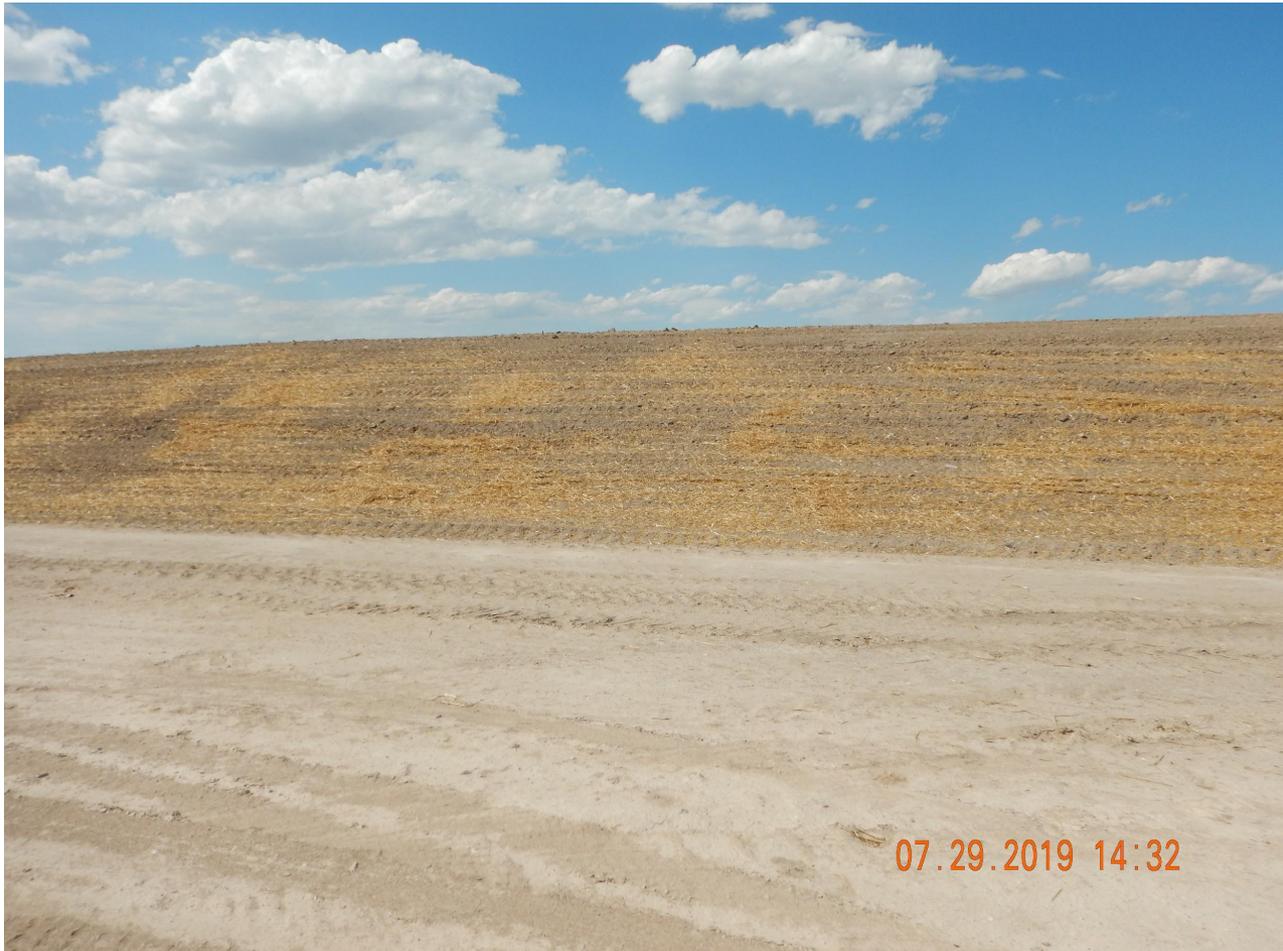
Photo 6. Photo taken from the northern location, facing North. Photo illustrates the topsoil stockpile which has been seeded and mulched.

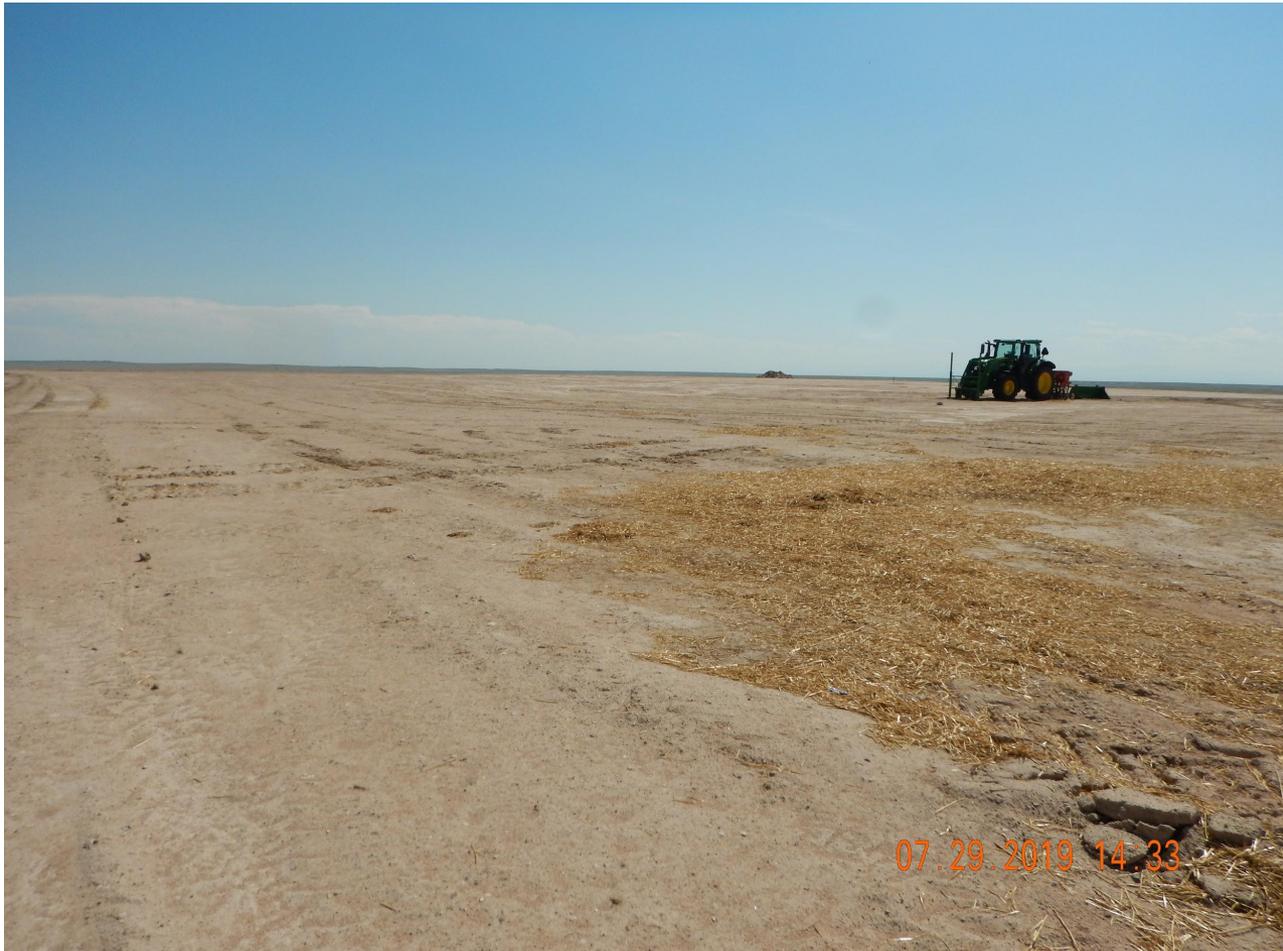
Photo 7. Photo taken from the northeastern location, facing South. Photo illustrates other portions beyond the well locations has only been compacted. Compaction alone may not be sufficient to properly stabilize the well pad from wind and water erosion.

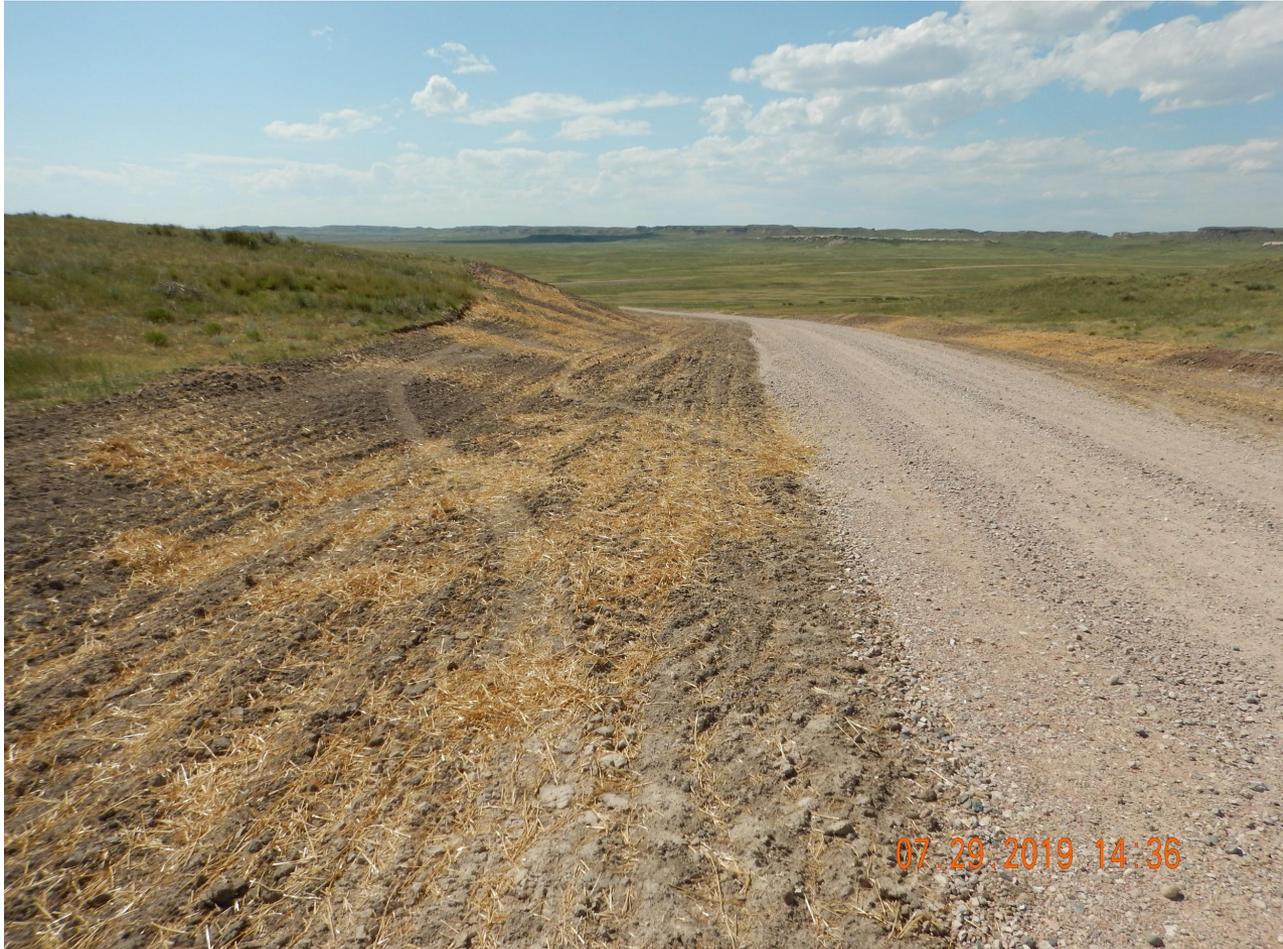
Photo 8. Photo taken from a portion of the access road, facing Northwest. Access road was pre-existing. Operator has seeded along the roadside ditch. Mulch does not appear to have been installed evenly which may not protect the seeded soil.

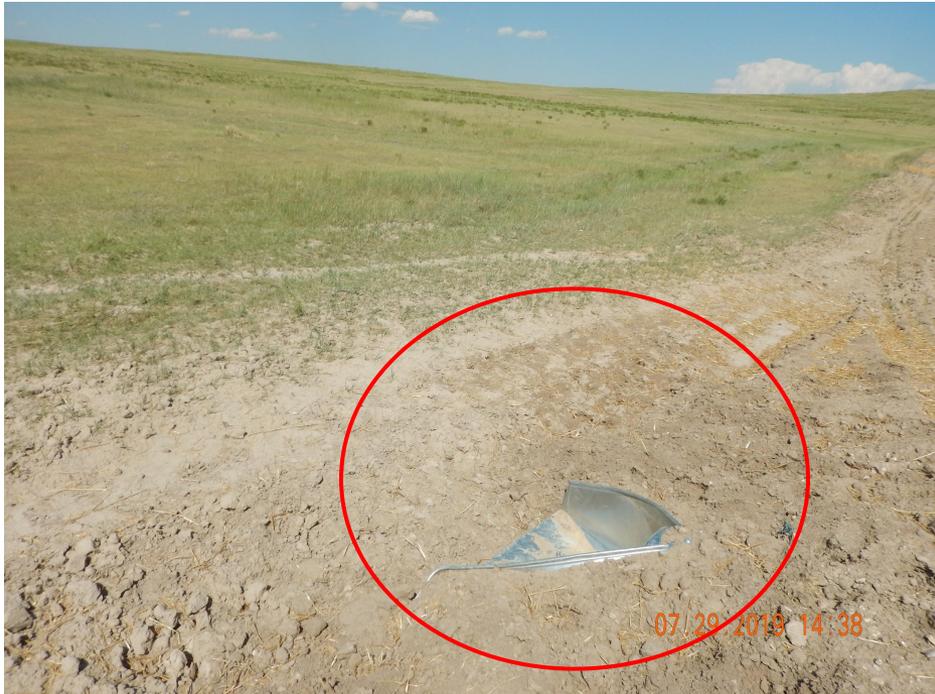
Photo 9. Photo taken from a portion of the access road, facing East. Photo illustrates inlet and outlets of culverts still need to be stabilized.

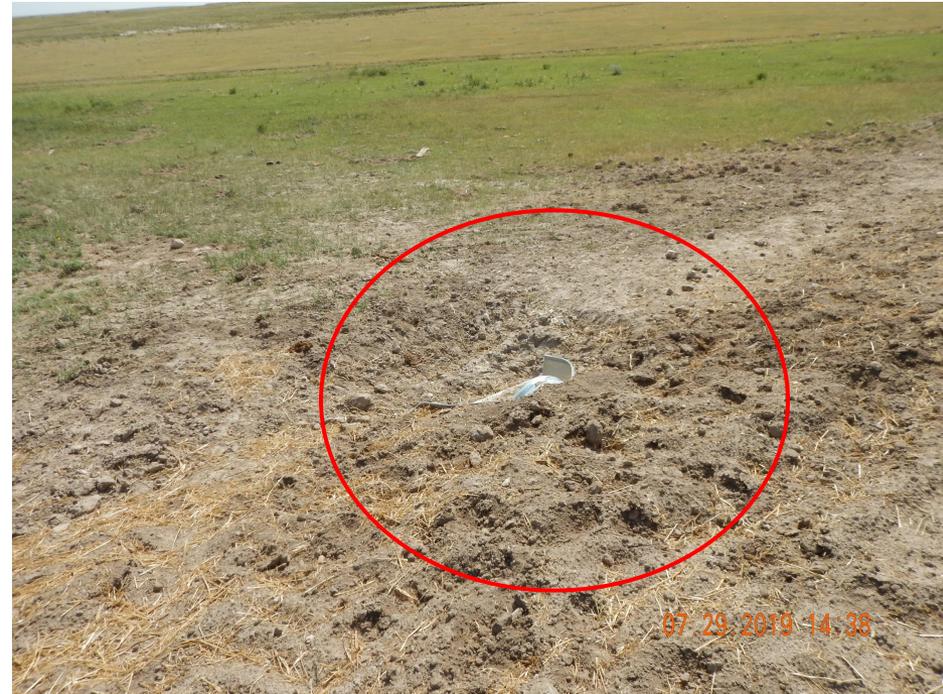
Photo 10. Photo taken from a portion of the access road, facing East. Photo illustrates inlet and outlets of culverts still need to be stabilized.

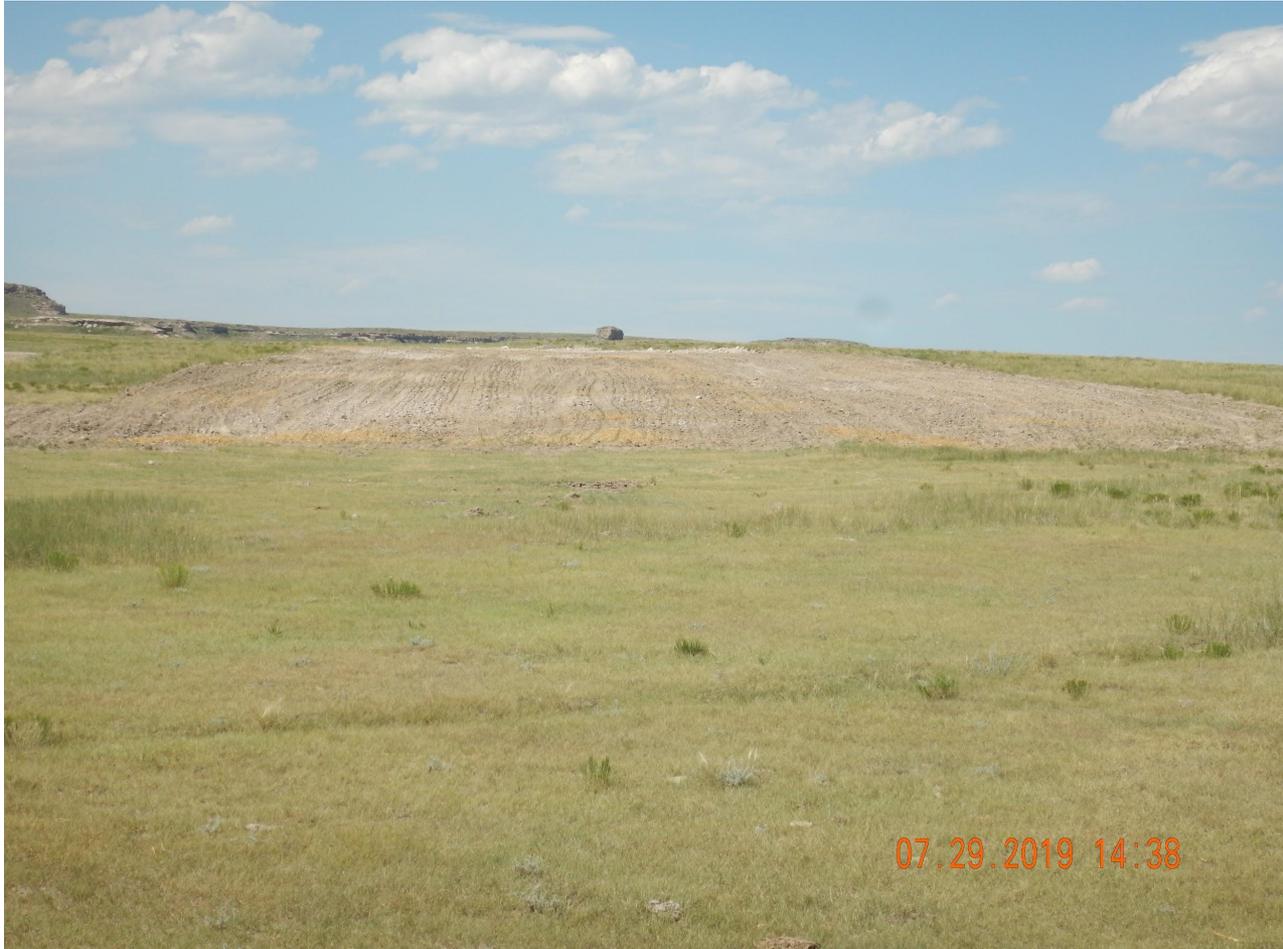
Photo 11. Photo taken from a portion of the access road, facing North. Photo illustrates an area that was used to temporarily store topsoil from the access road. Operator will be responsible for complying with Rule 1004 standards for this area.
