# Inspection Photos

API: 05-073-06478

Operator: NIGHTHAWK PRODUCTION

Inspection Date: 7/25/2019

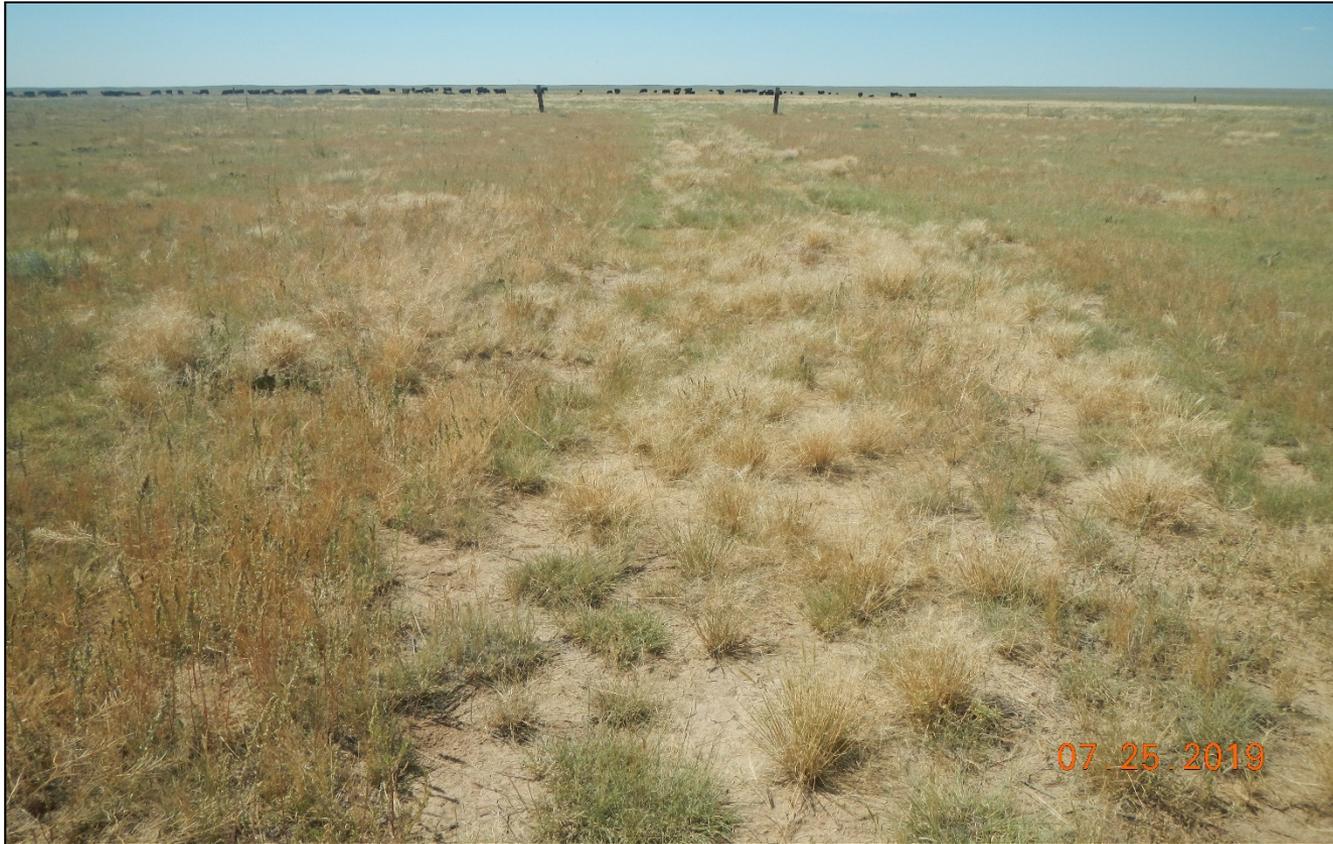
**Photo 1.** Facing south at the reclaimed access road. Vegetation is well established.

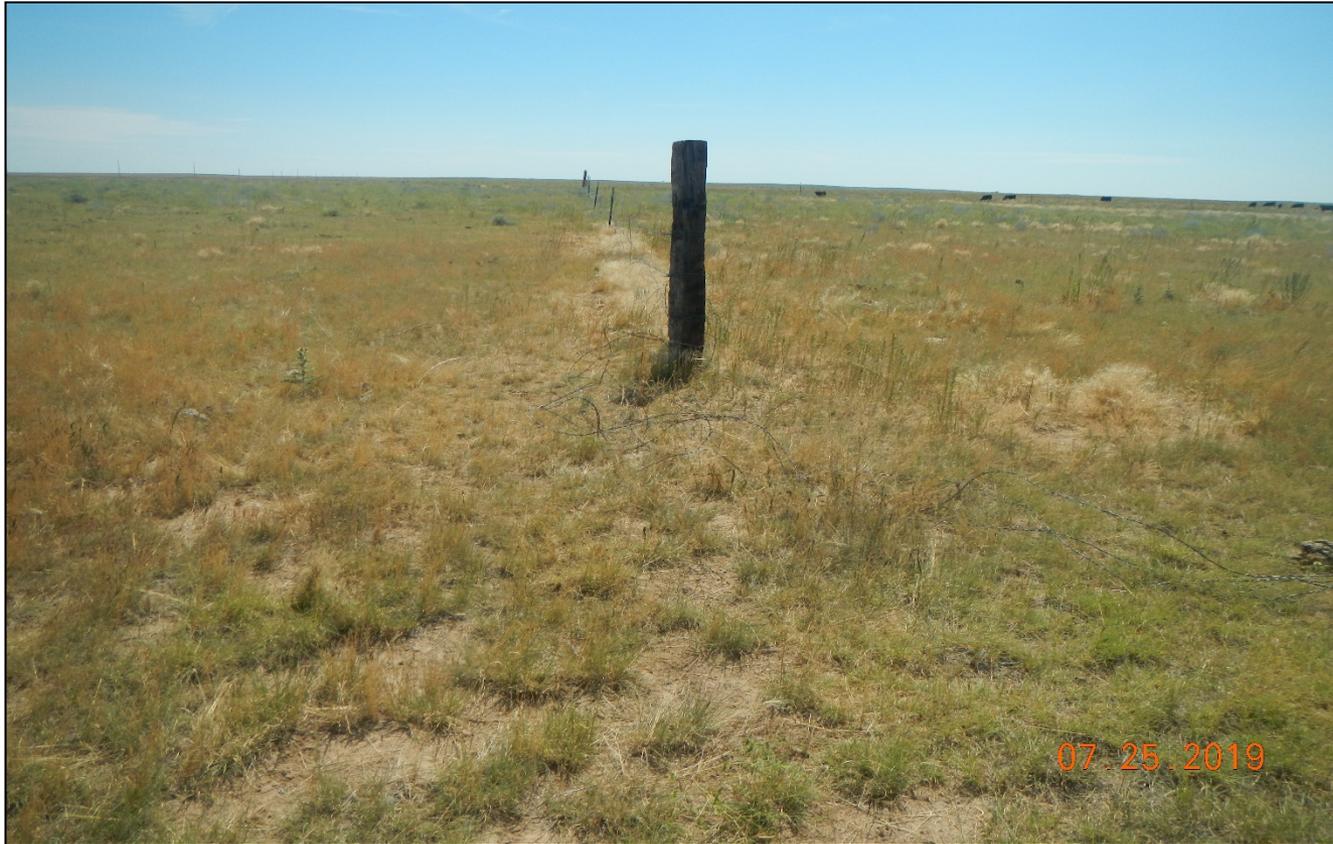
**Photo 2.** Perimeter fence remains around the location and is in disrepair.

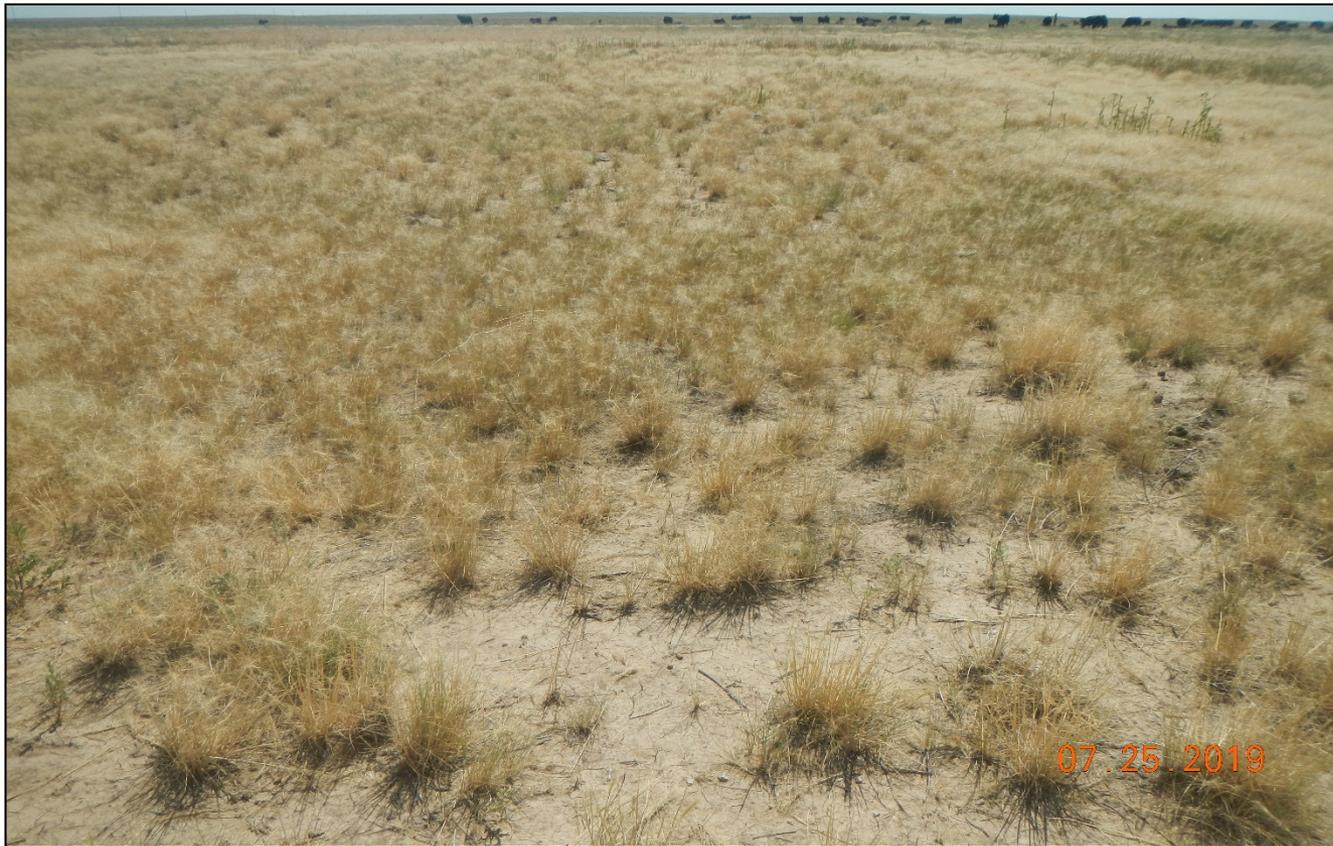
**Photo 3.** Facing south at the location. Vegetation is well established at this area.

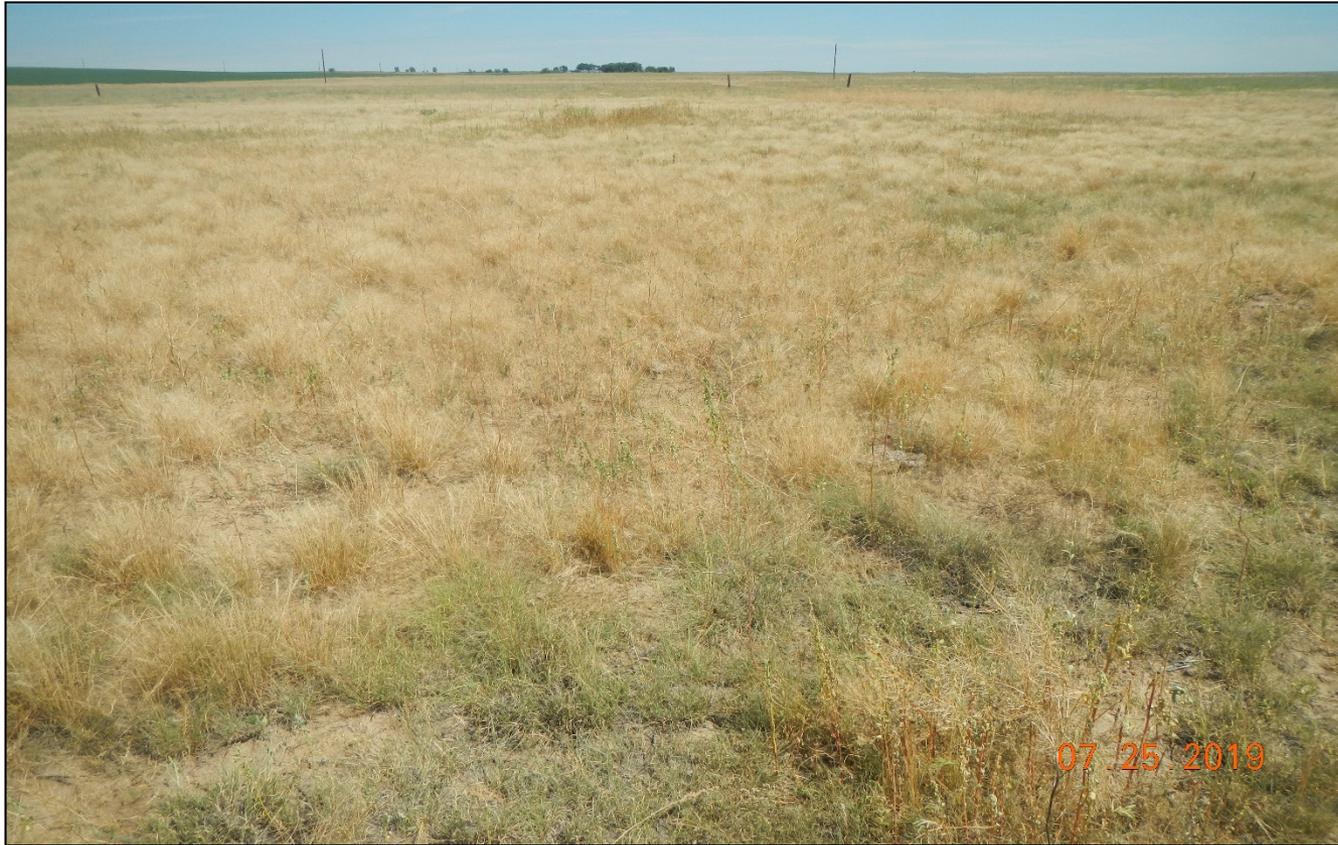
**Photo 4.** Facing north at the location. Vegetation is well established at this area.

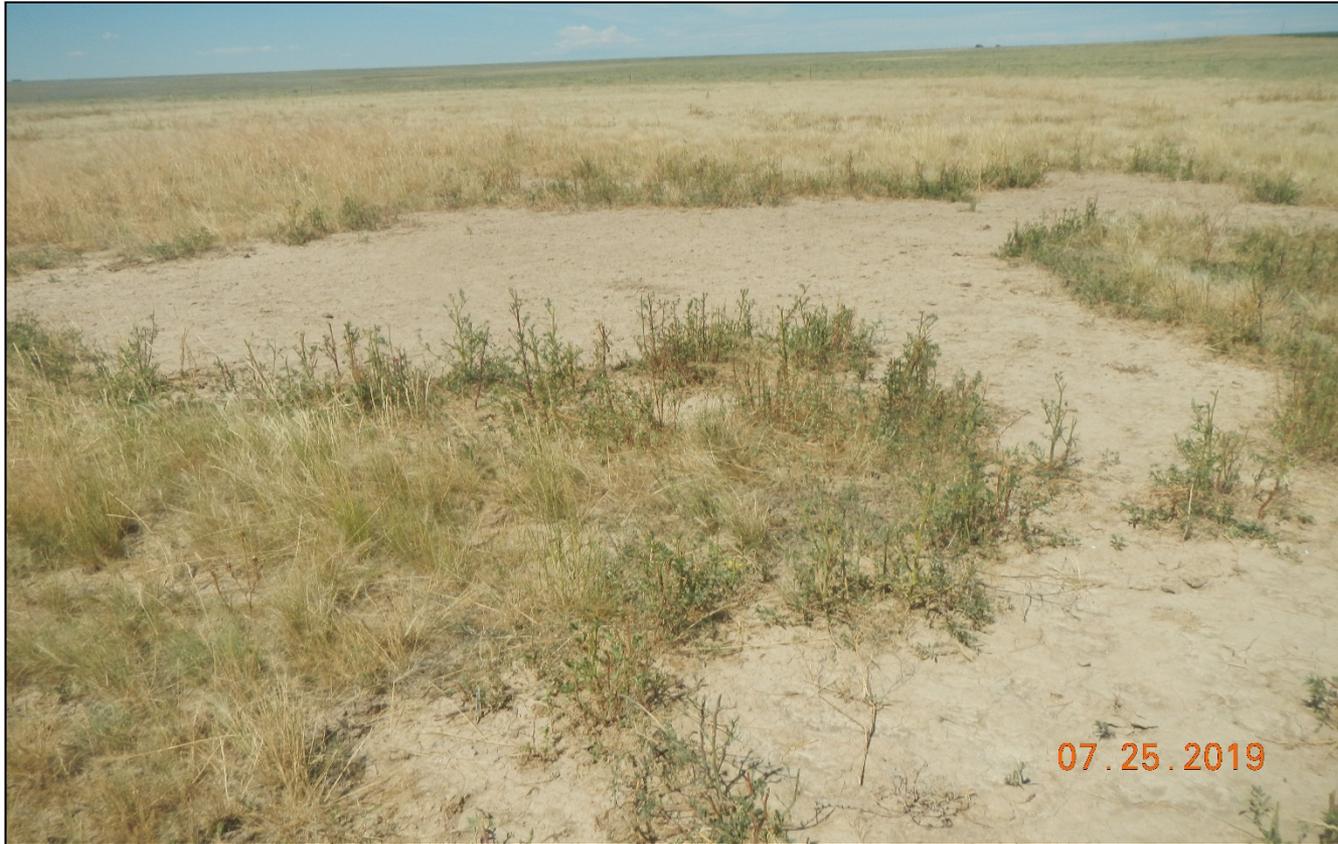
**Photo 5.** There is a bare are at the east side of the location. Approximately 50 ft. x 30 ft..

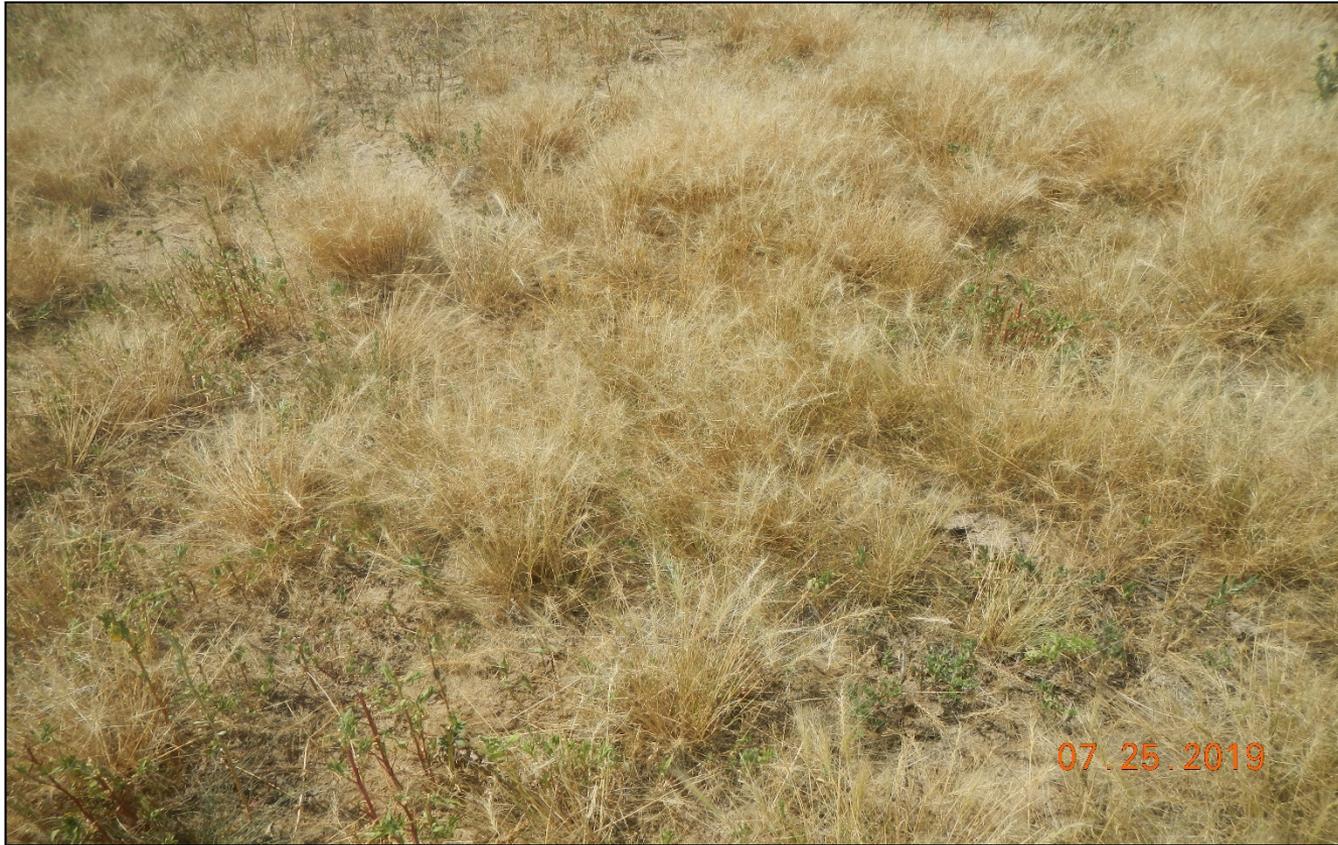
**Photo 6.** Vegetation consists primarily of Ely ely.

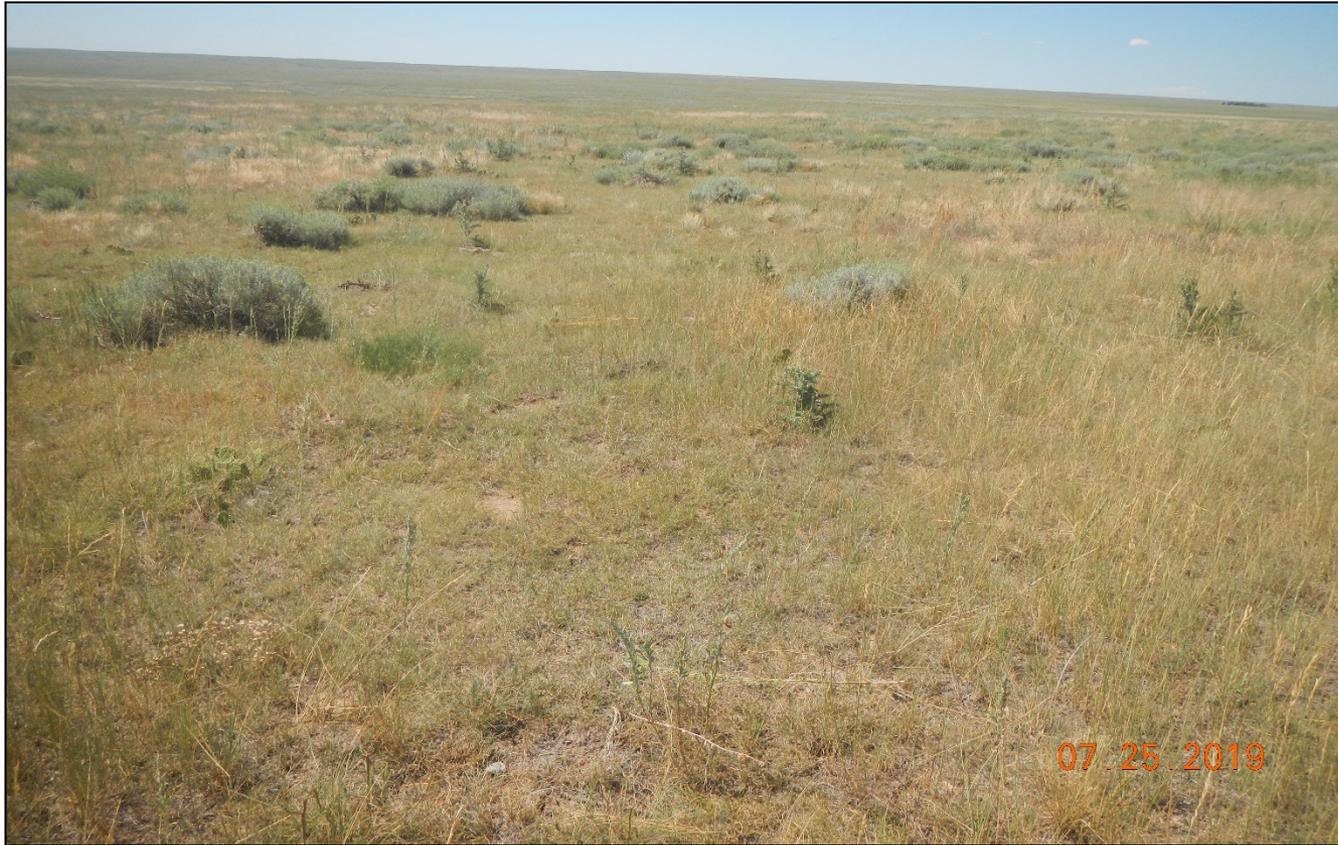
**Photo 7.** Facing toward the surrounding reference area.
