Inspection Photos

API: 05-073-06365

Operator: D90 ENERGY

Inspection Date: 7/25/2019

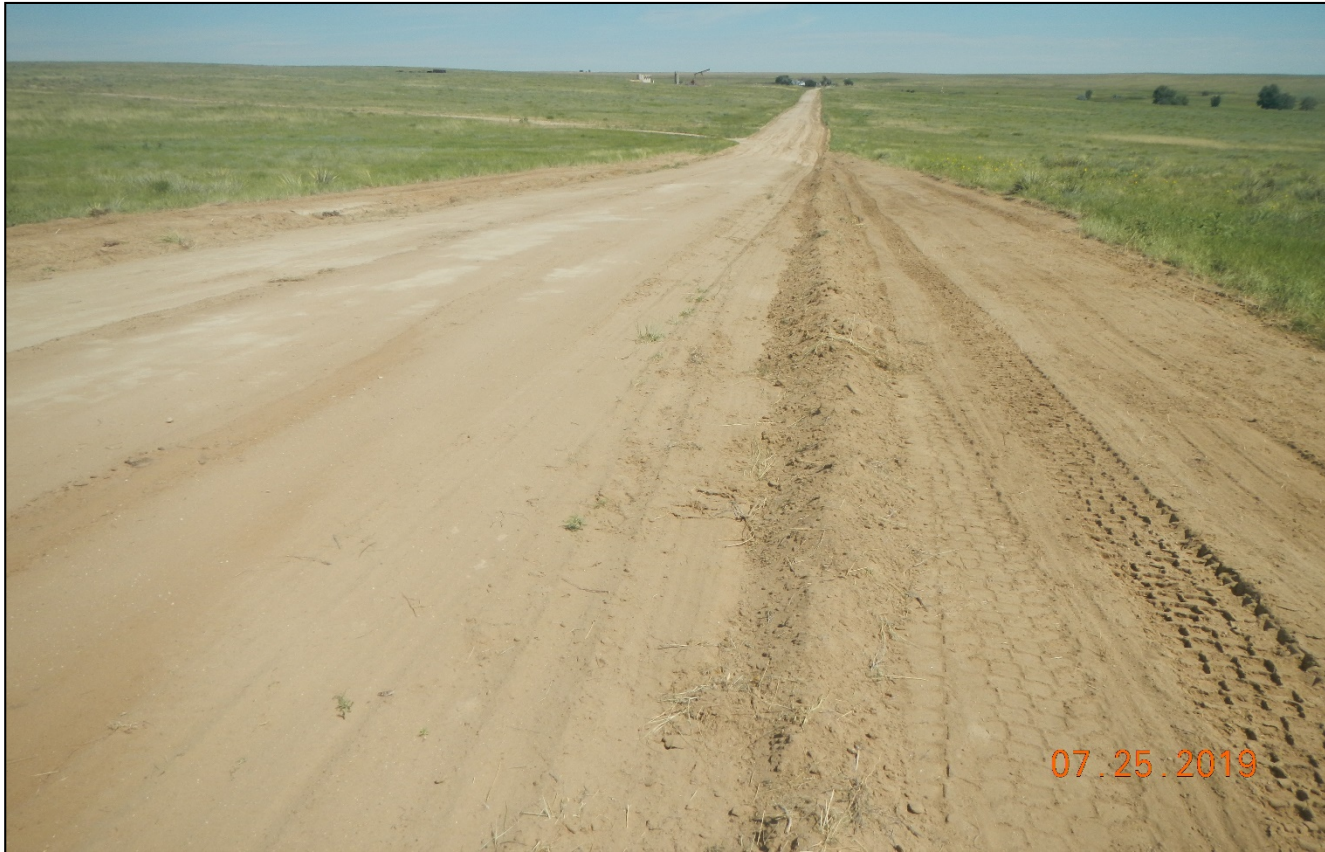
Photo 1. Facing north along the main road. The road was recently graded and widened. The side of the road was disturbed and needs to be revegetated.

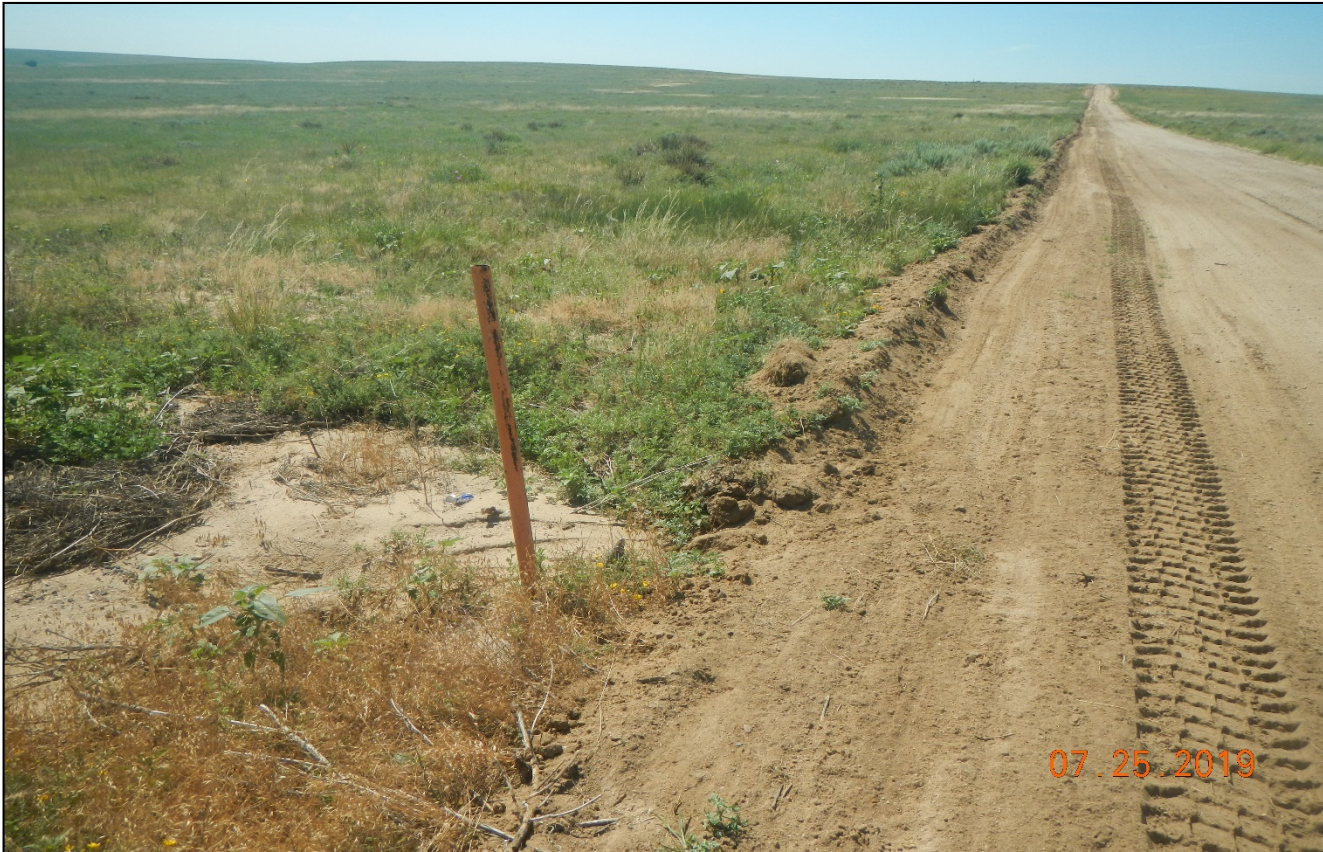
Photo 2. A culvert along the main road is filled in with sediment.

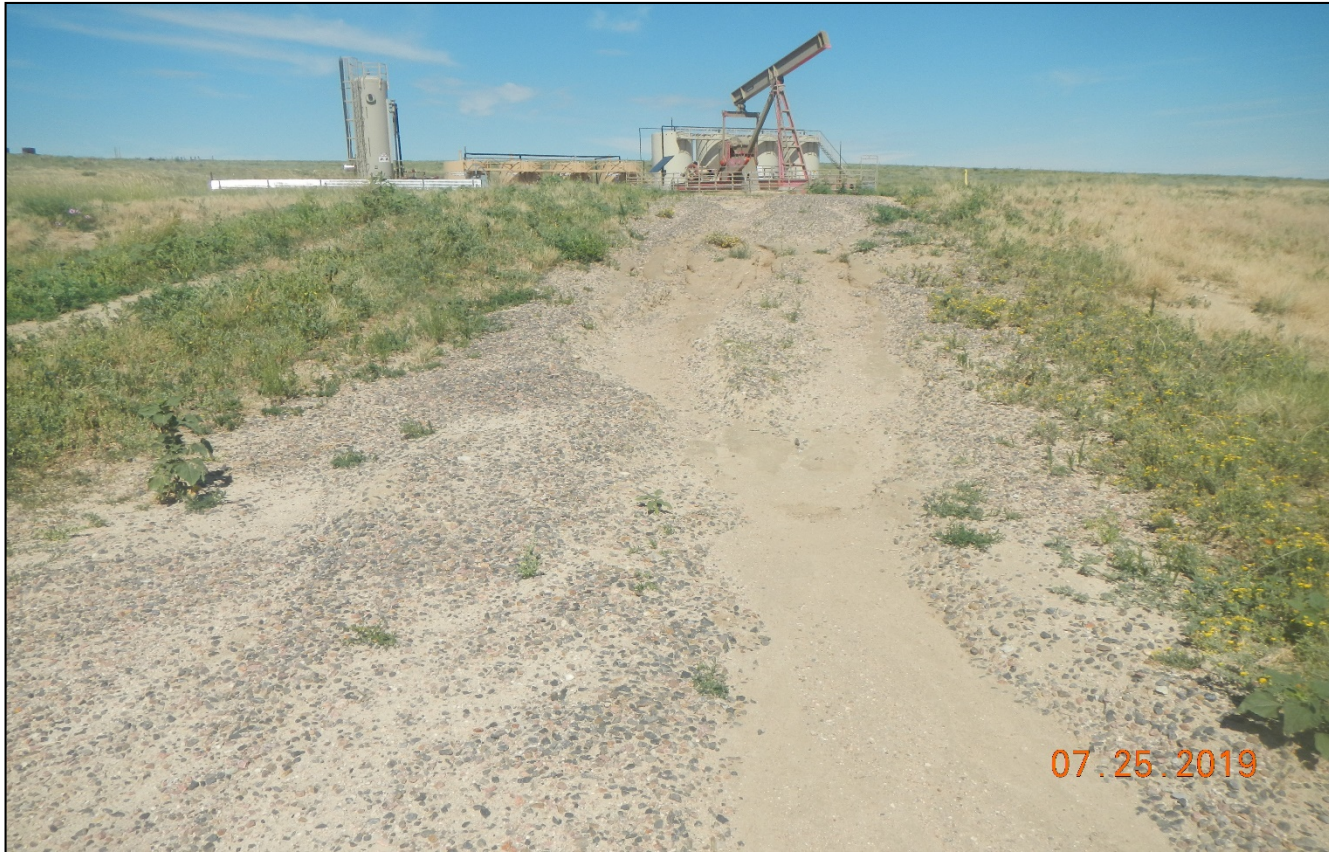
Photo 3. Facing northeast toward the location. There is erosion occurring along the access road.

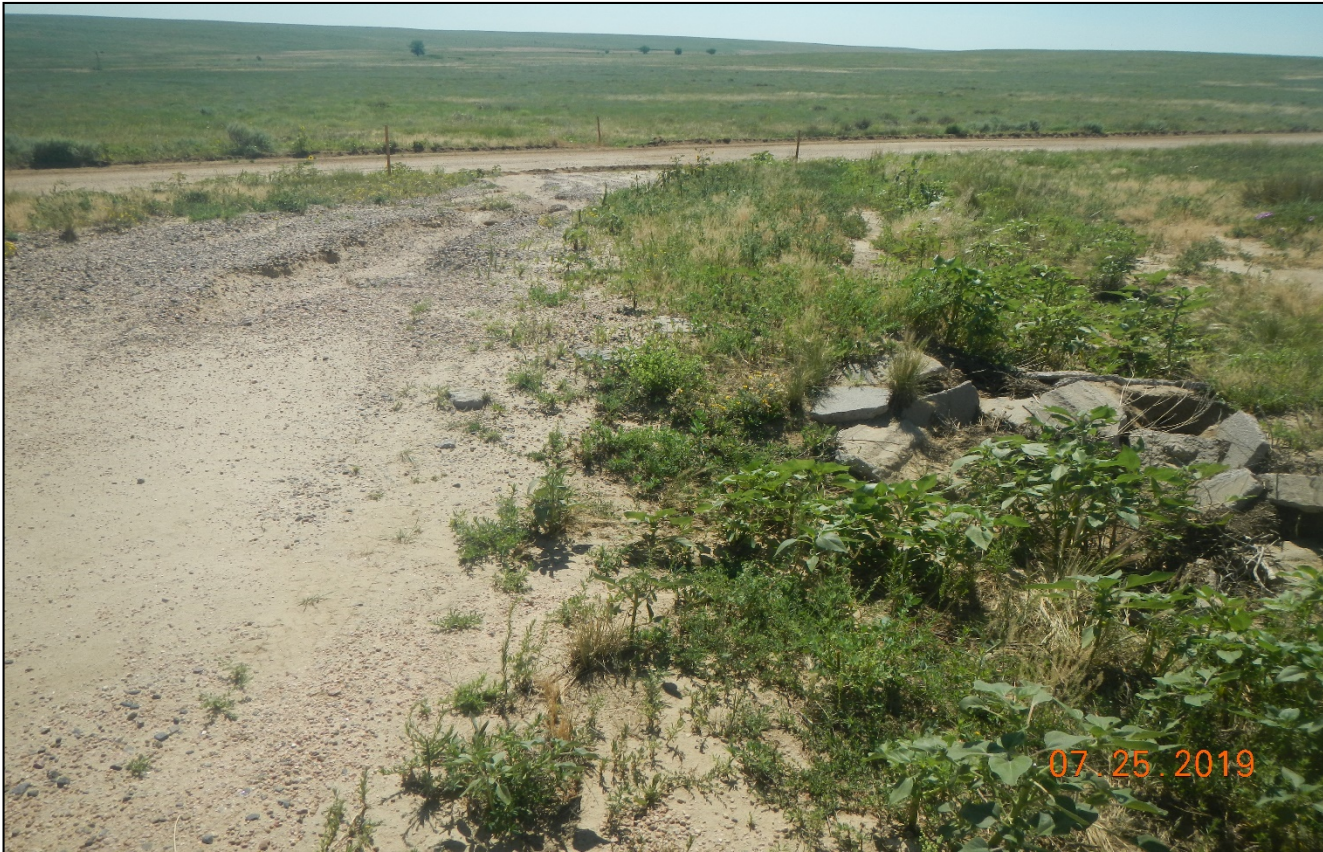
Photo 4. Facing back toward the access road. Rocks are piled in the drainage which is causing stormwater to flow down the access road.

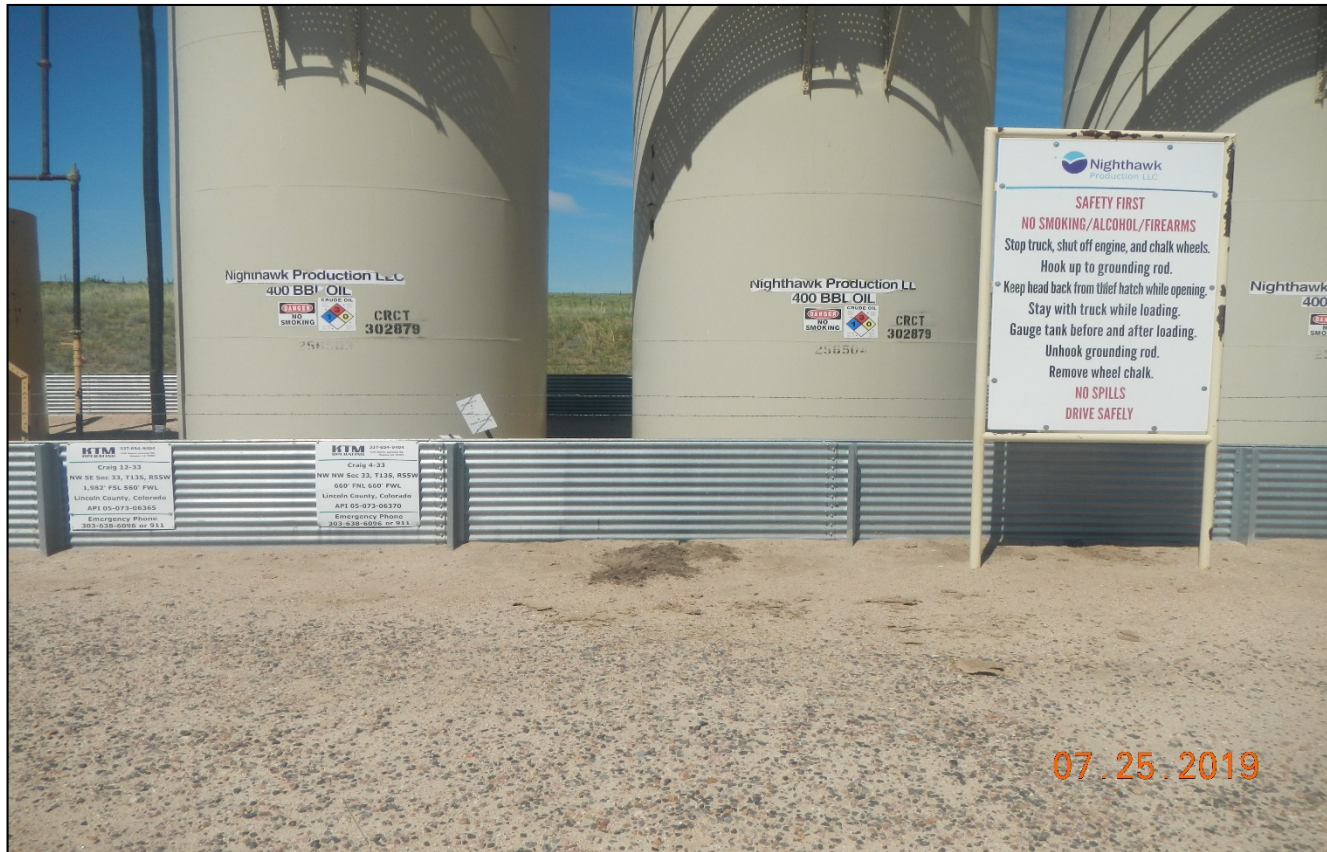
Photo 5. Old operator name remain on equipment and signs.

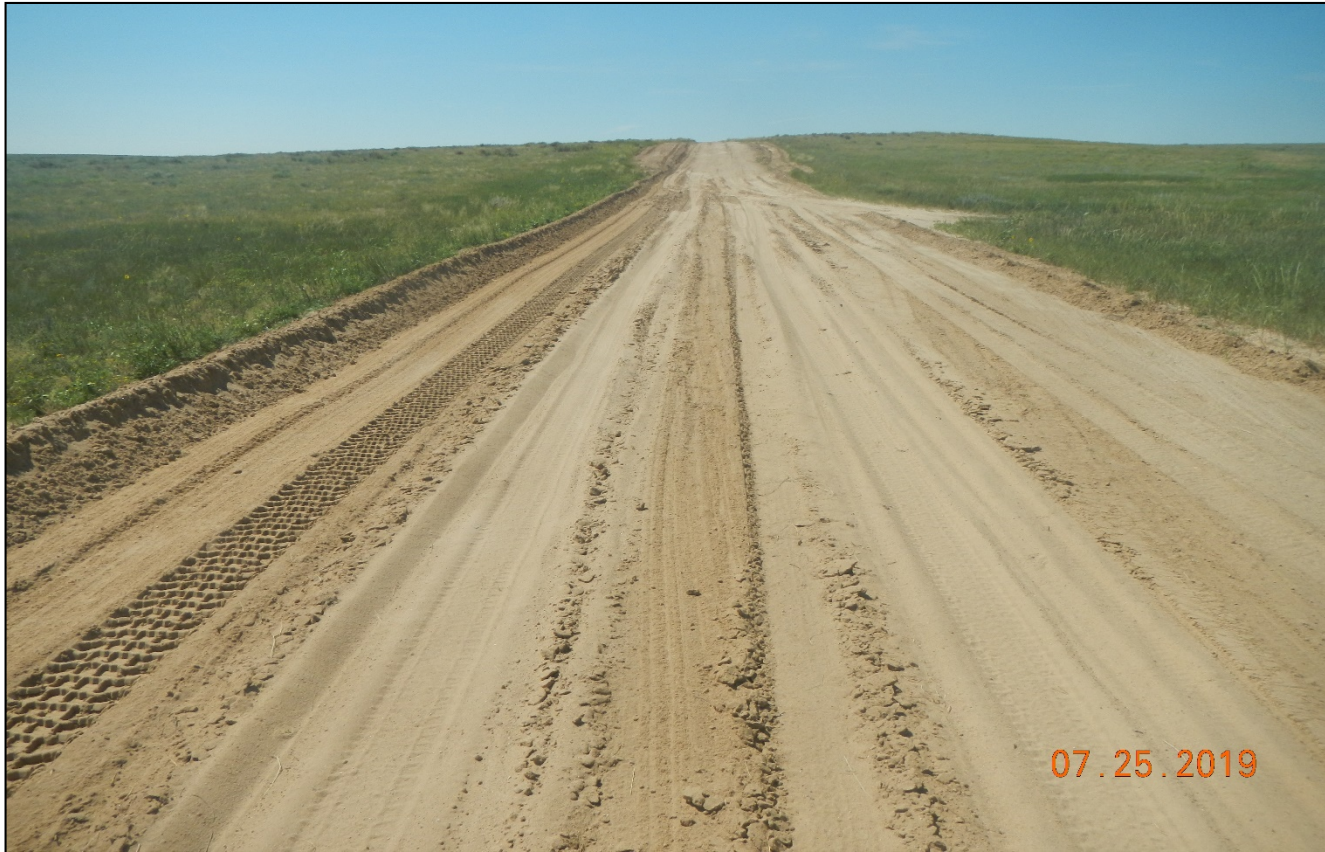
Photo 6. Recently graded road has sandy soils.
