CC 0632-13-22  
Location # 335113

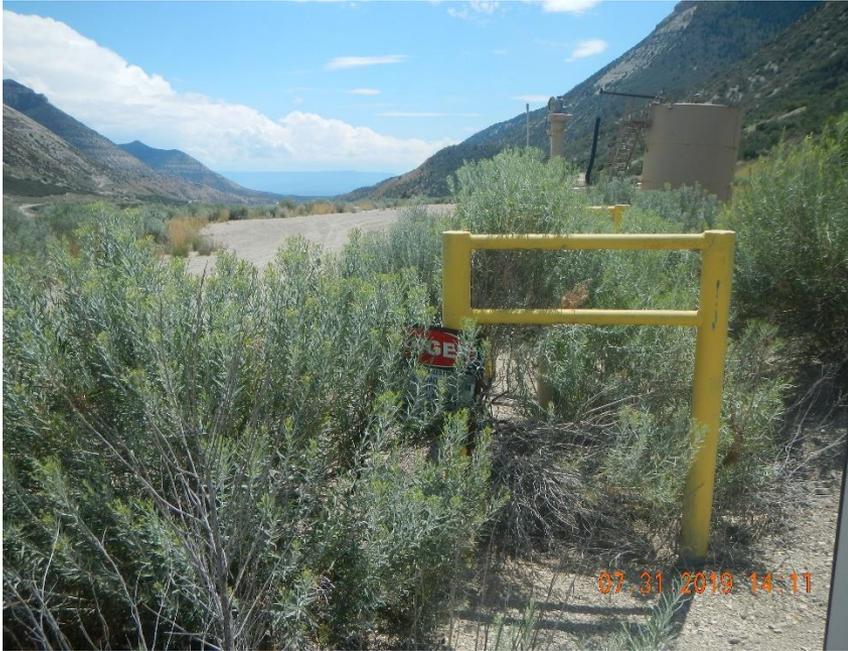
Danger sign by entrance is obstructed by weeds.

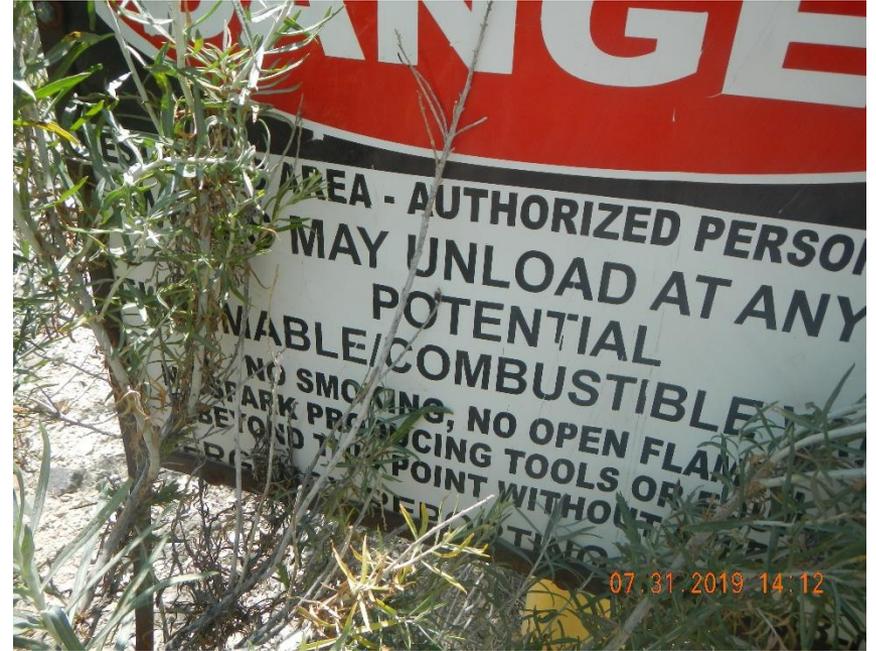
Danger sign by entrance is obstructed by weeds.

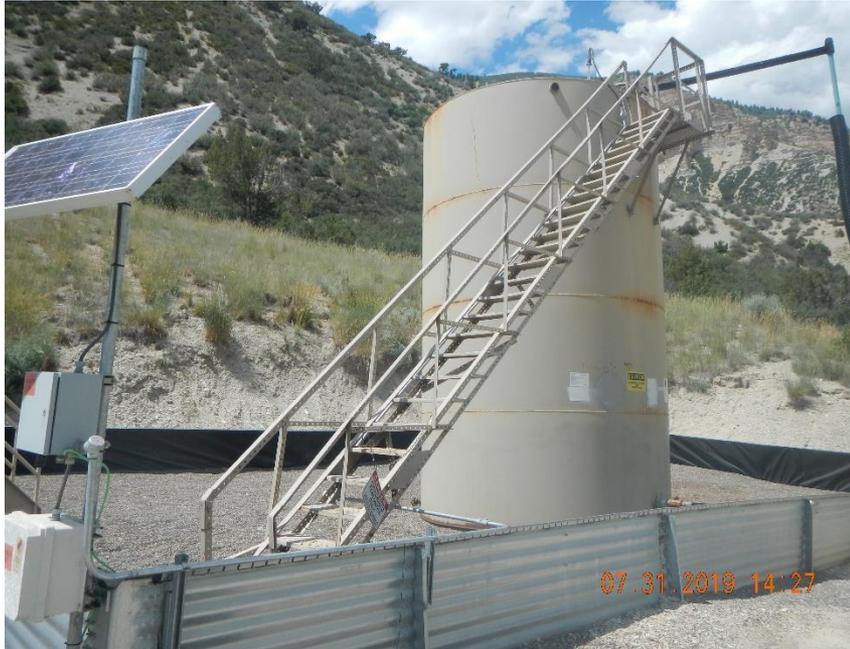
**Subsidence of unstable cut slope behind tank battery.**

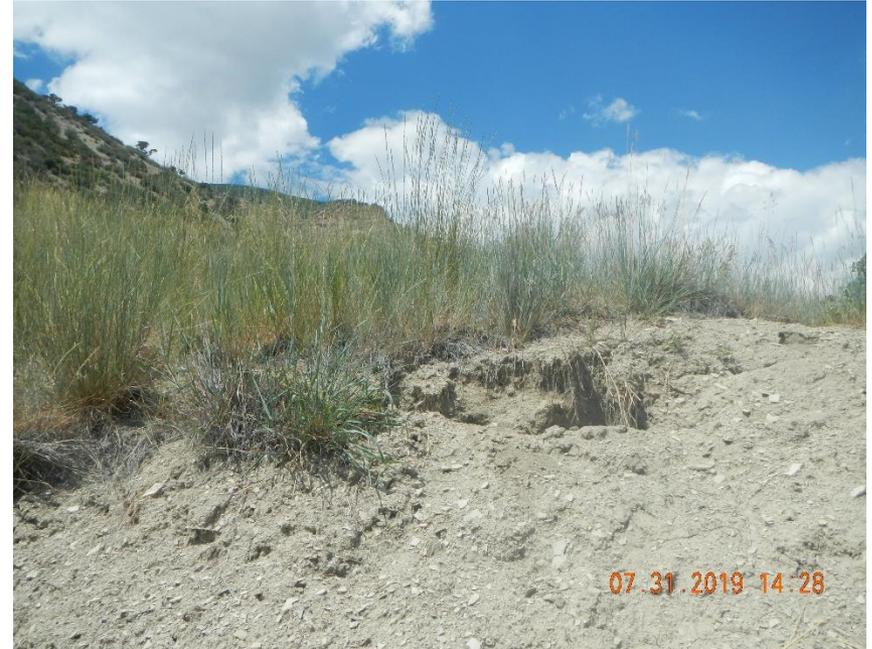
**Subsidence of unstable cut slope behind tank battery.**

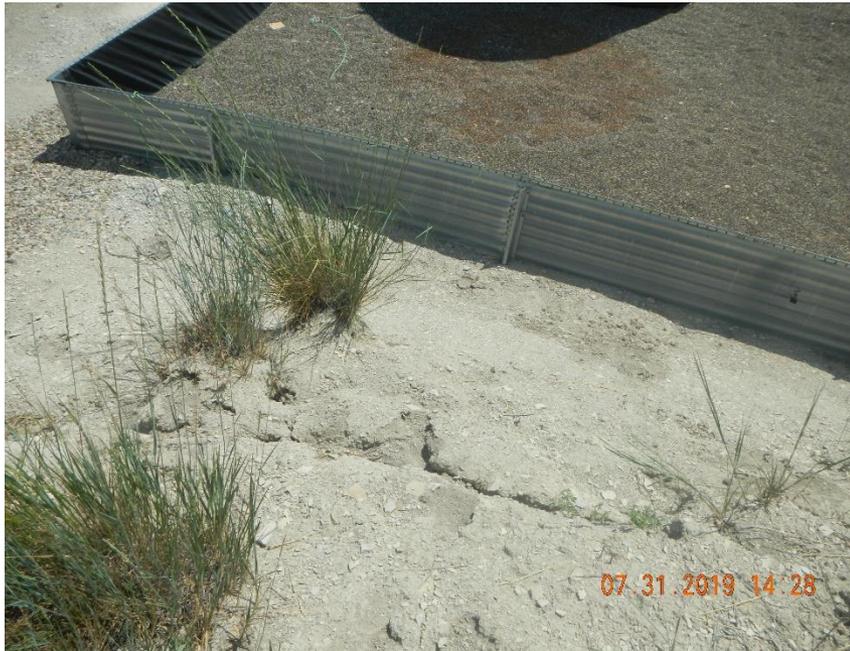
**Subsidence of unstable cut slope behind tank battery.**

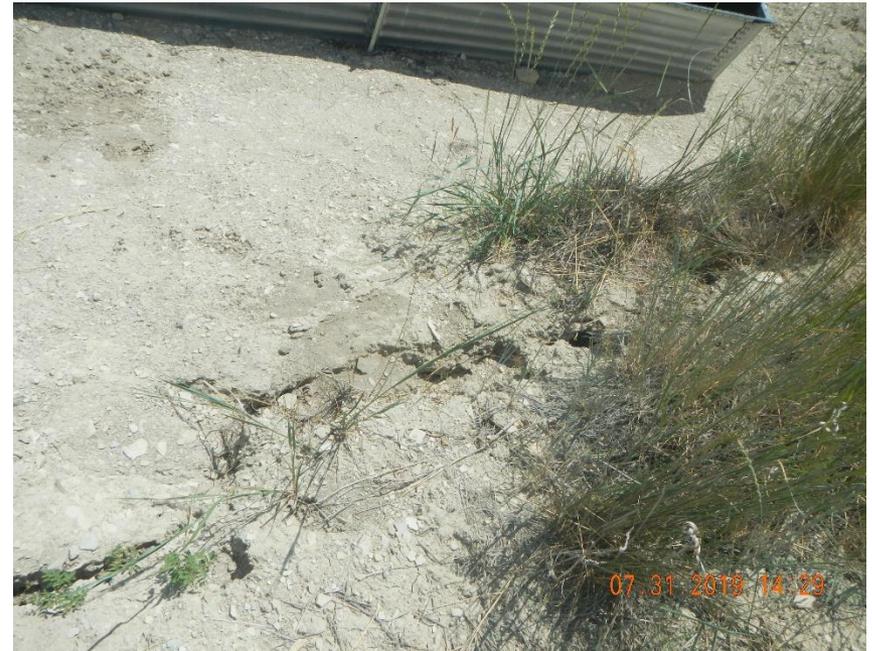
**Subsidence of unstable cut slope behind tank battery.**

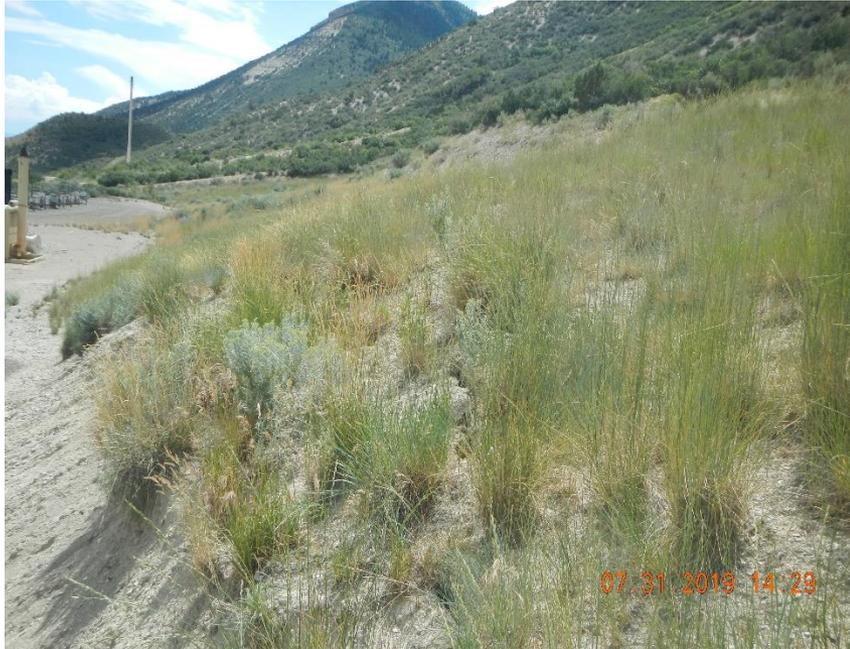
**Subsidence of unstable cut slope behind tank battery.**

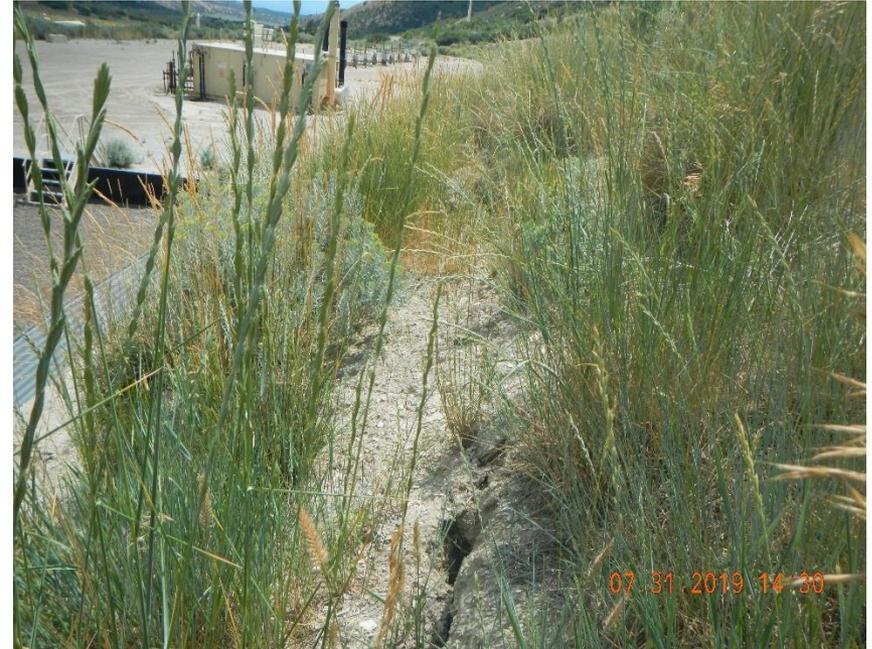
**Subsidence of unstable cut slope behind tank battery.**

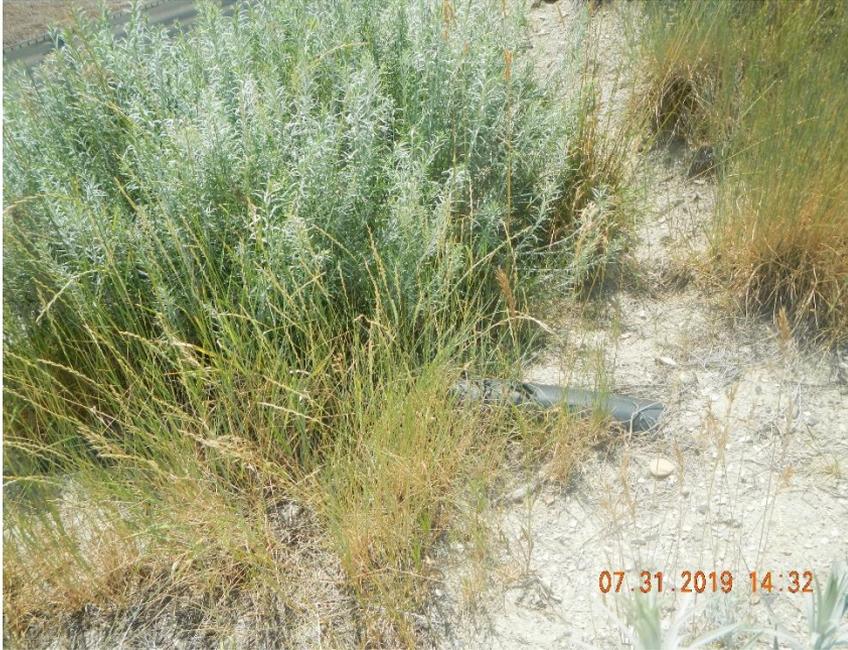
**8" black poly line exposed at entrance near tank battery and the cut off end comes out on other the side of roadway and entrance.**

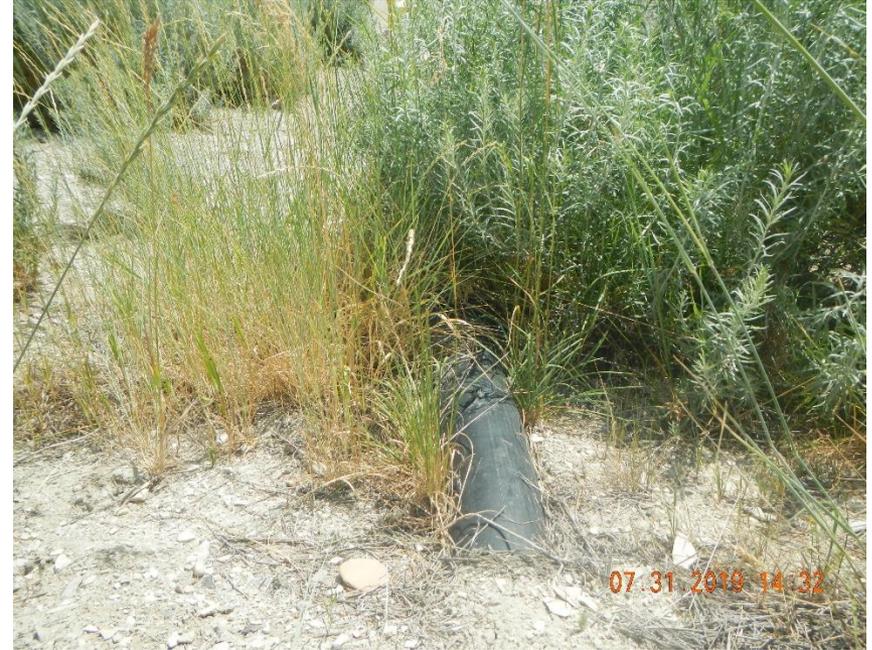
**8" black poly line exposed at entrance near tank battery and the cut off end comes out on other the side of roadway and entrance.**

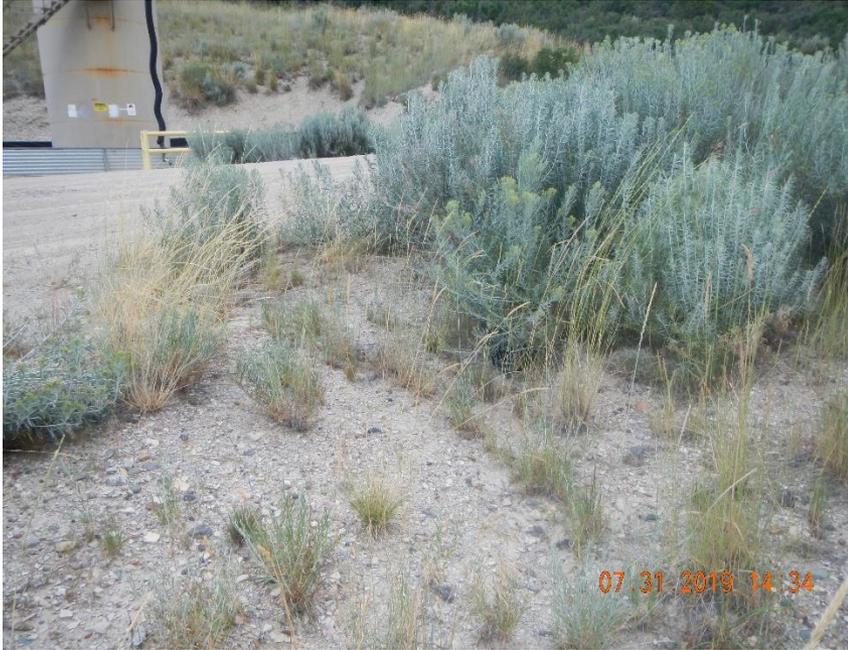
**8" black poly line exposed at entrance near tank battery and the cut off end comes out on other the side of roadway and entrance.**

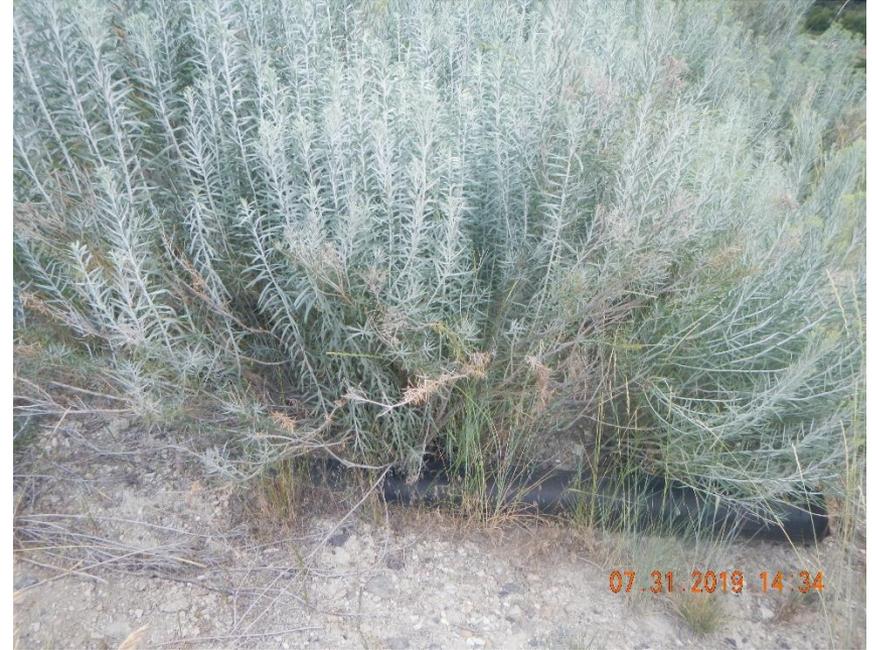
**8" black poly line exposed at entrance near tank battery and the cut off end comes out on other the side of roadway and entrance.**

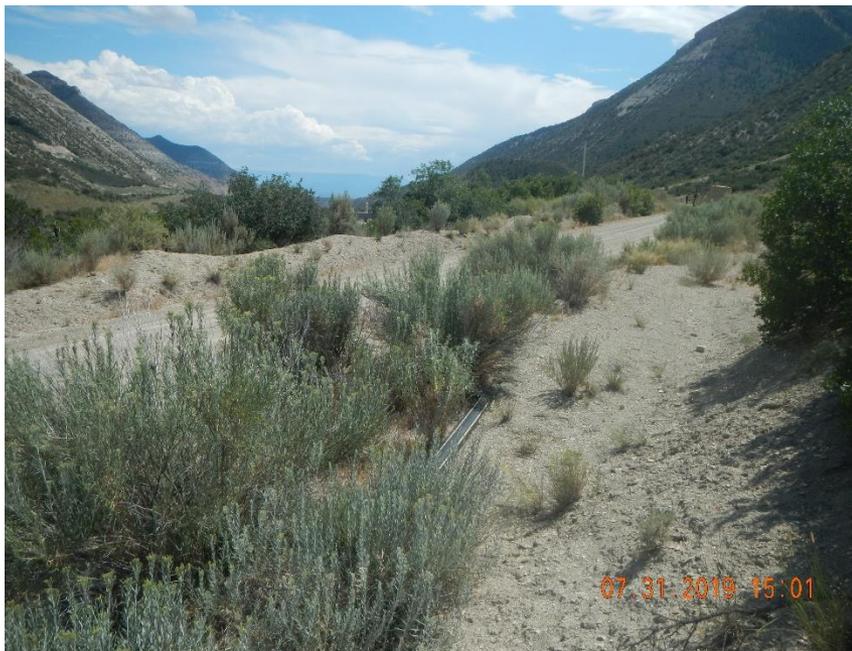
Approximately 35' piece of poly pipe along road N39.48783  
W108.24905

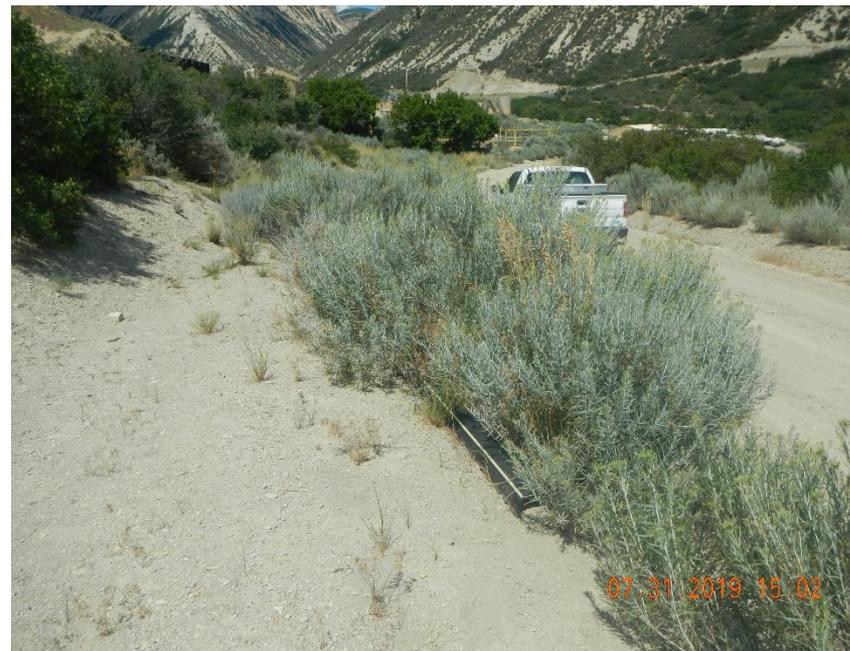
Approximately 35' piece of poly pipe along road N39.48783  
W108.24905

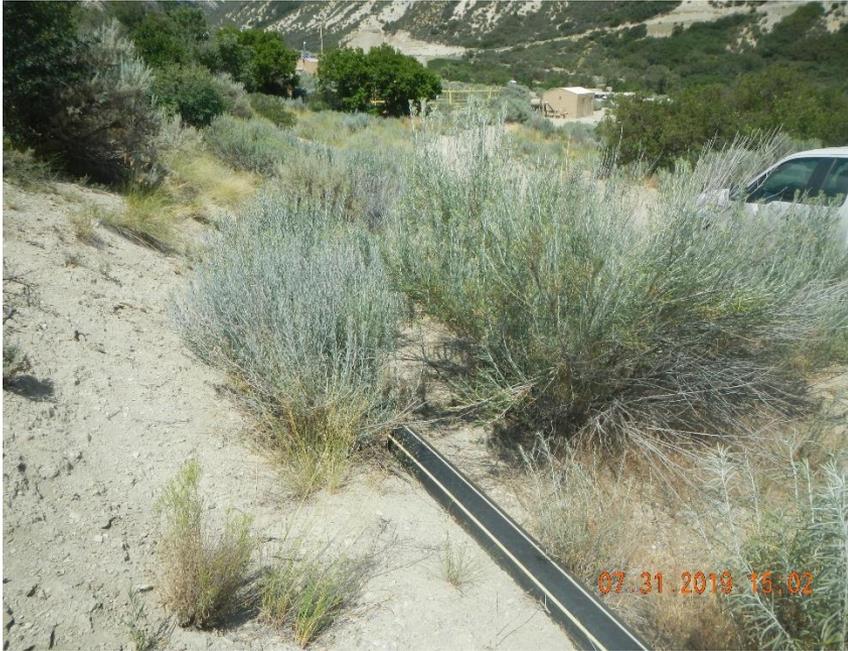
Approximately 35' piece of poly pipe along road N39.48783  
W108.24905

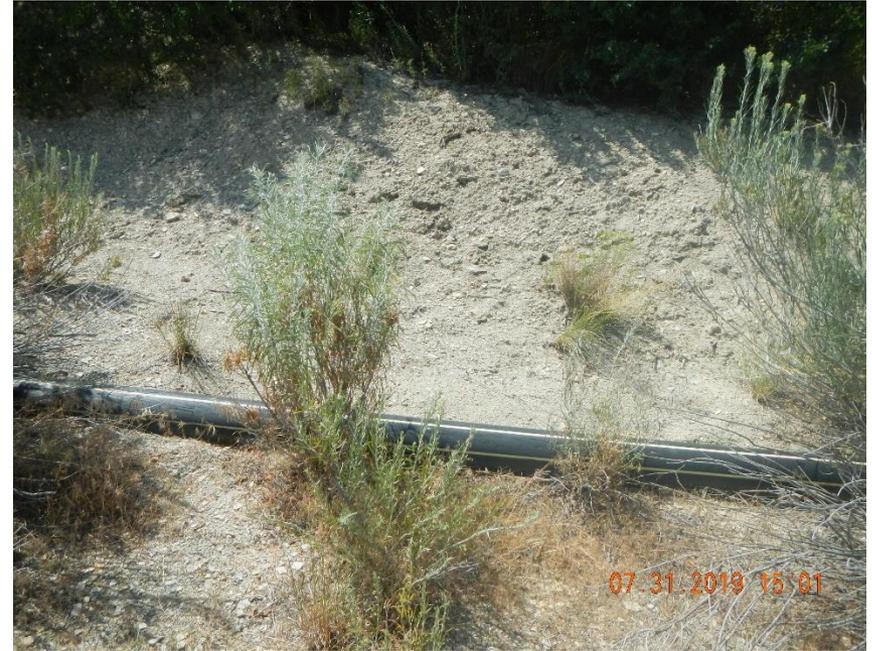
Approximately 35' piece of poly pipe along road N39.48783  
W108.24905
