# Inspection Photos

API: 05-041-06072

Operator: HILCORP ENERGY COMPANY

Inspection and Photo Date: 7/25/2019

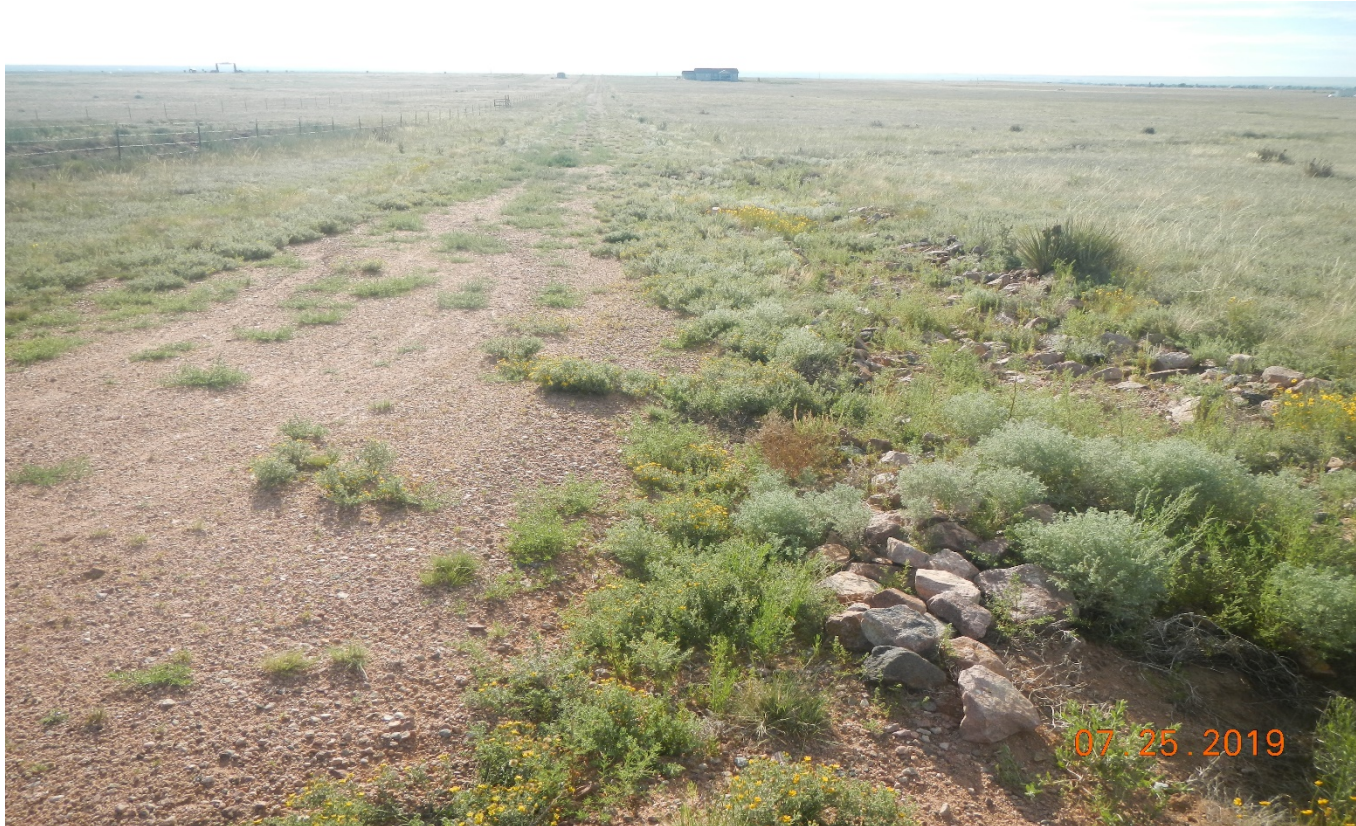
**Photo 1.** Facing east on the access road. Rock rip/rap can be seen in the drainage channel. There is desirable and undesirable weedy vegetation establishing in the drainage.

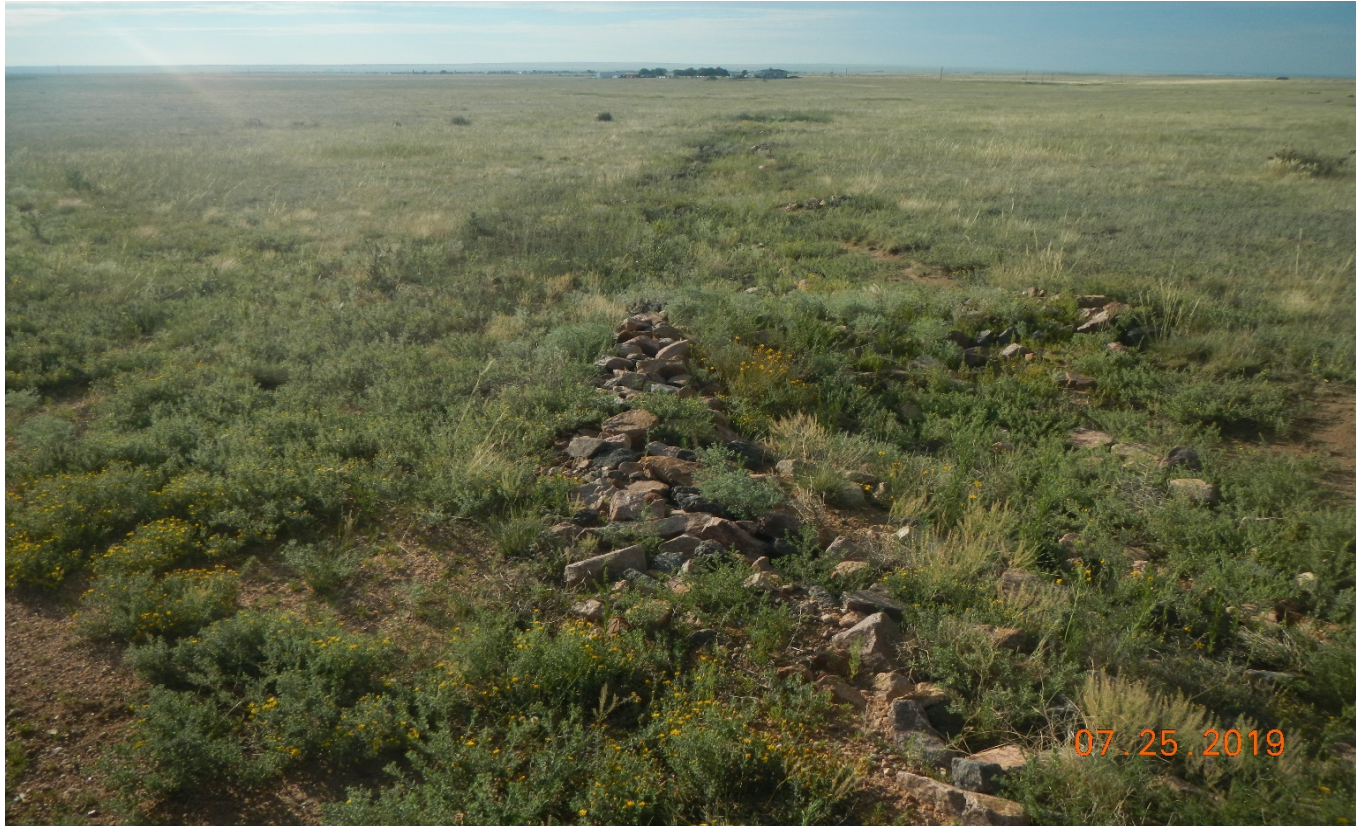
**Photo 2.** The drainage channel extends far out into the pasture. This is additional disturbance caused by erosion. The channel needs to be recontoured to grade and reclaimed/reseeded. A proper sediment trap should be constructed to limit sediment discharge. This corrective action has not been completed. This photo depicts noncompliance of the corrective action.

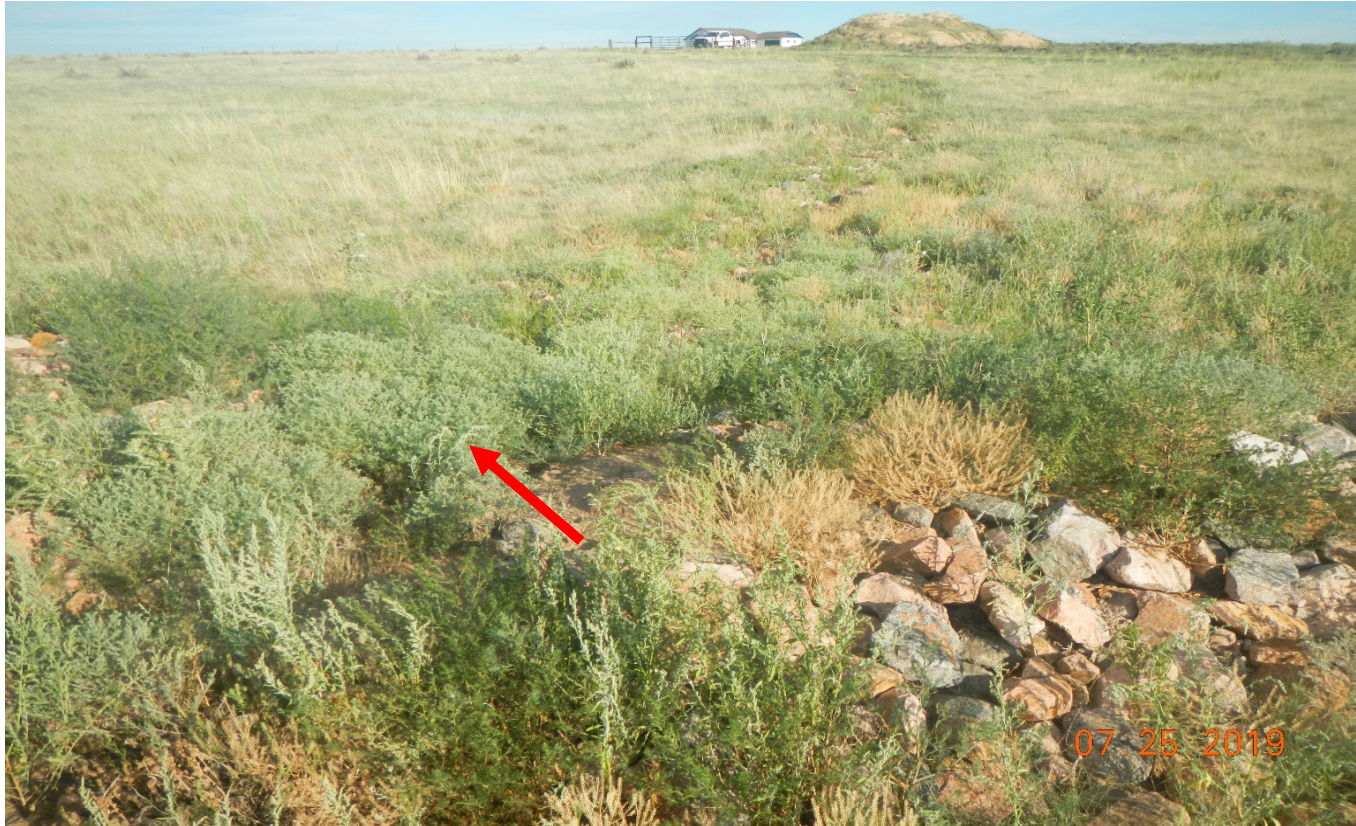
**Photo 3.** Standing out in the pasture facing northwest toward the road. The erosion channel has not been reclaimed and there is rock rip/rap scattered along the channel. This photo depicts noncompliance of the corrective action. There is desirable and undesirable weedy vegetation (shown by red arrow) establishing in the drainage.

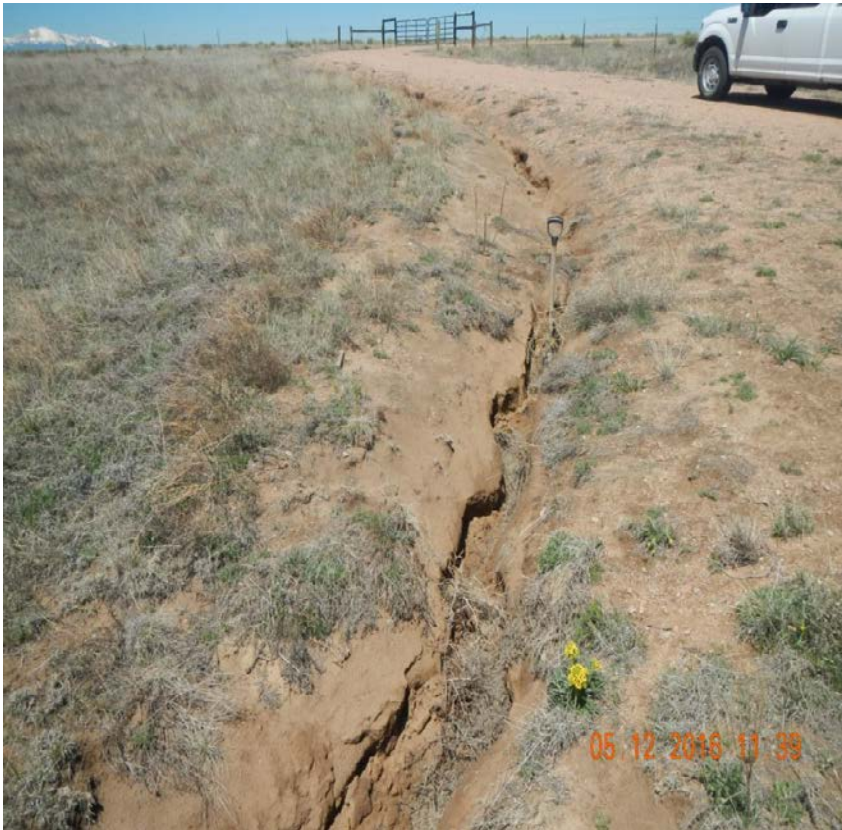
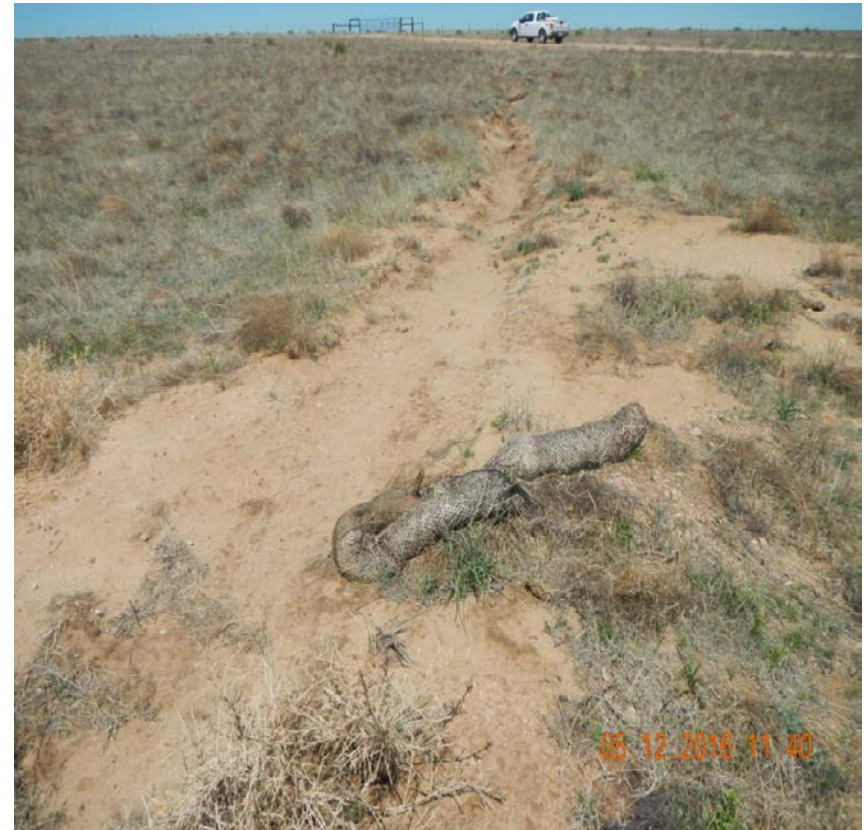
**Photo 4.** The two photos shown were taken on 5/12/2016 when erosion channel developed extending into the pasture which was previously undisturbed. The two previous photos 2 & 3, shows that this erosion channel/disturbance was never reclaimed.

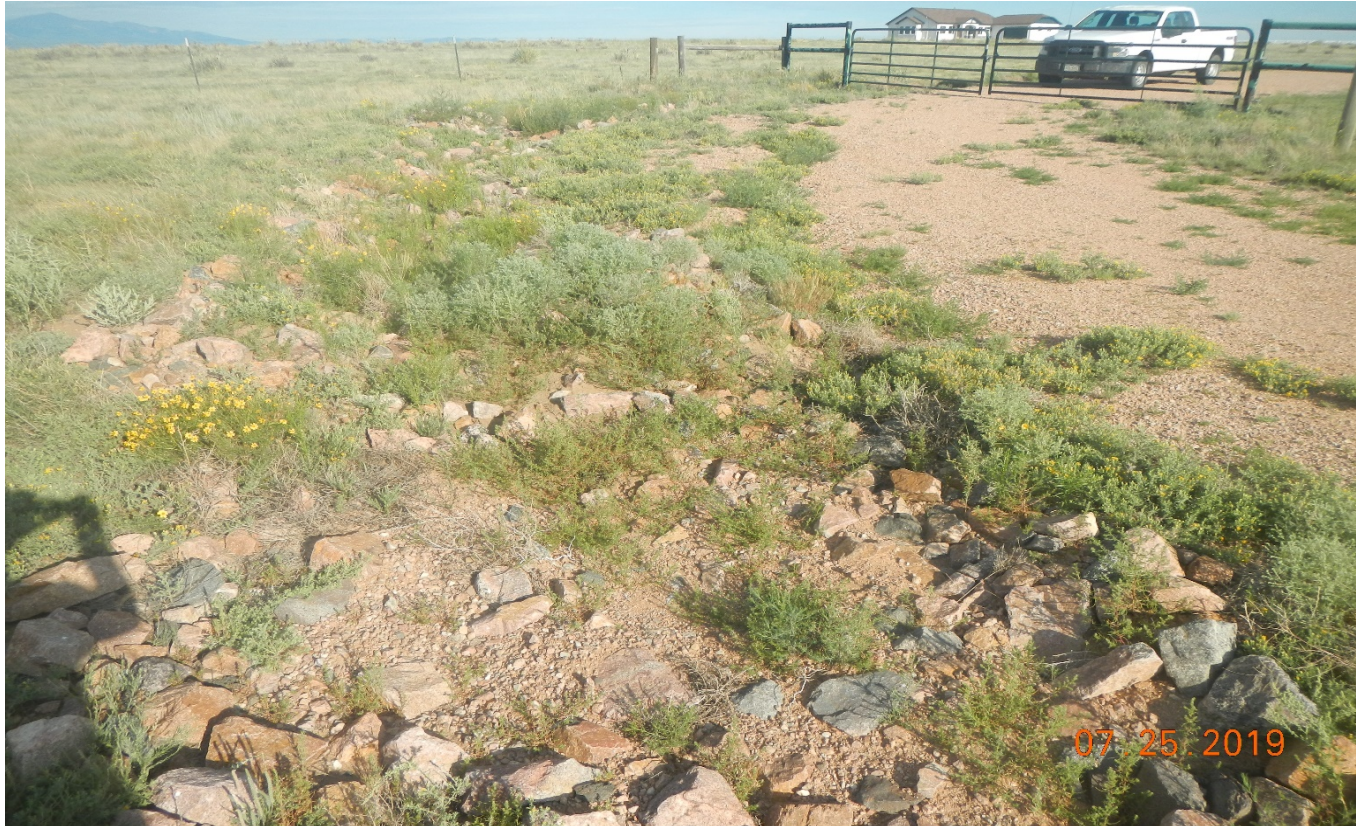
**Photo 5.** Rock rip/rap can be seen in the drainage channel. Rock check dams have been lowered to allow water flow. This photo depicts compliance of the corrective action. There is desirable and undesirable weedy vegetation establishing in the drainage.

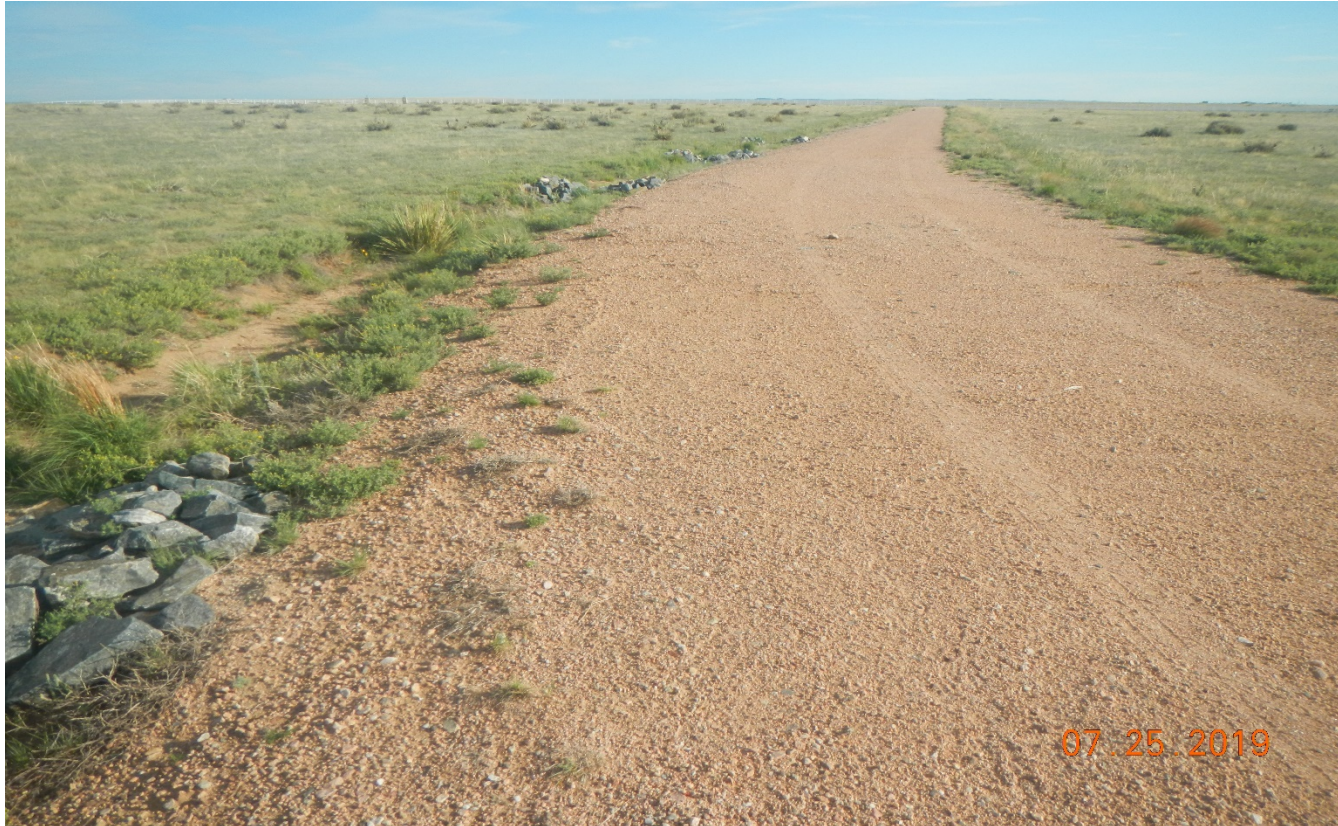
**Photo 6.** Rock check dams have been installed further up the road from the gate shown in photo 4. This photo depicts compliance of the corrective action.

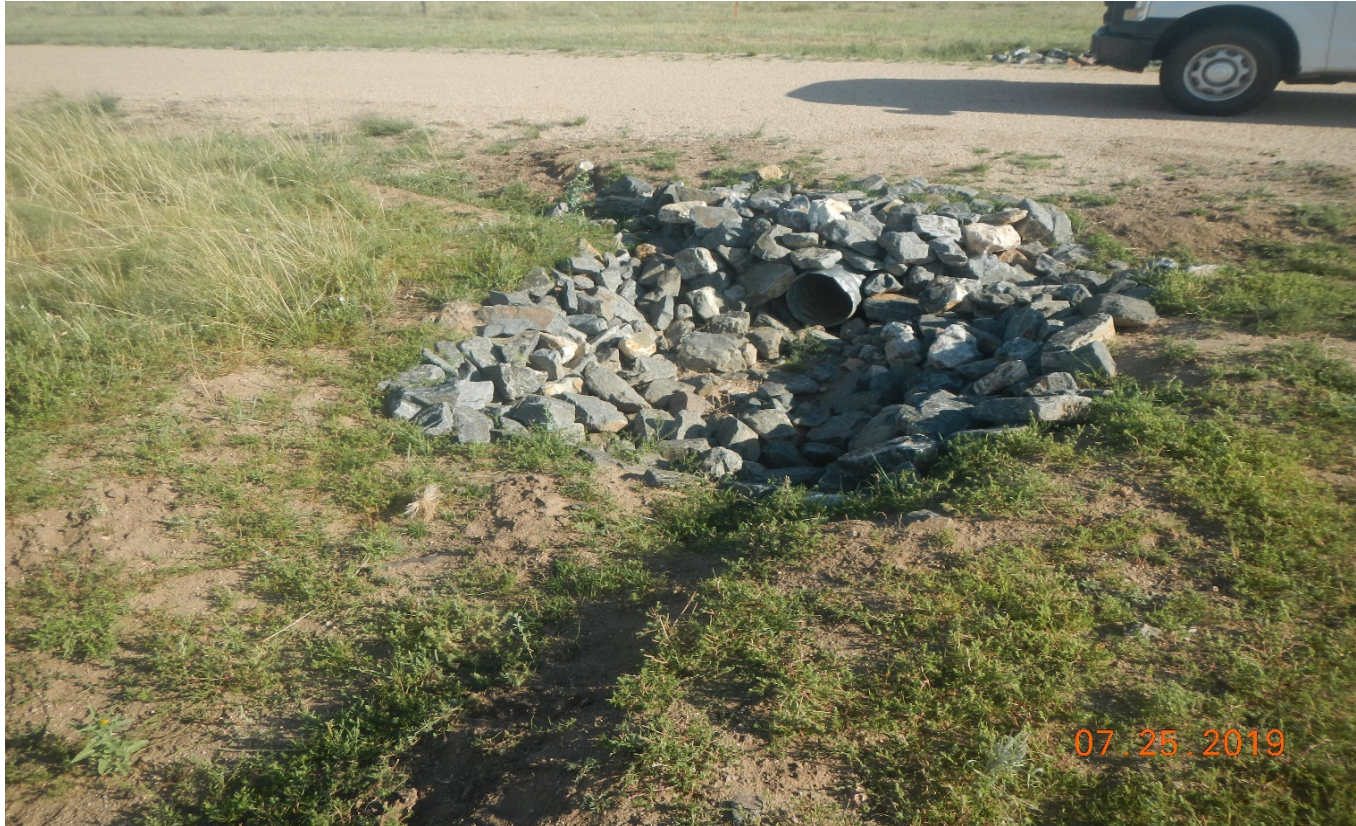
**Photo 8.** The outlet culvert rock rip/rap has been lowered to allow sediment to settle and not restrict stormwater flow. This photo depicts compliance of the corrective action. There is desirable and some undesirable weedy vegetation.

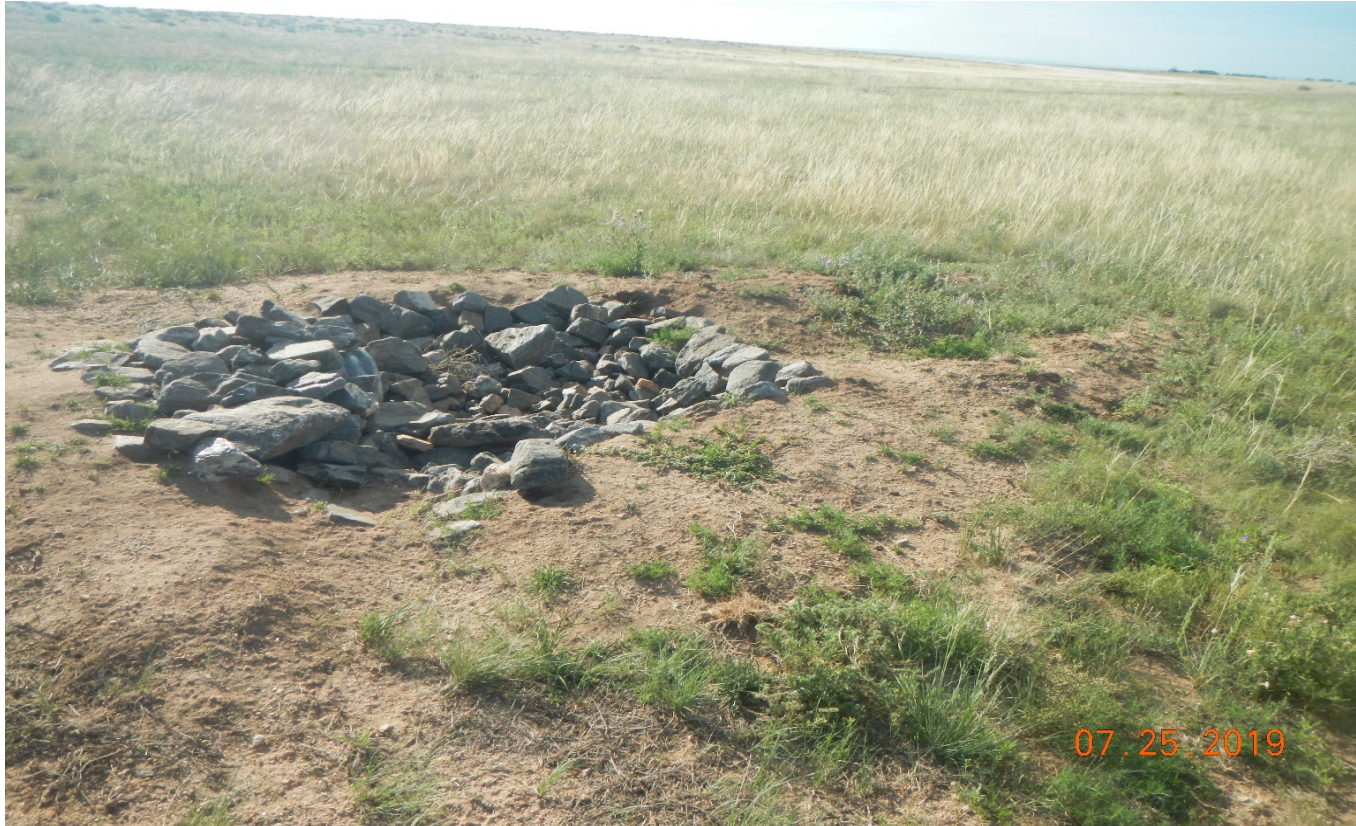
**Photo 9.** The outlet culvert rock rip/rap has been lowered to allow sediment to settle and not restrict stormwater flow. This photo depicts compliance of the corrective action.

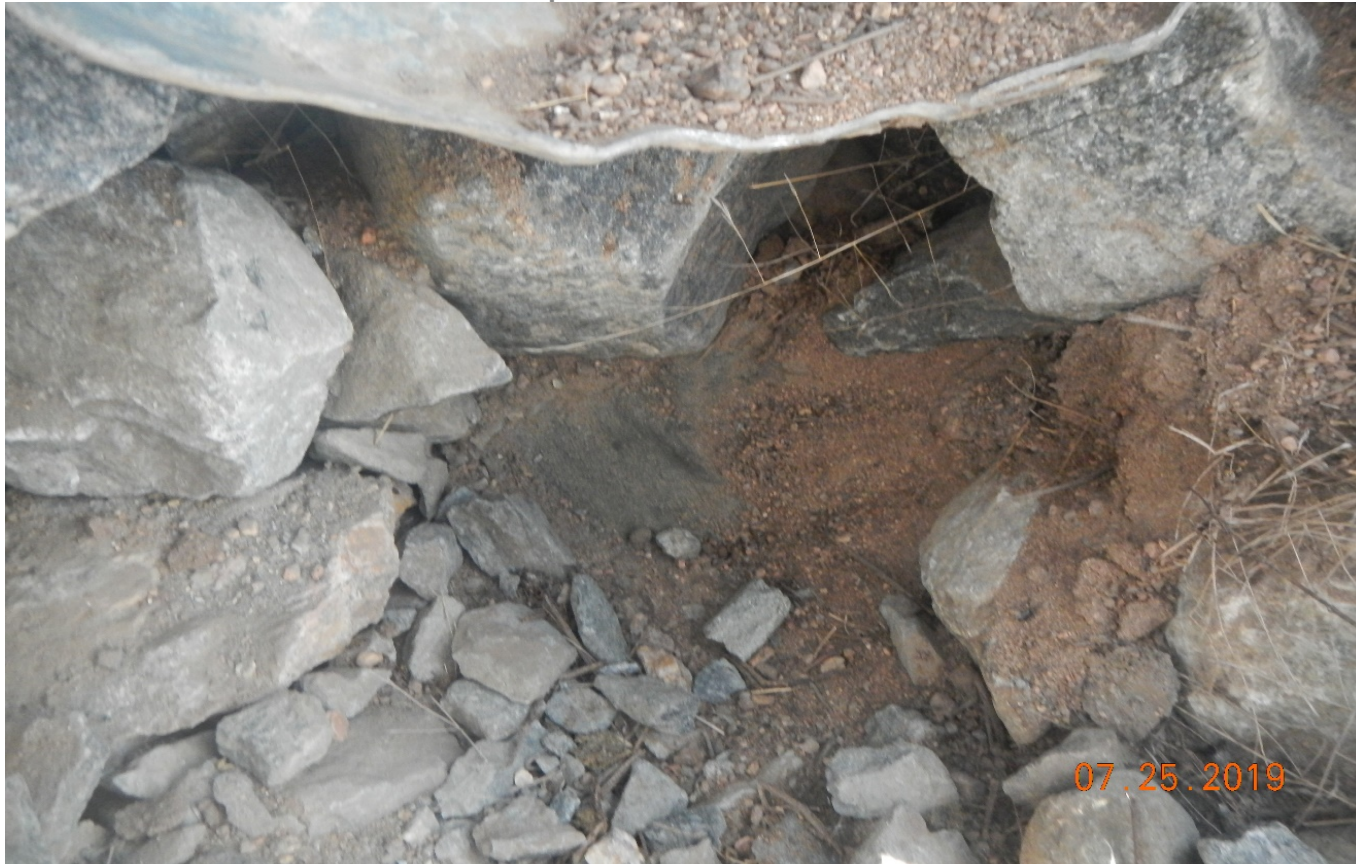
**Photo 10.** Geotextile was installed at the culverts outlet protection.  
This photo depicts compliance of the corrective action.

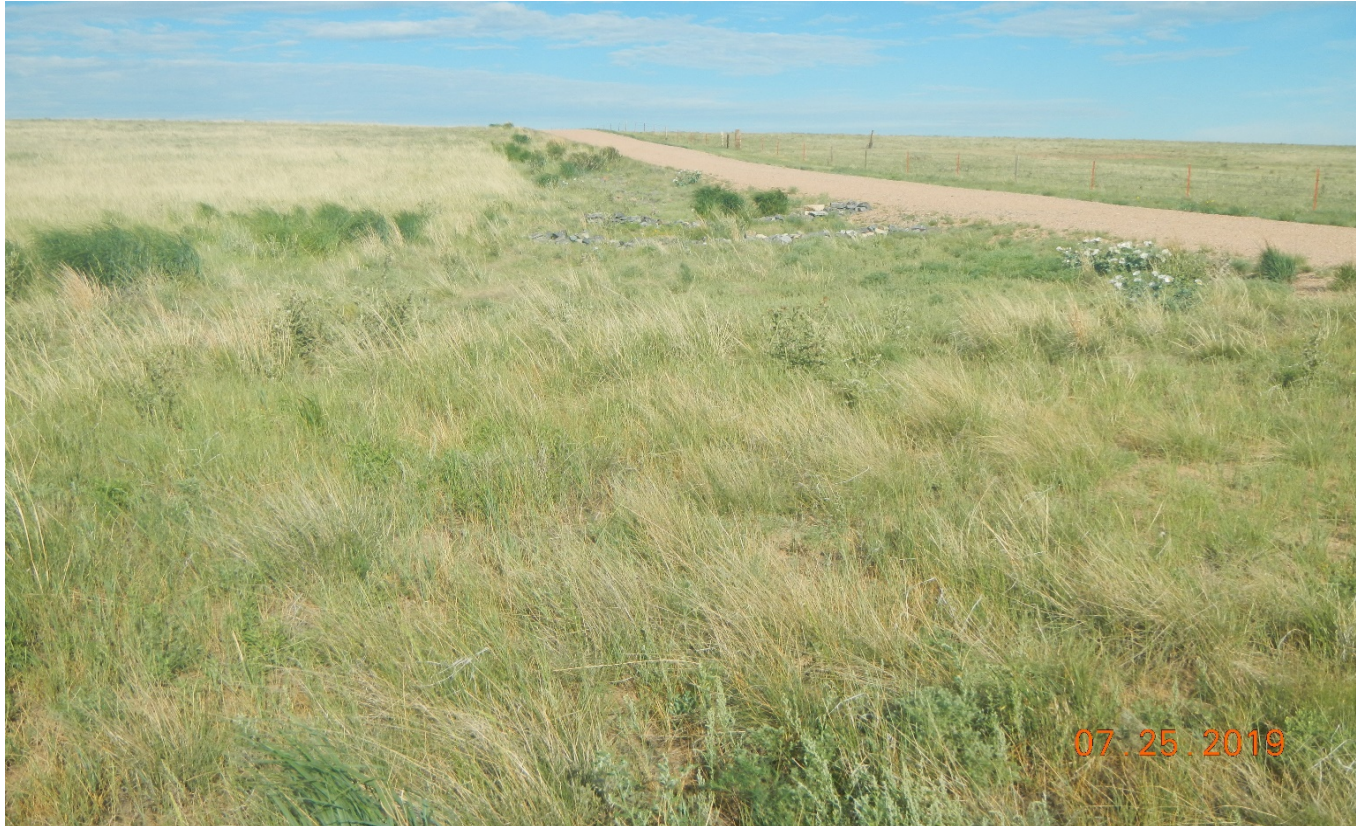
**Photo 12.** Vegetation is beginning to establish along the side of the access road where disturbance occurred. Rock check dams have been installed up gradient along the road. This photo depicts compliance of the corrective action.

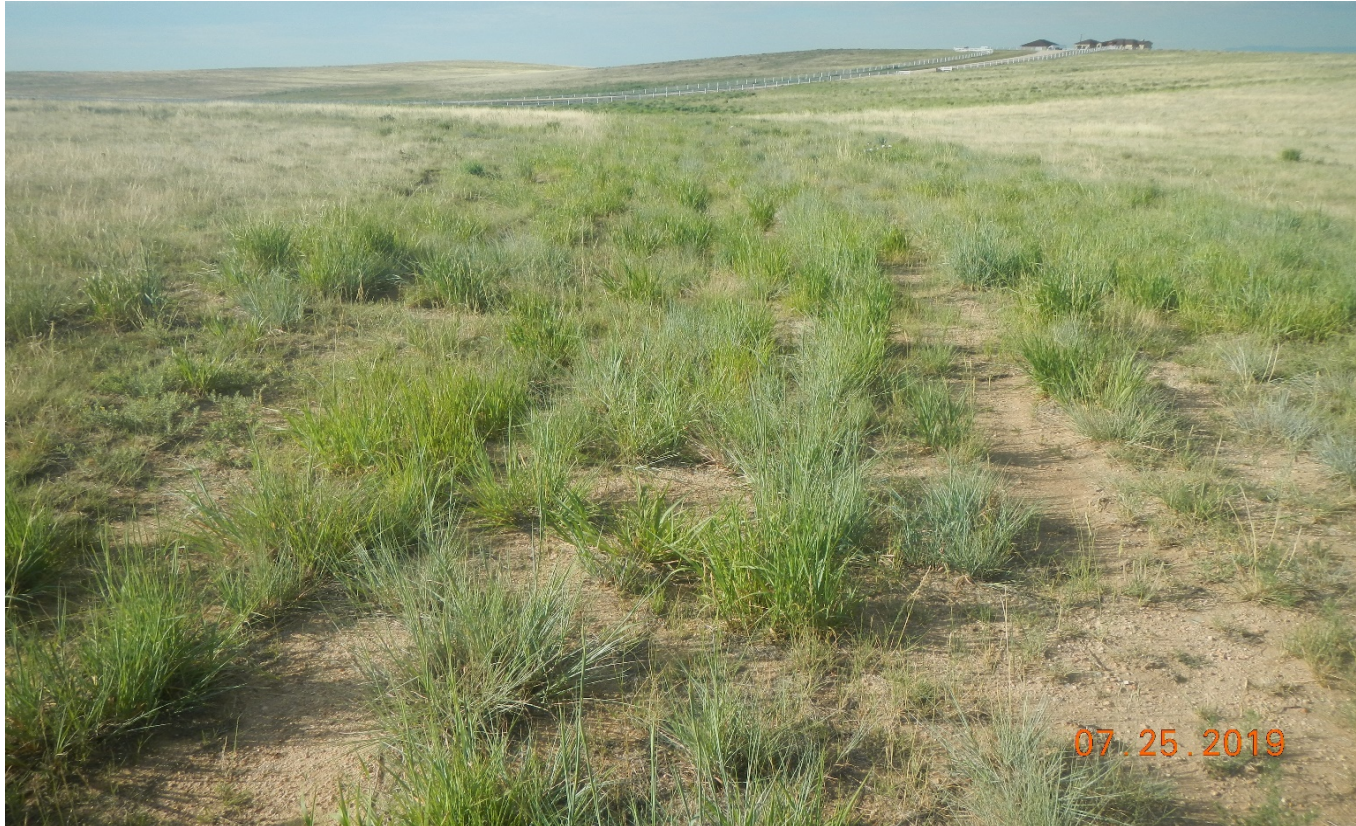
**Photo 13.** Facing south toward the reclaimed access road and location. Vegetation appears to be establishing. This photo depicts compliance of the corrective action. This photo depicts compliance of the corrective action, however this area needs to be monitored for successful revegetation.

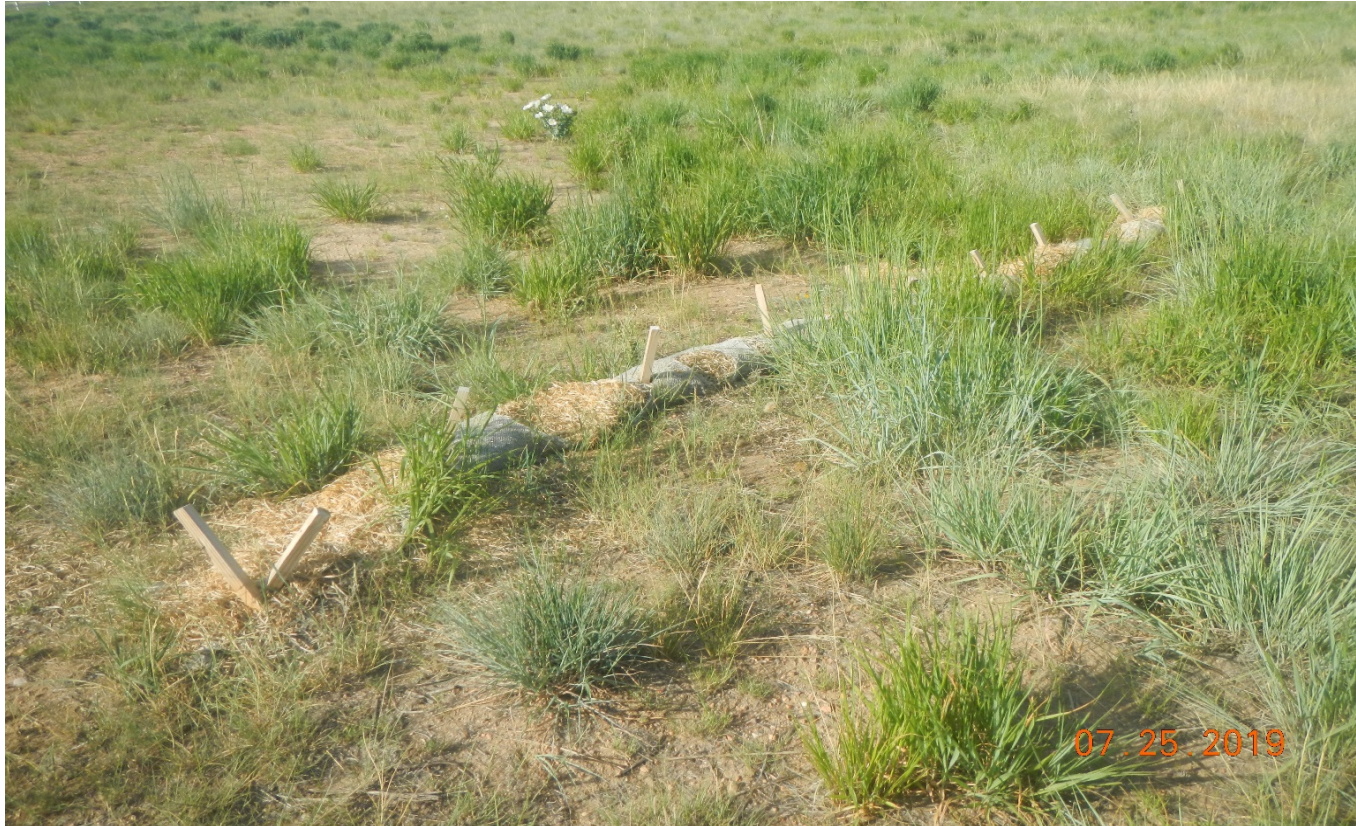
**Photo 14.** Wattles installed at the location have degraded and need to be removed or replaced.

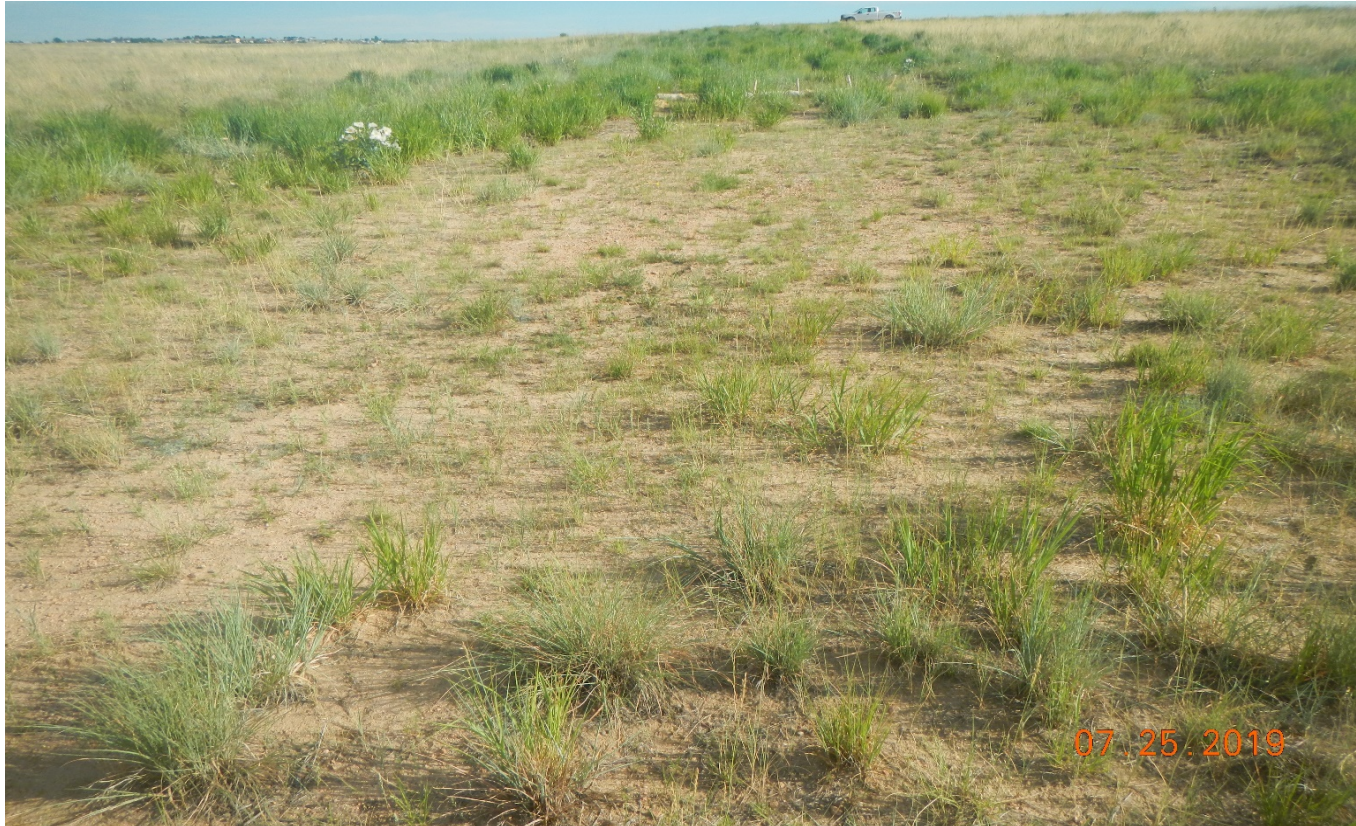
**Photo 15.** Facing north at the location. This area was reseeded and vegetation is establishing. This photo depicts compliance of the corrective action, however this area needs to be monitored for successful revegetation.

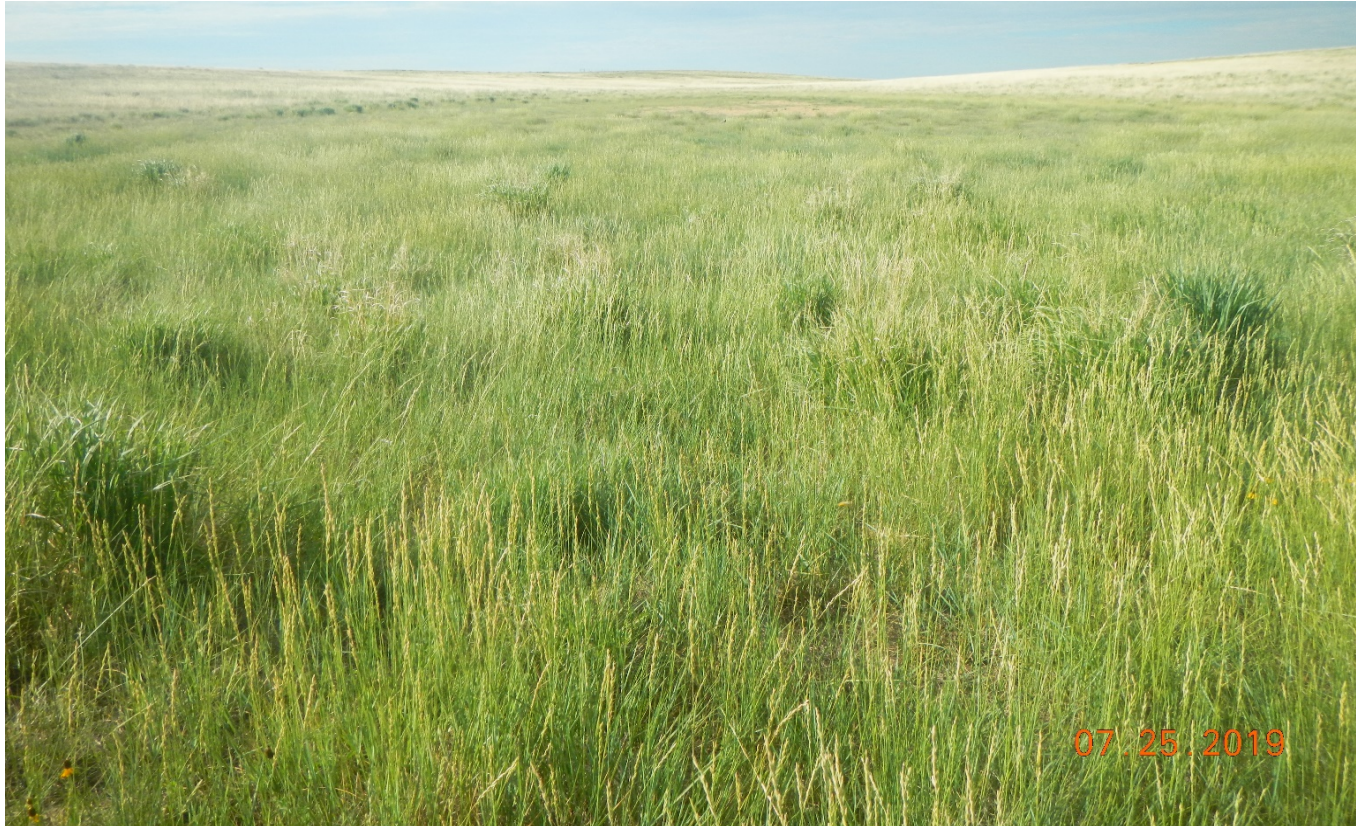
**Photo 17.** Vegetation is well established at the southern portion of the location.

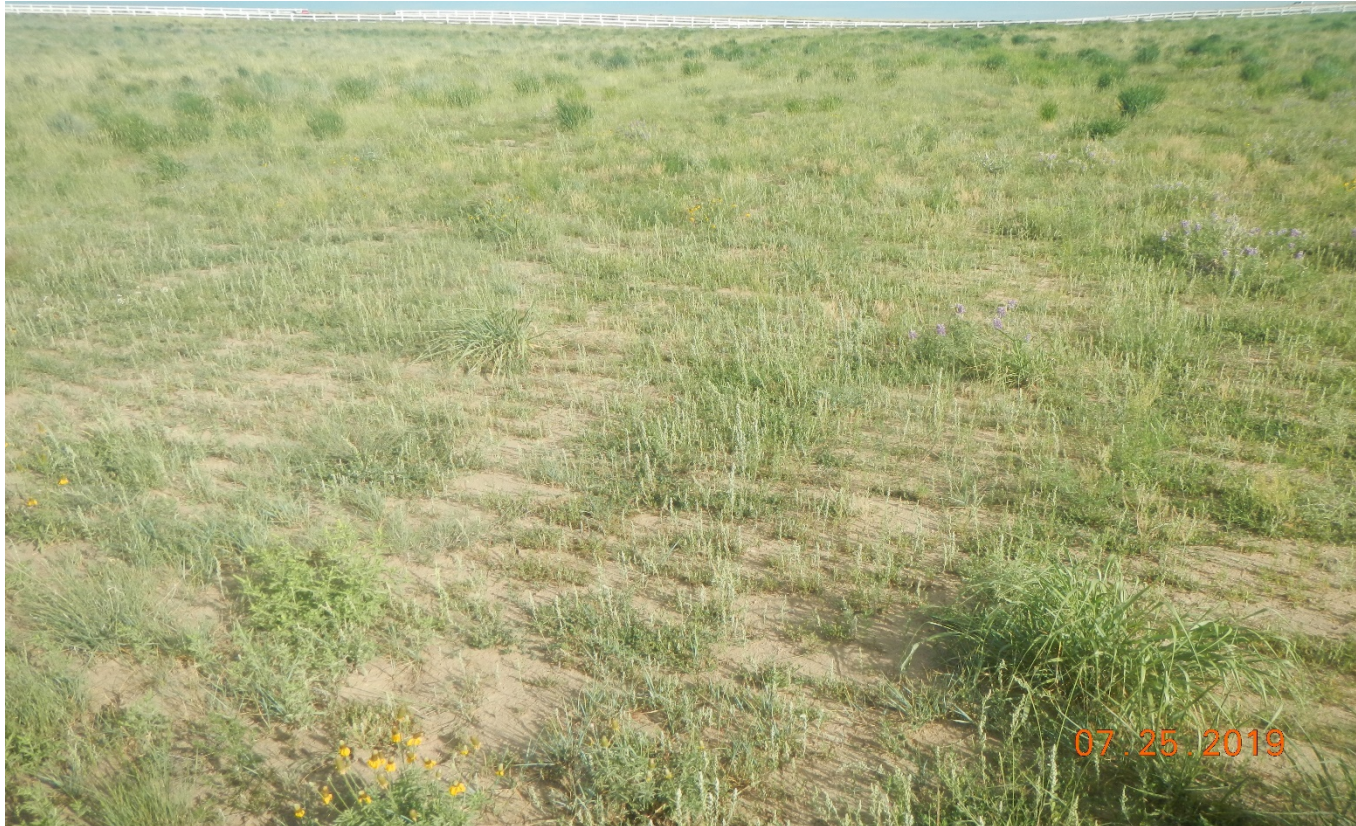
**Photo 18.** Facing north at the southern portion of the location. This area was reseeded and vegetation is establishing. This photo depicts compliance of the corrective action, however this area needs to be monitored for successful revegetation.

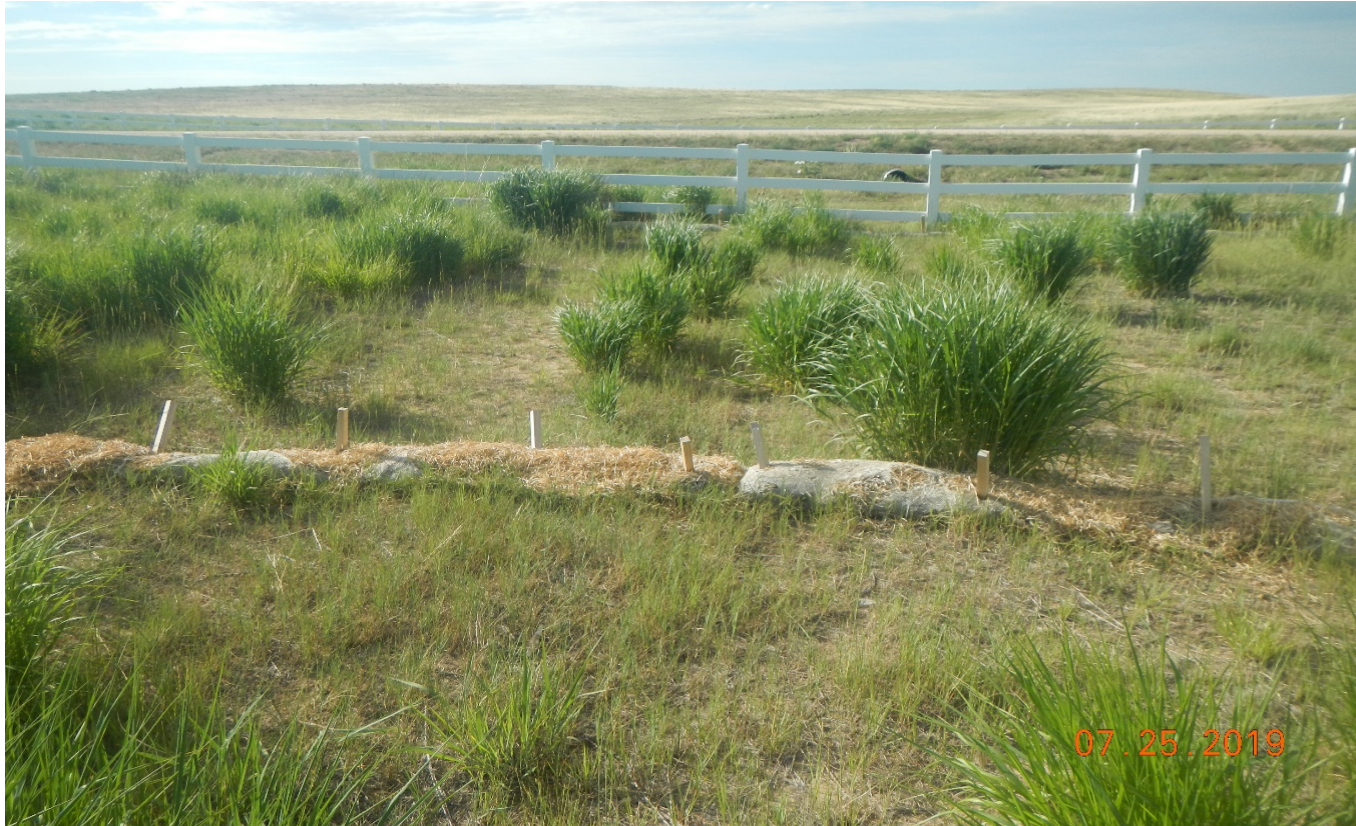
**Photo 19.** Wattles installed at the location have degraded and need to be removed or replaced.
