Maralex Resources Inc.
API # 077-08601
Inspection # 696600436

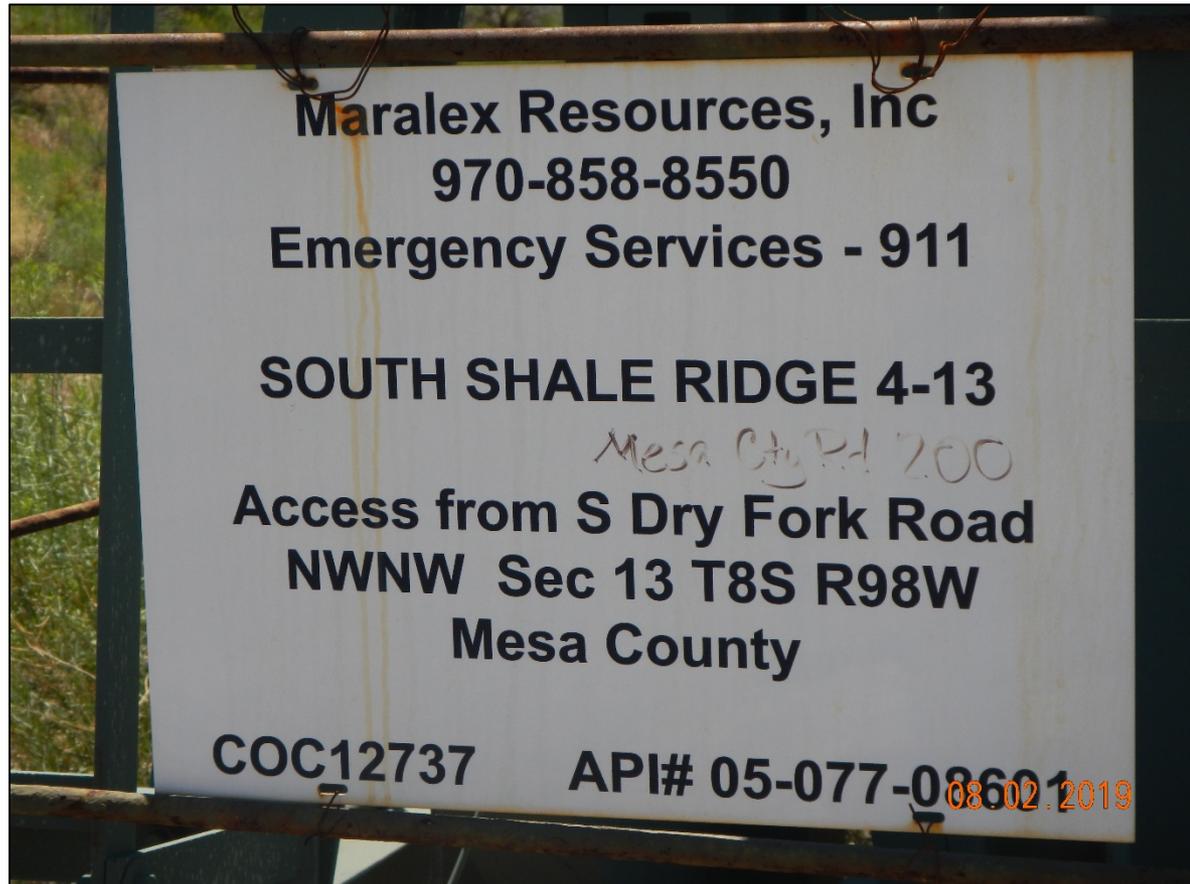
Photo #1 Sign is posted at the Pump Jack

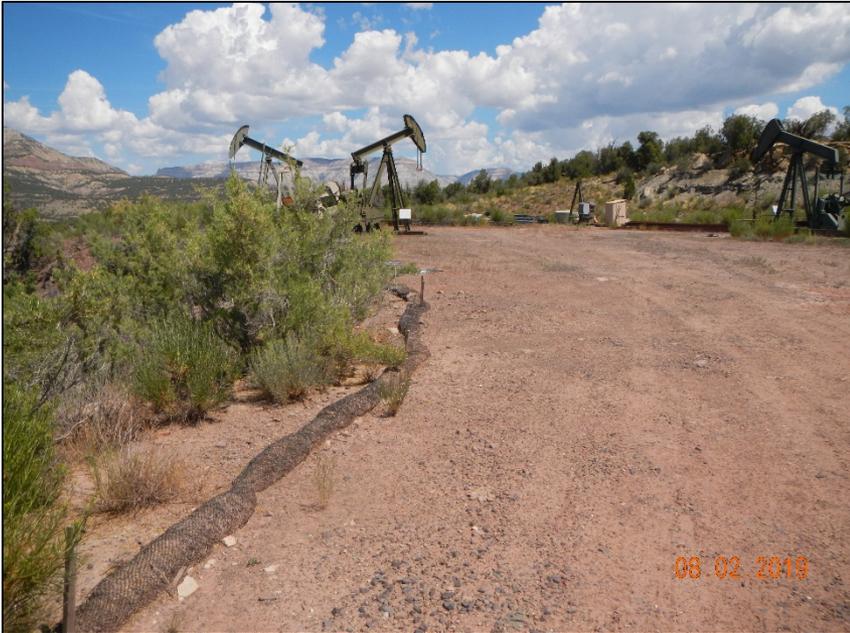
Photo #2 Photo at entrance of location.

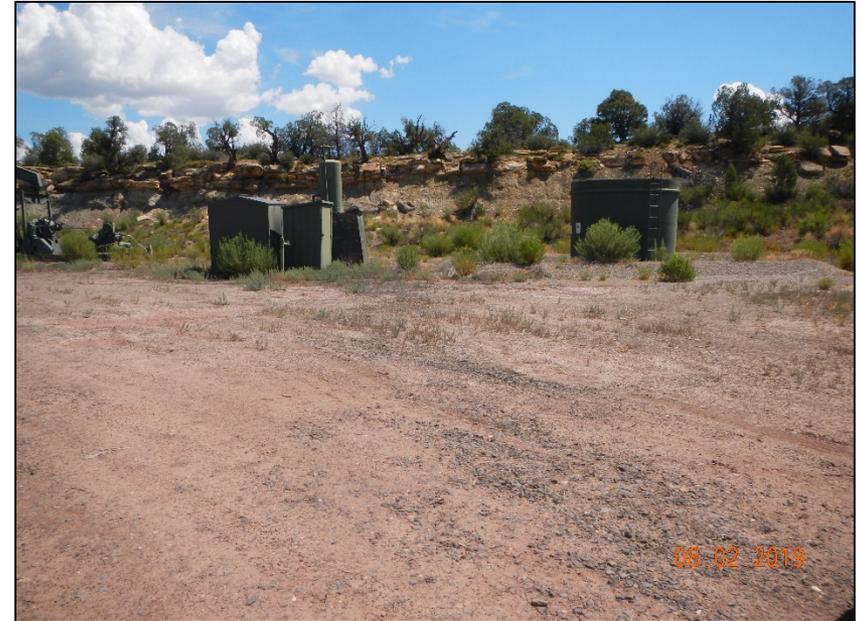
Photo #3 Photo at entrance of location.

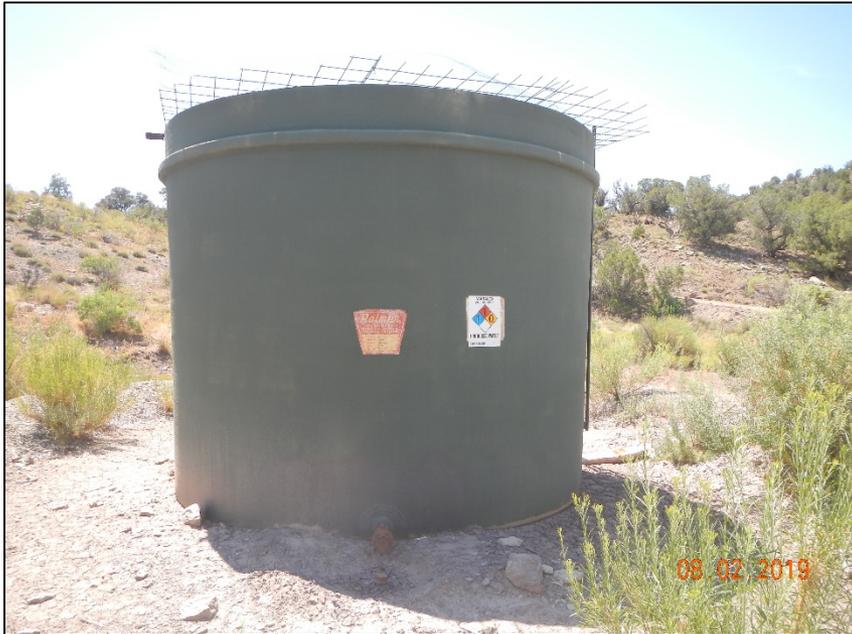
Photo #4 Photo of tank battery. Weeds inside of tank containment.

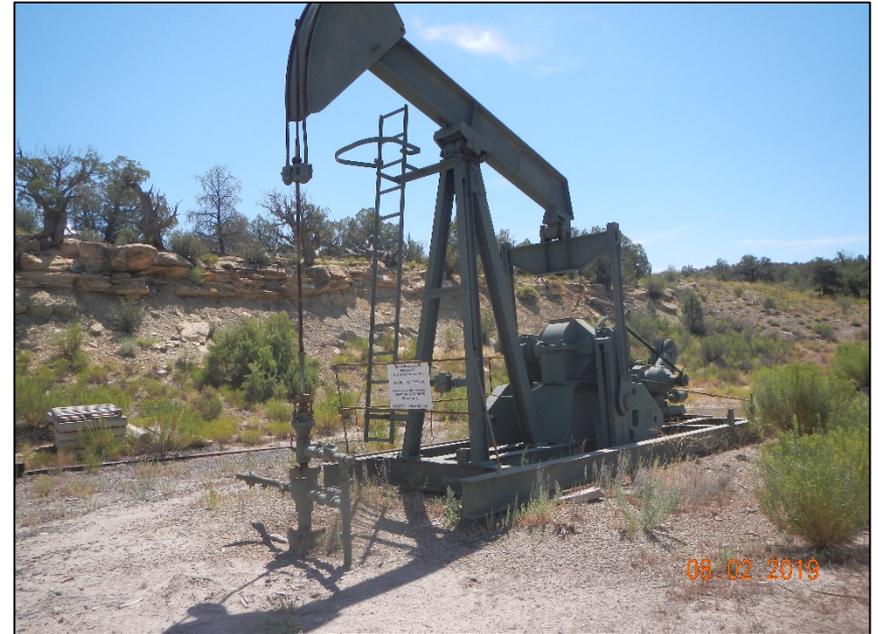
Photo #5. Photo of wellhead and pump jack. Weeds are present.

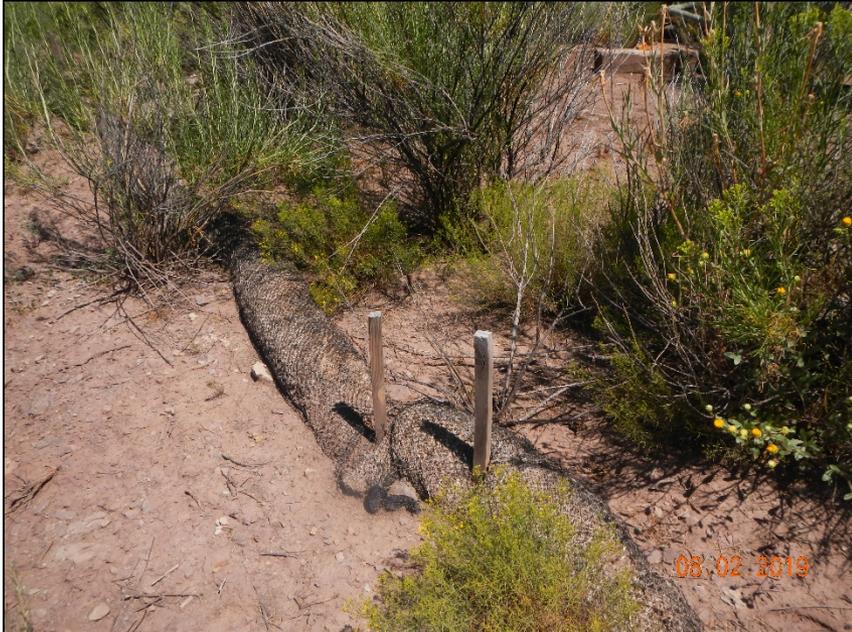
Photo #6 BMP or waddles in need maintenance.

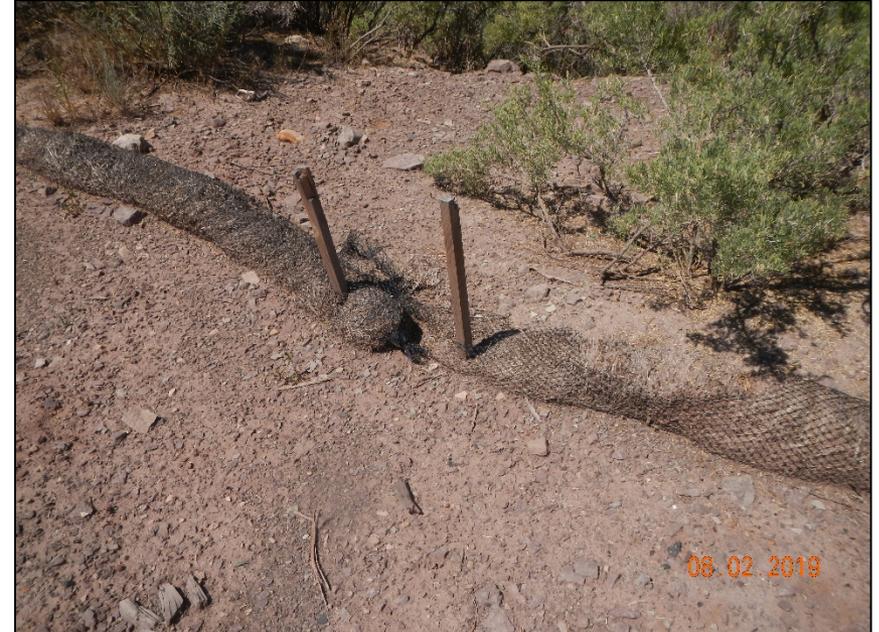
Photo #7 BMP or waddles in need maintenance.

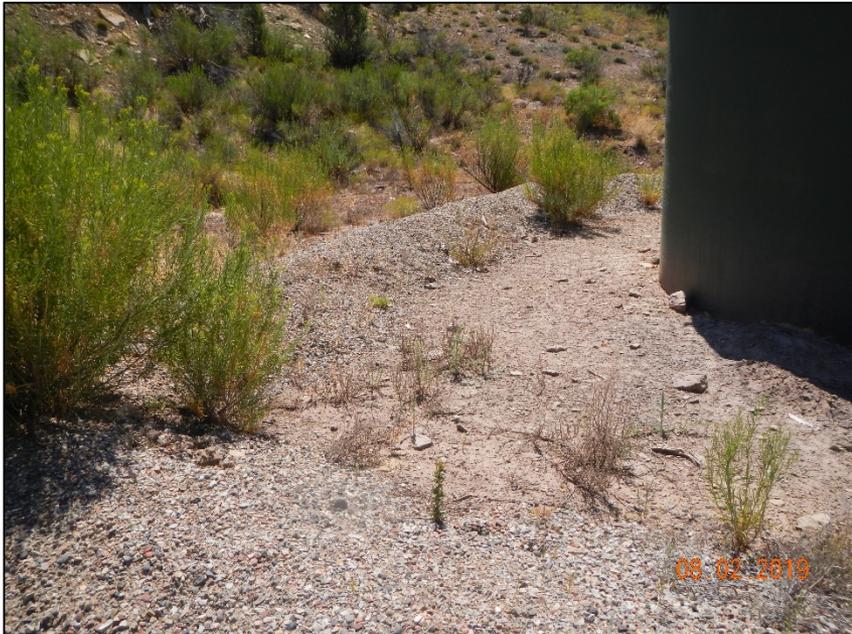
Photo #8 Weeds or Debris inside of tank containment.

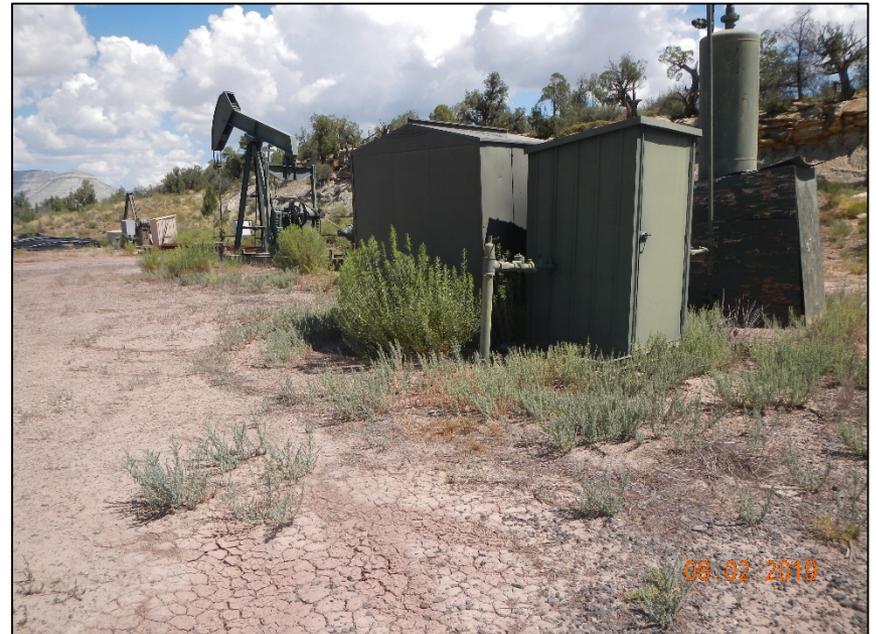
Photo #9 Weeds or Debris around production equipment

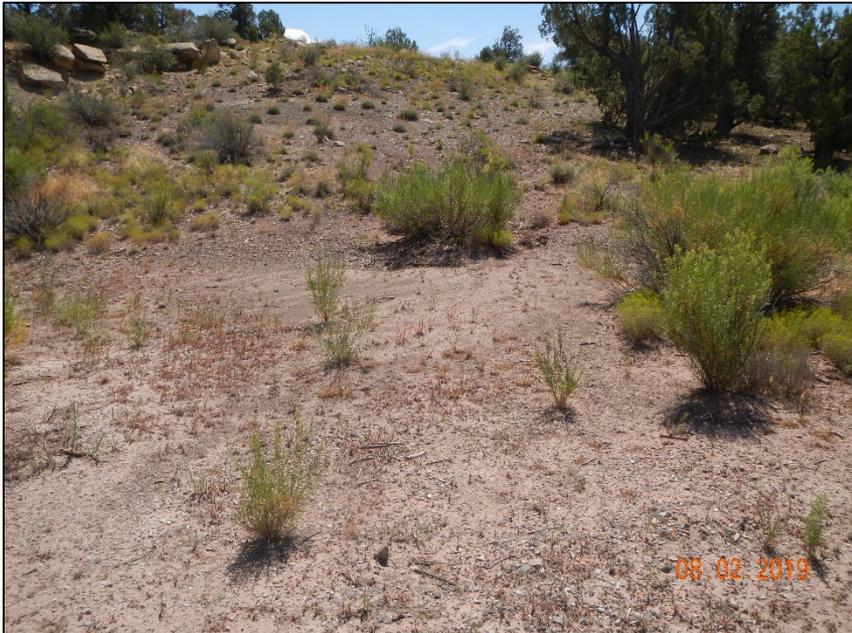
Photo # 10 Erosion is evident along un-stabilized slope at the south-east side of location.

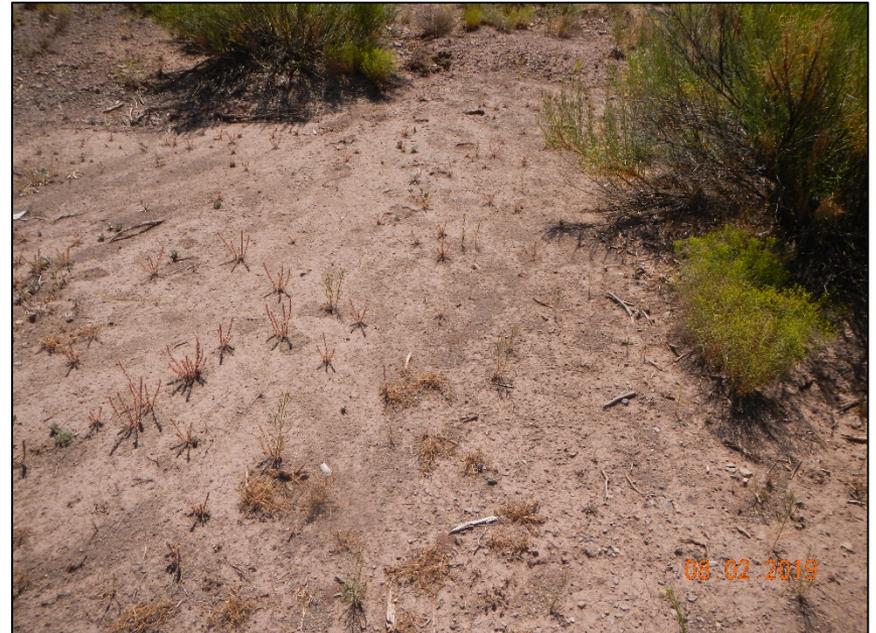
Photo # 11 Erosion is evident along un-stabilized slope at the south-east side of location, choking out vegetation.

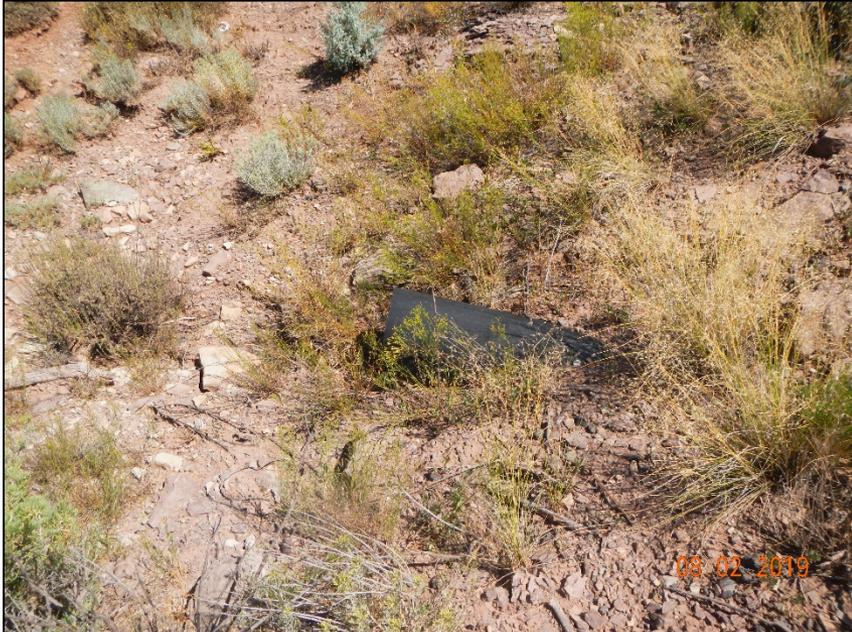
Photo #12 Culvert in need of maintenance.

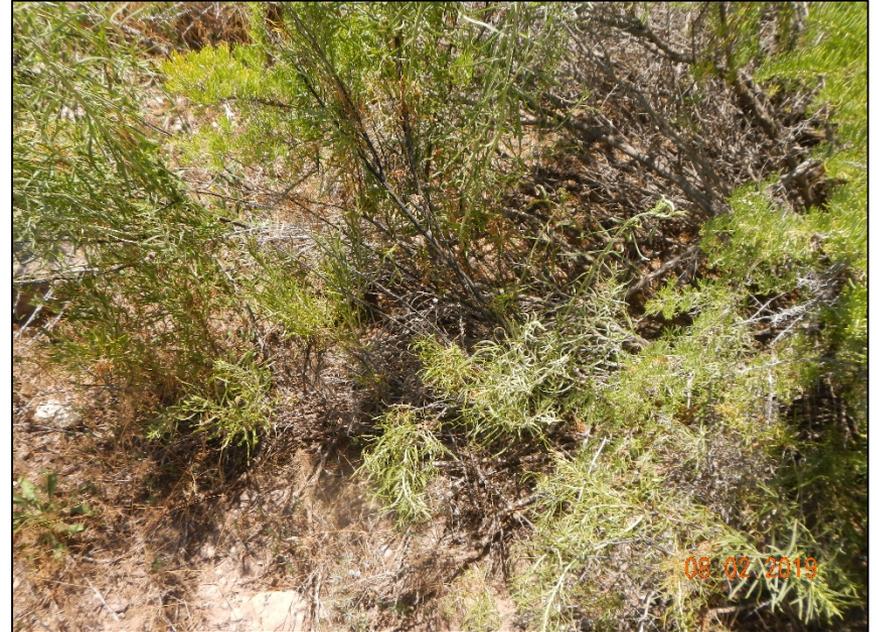
Photo #13 Culvert in need of maintenance on upstream side.

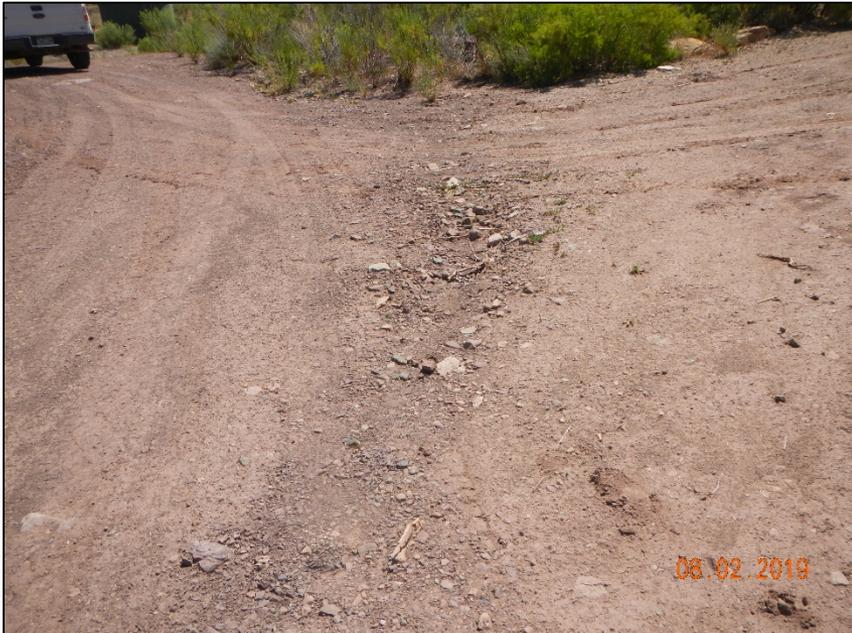
**Photo #14 Erosion sediment moving off location and down
Access road**

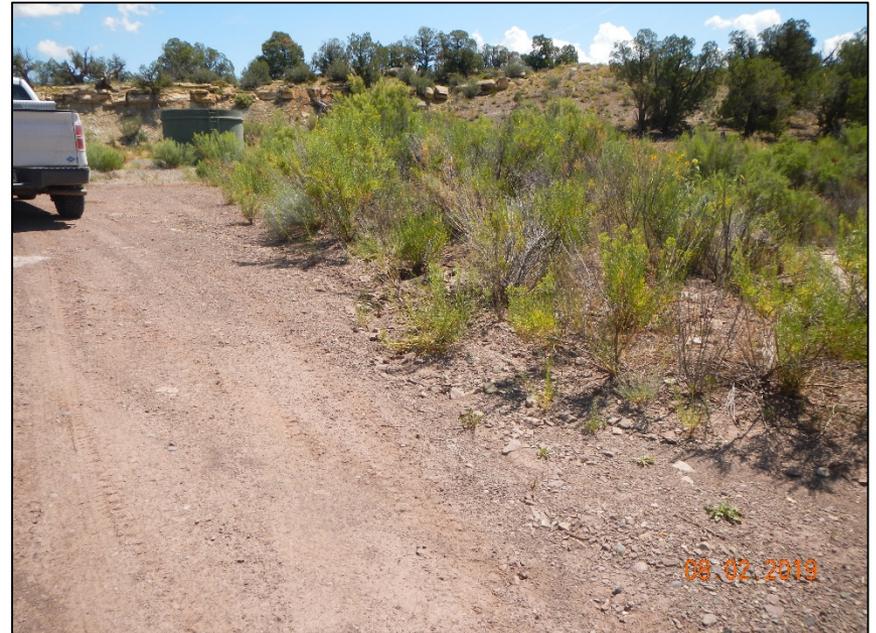
**Photo #15 Erosion sediment moving off location and down
Access road**
