Inspection Photos

API: 05-055-06012

Operator: OXY USA INC

Inspection Date: 8/1/2019

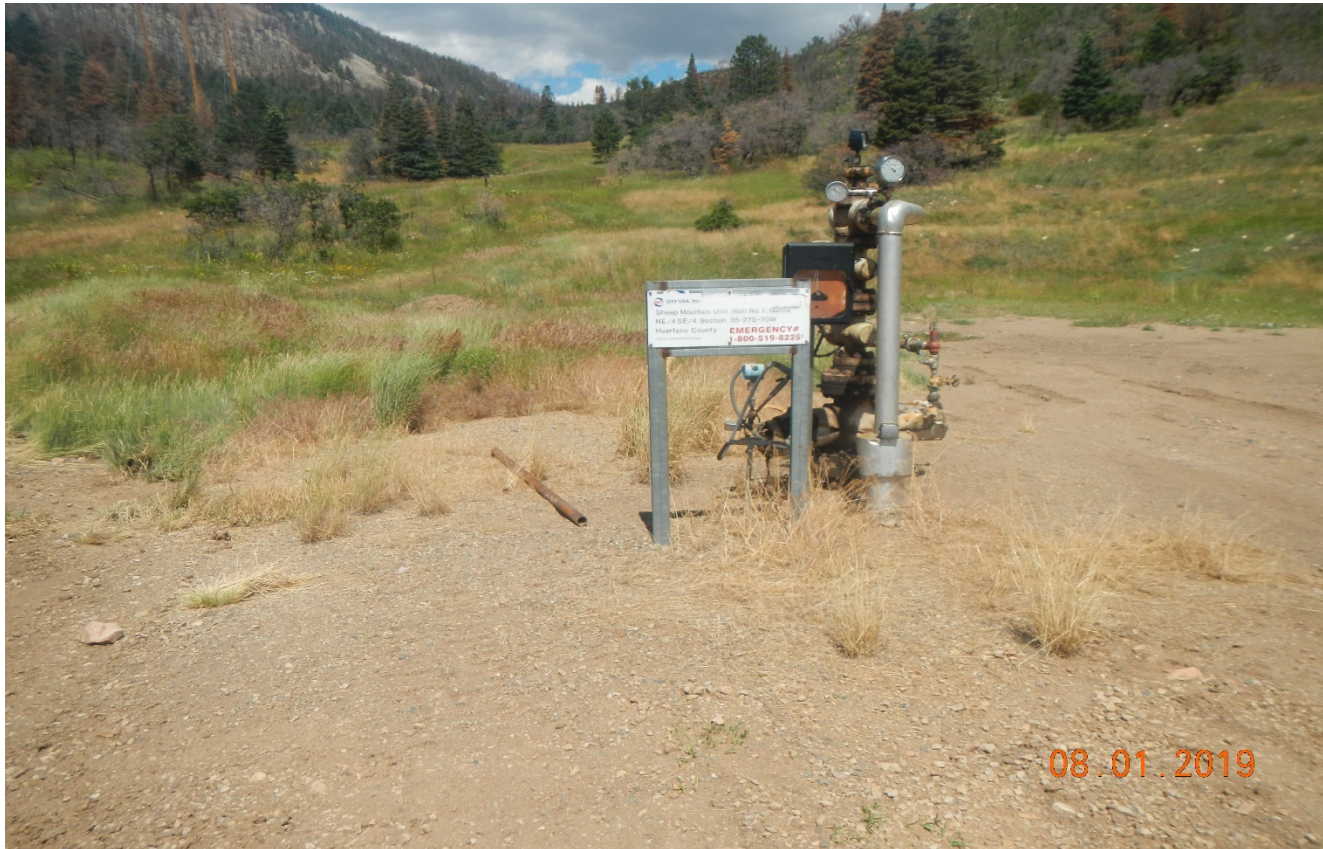
Photo 1. The operator name on well sign has been updated.

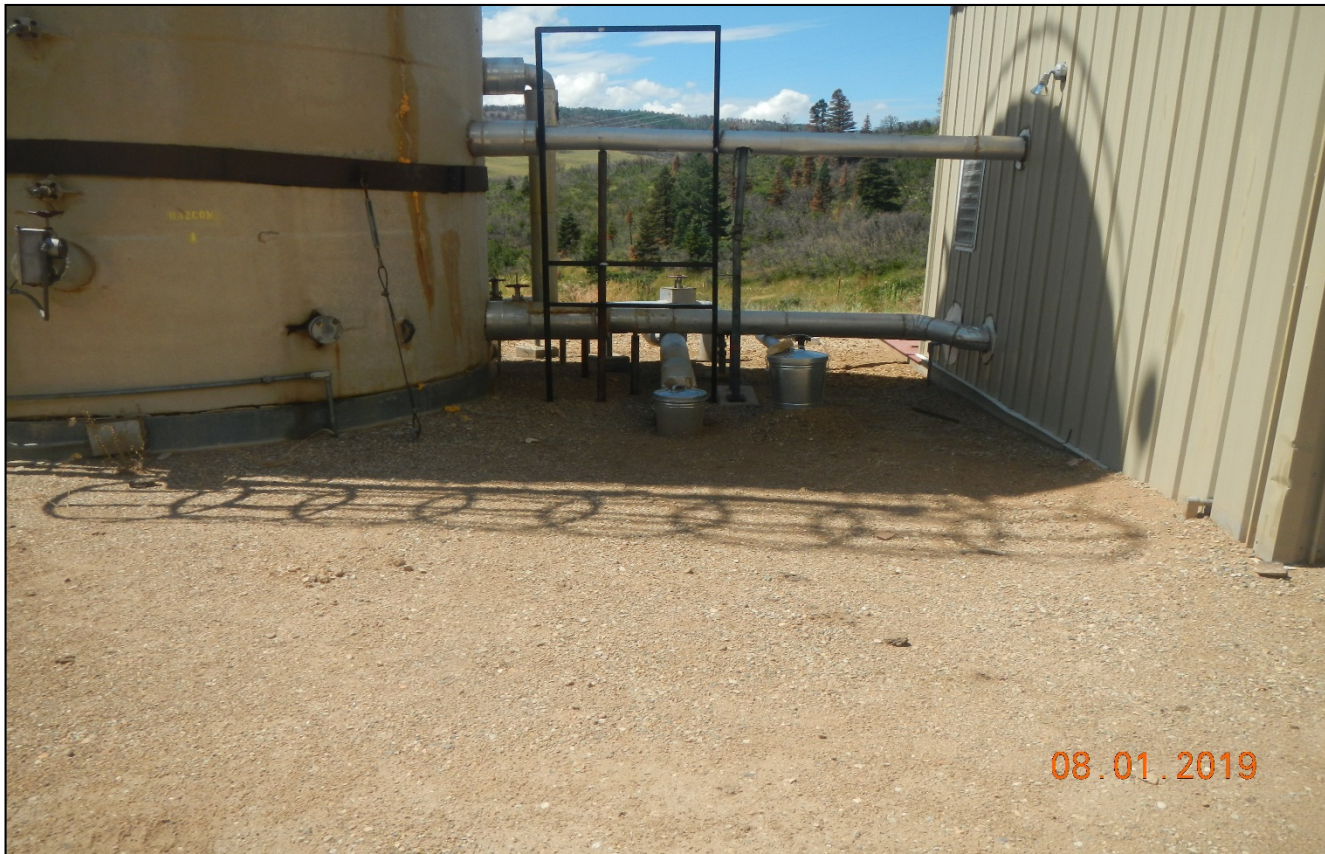
Photo 2. The secondary containment at discharge point has been repaired.

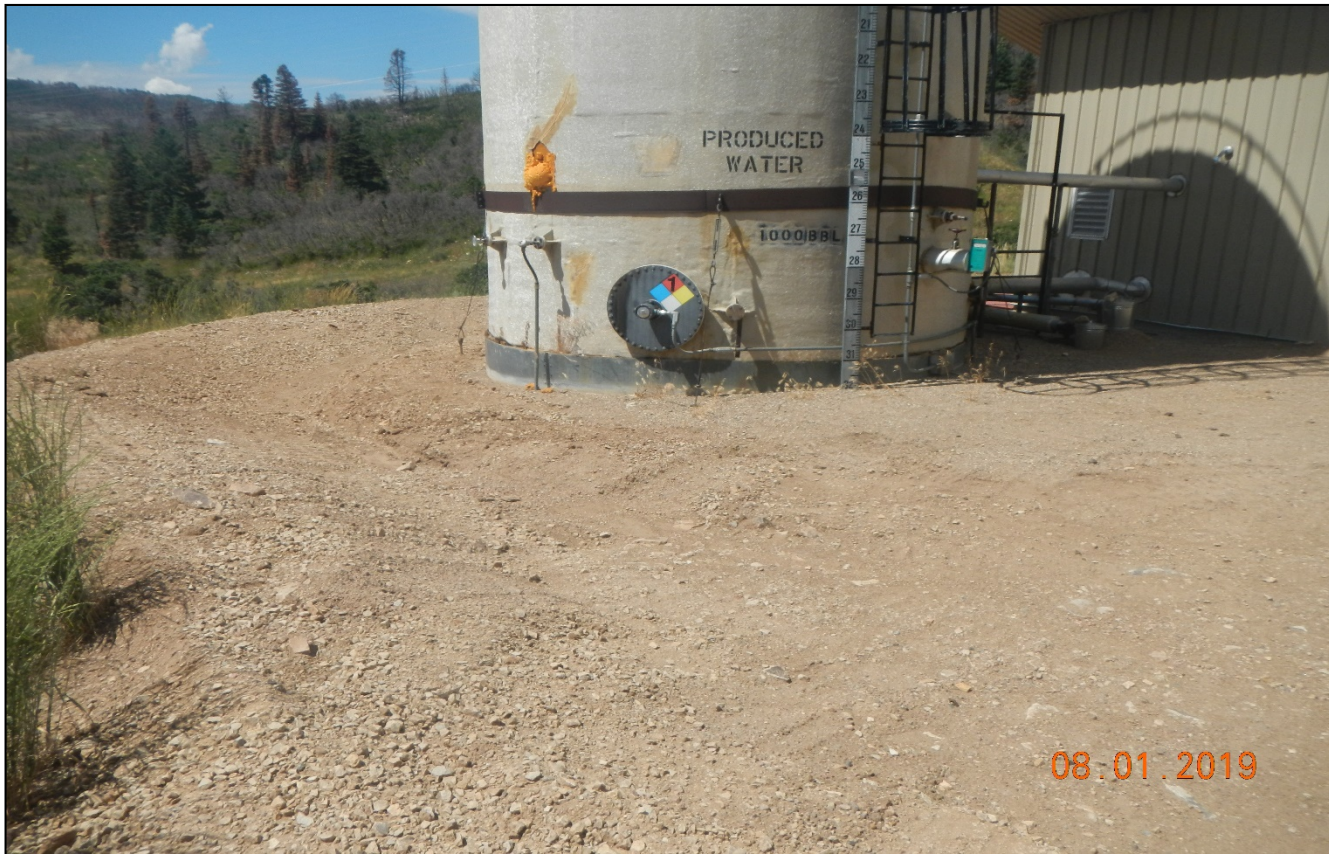
Photo 3. Facing toward the tank. Berm has been rebuilt.

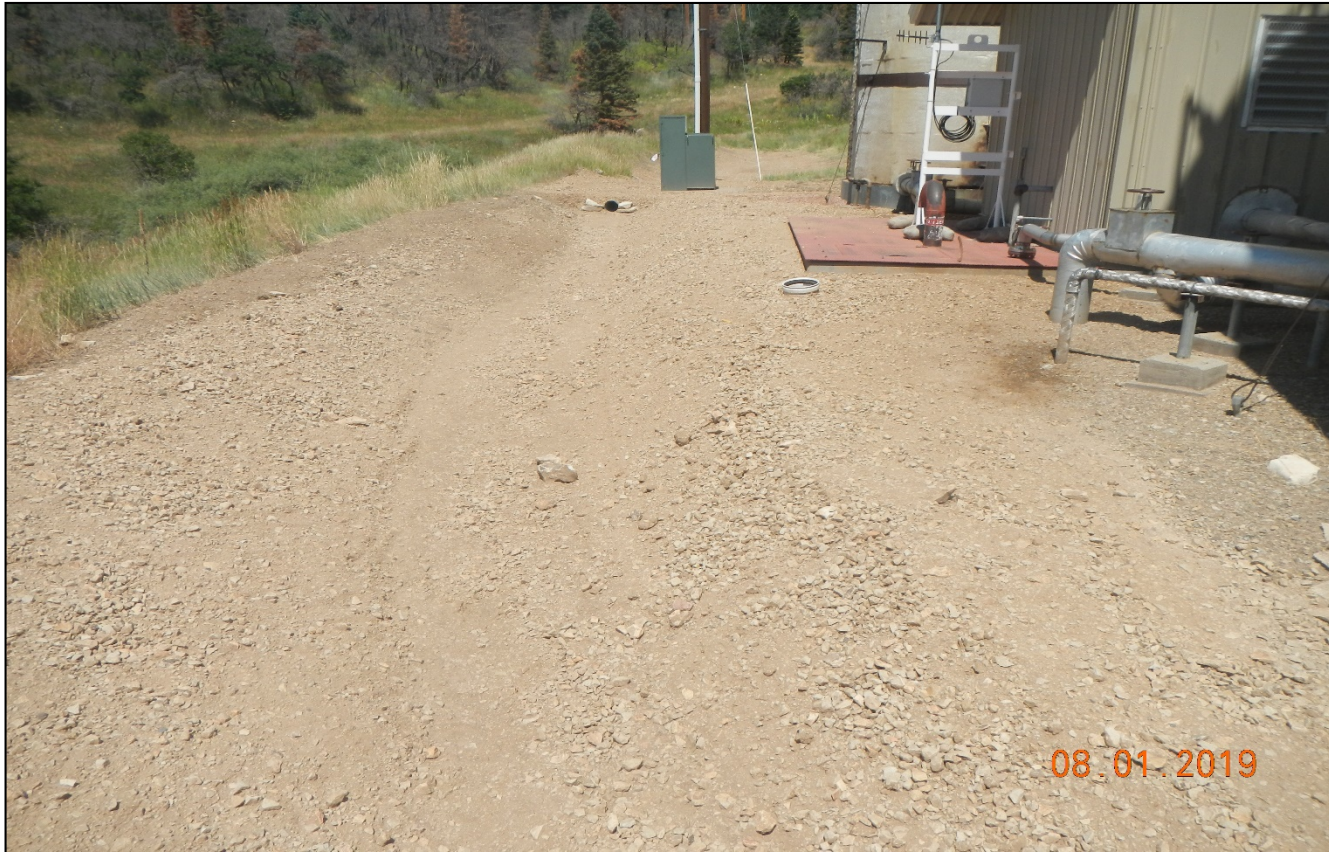
Photo 4. The contaminated soils behind the tanks have been removed and replaced with road base material.

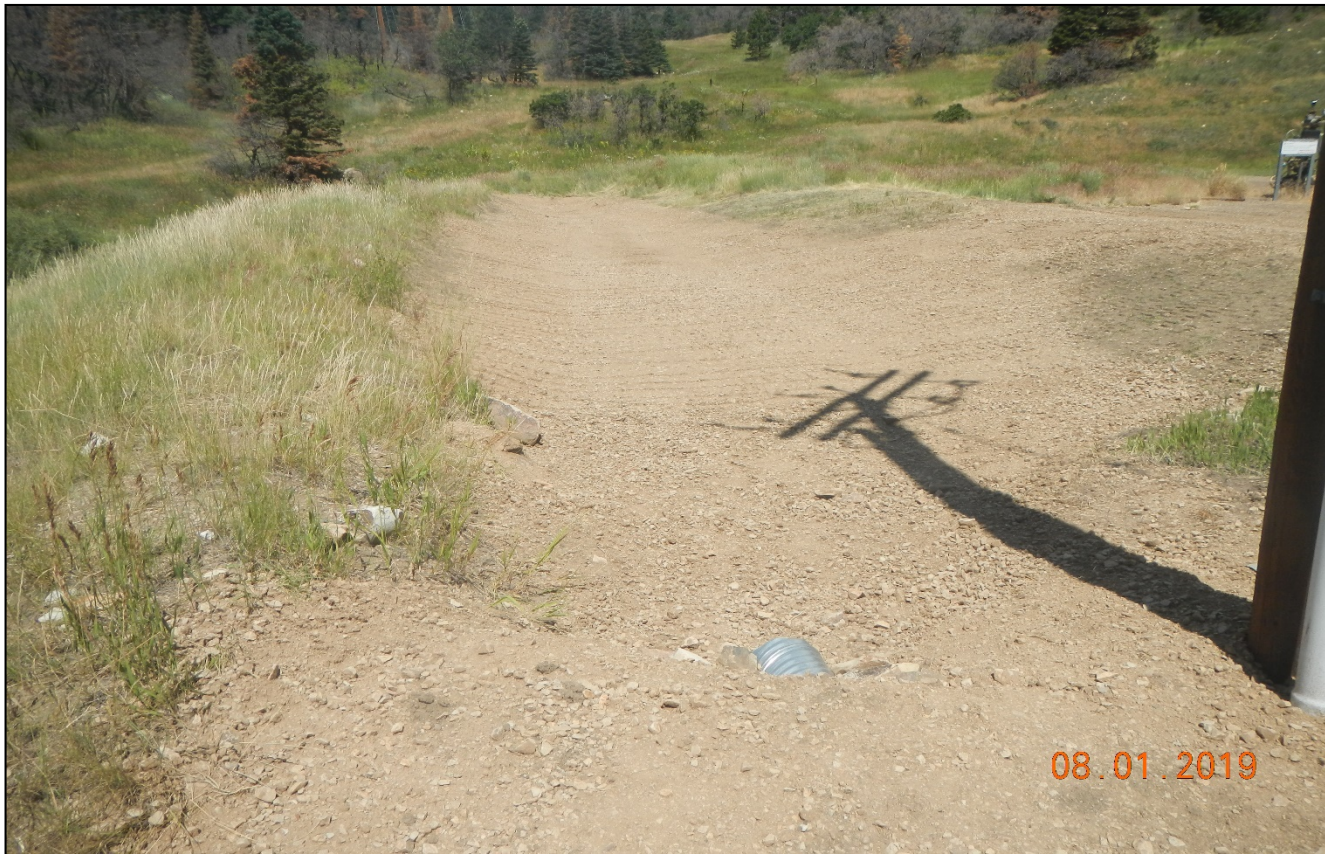
Photo 5. Facing toward the pit which appears to be cleaned up of contaminated soils.

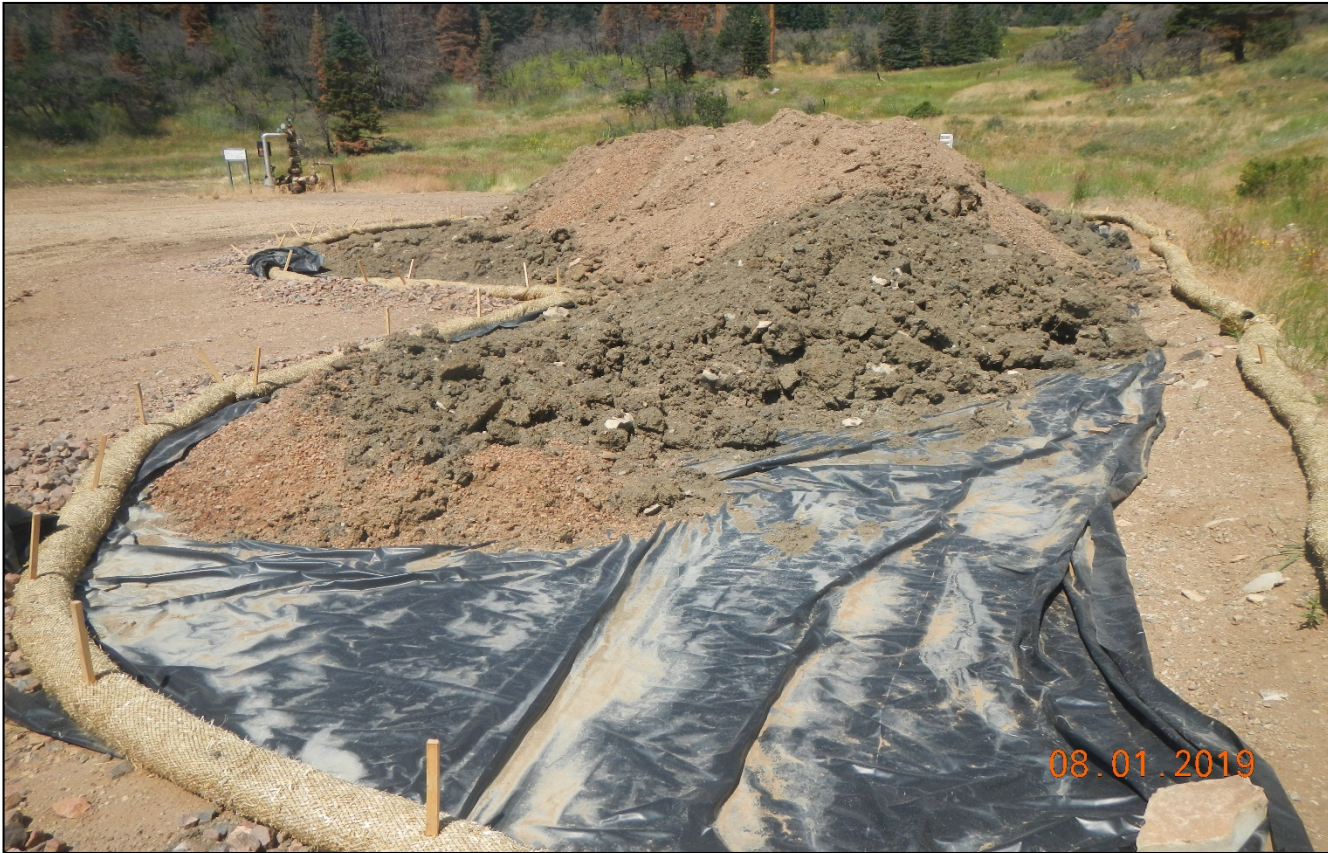
Photo 6. There is a pile of contaminated soil removed from the pit that remains at the location.

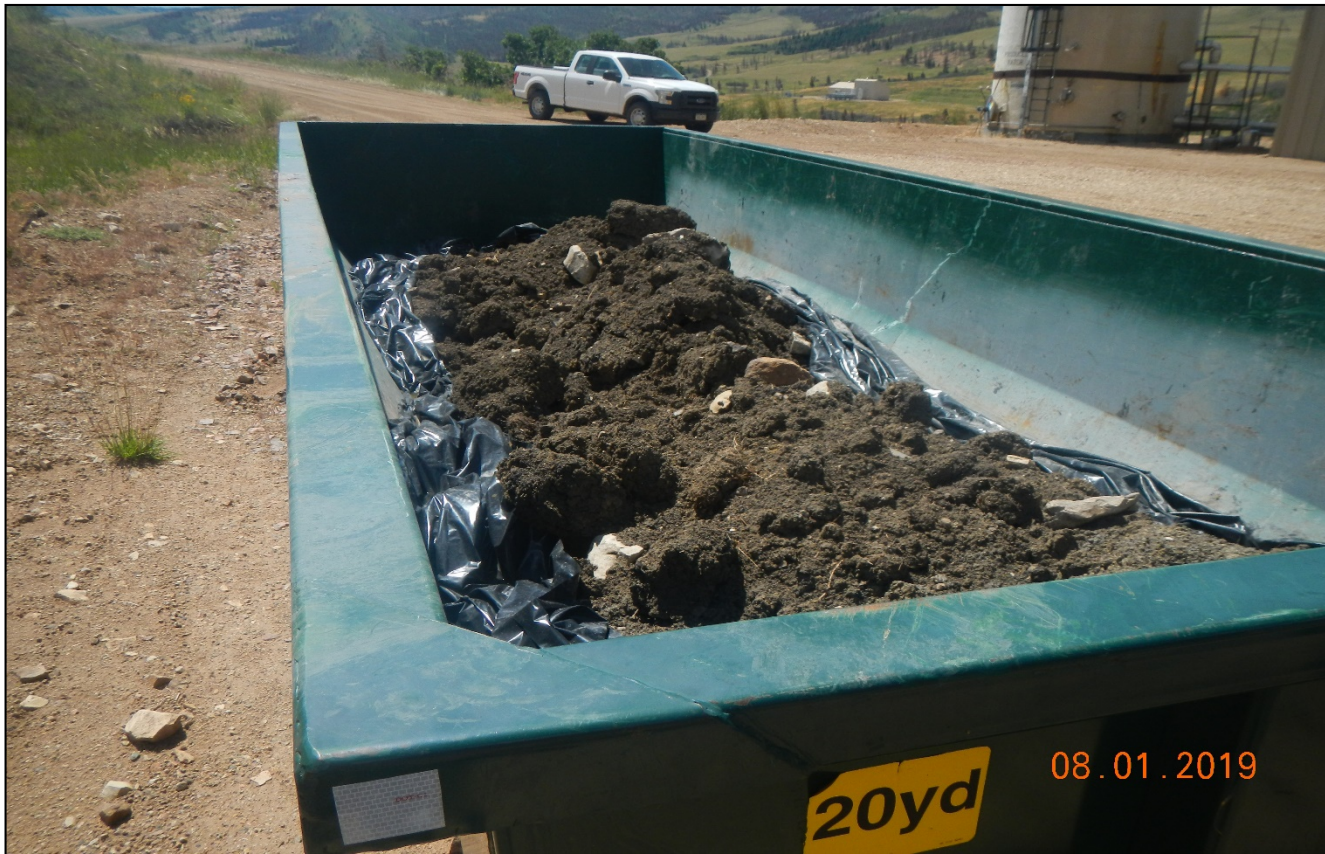
Photo 7. There is a container with some of the contaminated soil placed inside.

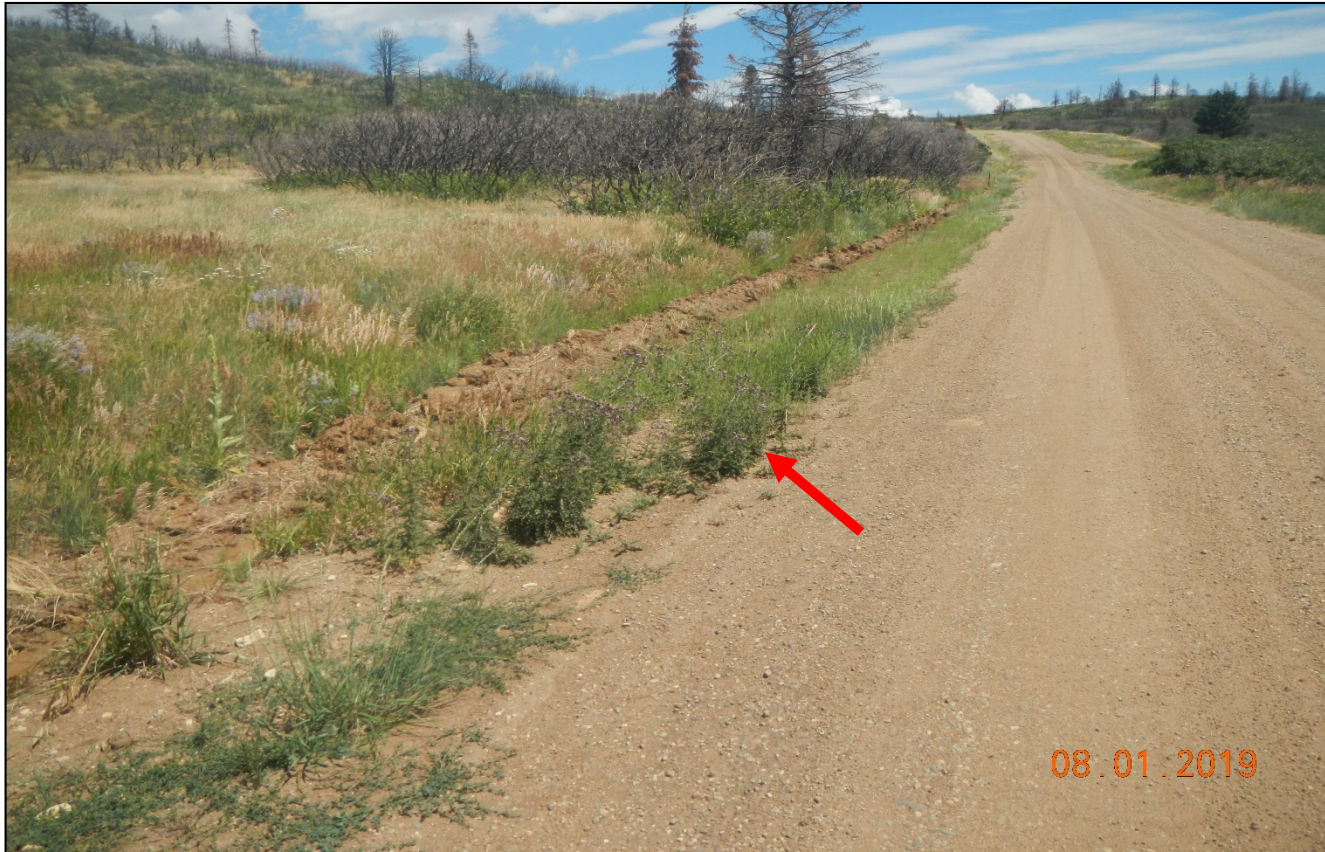
Photo 7. There were noxious weeds along the access road that were not treated. Canada thistle.
