Inspection Photos

API: 05-055-06037

Operator: OXY USA INC

Inspection Date: 8/1/2019

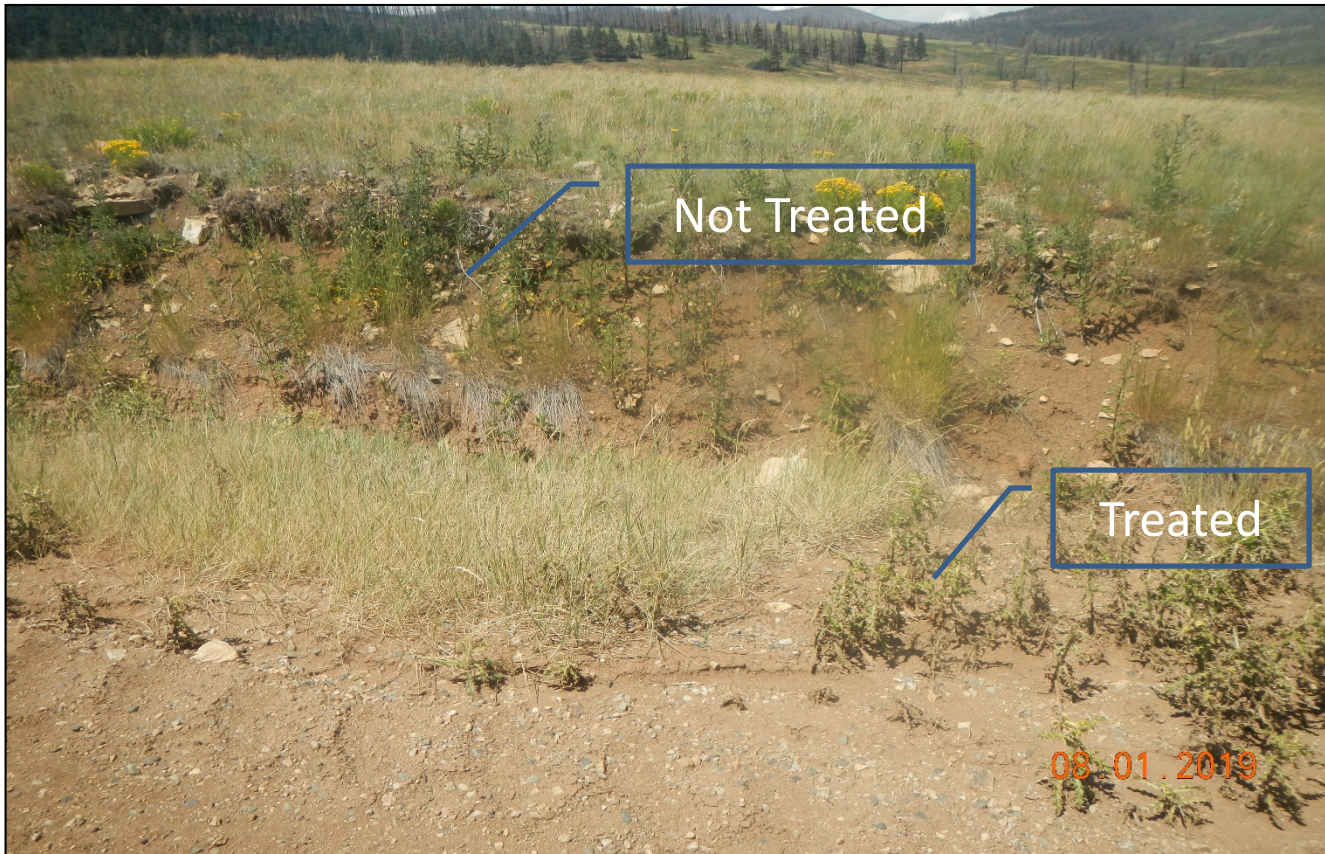
Photo 1. There were some noxious weeds along the road that were treated and wilting. Other noxious weeds just a little further out along the cut slope were not treated.

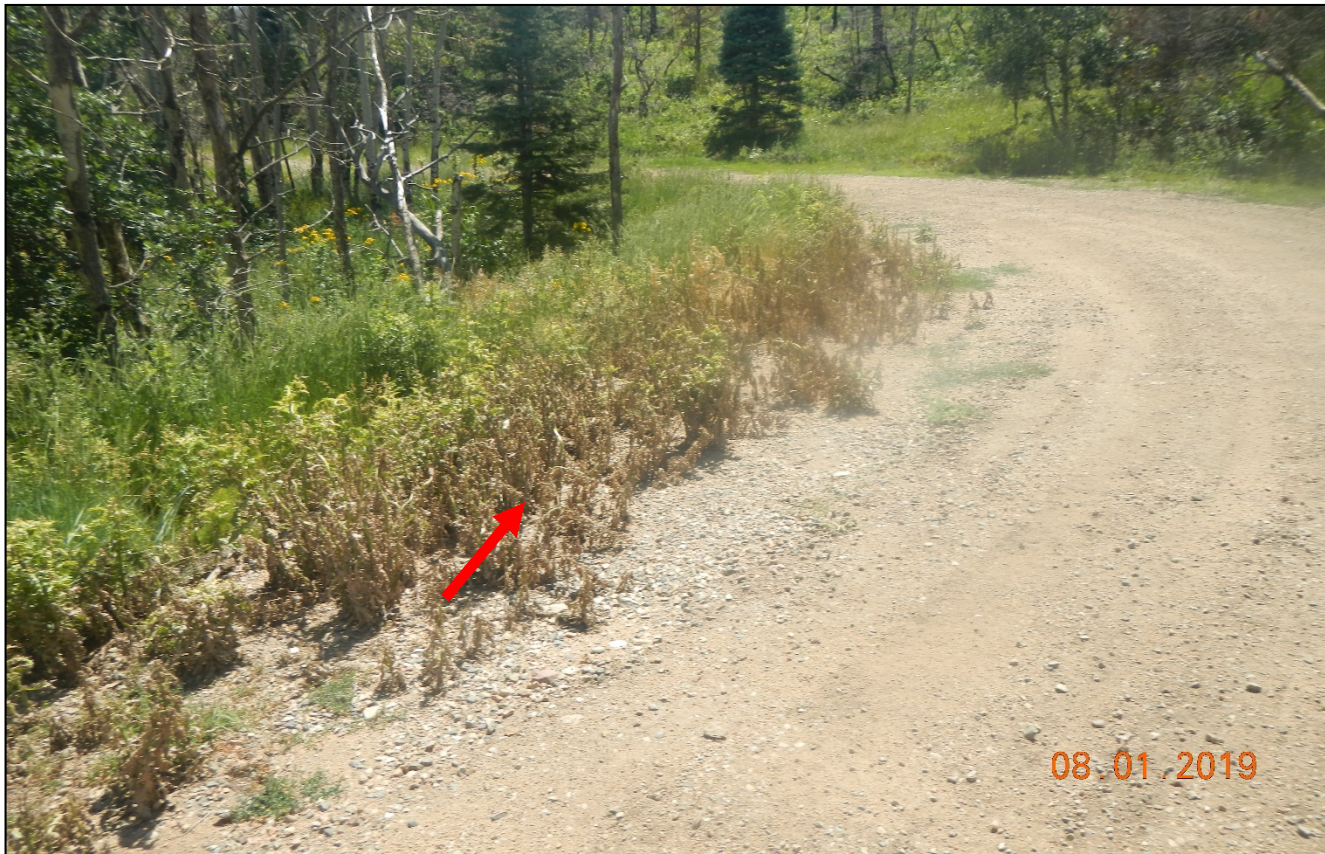
Photo 2. There are some noxious weeds along the road that are wilting.

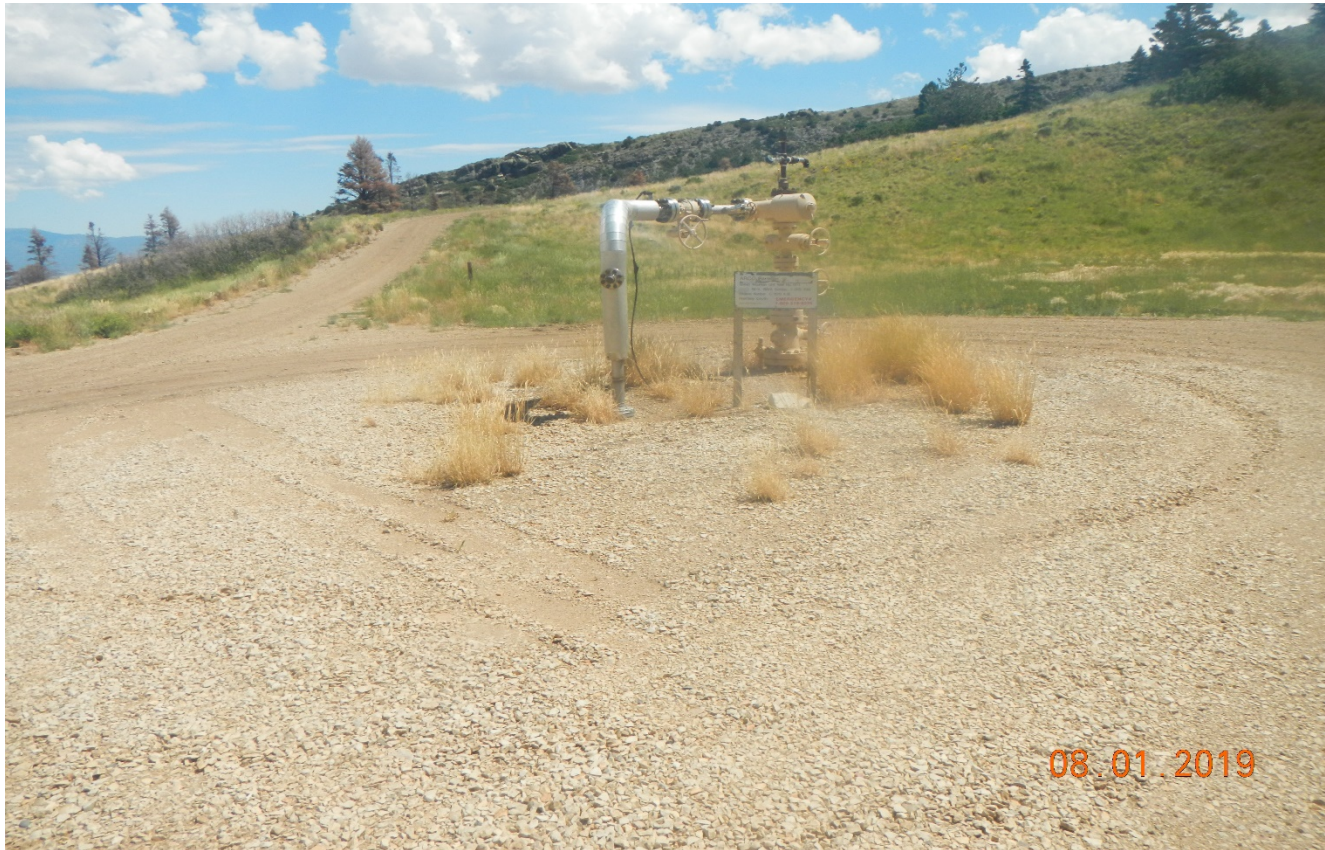
Photo 3. The operator name does not reflect current operator.

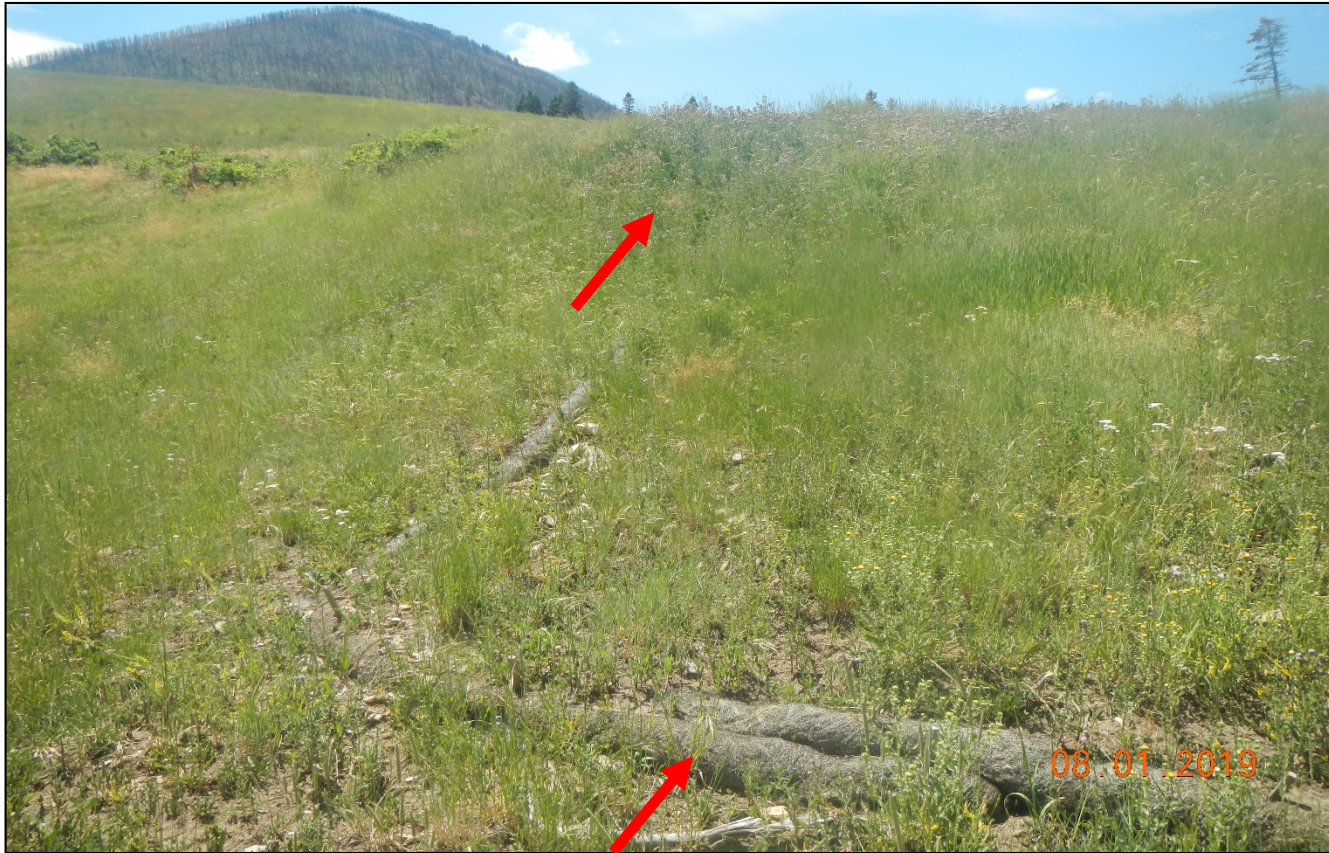
Photo 4. Noxious weeds have not been controlled along the cut slope. Wattles are degraded.

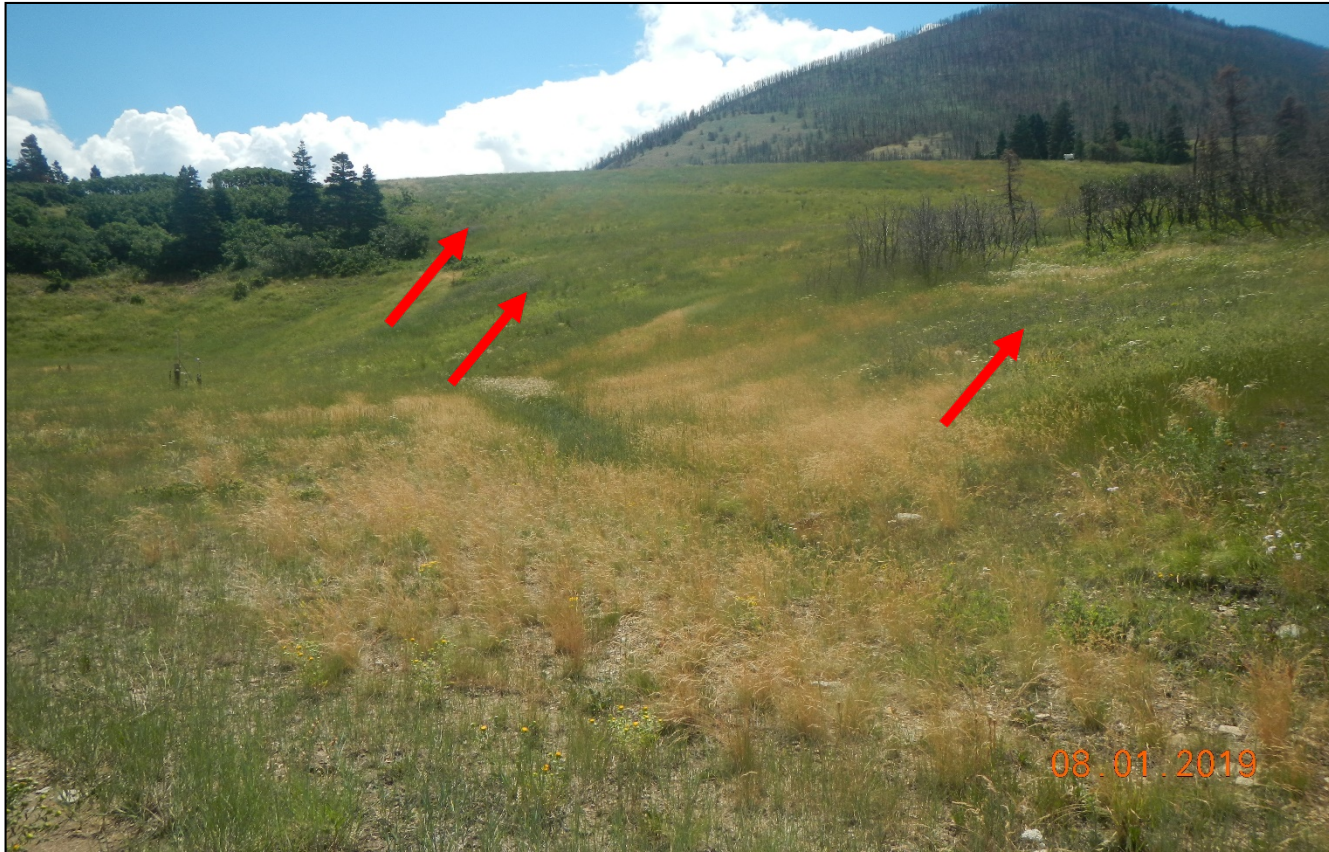
Photo 5. Further back facing south at the location. Red arrows point to noxious weed infestation (Red arrow).
