Inspection Photos

API: 05-055-06309

Operator: ALTA MESA SERVICES

Inspection Date: 8/1/2019

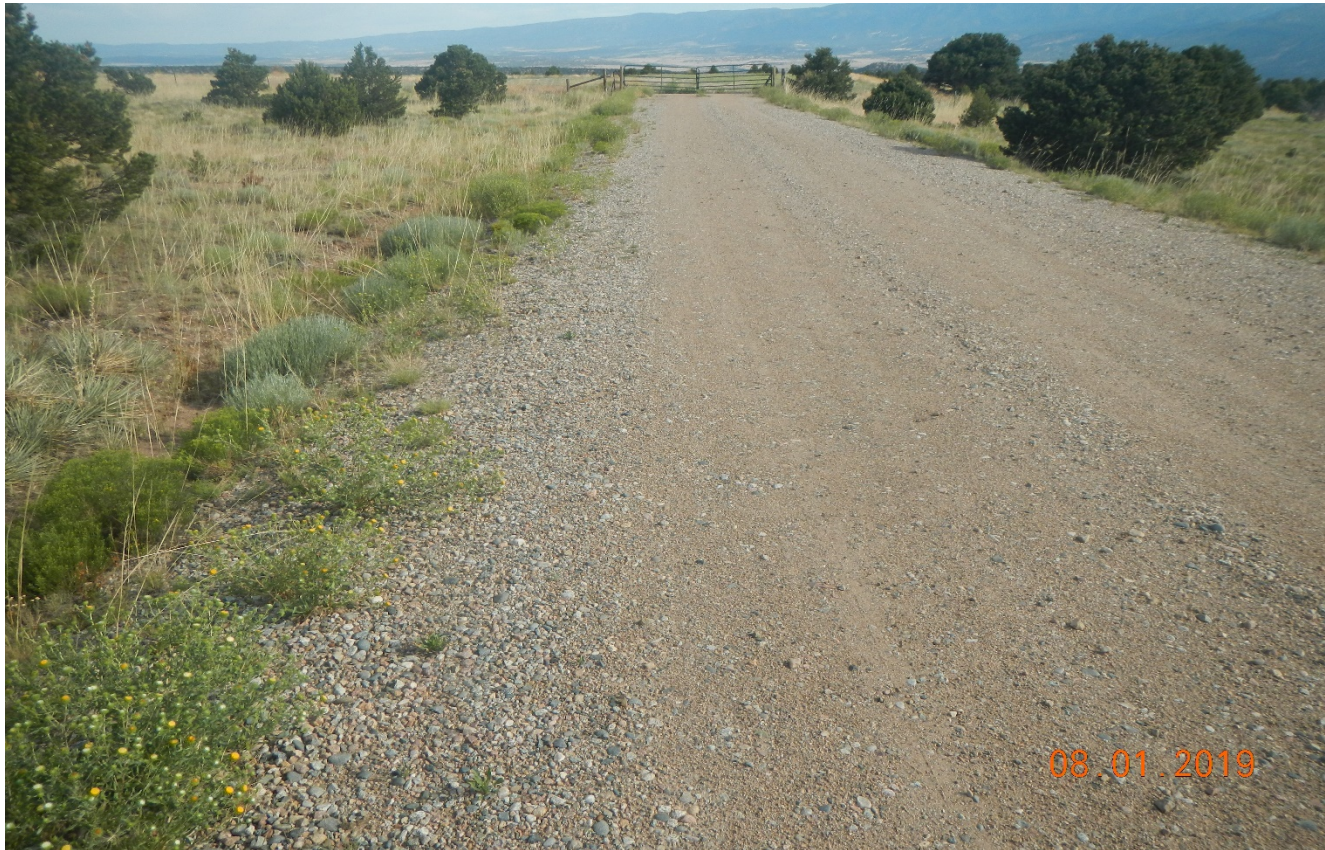
Photo 1. Facing north toward access road.

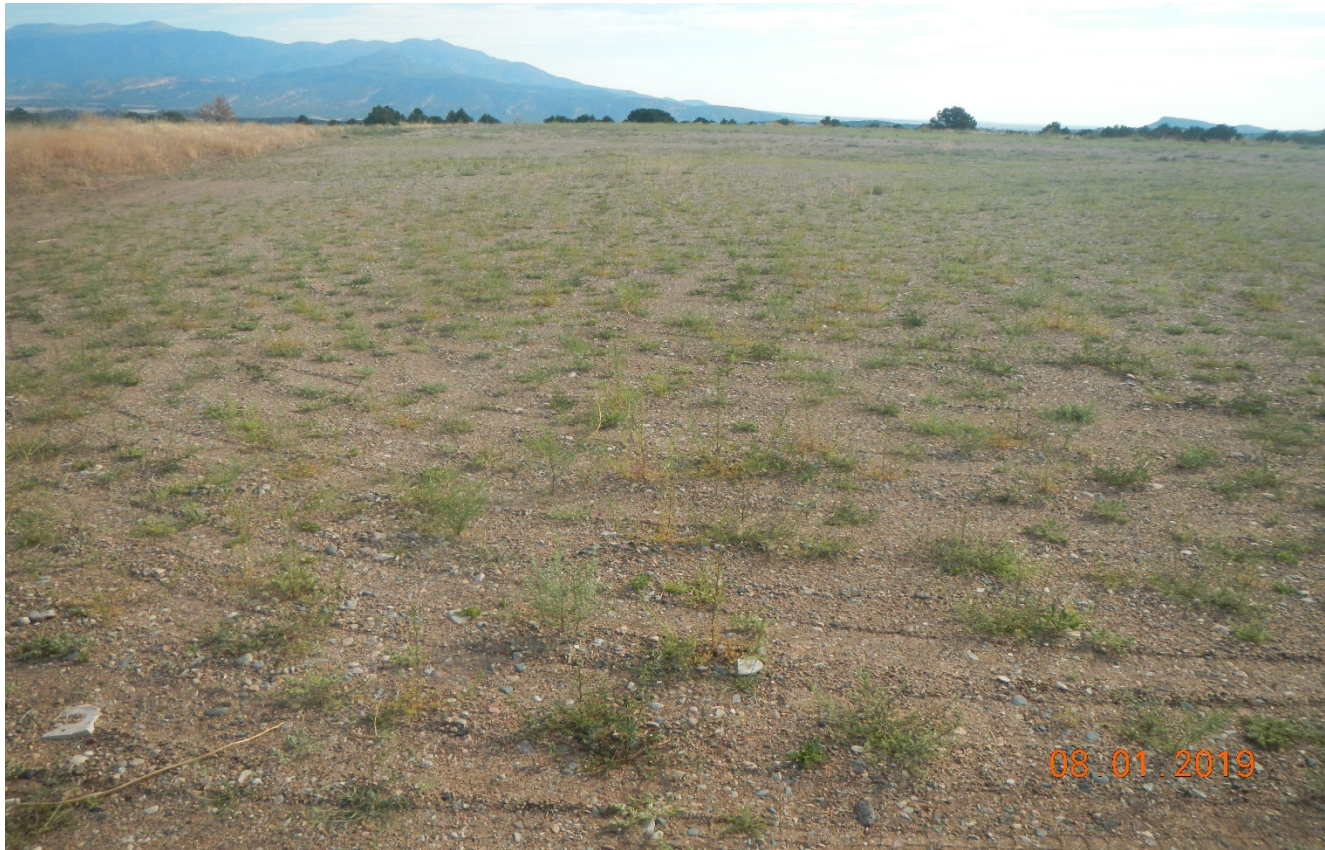
Photo 2. Facing north toward the location which is left graveled.

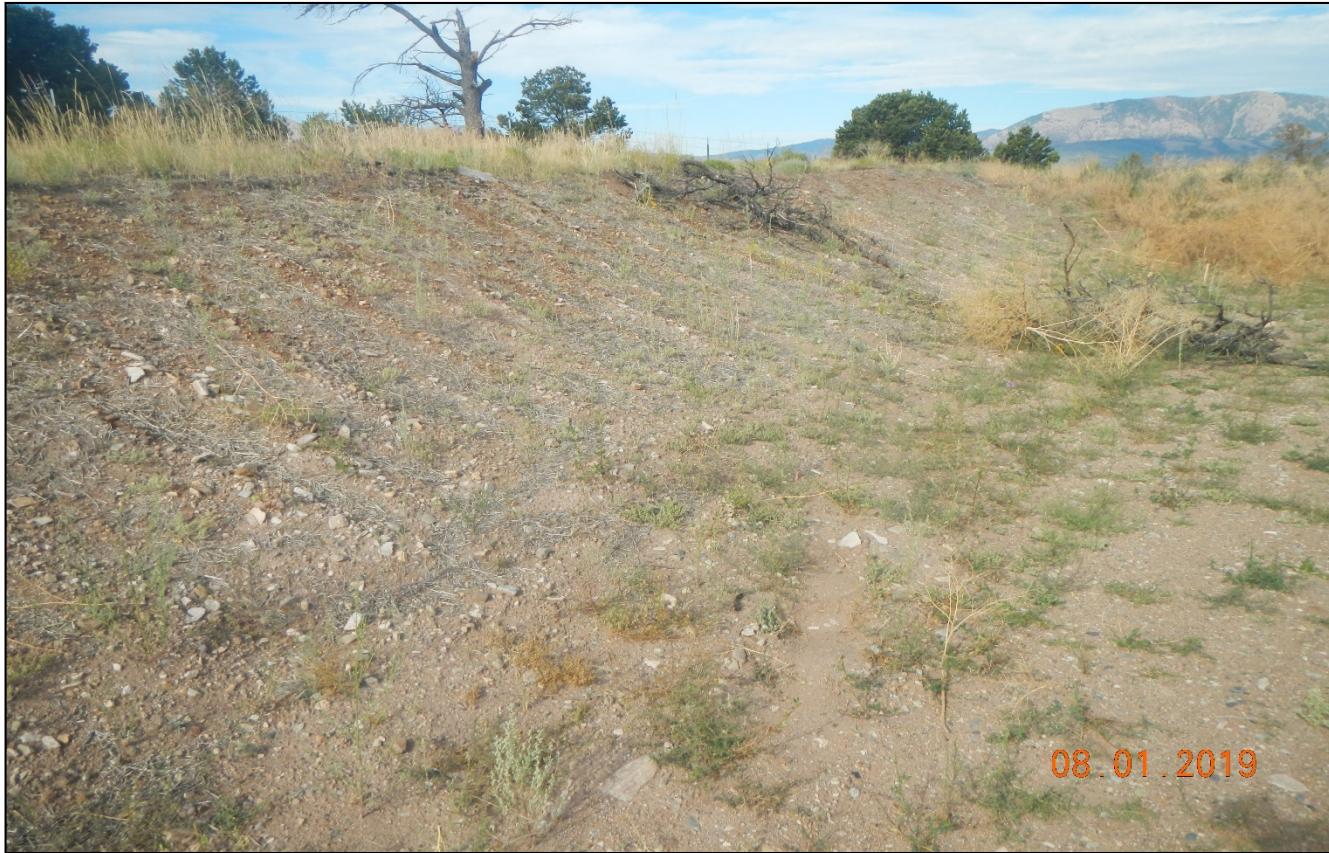
Photo 3. Facing west along the cut slope.

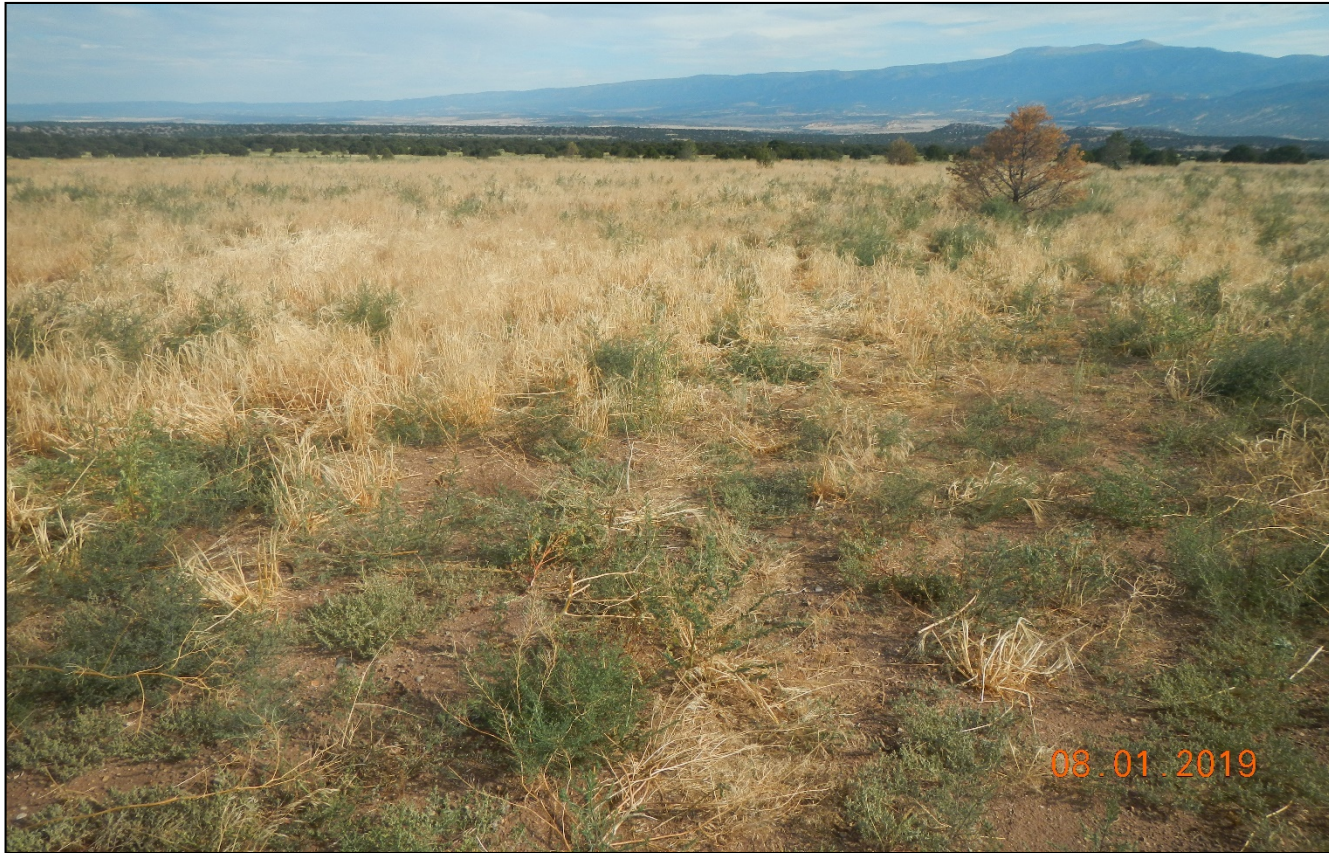
Photo 4. Facing northwest toward the reclaimed location. The cover crop has dried up and mostly weeds are establishing.

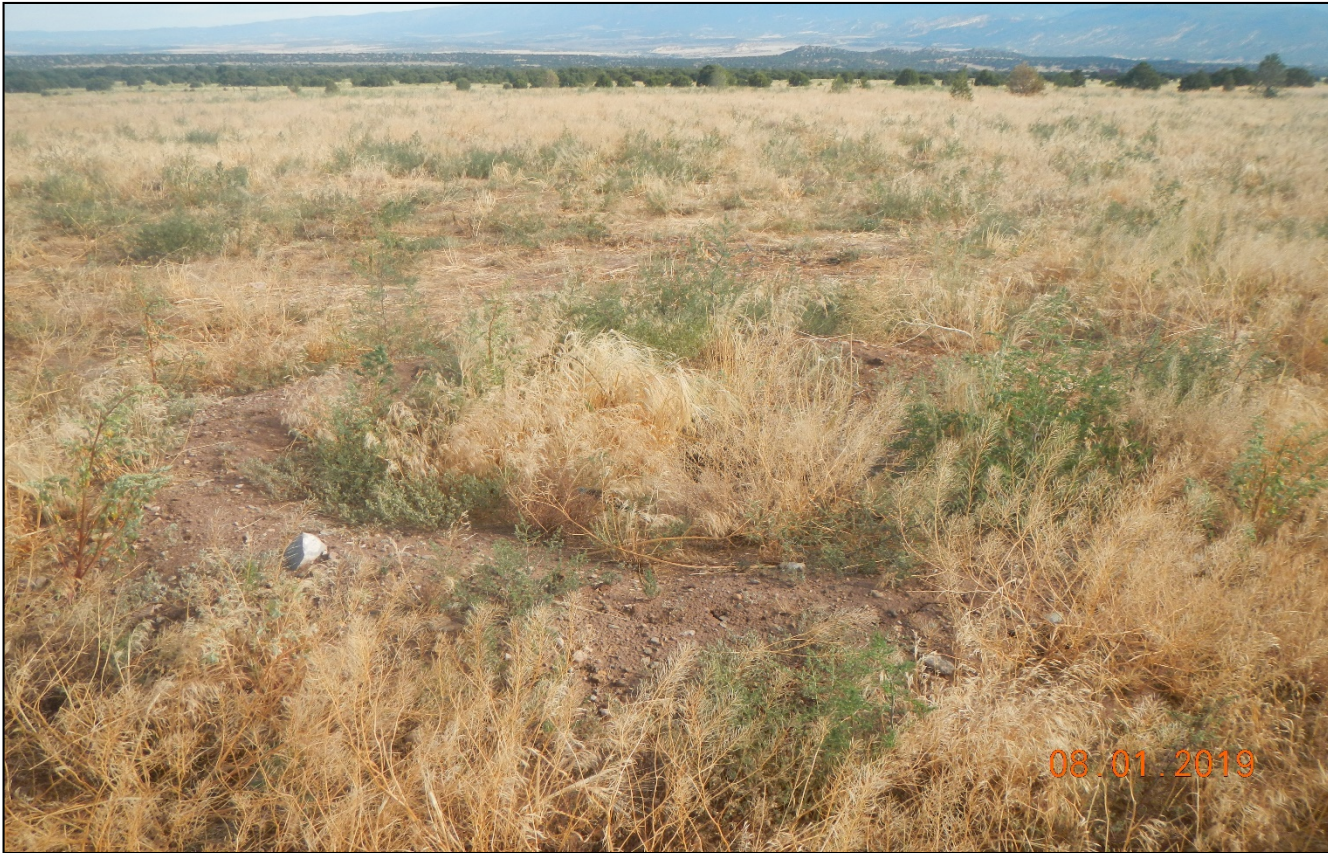
Photo 5. Some of the dead trees have been removed from the location.

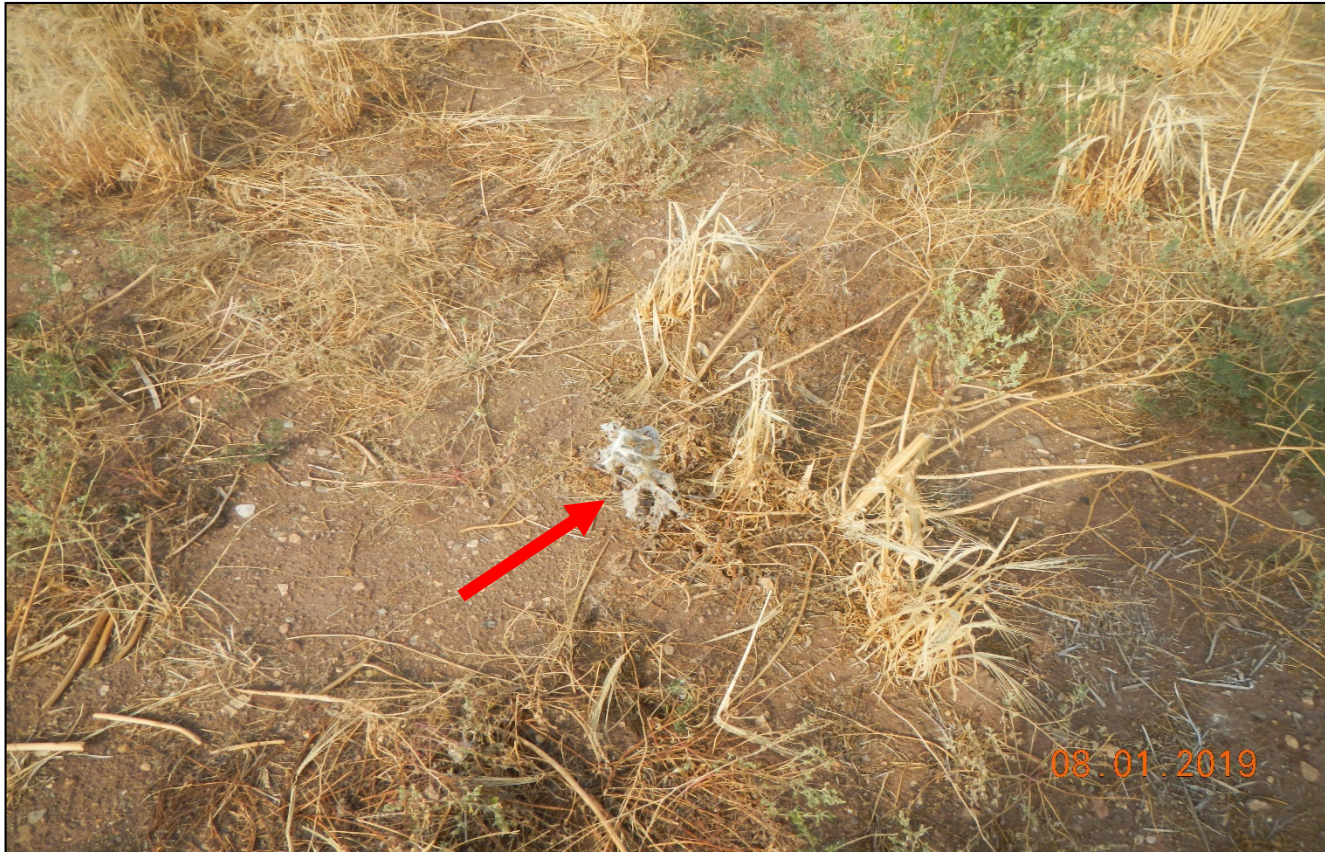
Photo 6. It appears noxious weeds have been controlled.

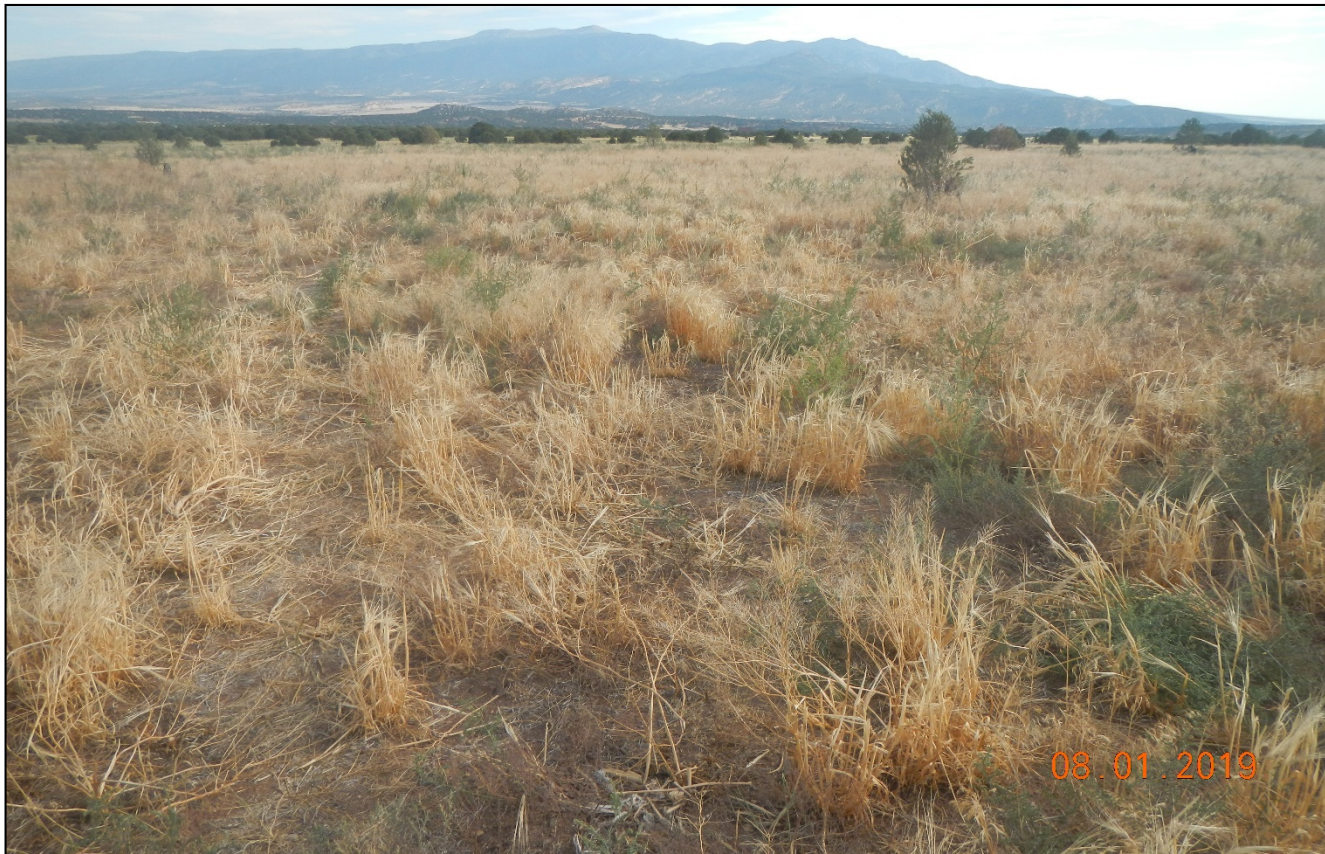
Photo 7. Facing north at the reclaimed portion of the location.

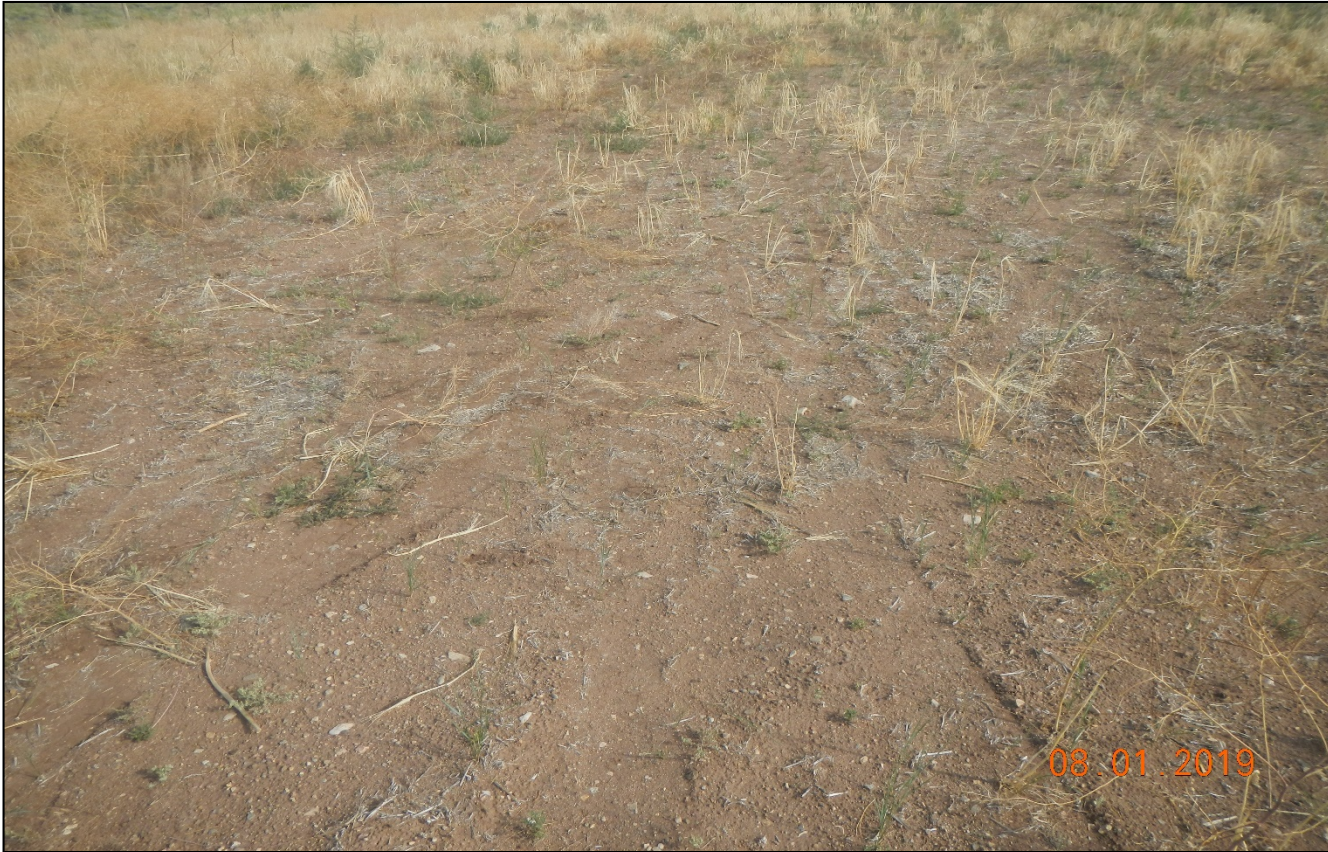
Photo 8. Facing southeast at the location. There are numerous weeds growing throughout the area.

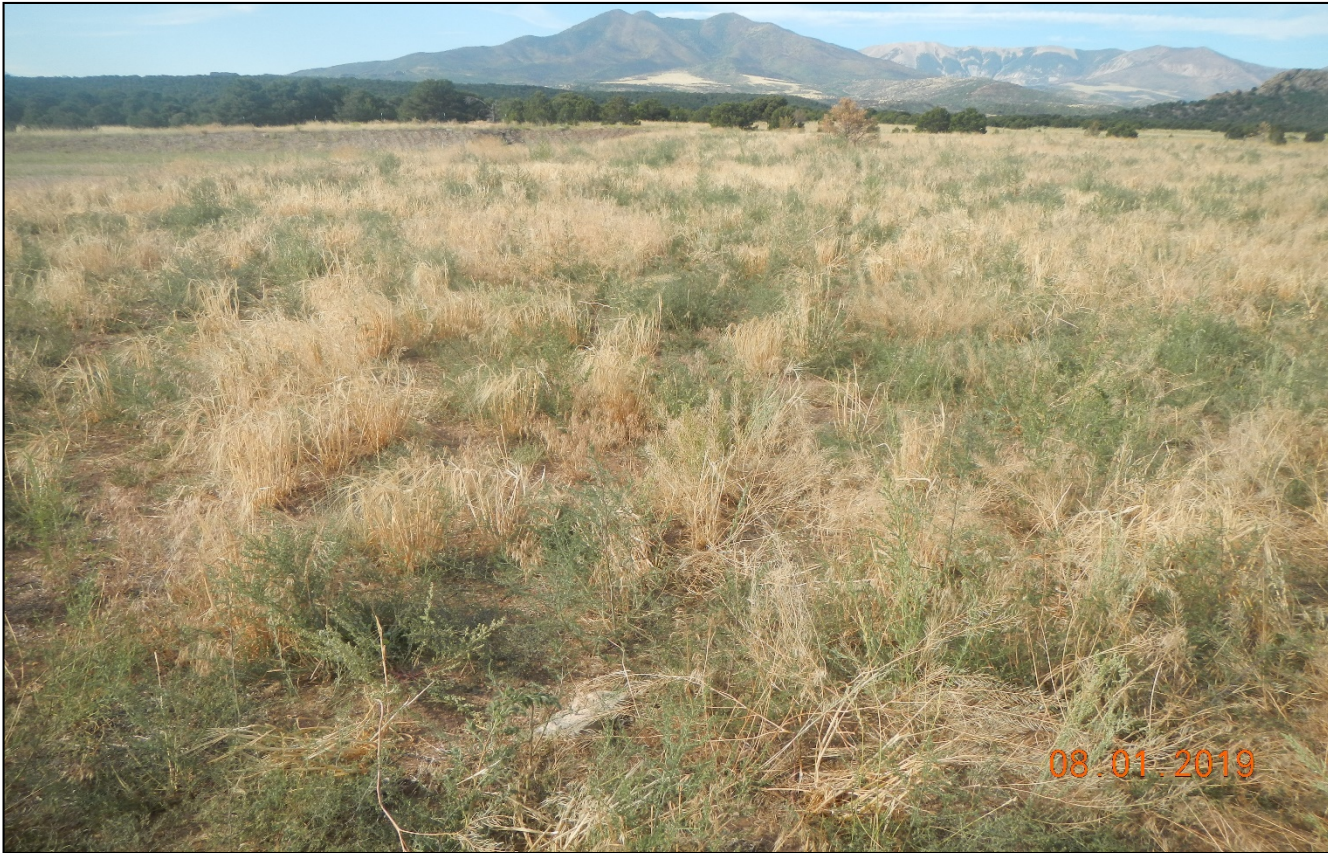
Photo 9. Facing southwest at the reclaimed portion of the location. There are numerous undesirable weeds growing throughout the area. (Russian thistle, Pigweed)

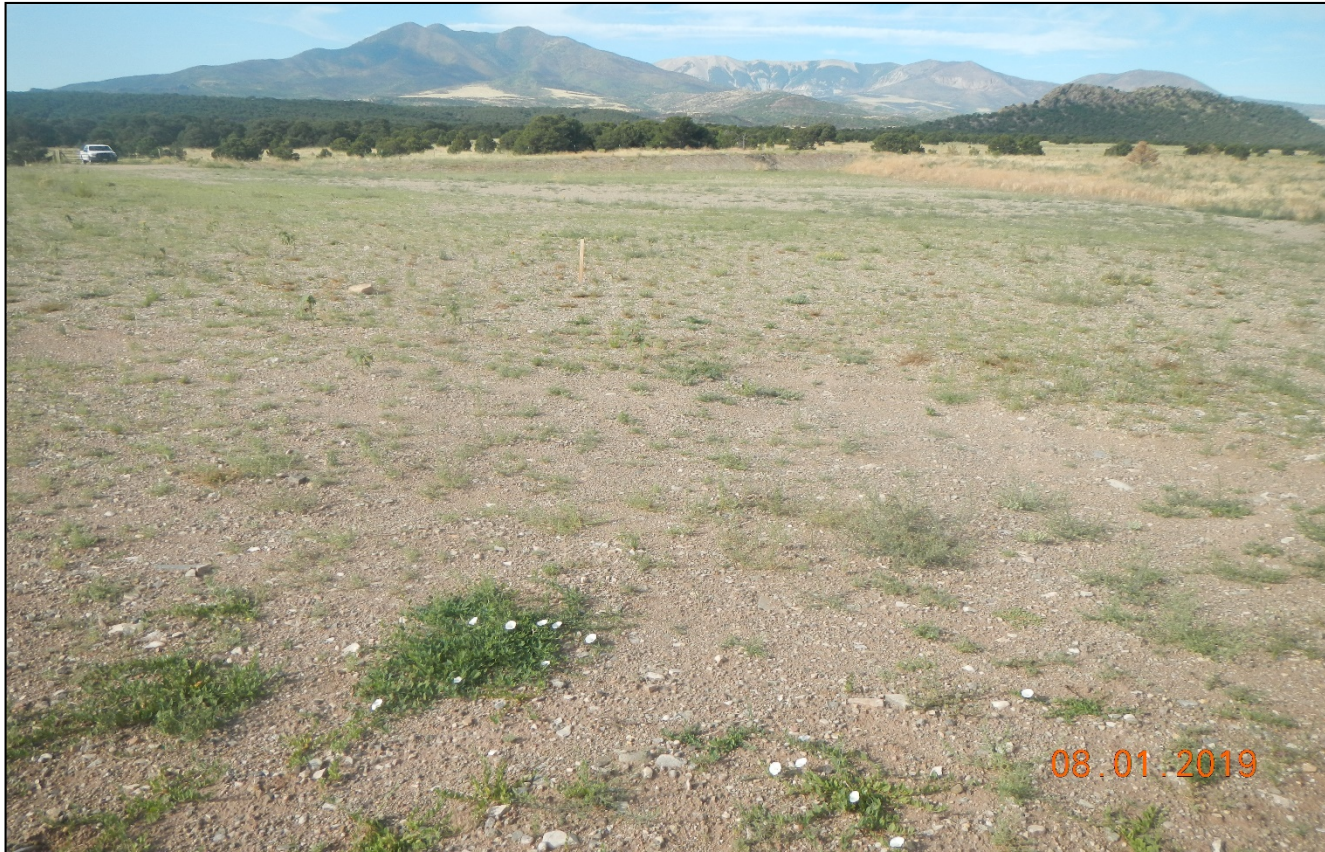
Photo 10. Facing south at toward the gravel pad not reclaimed.

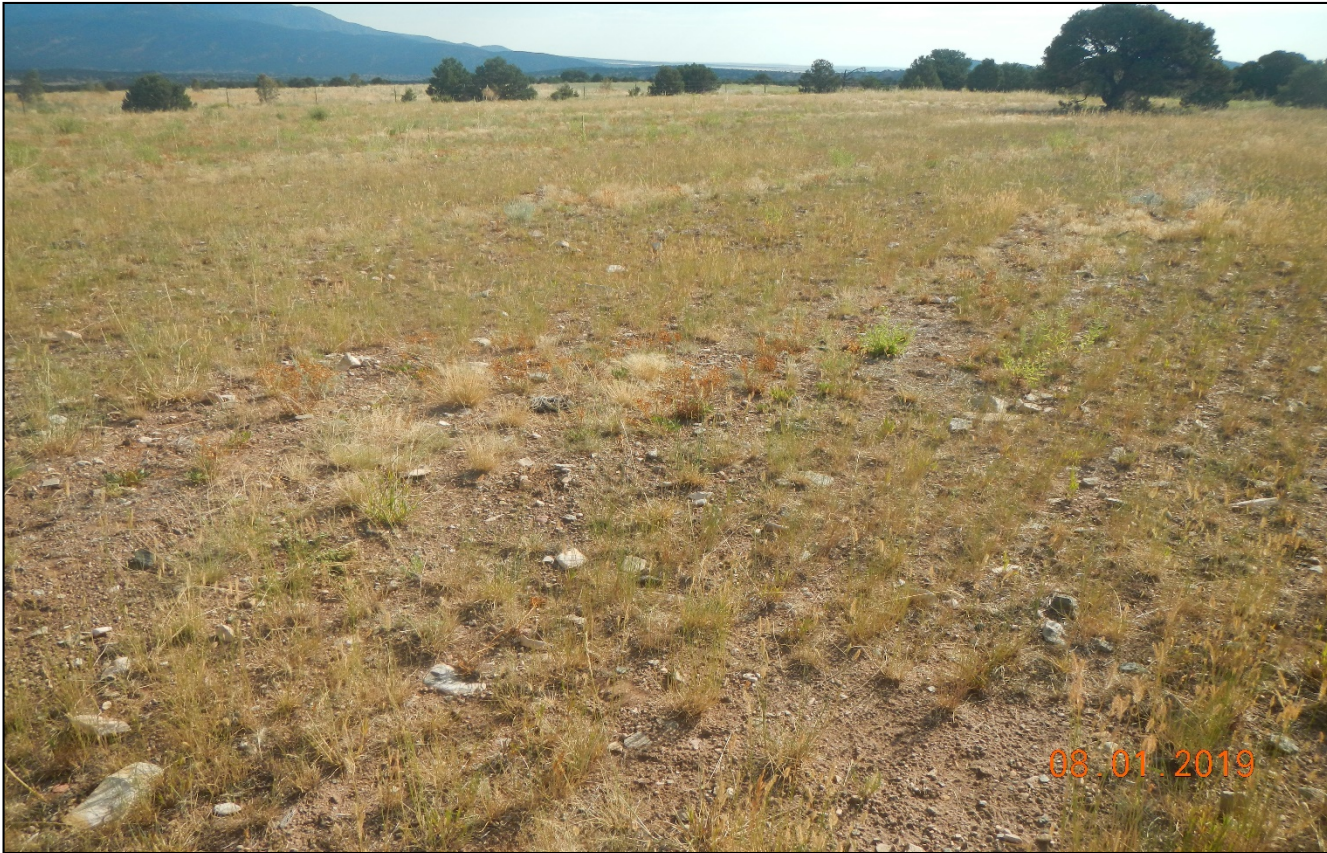
Photo 11. Southwest of the location where unpermitted disturbance occurred. Facing northeast. Vegetation is establishing throughout this area.

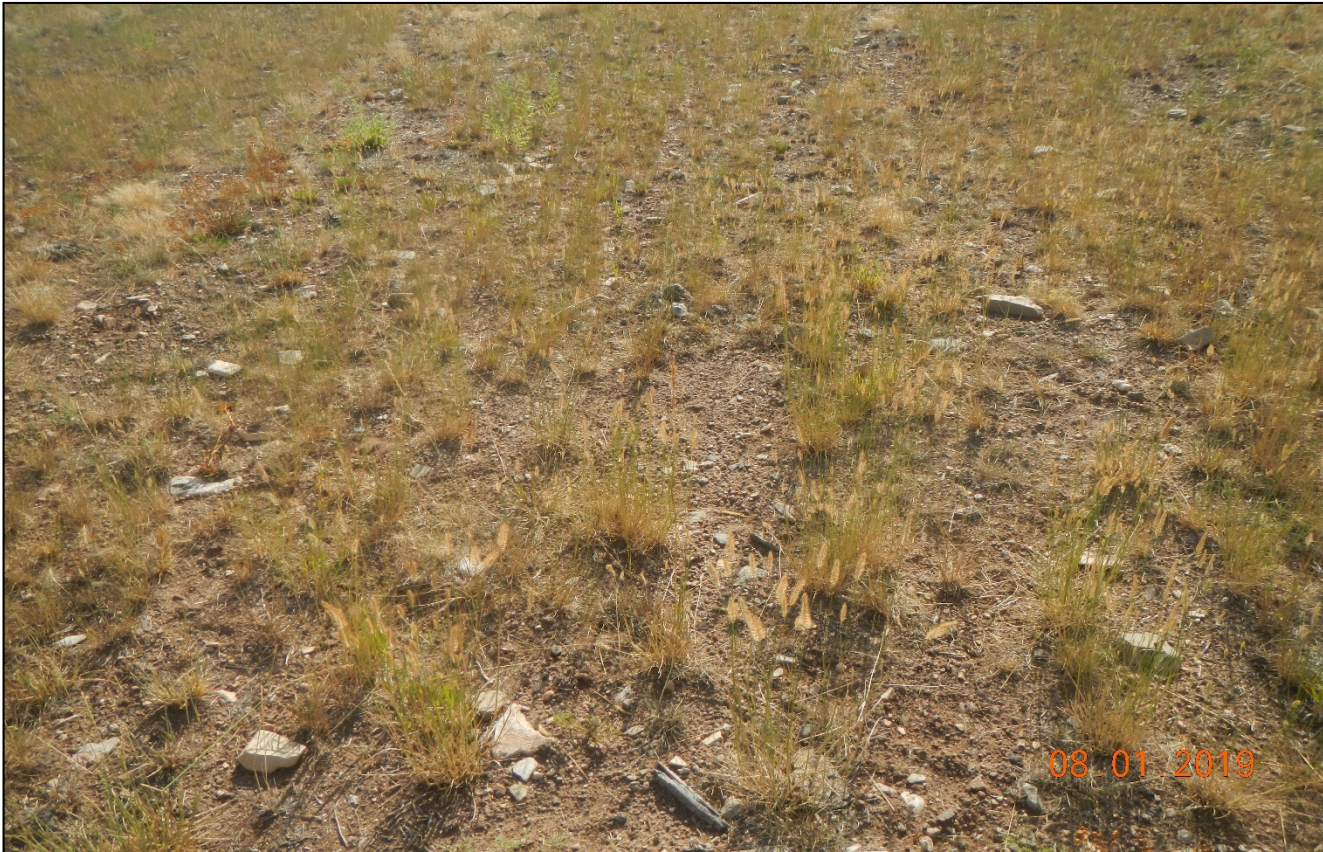
Photo 13. View of vegetation establishment at the northwest unpermitted disturbance area. Vegetation observed included Squeal tail, Needle and thread grass, Western wheat grass, Crested wheatgrass, Scarlet globemallow, among other species.

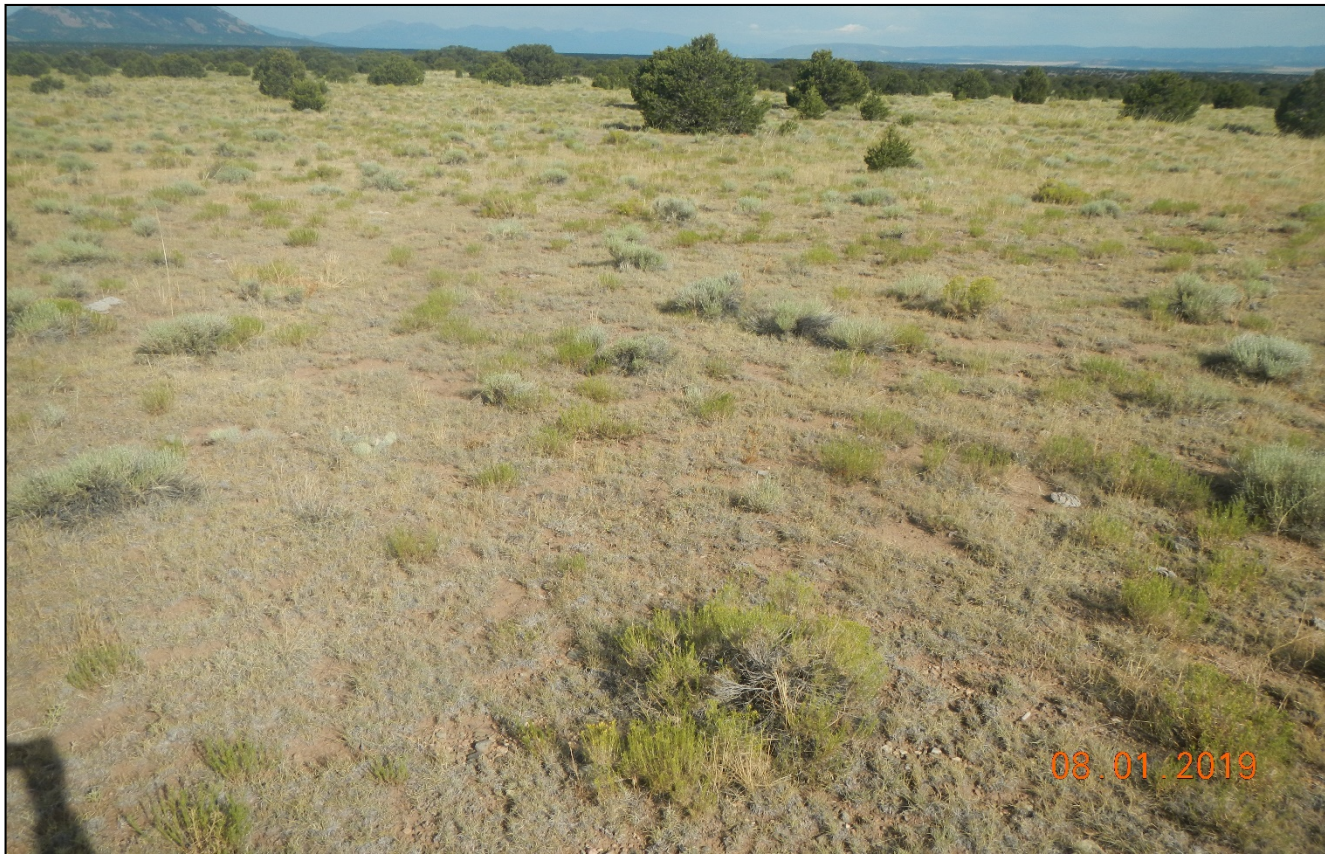
Photo 14. Facing toward the surrounding reference area.
