Inspection Photos

08/02/2019

Operator: WHITING OIL & GAS CORPORATION
- 96155

Location ID: 435245
Weld County, CO

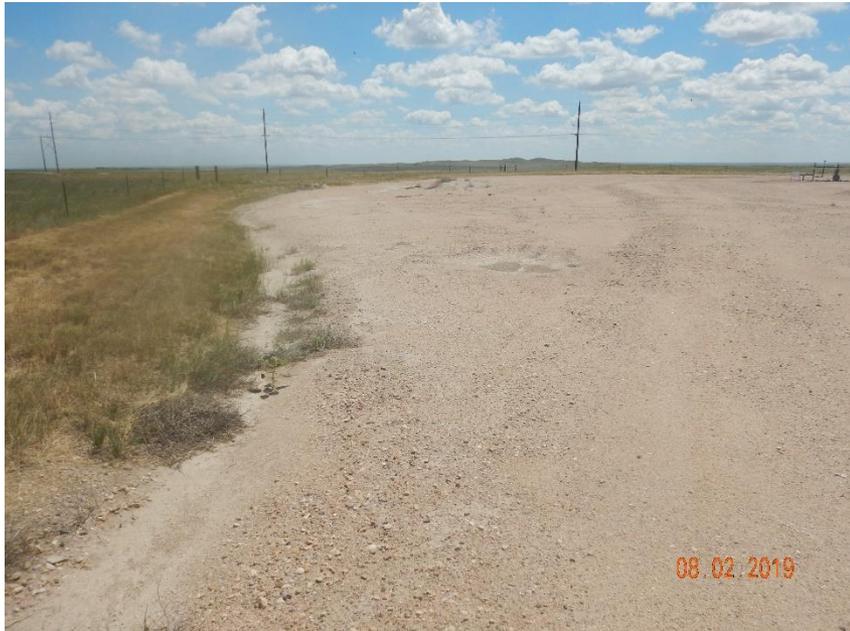
Photo 1: Photo taken from the northeast end of the location, facing south. Photos 1-3 provide an overview of the location from south, southwest to west. Photos show that only the areas of the access road, and immediate areas surrounding the wells appear to have been stabilized. Photo shows large areas that remain unstabilized where stormwater ponding outside of the perimeter ditch is evident.

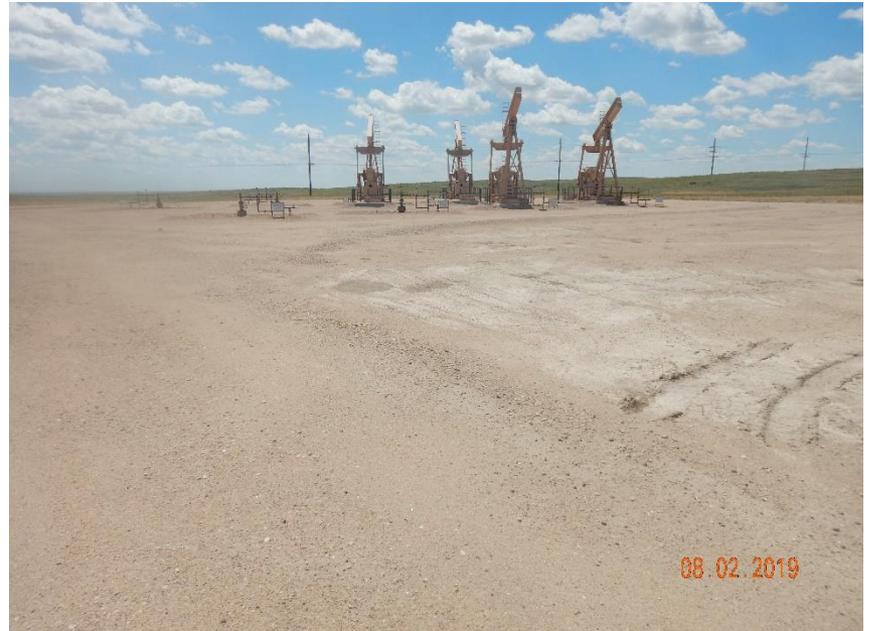
Photo 2: See comments under photo 1.

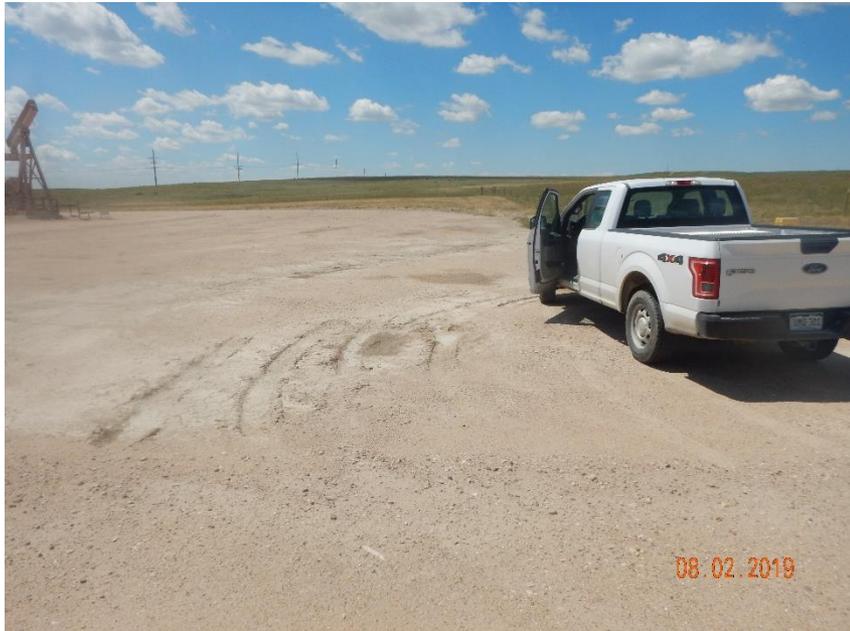
Photo 3: See comments under photo 1.

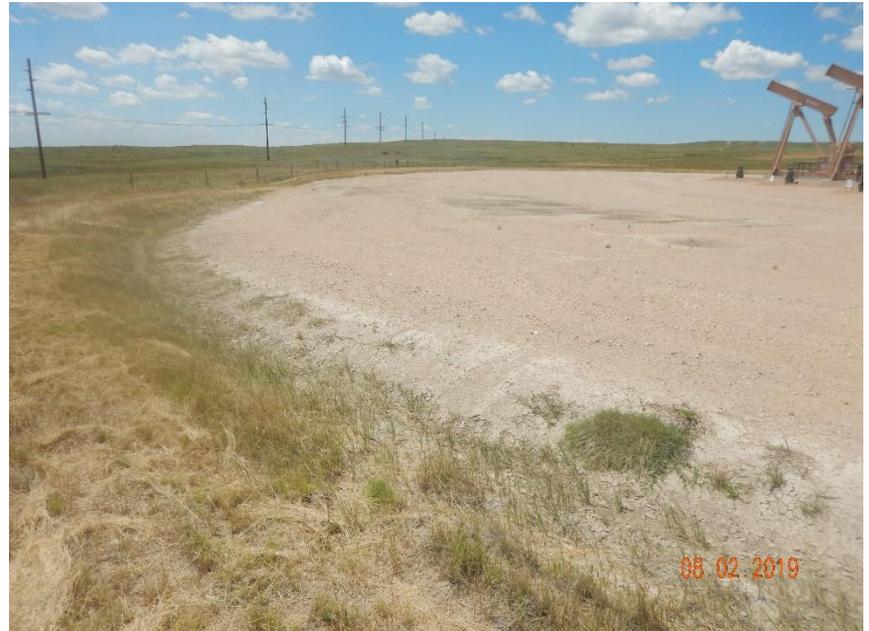
Photo 4: Photo taken from the southeast end of the location, facing west. Photos 1-3 provide an overview of the location from west, northwest to north. Photos show that only the areas of the access road, and immediate areas surrounding the wells appear to have been stabilized. Photo shows large areas that remain unstabilized where stormwater ponding outside of the perimeter ditch is evident.

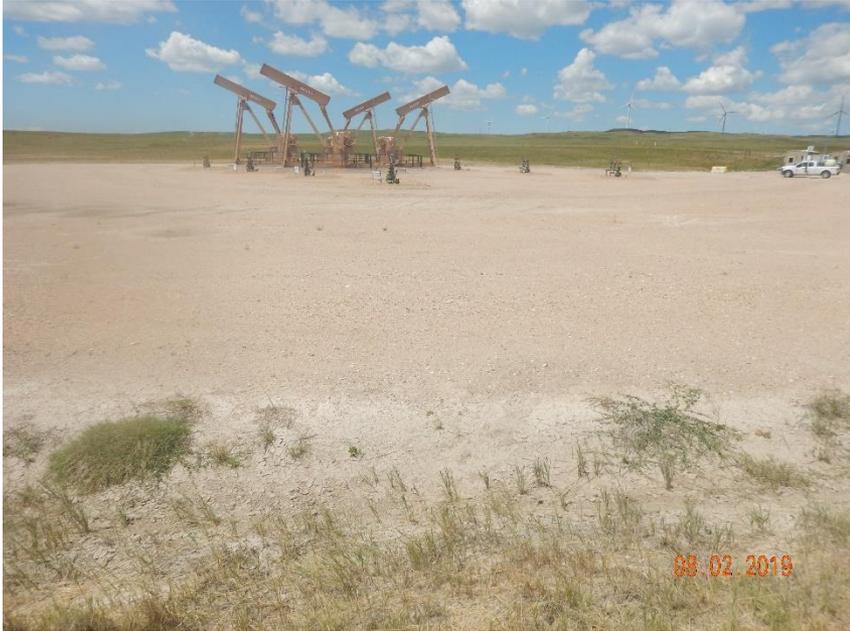
Photo 5: See comments under photo 4.

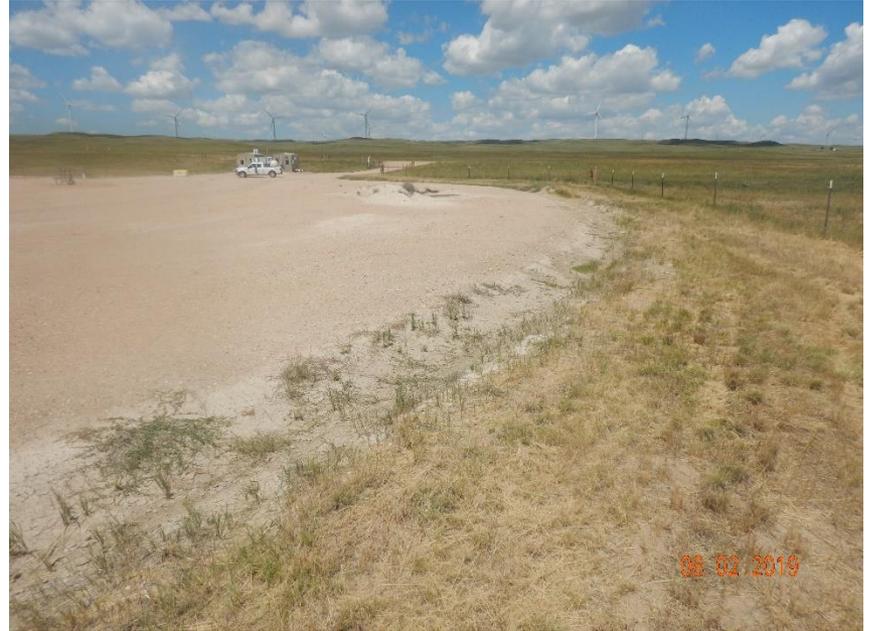
Photo 6: See comments under photo 4.

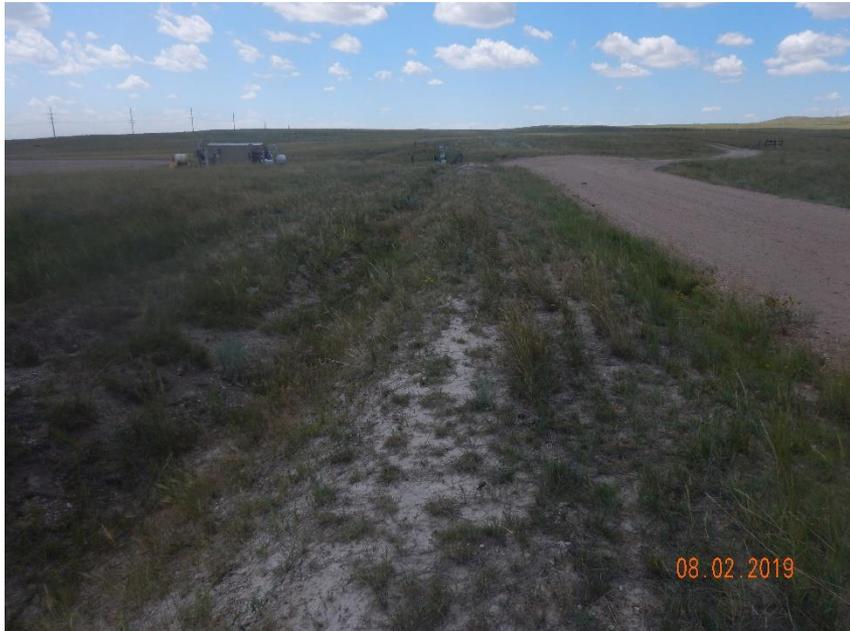
Photo 7: Photo taken from the north end of the location, facing west. Photo shows the perimeter stormwater ditch during initial construction activities remaining. Ditch does not appear to be needed and requires reclamation.

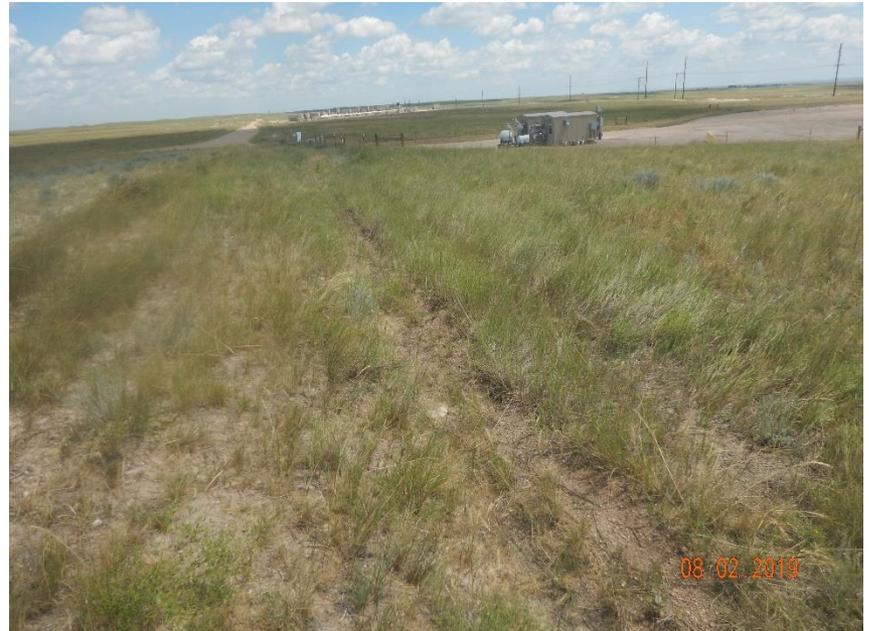
Photo 8: Photo taken from the north end of the location, facing east. Photo shows the perimeter stormwater ditch during initial construction activities remaining. Ditch does not appear to be needed and requires reclamation.

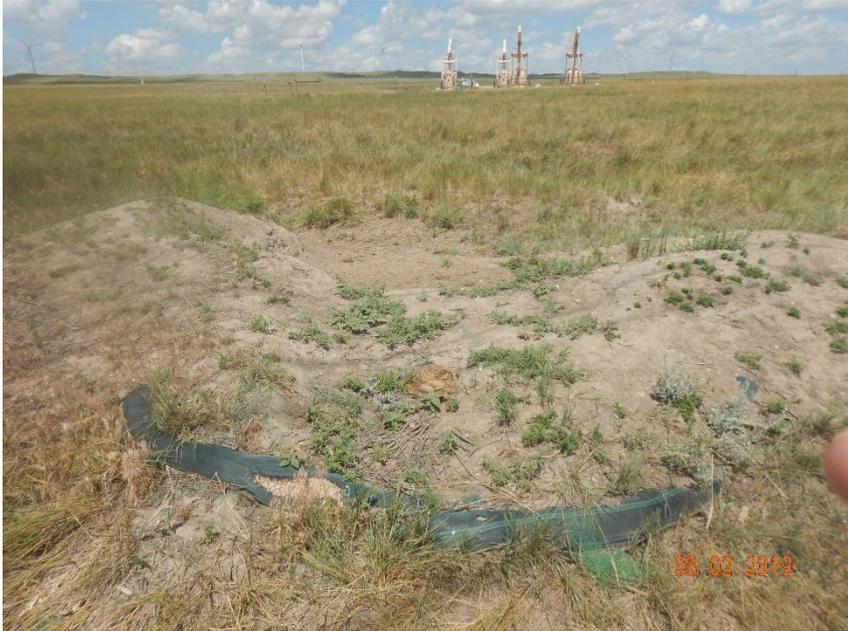
Photo 9: Photo taken from the south end of the location, facing north. Photo shows the perimeter stormwater ditch, and sediment during initial construction activities remaining. BMPs have not been maintained, do not appear to be needed and requires reclamation.

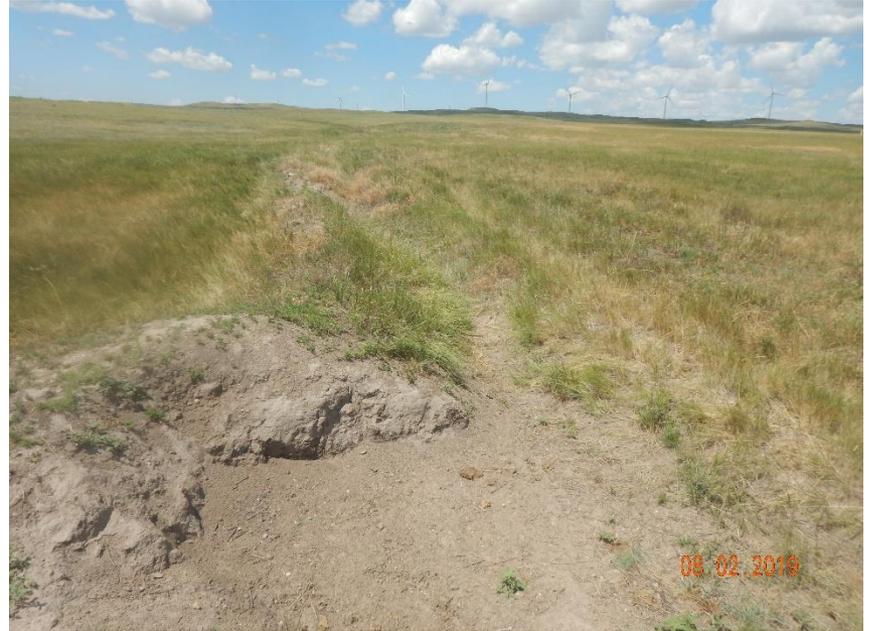
Photo 10: Photo taken from the south end of the location, facing northwest. Photo shows the perimeter stormwater ditch, and sediment during initial construction activities remaining. BMPs have not been maintained, do not appear to be needed and requires reclamation.

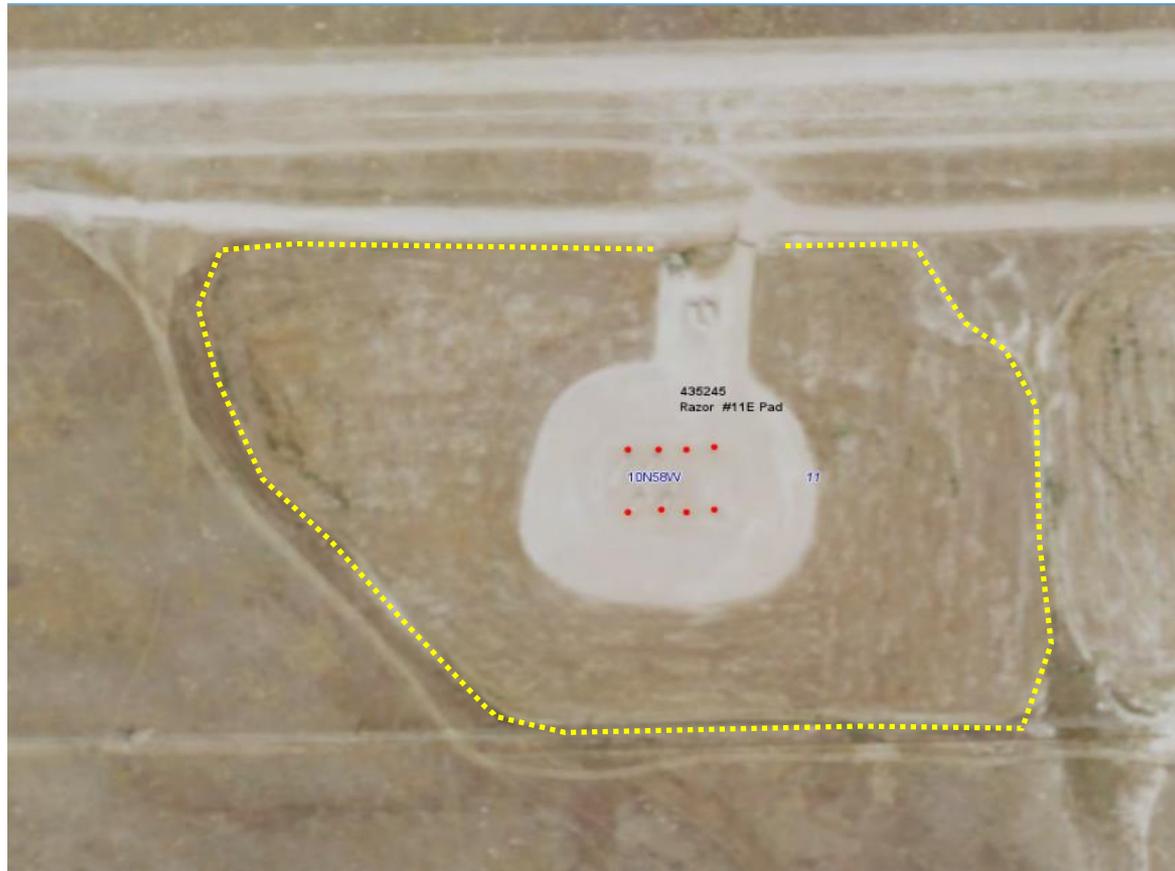
Photo 11: 2017 COGCC COGIS aerial image. Photo shows perimeter stormwater ditch (yellow dotted line) w/ sediment traps, BMPs, etc... that require reclamation
