# Inspection Photos

08/02/2019

Operator: WHITING OIL & GAS CORPORATION  
- 96155

Location ID: 435644  
Weld County, CO

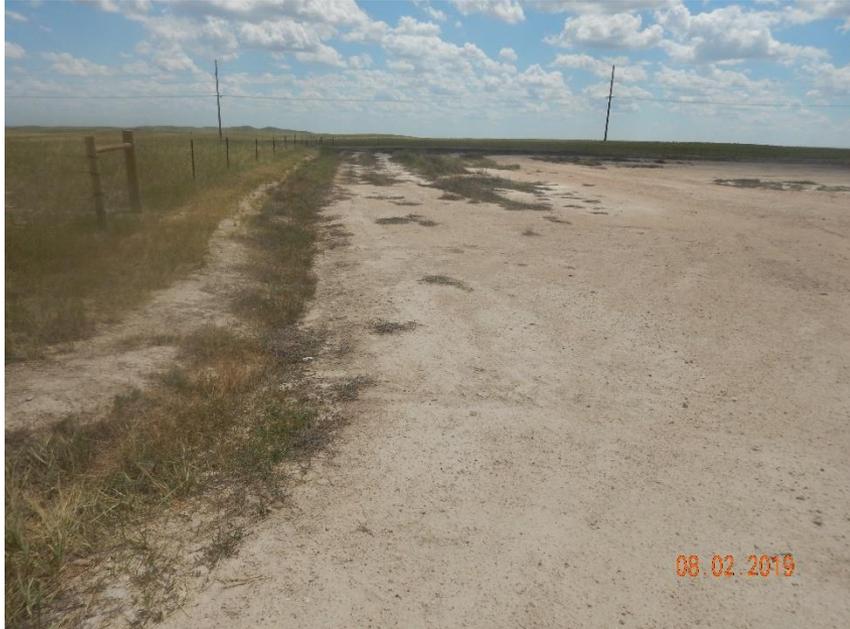
**Photo 1:** Photo taken from the northeast end of the location, facing south. Photos 1-3 provide an overview of the location from south, southwest to west. Photos show that only the areas of the access road, and immediate areas surrounding the wells appear to have been stabilized. Photo shows large areas that remain unstabilized where stormwater ponding outside of the perimeter ditch is evident.

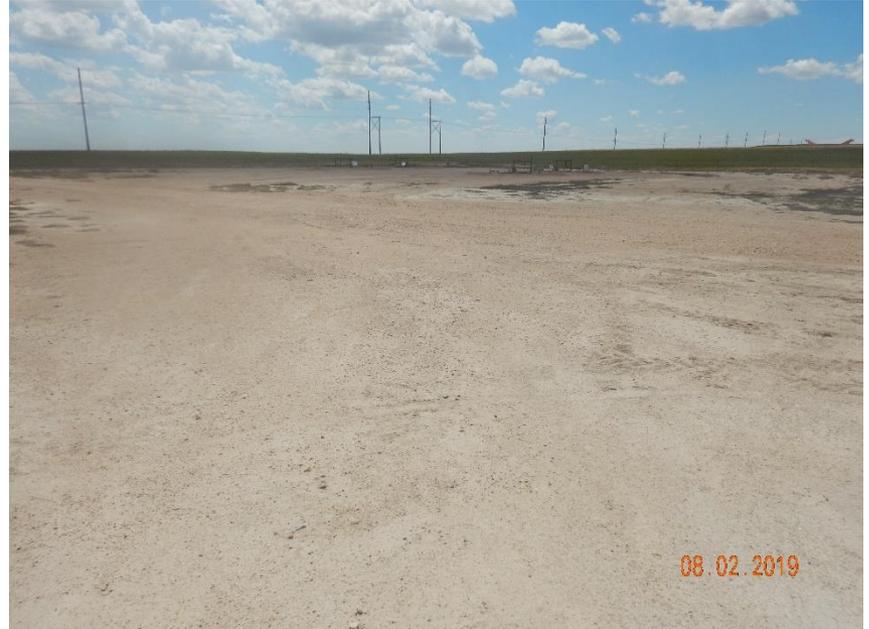
**Photo 2:** See comments under photo 1.

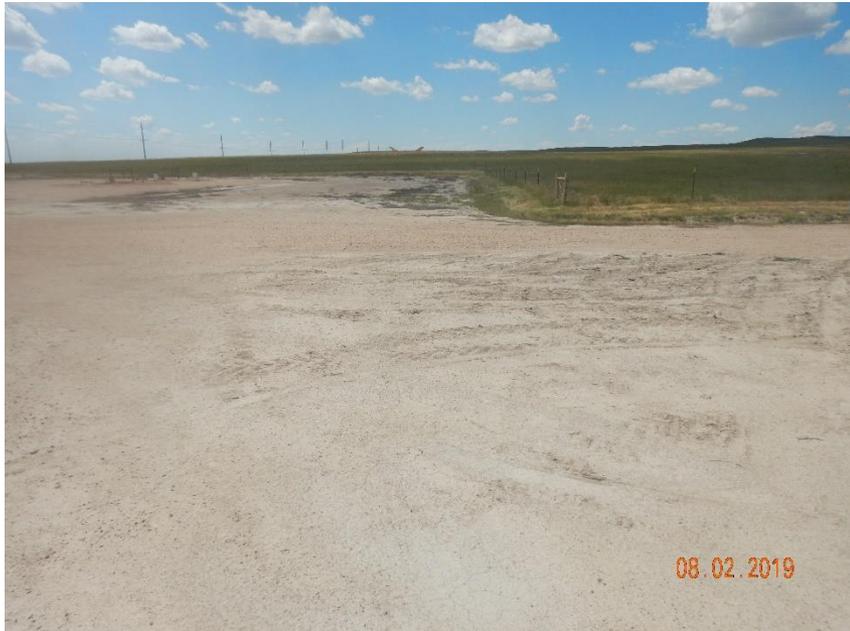
**Photo 3:** See comments under photo 1.

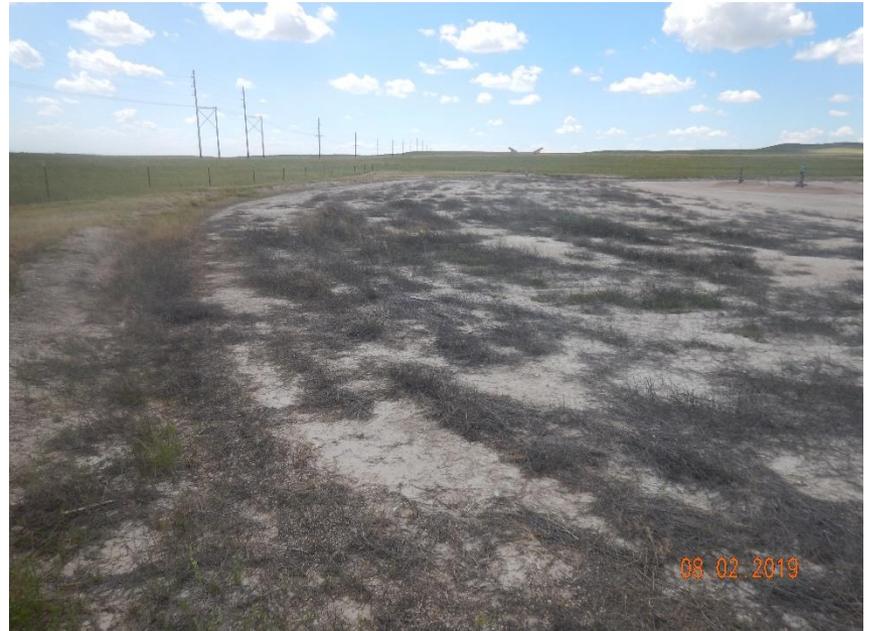
**Photo 4:** Photo taken from the southeast end of the location, facing west. Photos 4-6 provide an overview of the location from west, northwest to north. Photos show that only the areas of the access road, and immediate areas surrounding the wells appear to have been stabilized. Photo shows large areas that remain unstabilized where stormwater ponding outside of the perimeter ditch is evident.

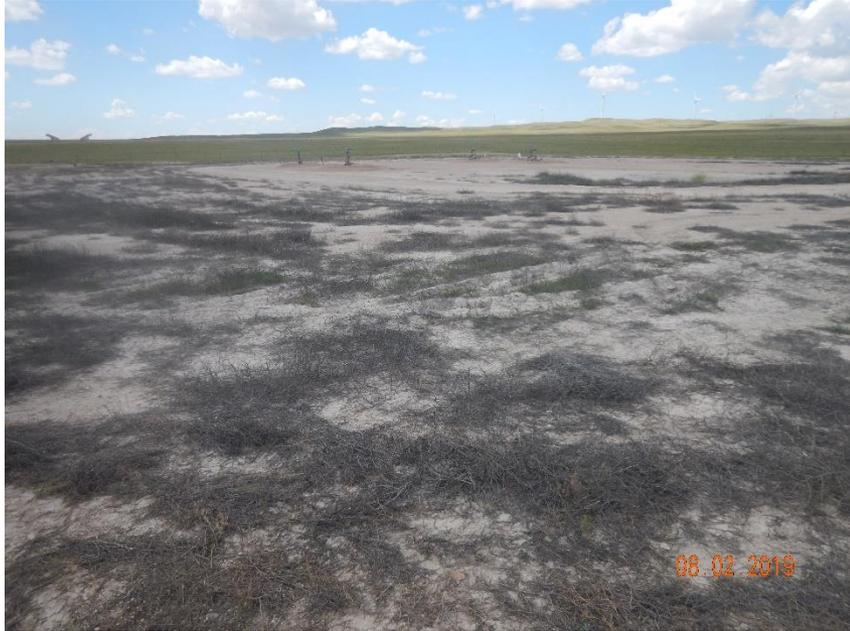
**Photo 5:** See comments under photo 4.

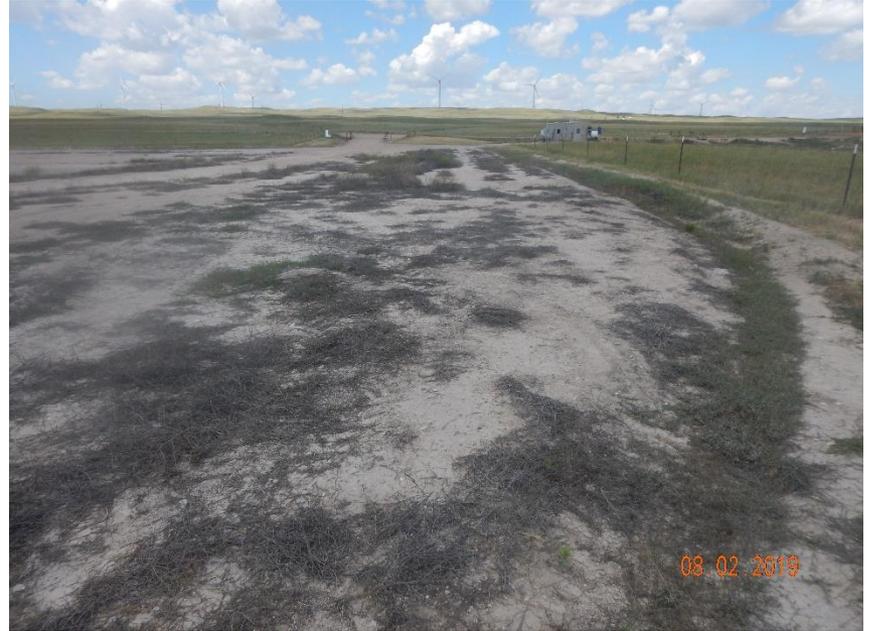
**Photo 6:** See comments under photo 4.

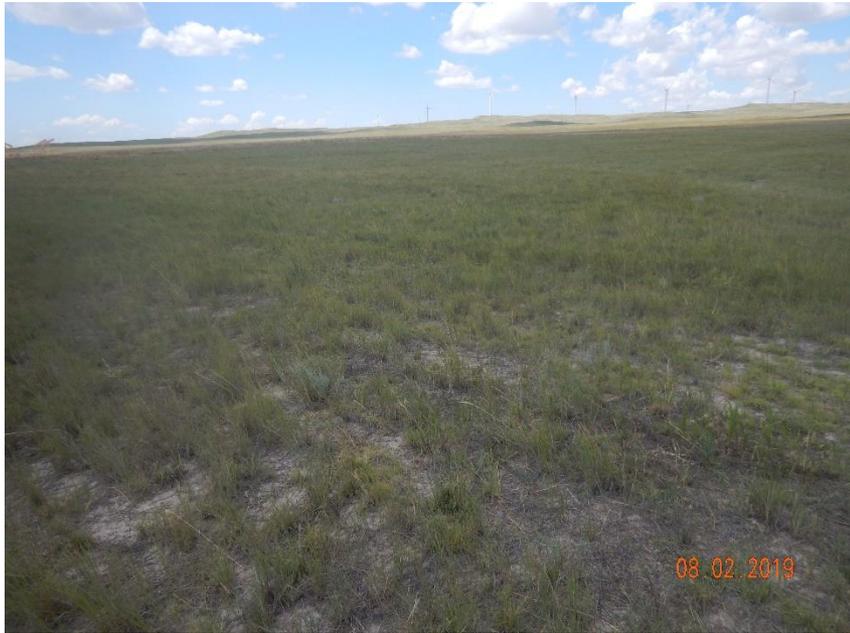
**Photo 7:** Photo taken from the south end of the location, facing northwest. Photos 7-9 provide an overview of the interim and reclamation areas from northwest, north, and east.

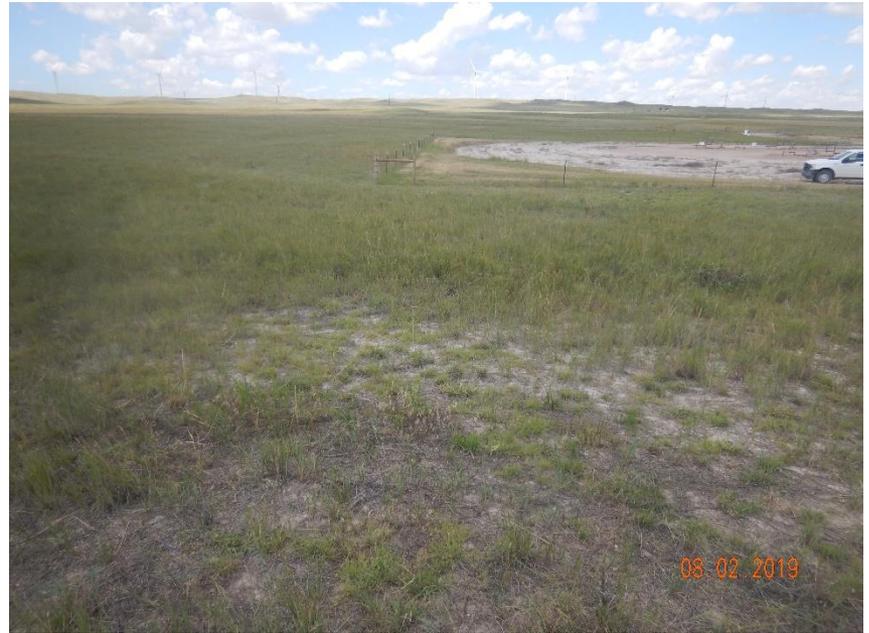
**Photo 8:** See comments under photo 7.

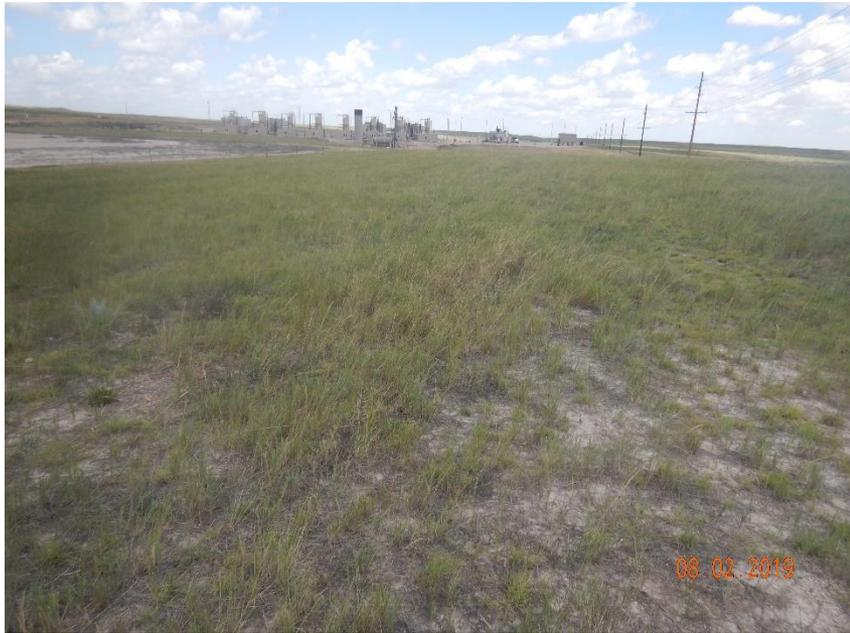
**Photo 9:** See comments under photo 7.

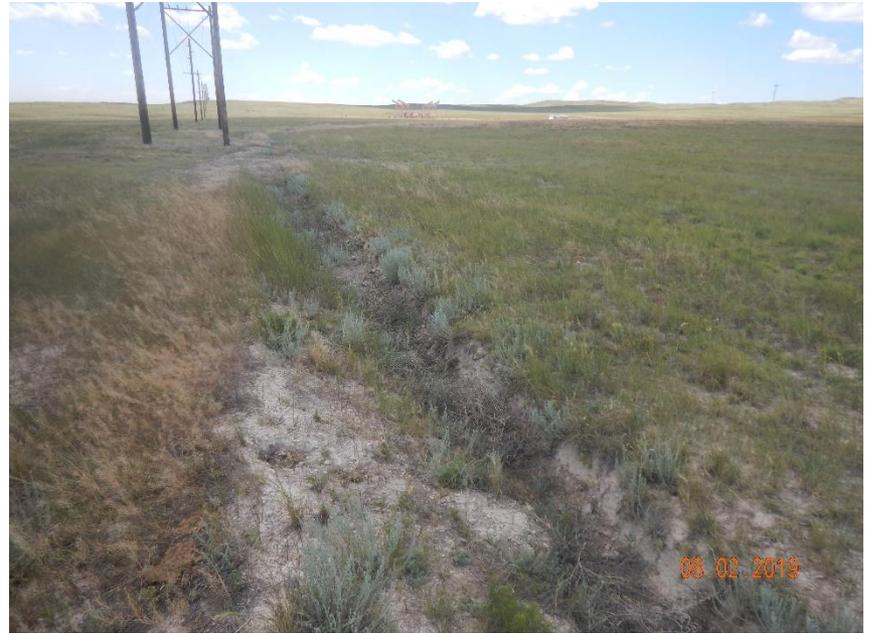
**Photo 10:** Photo taken from the south end of the location, facing west. Photo shows the perimeter stormwater ditch during initial construction activities remaining. BMPs have not been maintained, do not appear to be needed and require reclamation.

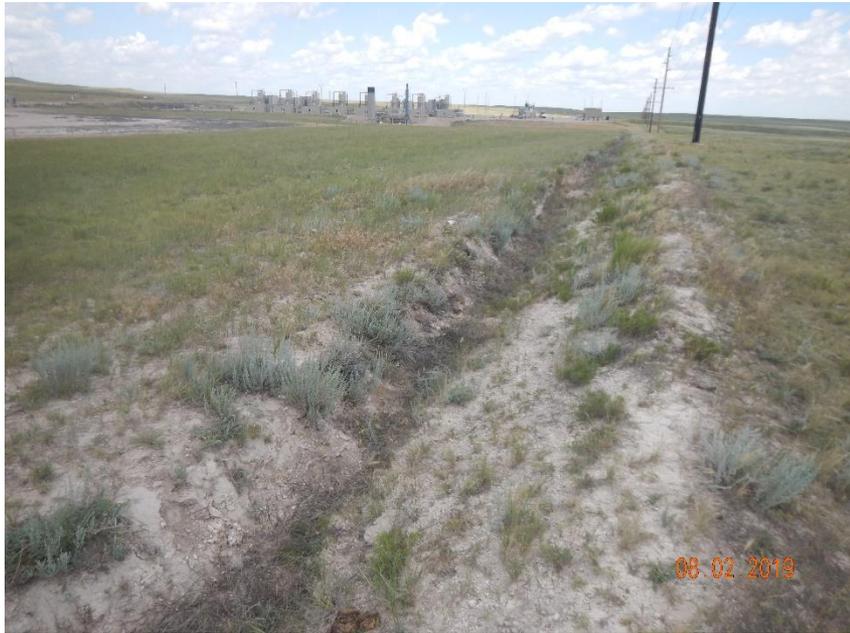
**Photo 11:** Photo taken from the south end of the location, facing east. Photo shows the perimeter stormwater ditch during initial construction activities remaining. BMPs have not been maintained, do not appear to be needed and require reclamation.

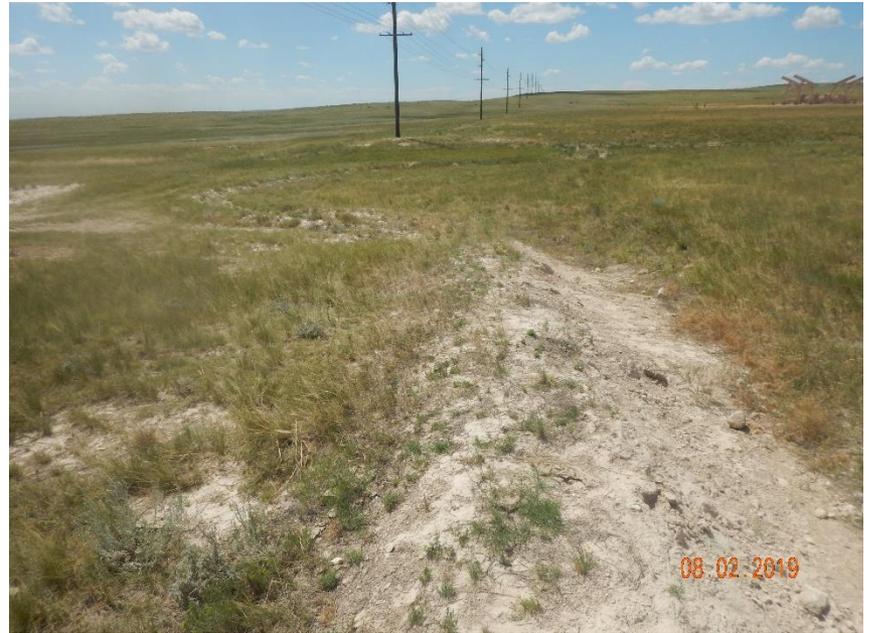
**Photo 12:** Photo taken from the southwest end of the location, facing west. Photo shows the perimeter stormwater ditch during initial construction activities remaining. BMPs have not been maintained, do not appear to be needed and require reclamation.

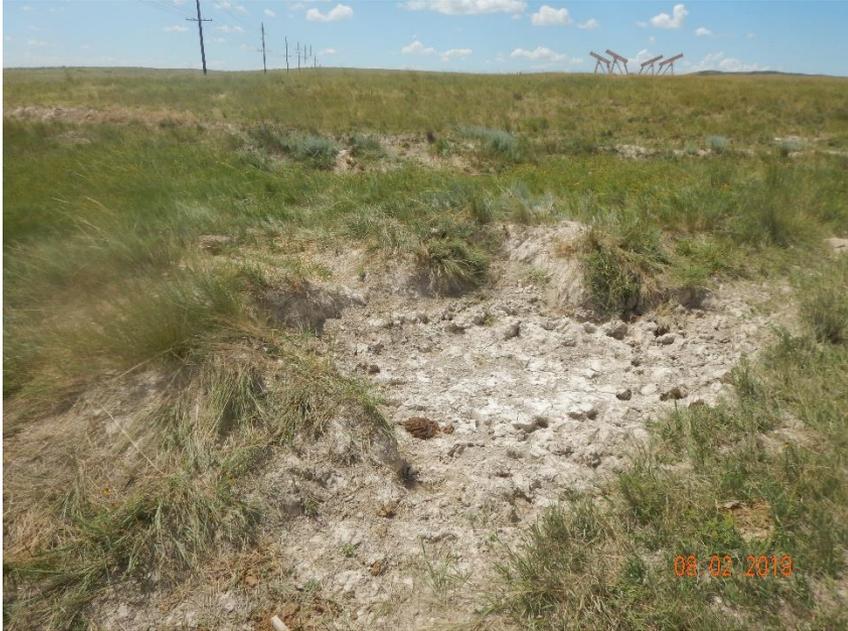
**Photo 13:** Photo taken from the southwest end of the location, facing west. Photo shows the perimeter stormwater ditch and sediment trap BMPs during initial construction activities remaining. BMPs have not been maintained, do not appear to be needed and require reclamation.

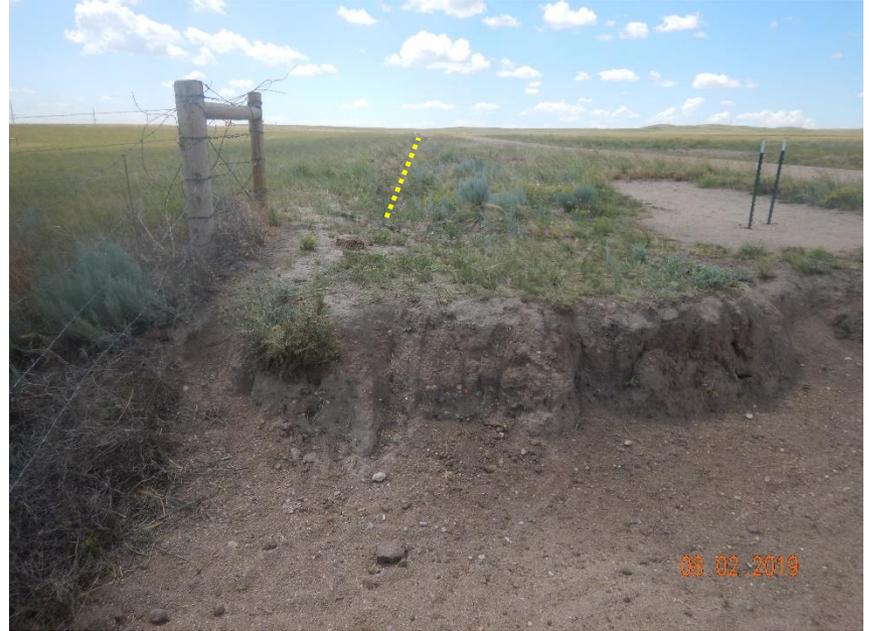
**Photo 14:** Photo taken from the north end of the location, facing west. Photo shows the perimeter stormwater ditch during initial construction activities remaining. BMPs have not been maintained, do not appear to be needed and require reclamation.

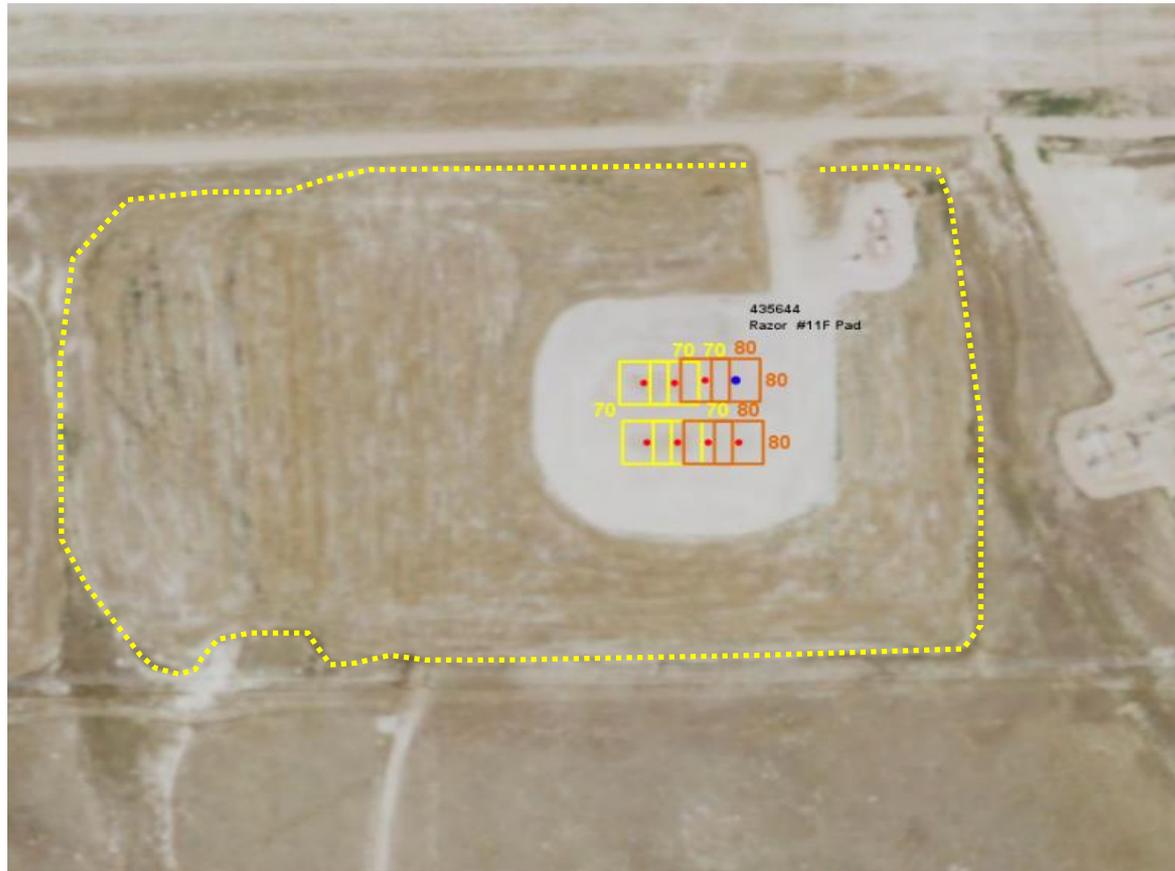
**Photo 15:** 2017 COGCC COGIS aerial image. Photo shows perimeter stormwater ditch (yellow dotted line) w/ sediment traps, BMPs, etc... that require reclamation
