Inspection Photos
Location Name: Mesa H2-797 Pad
Location ID: #439917
Inspection Date: July 26, 2019

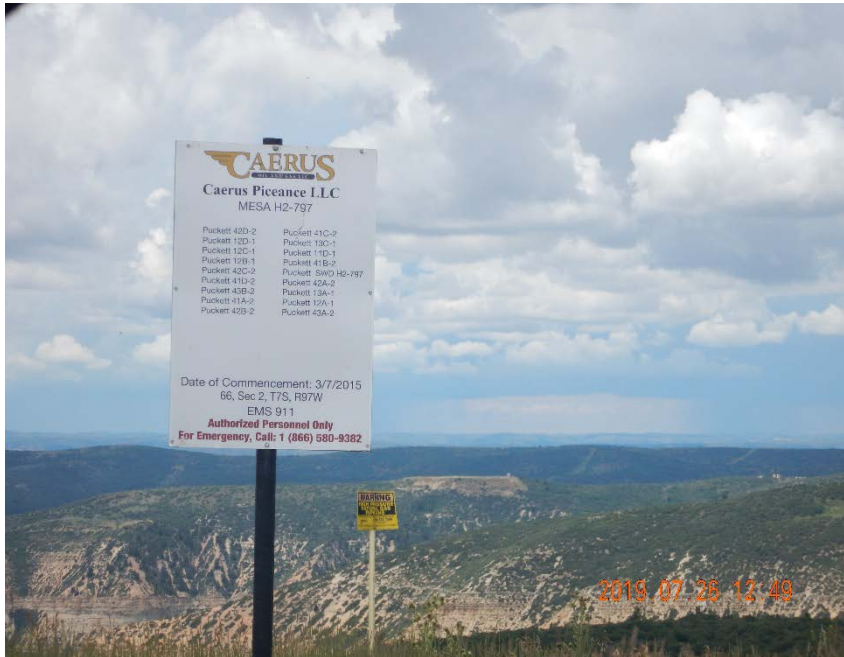
Photo #1 – Facility sign.

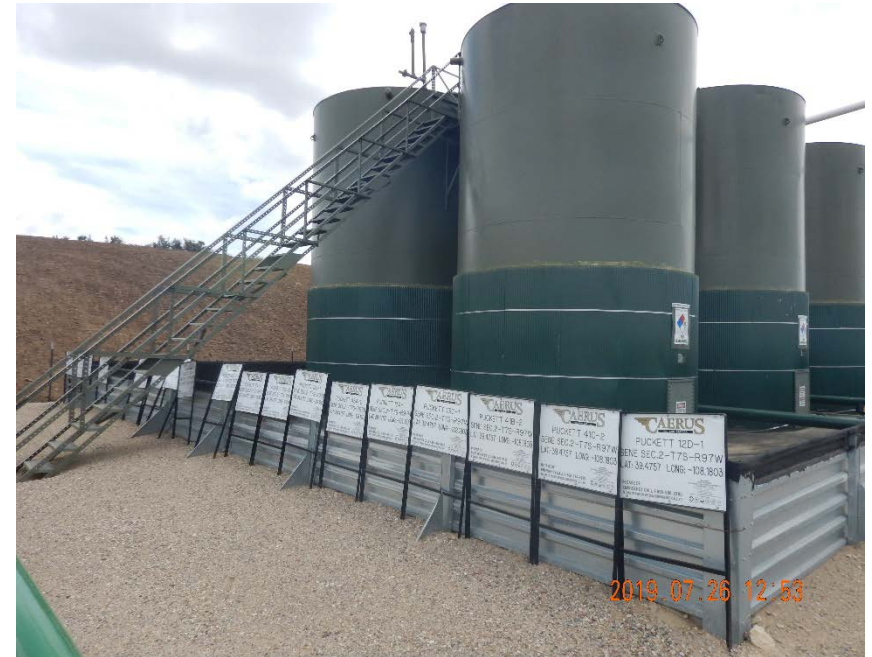
Photo #2 – Tank battery signs.

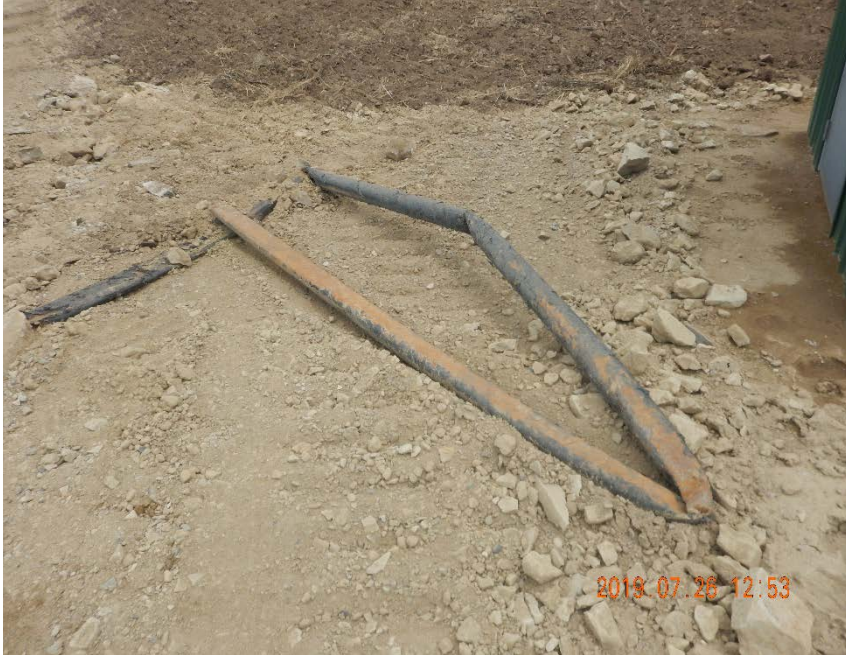
Photo #3 – Junk pipe located northeast of tank battery.

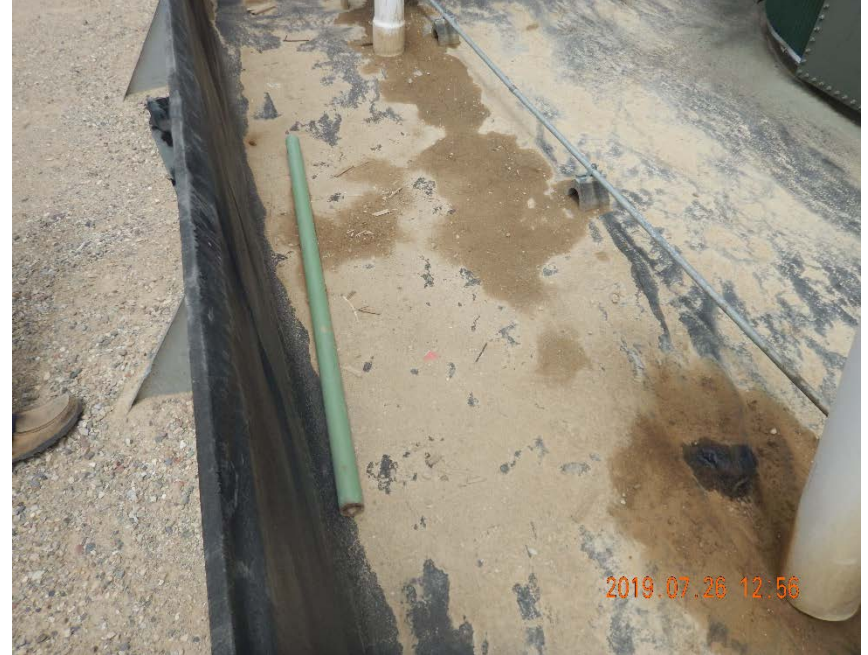
Photo #4 – Metal pipe stored inside of lined secondary containment area (west side).

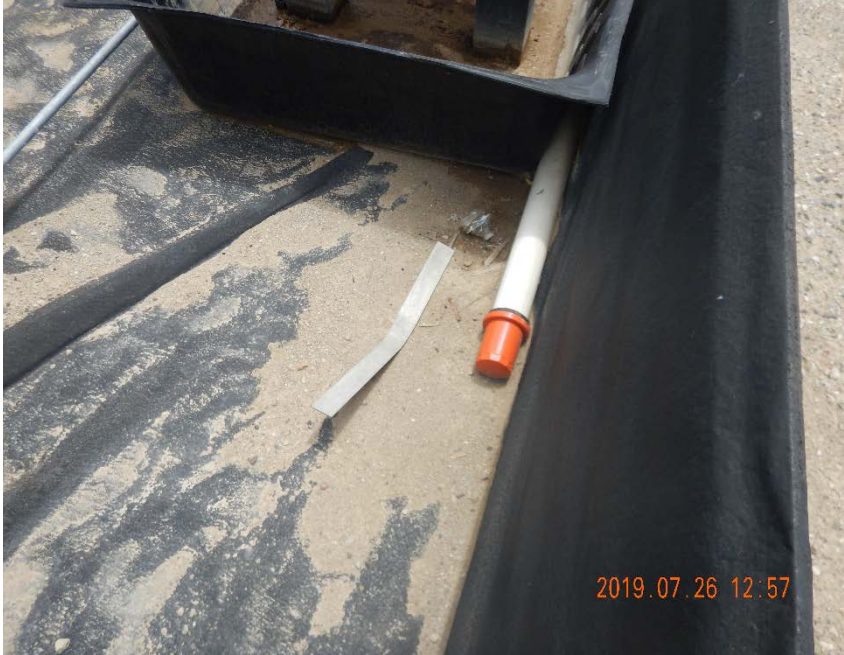
Photo #5 – Metal scrap and unused equipment stored inside of lined secondary containment area (southwest corner).

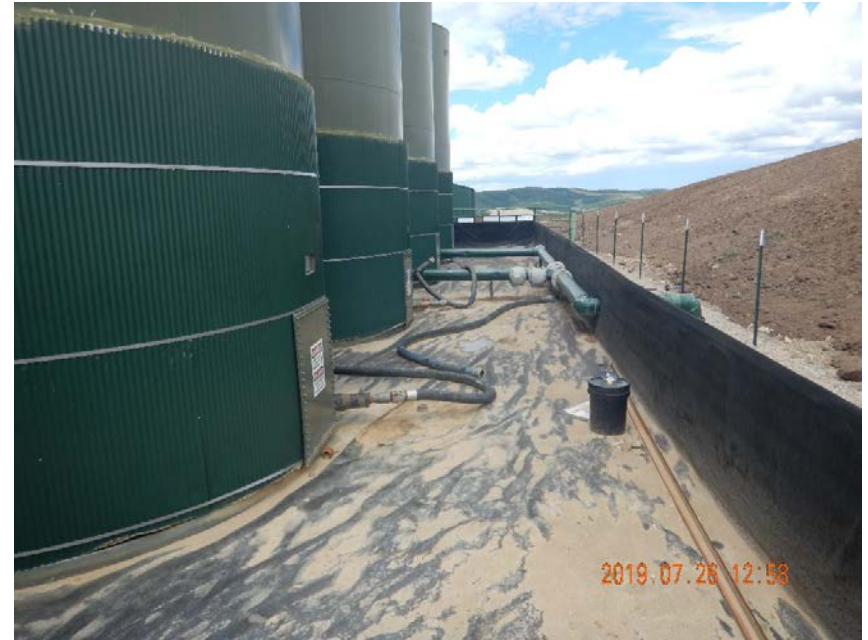
Photo #6 – Angle iron and hoses with metal fittings stored inside of lined secondary containment area (east side).

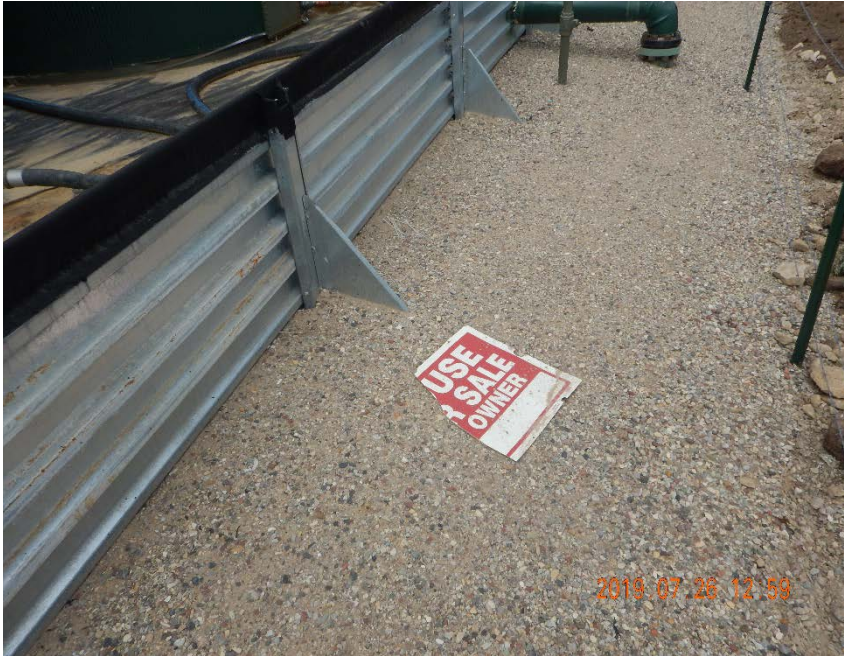
Photo #7 – Trash outside of secondary containment (east side).

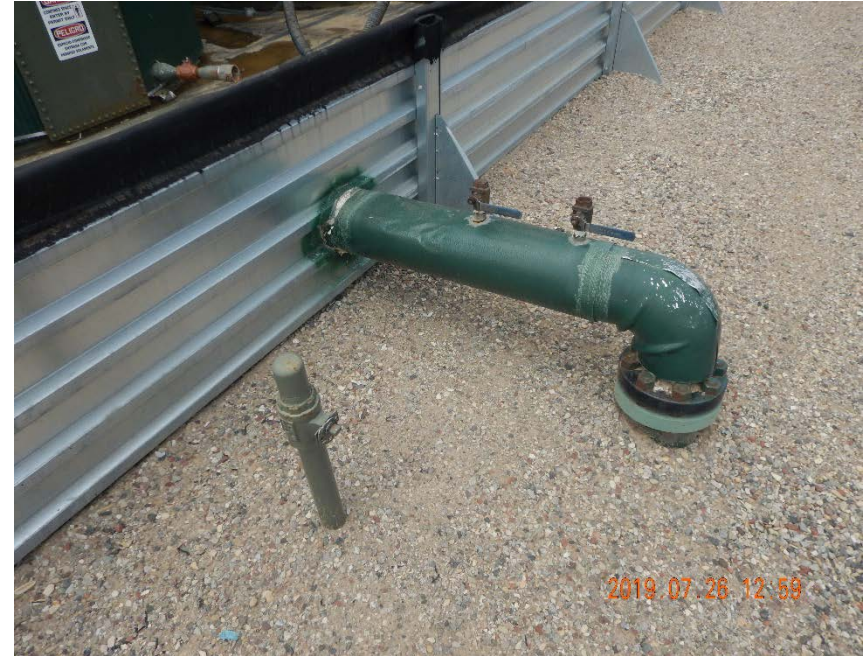
Photo #8 – Unmarked, unused 2" flowline riser east of tank battery.

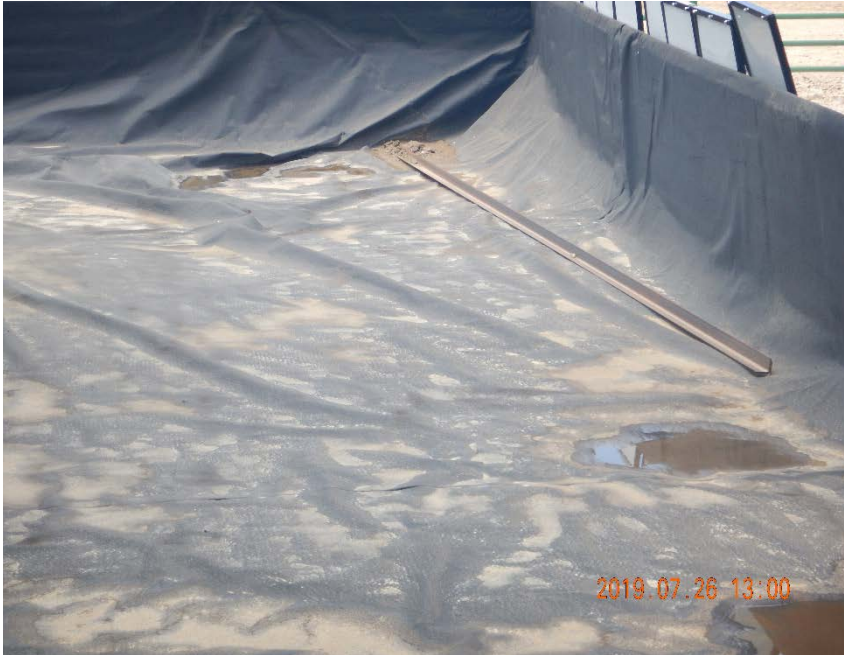
Photo #9 – Angle iron stored inside of lined secondary containment area (northwest corner).

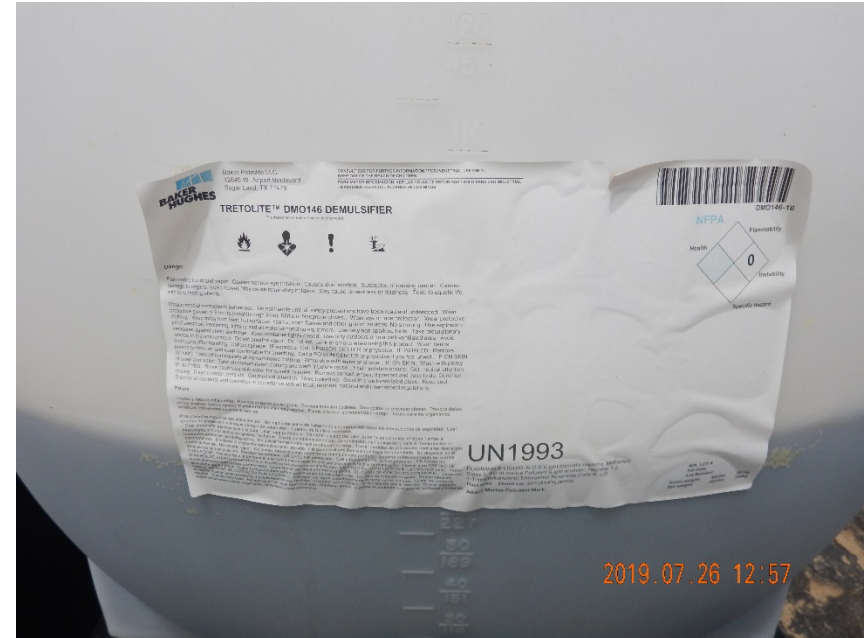
Photo #10 – Faded NFPA placard on day tank stored inside southwest corner of lined secondary containment area.

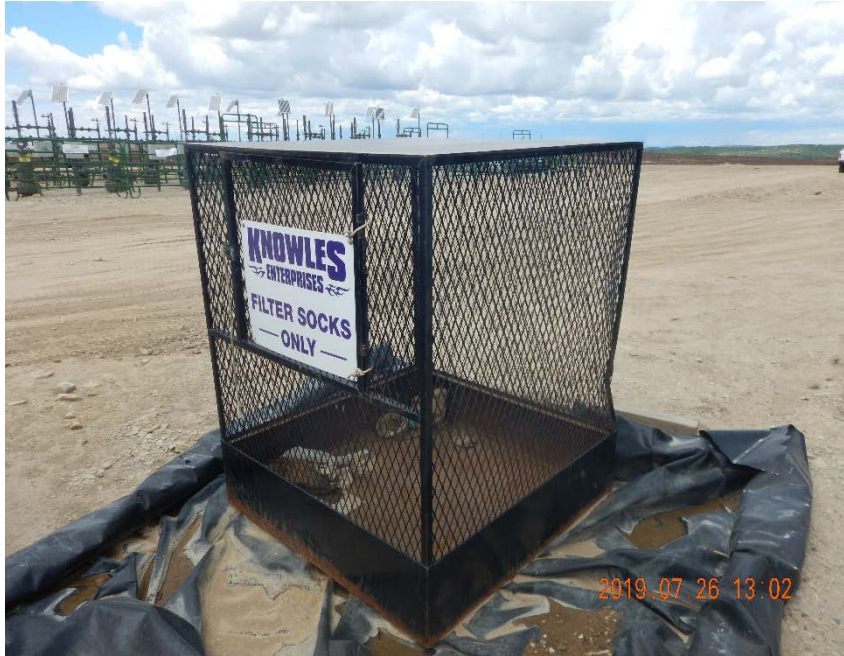
Photo #11 – Filter sock containment device on top of liner, located west of separators.

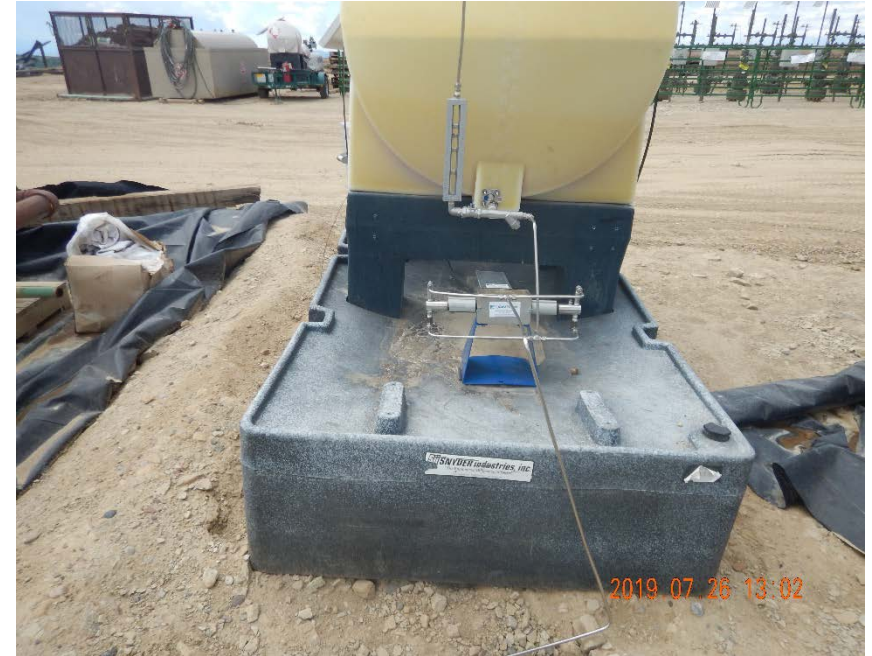
Photo #12 – Day tank with process piping located west of separators.

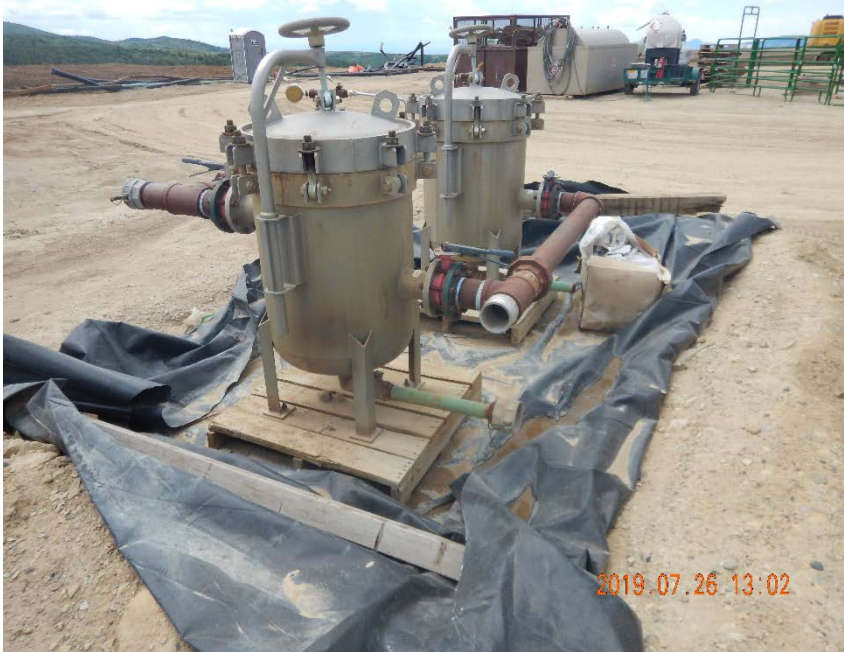
Photo #13 – Filter pots on top of liner, located west of separators.

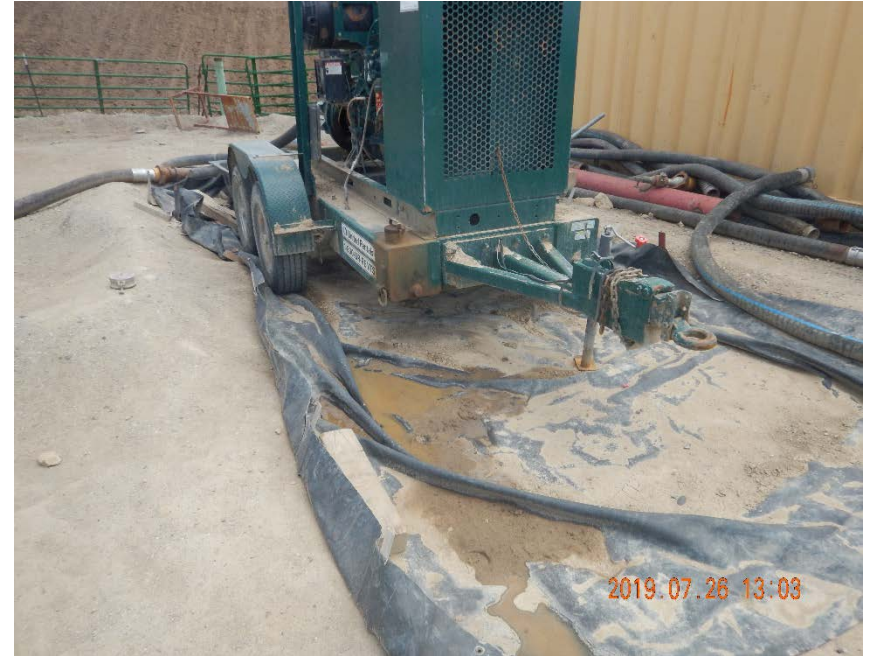
Photo #14 – Pump on top of liner. Note pump wheels and hitch jack directly on liner may cause damage due to vibration.

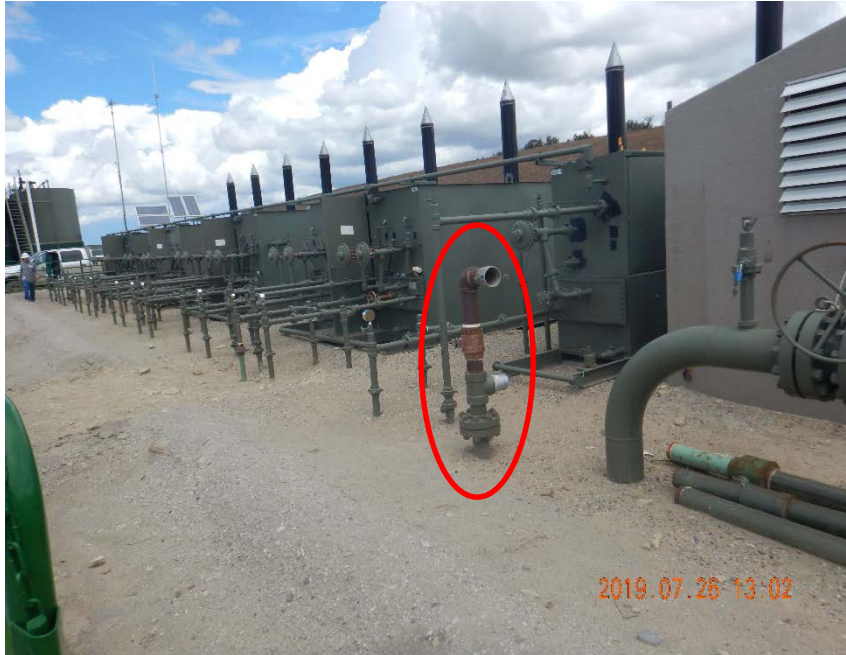
Photo #15 – Unused, unmarked, and uncapped flowline riser located at south end of separators.

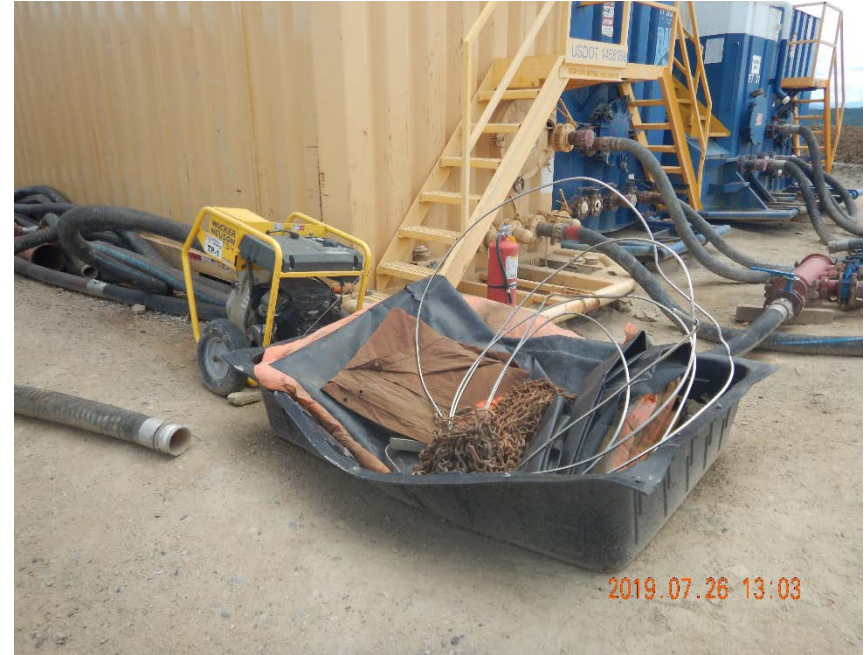
Photo #16 – Equipment storage north of frac tanks (1).

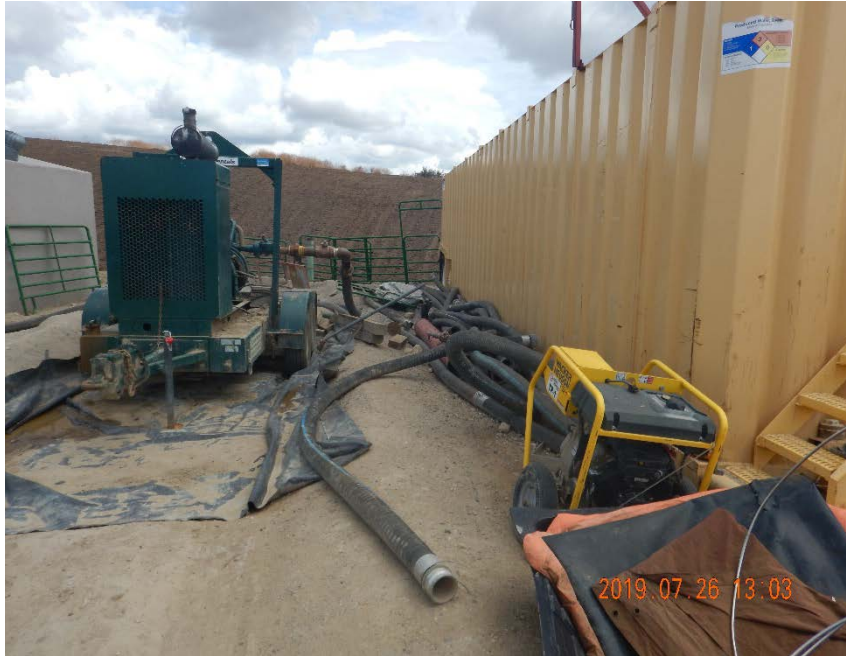
Photo #17 - Equipment storage north of frac tanks (2).

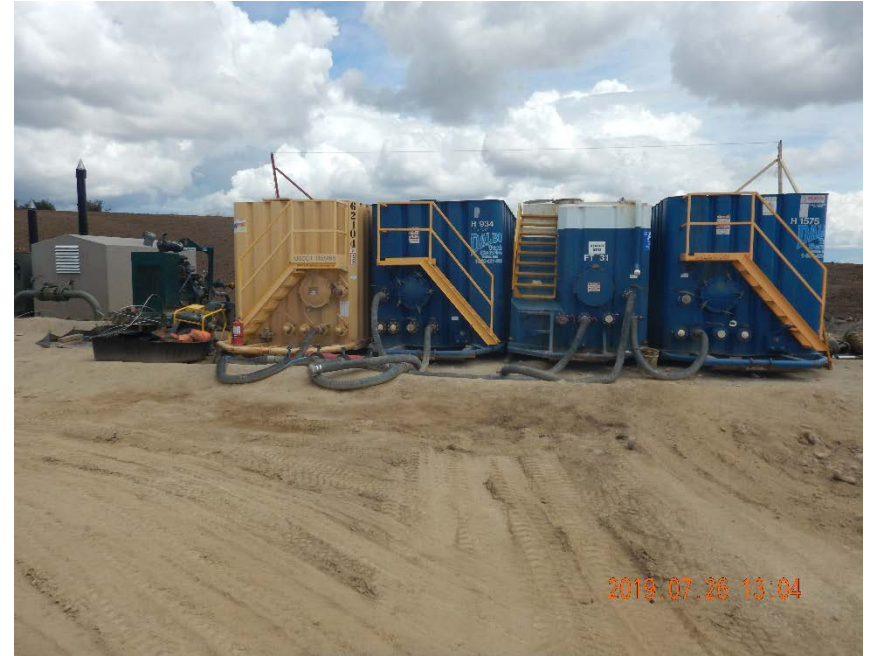
Photo #18 – Frac tanks located at southeast side of location.

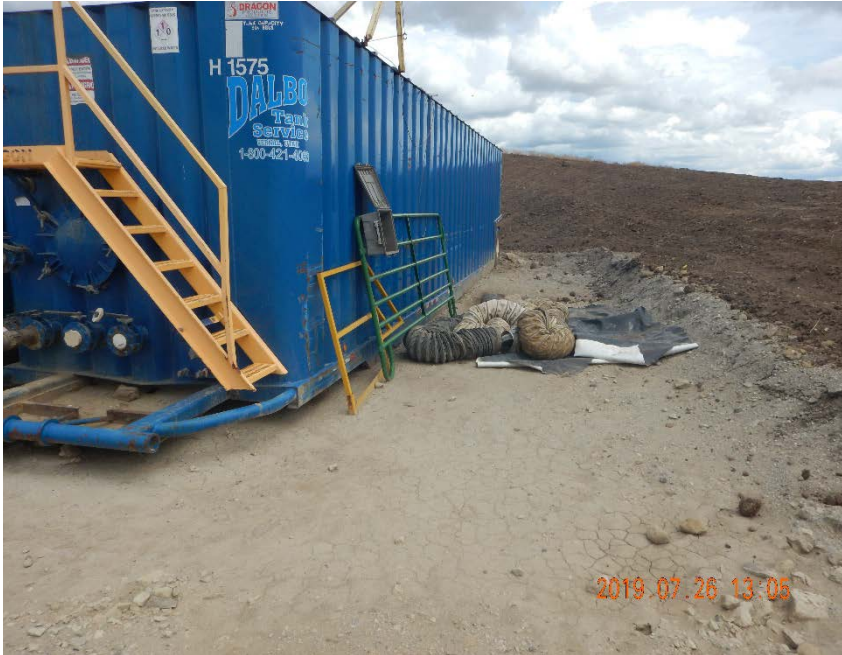
Photo #19 - Equipment storage south of frac tanks.

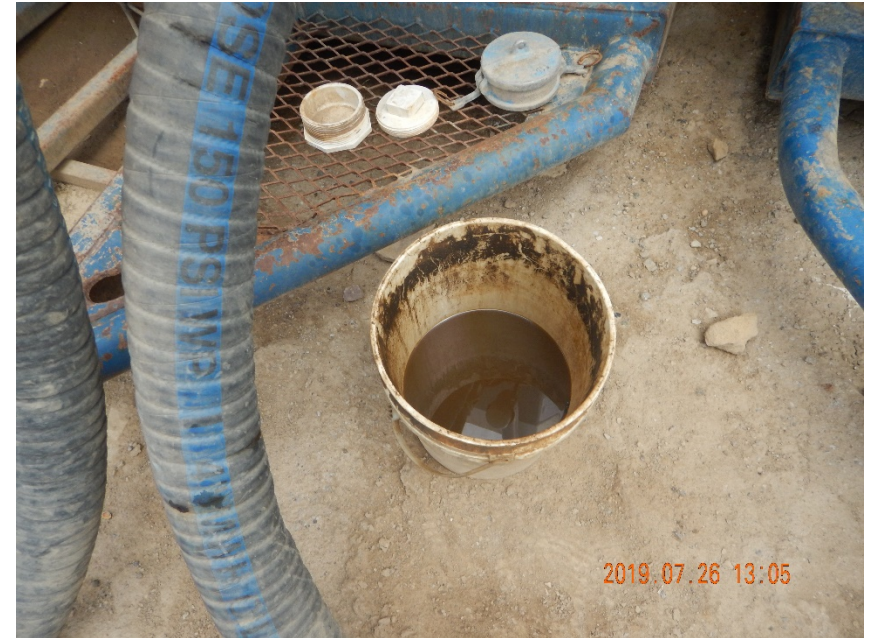
Photo #20 – Bucket of unidentified fluid stored on west side of frac tanks.

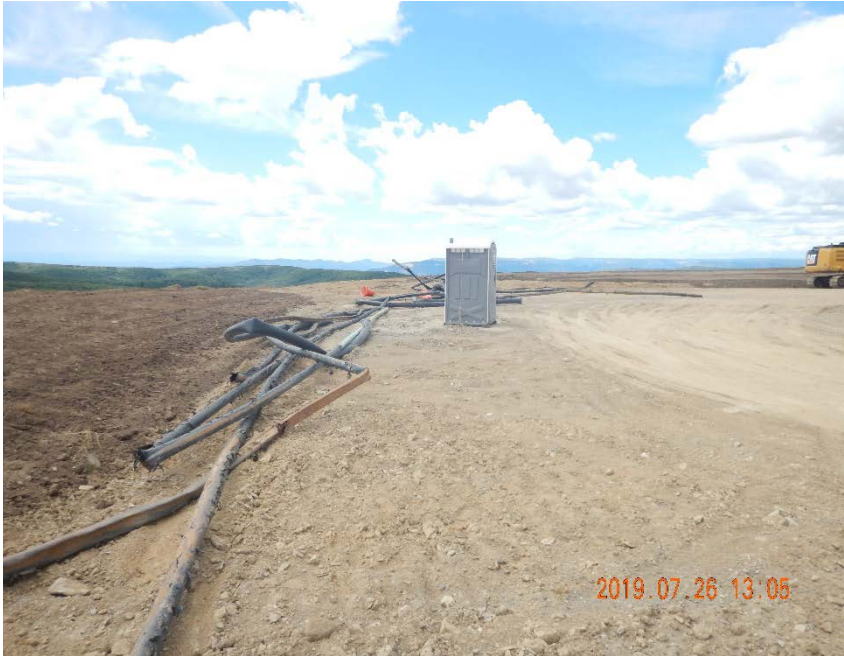
Photo #21 - Junk pipe stored along south side of location.

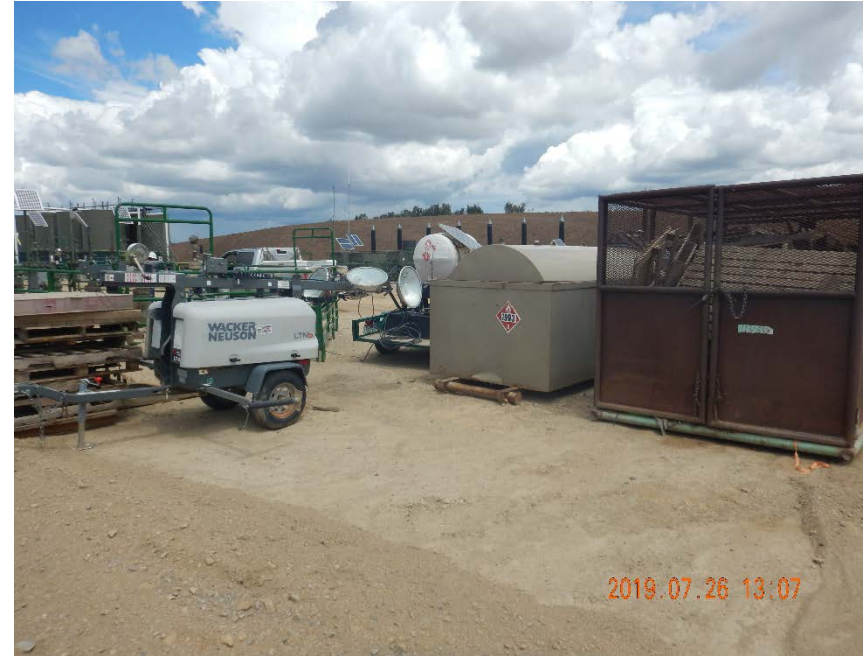
Photo #22 – Additional ancillary equipment (day tank, diesel AST, trash container) located south of wellhead area.

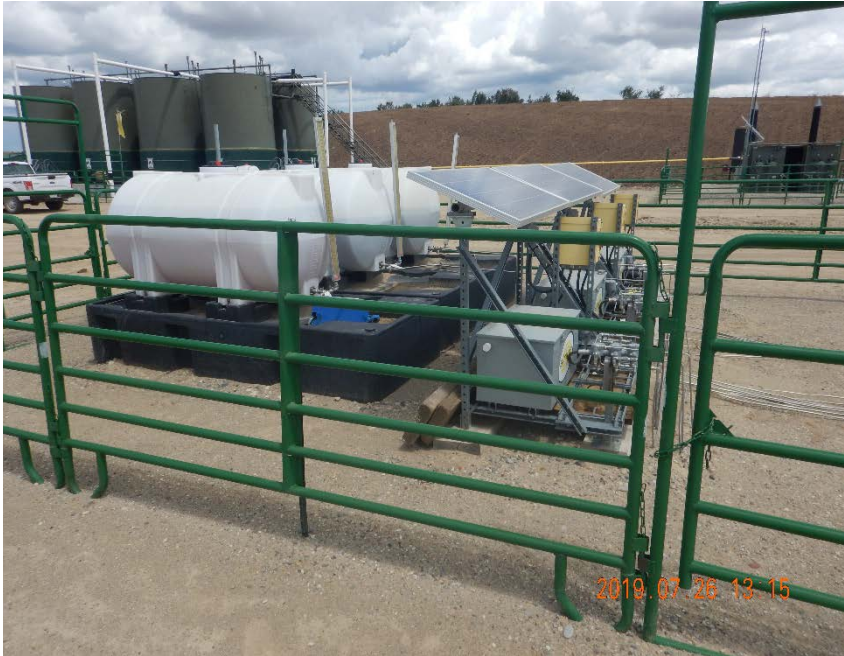
Photo #23 – Day tanks inside of secondary containment on north side of fenced wellhead area.

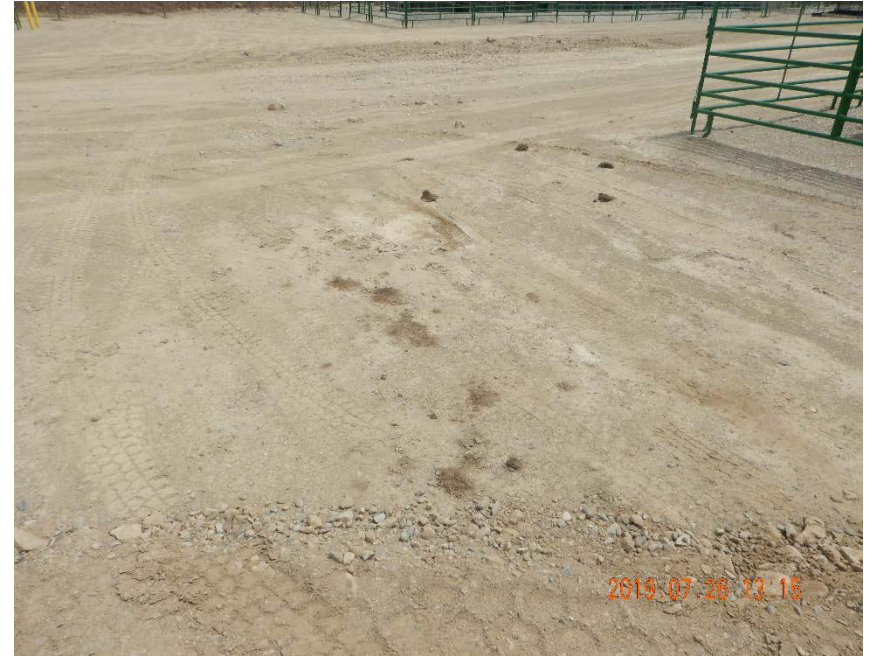
Photo #24 – Localized accumulations of oil-stained soil north of fenced wellhead area.
