Inspection Photos  
Location Name: 596-33C  
Location ID: 335880  
Inspection Date: July 29, 2019

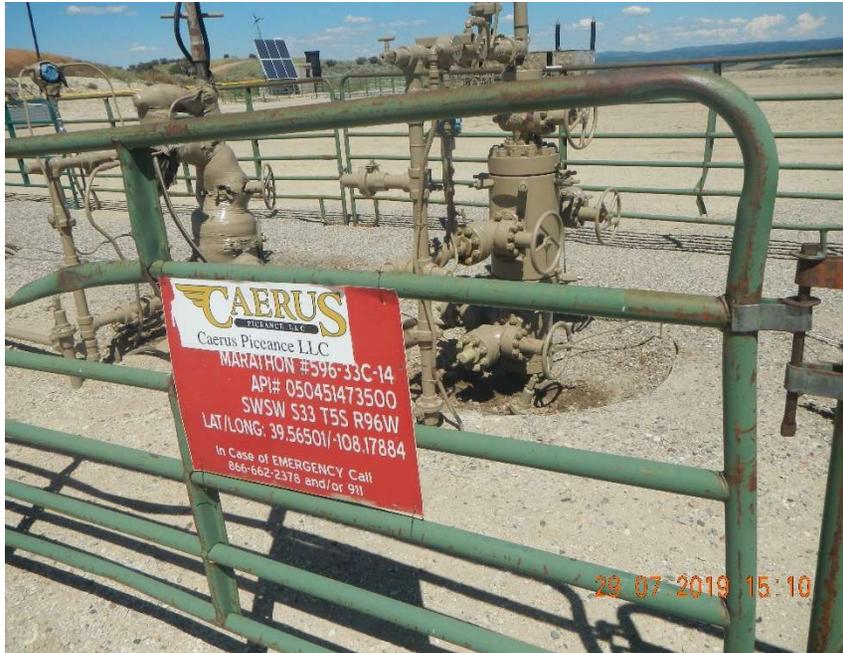
Photo #3 - Localized accumulation of oily waste (oil-stained soil) in the 596-33C-14 cellar.

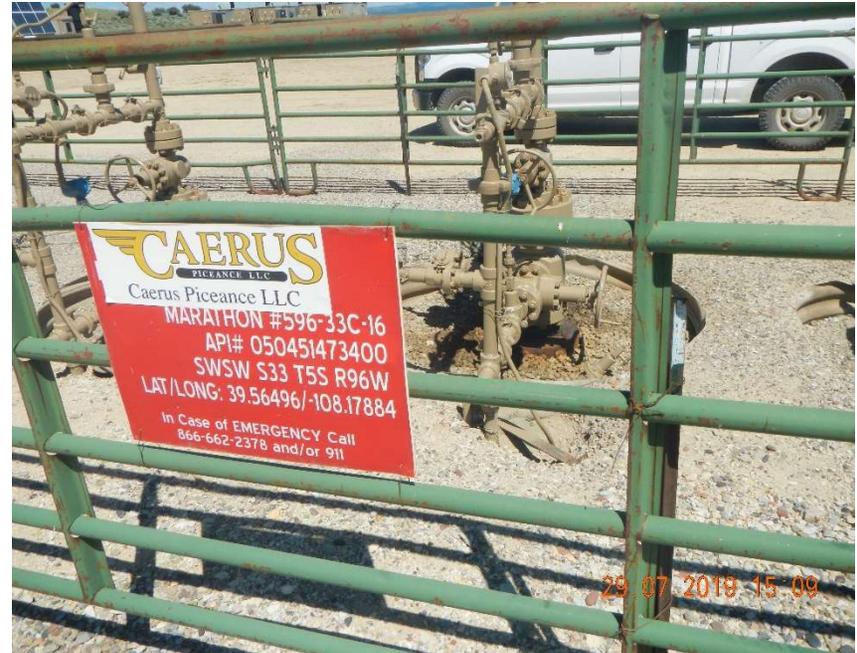
Photo #4 - Localized accumulation of oily waste (oil-stained soil) in the 596-33C-16 cellar.

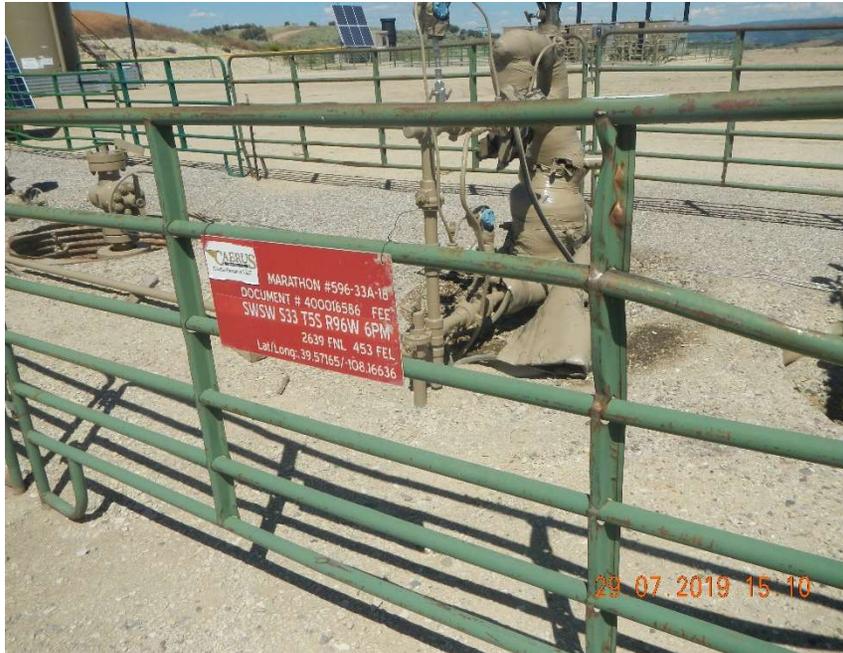
Photo #5 - Localized accumulation of oily waste (oil-stained soil) in the 596-33C-18 cellar.

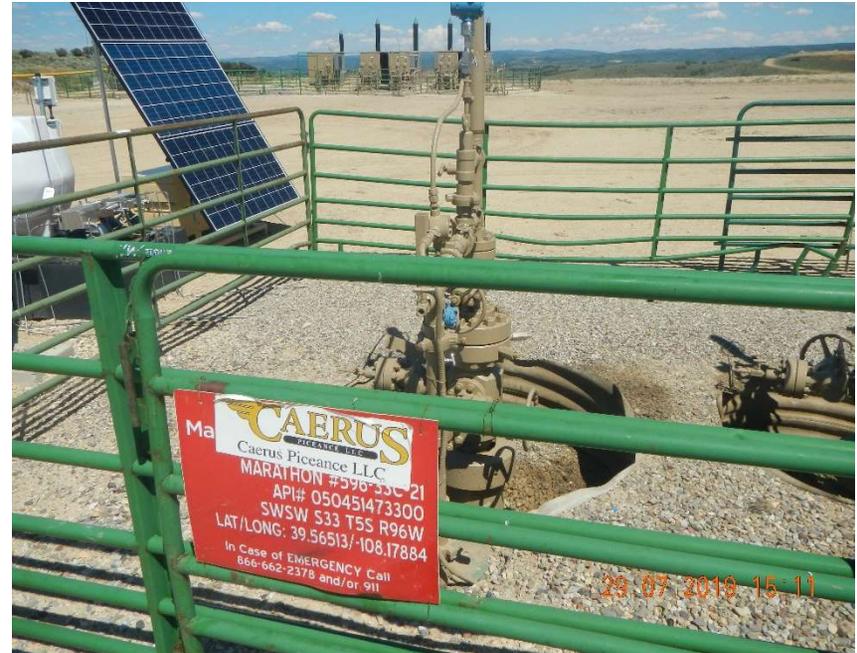
Photo #6 - - Localized accumulation of oily waste (oil-stained soil) in the 596-33C-21 cellar. Uncovered cellars with no wildlife egress.

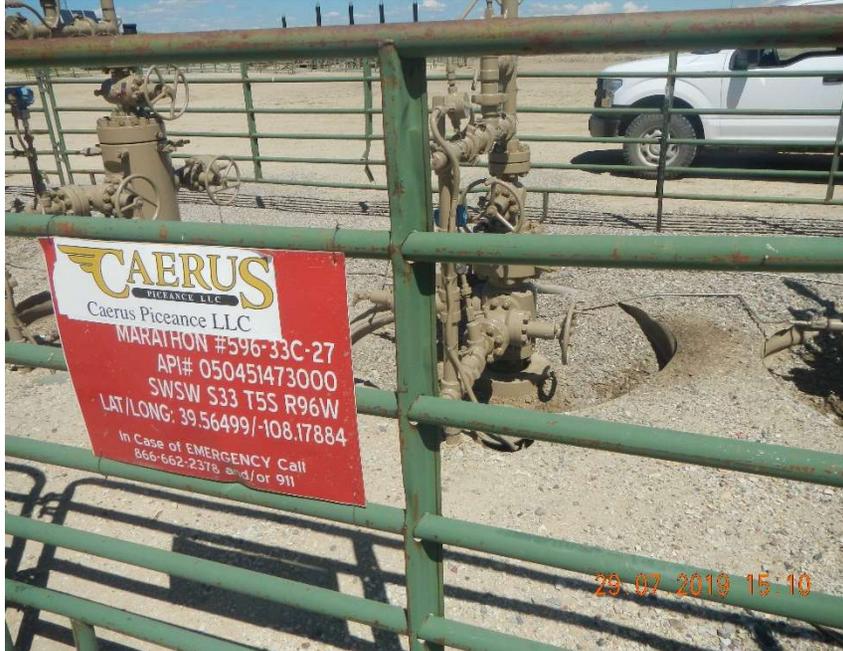
Photo #7 - Localized accumulation of oily waste (oil-stained soil) in the 596-33C-27 cellar.

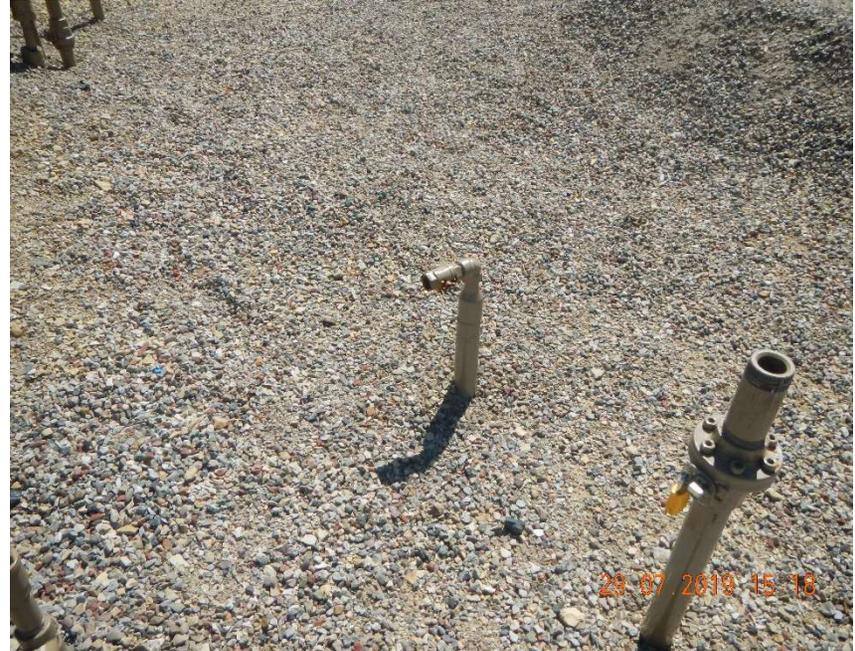
Photo #8 – View of unmarked flowline located north of the separators.

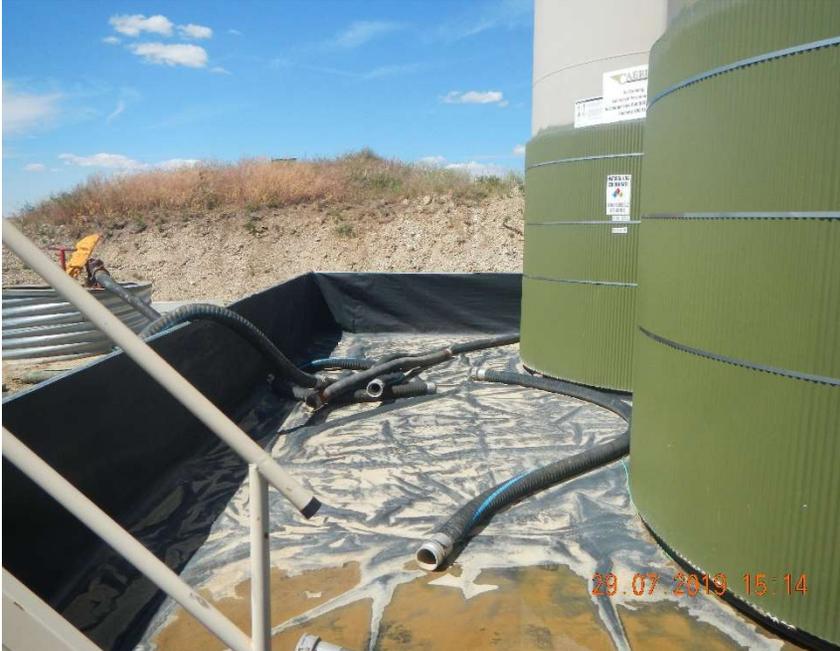
**Photo #9 - Assorted metal equipment stored in direct contact with tank battery liner.**

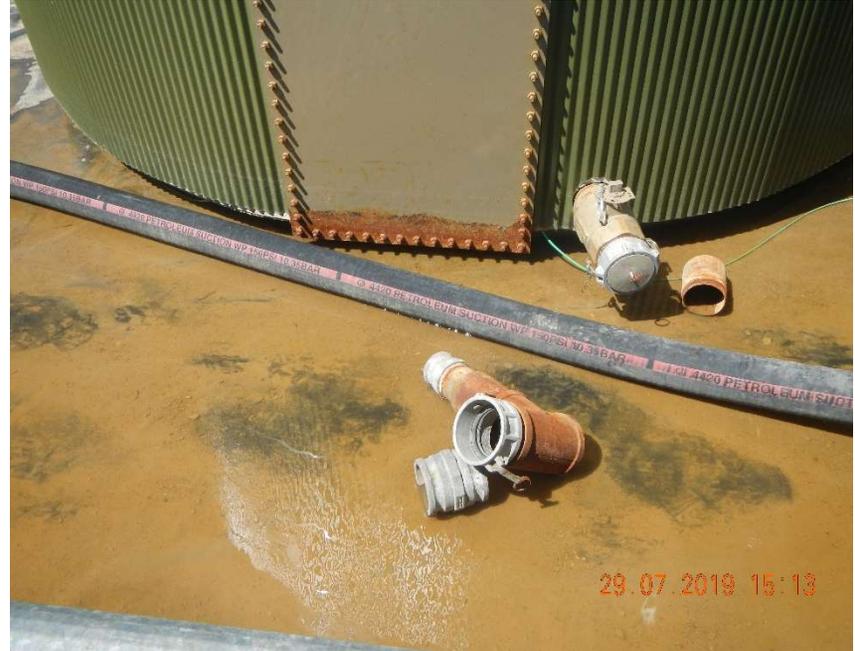
**Photo #10 - Assorted metal equipment stored in direct contact with tank battery liner.**

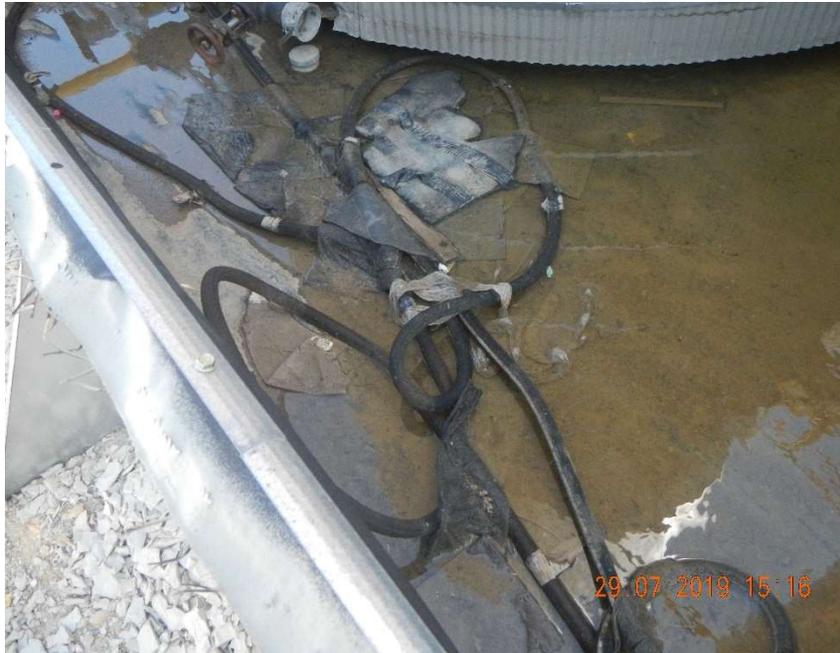
**Photo #11 – View of trash.**

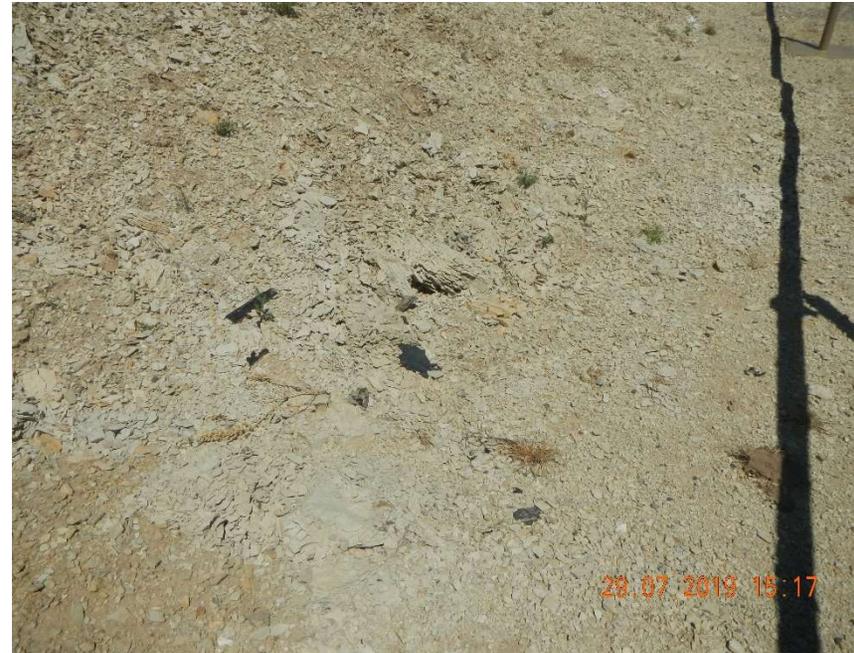
**Photo #12 – View of trash.**
