Inspection Photos

API: 05-071-06340

Operator: TIMBER CREEK OPERATING LLC

Inspection Date: 8/8/2019

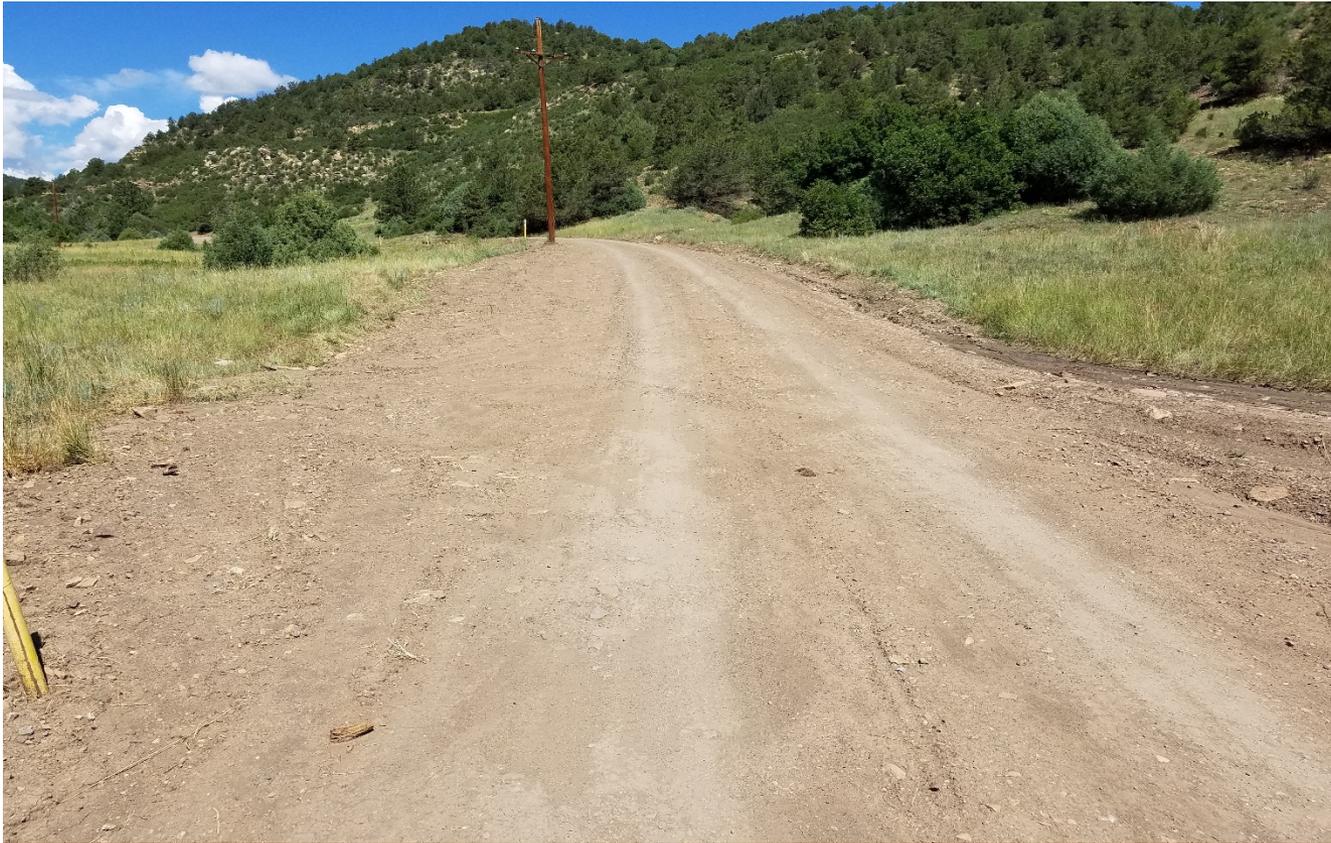
Photo 1. Facing northwest at mouth of the canyon. The main road has recently be graded.

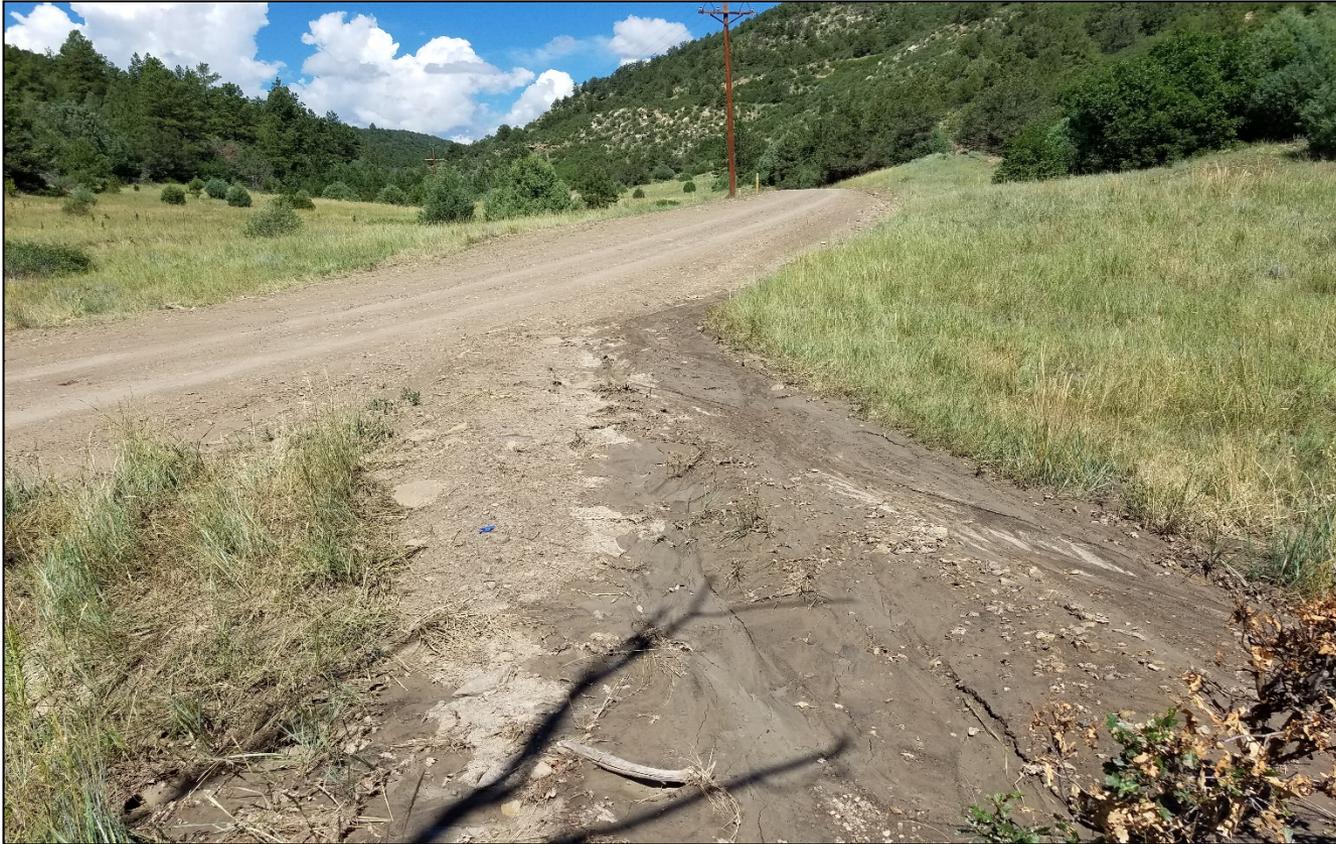
Photo 2. Sediment has already filled into the diversion ditch since grading occurred. A sediment trap or rock checkdamns may be need to control erosion.

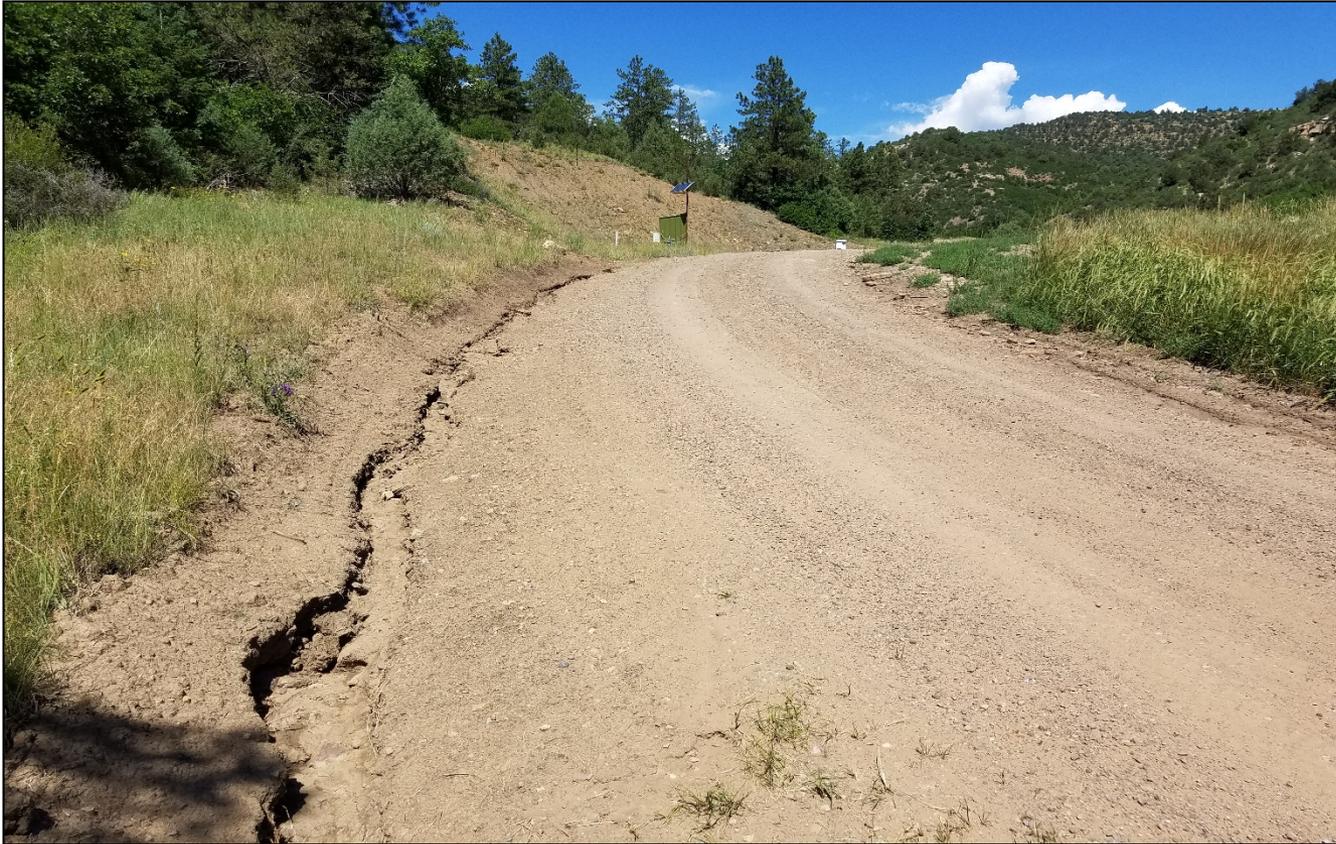
Photo 5. Erosion channel has already developed where erosion was repaired. BMP's need to be installed to control erosion.
