# Inspection Photos

Operator: BISON OIL & GAS II LLC # 10661

Location ID: 455519

COGCC

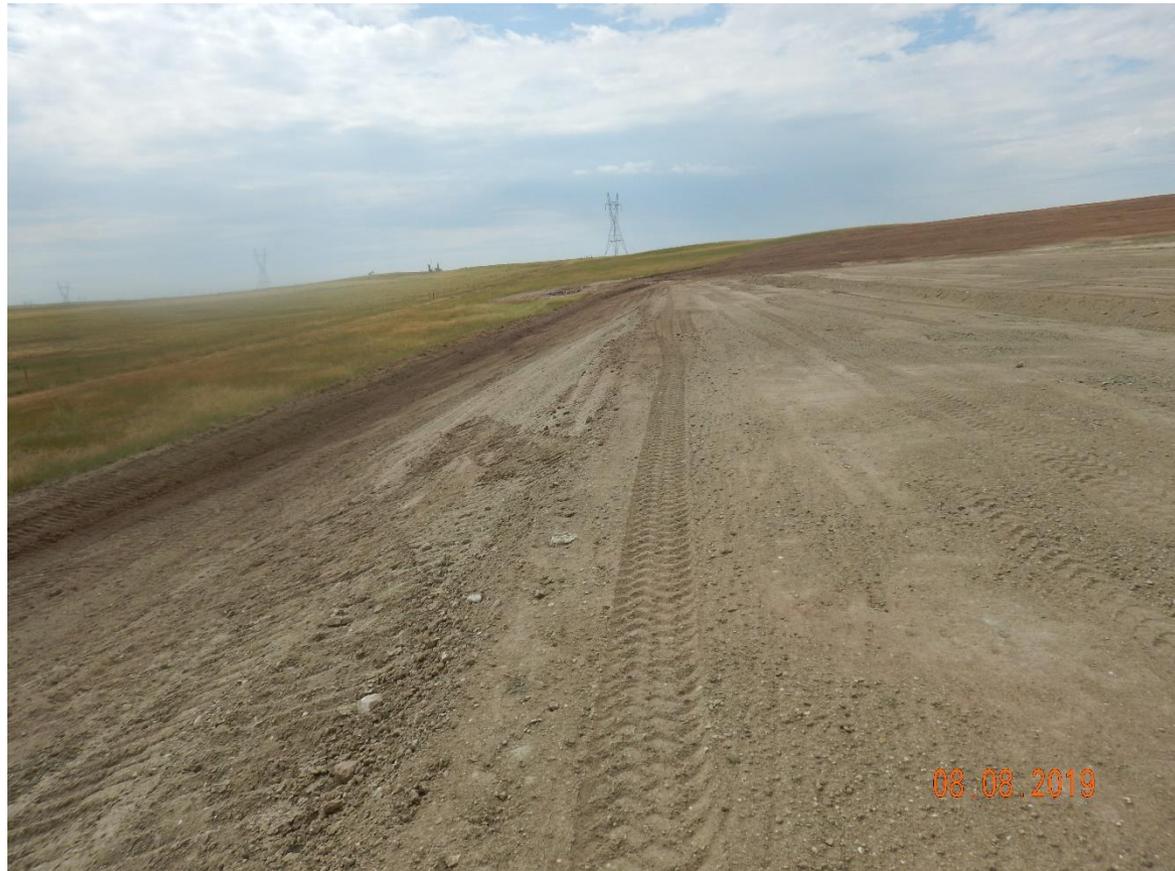
**Photo 1:** Photo taken from the east end of the pad, facing south. Photos 1-4 provide and overview of the current pad from south, southwest, northwest to north.

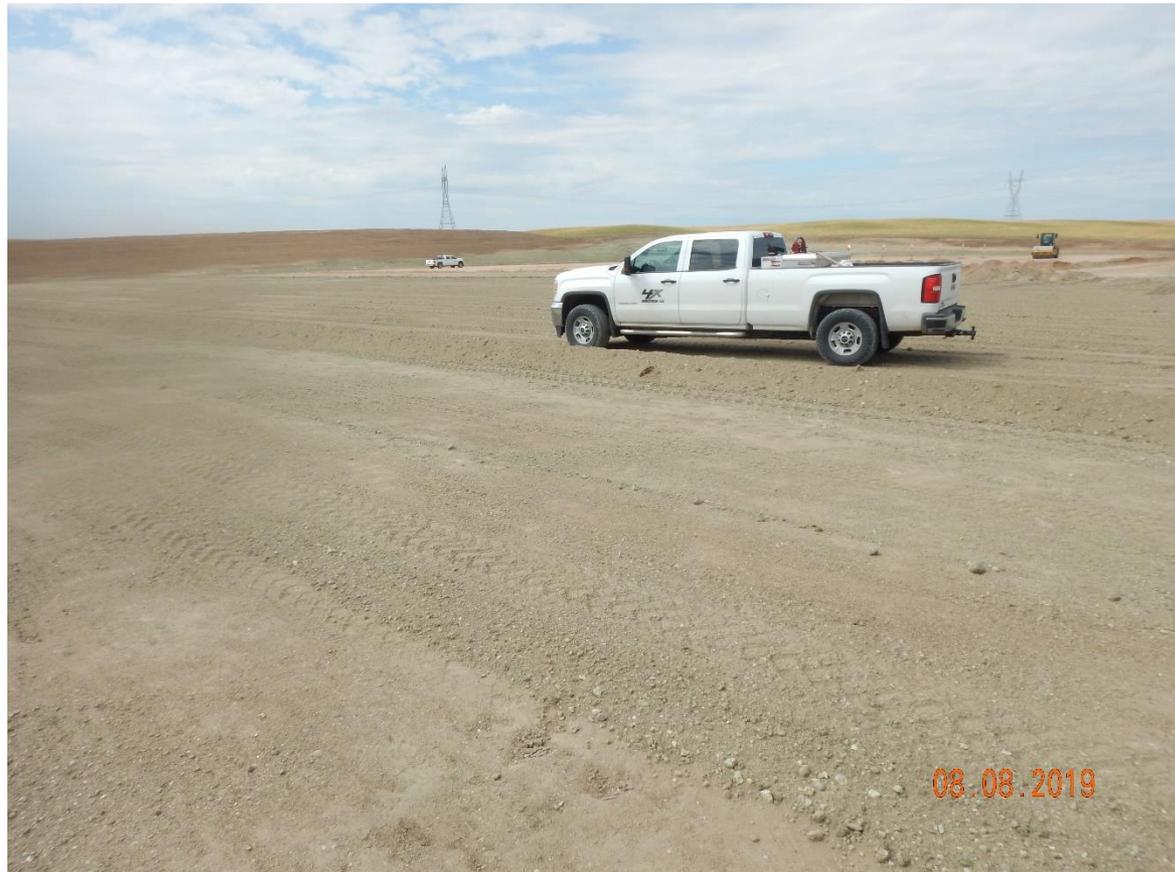
**Photo 2:** See comments under photo 1.

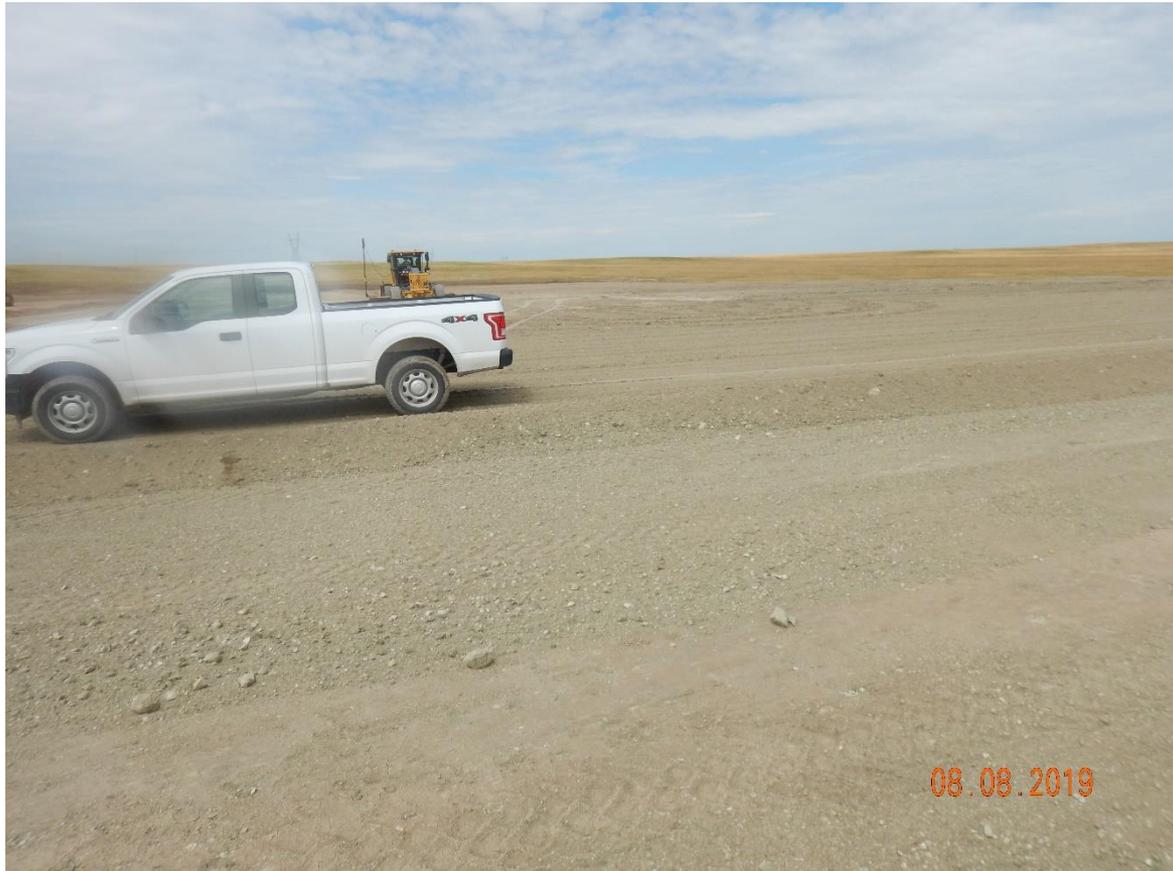
**Photo 3:** See comments under photo 1.

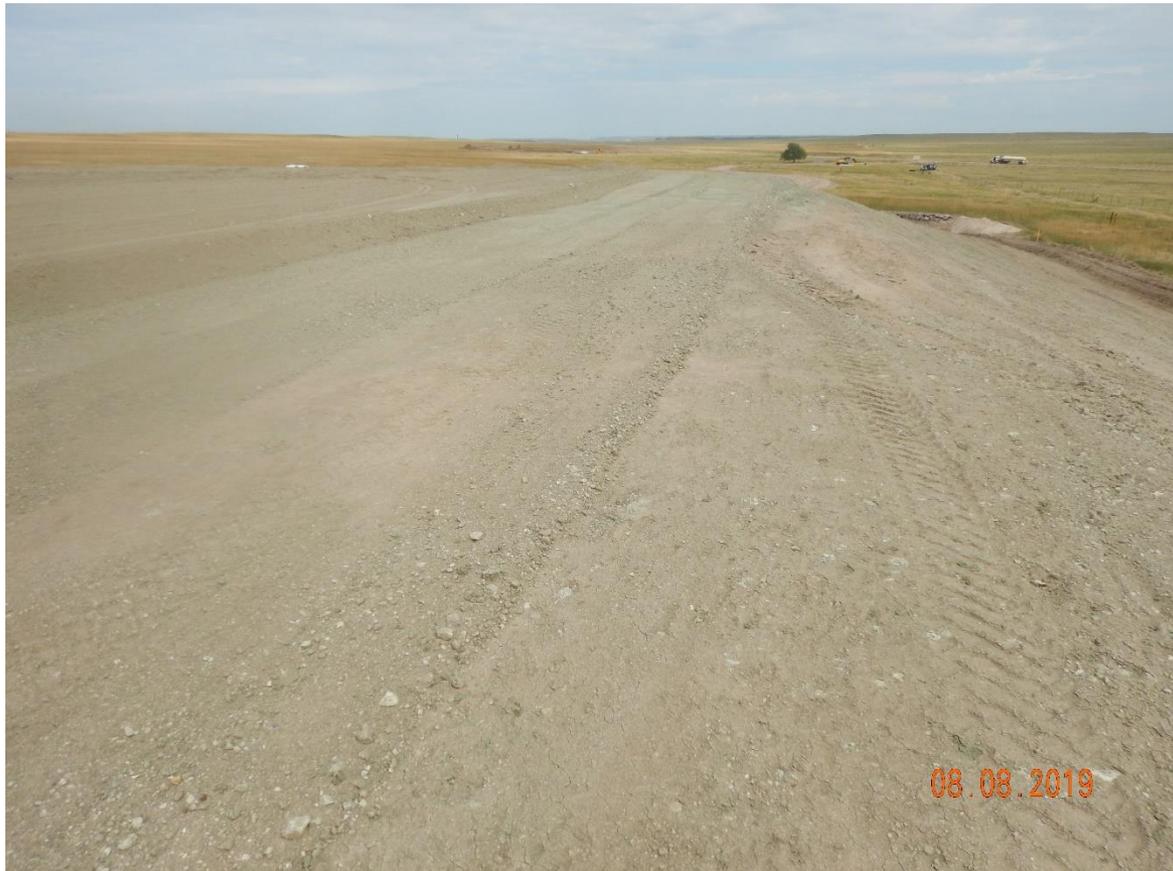
**Photo 4:** See comments under photo 1.

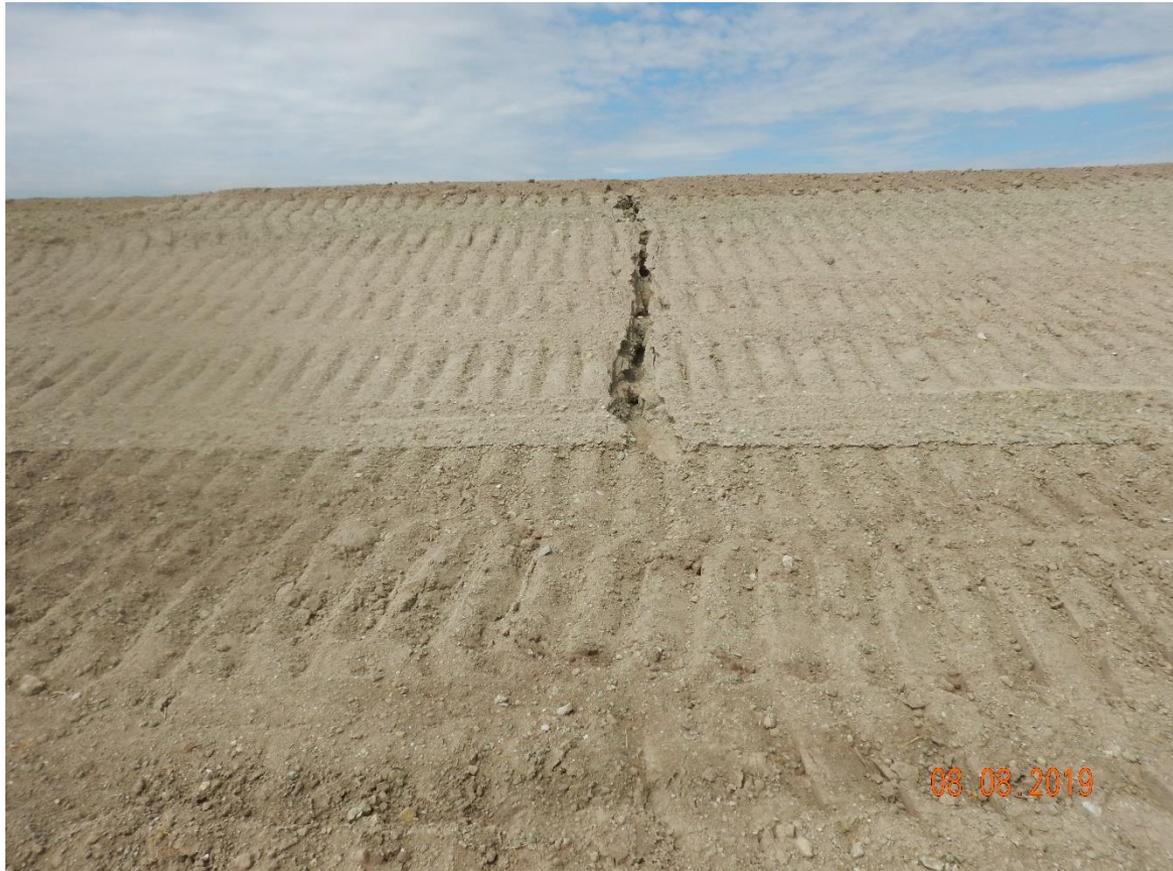
**Photo 5:** Photo taken from the slopes on the east end of the location. Photo shows operator has installed tracking BMP to stabilize the slopes on the location. BMP has not been installed in accordance with good engineering practices. Tracking has not been installed up and down the slope, thus facilitating gulley erosion degradation.

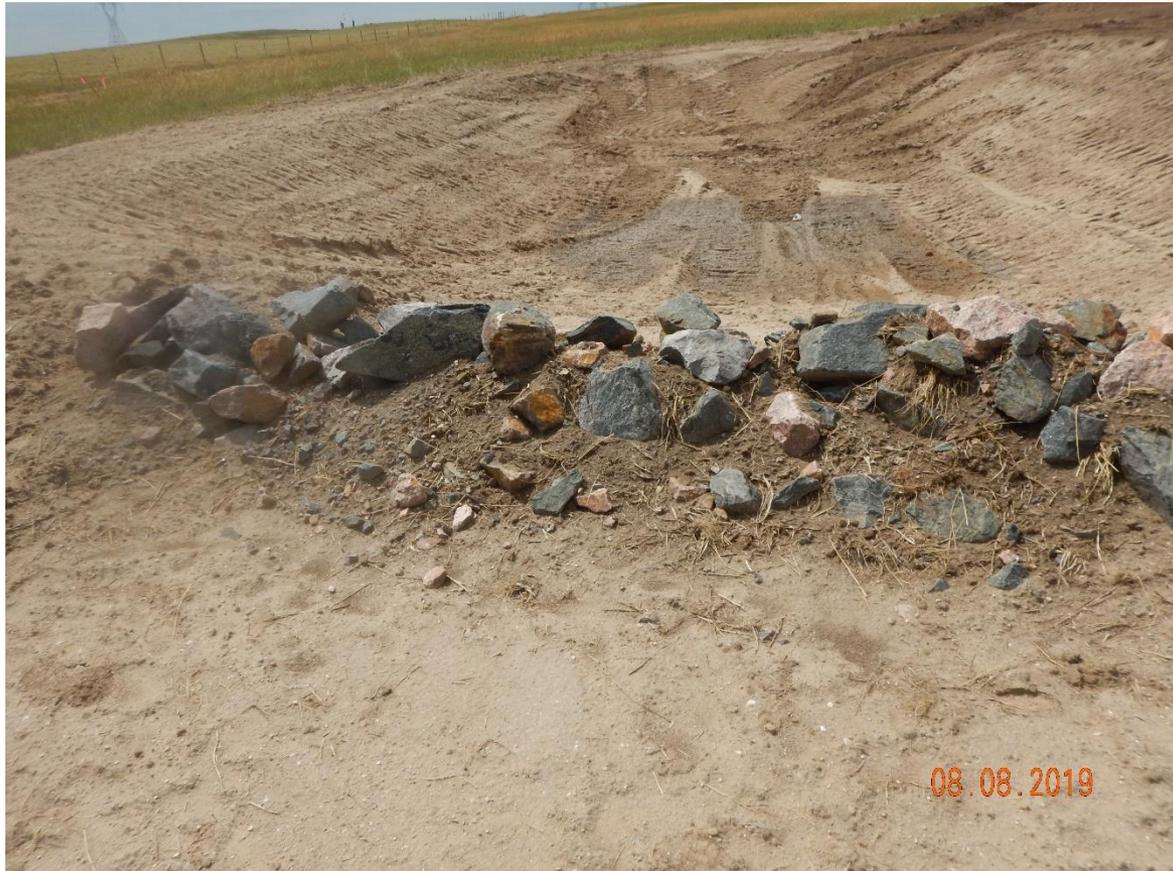
**Photo 6:** Photo taken from the southeast end of the location. Photo shows one of the three stormwater sediment traps on the location. Traps appear to be sufficient in size, however, sediment traps have not been constructed in accordance with good engineering practices; slopes at traps remain improperly tracked. BMPs missing inlet armoring/protection. Rock aggregate used for outlet protection appears too large in size to slow stormwater discharge, trap sediment and sufficiently stabilize outlet. Additionally outlet has been intentionally filled with material. This forces outlet to work as a dam, rather than allowing for sediment laden free stormwater discharge.

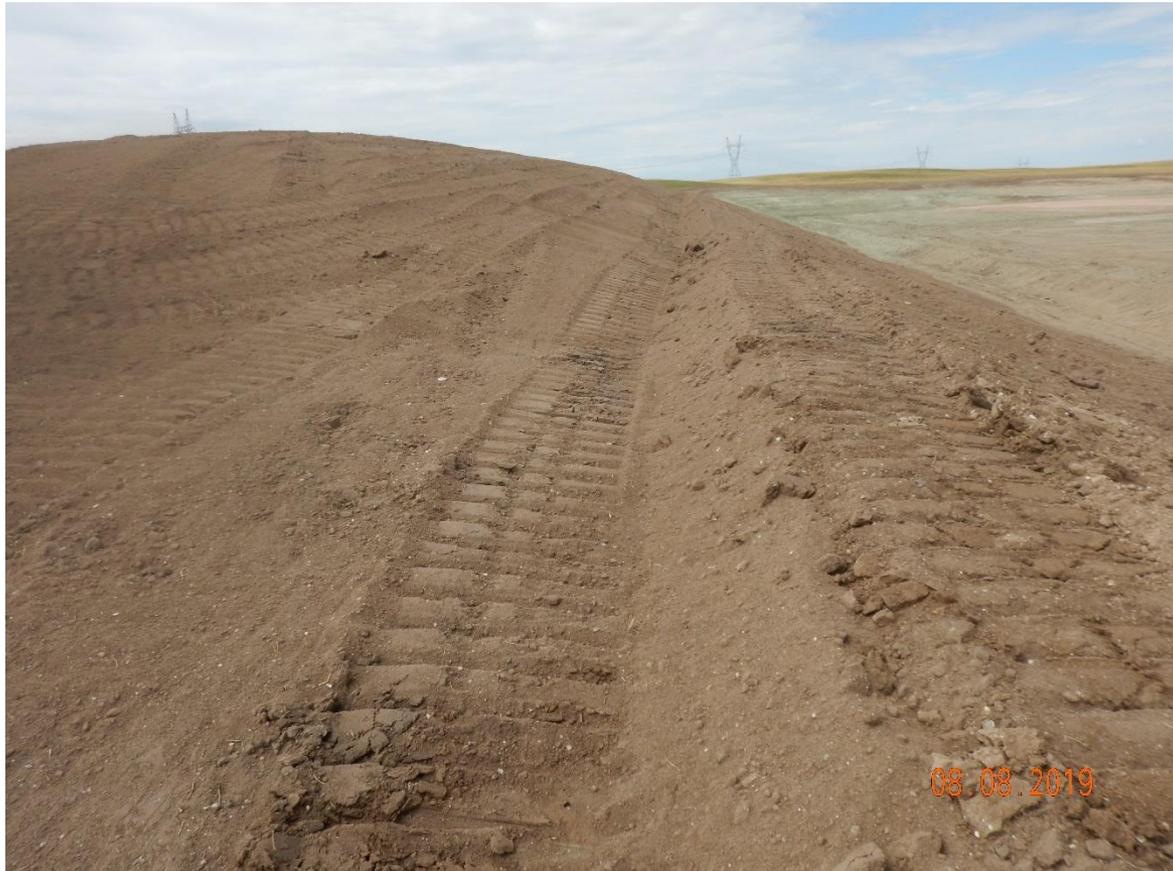
**Photo 7:** Photo taken from the topsoil stockpile on the south end of the location. Three stormwater diversion ditch/berms have been constructed: 1 @ the pad perimeter, 1@ base of the soil stockpiles, and 1@ the perimeter of the disturbance area. Ditch/berm have not been installed in accordance with good engineering practices; Ditch/berm remains loose, unconsolidated material, that will contribute to sediment laden stormwater discharge. Photo also shows tracking on slopes is insufficient (See photo 5)

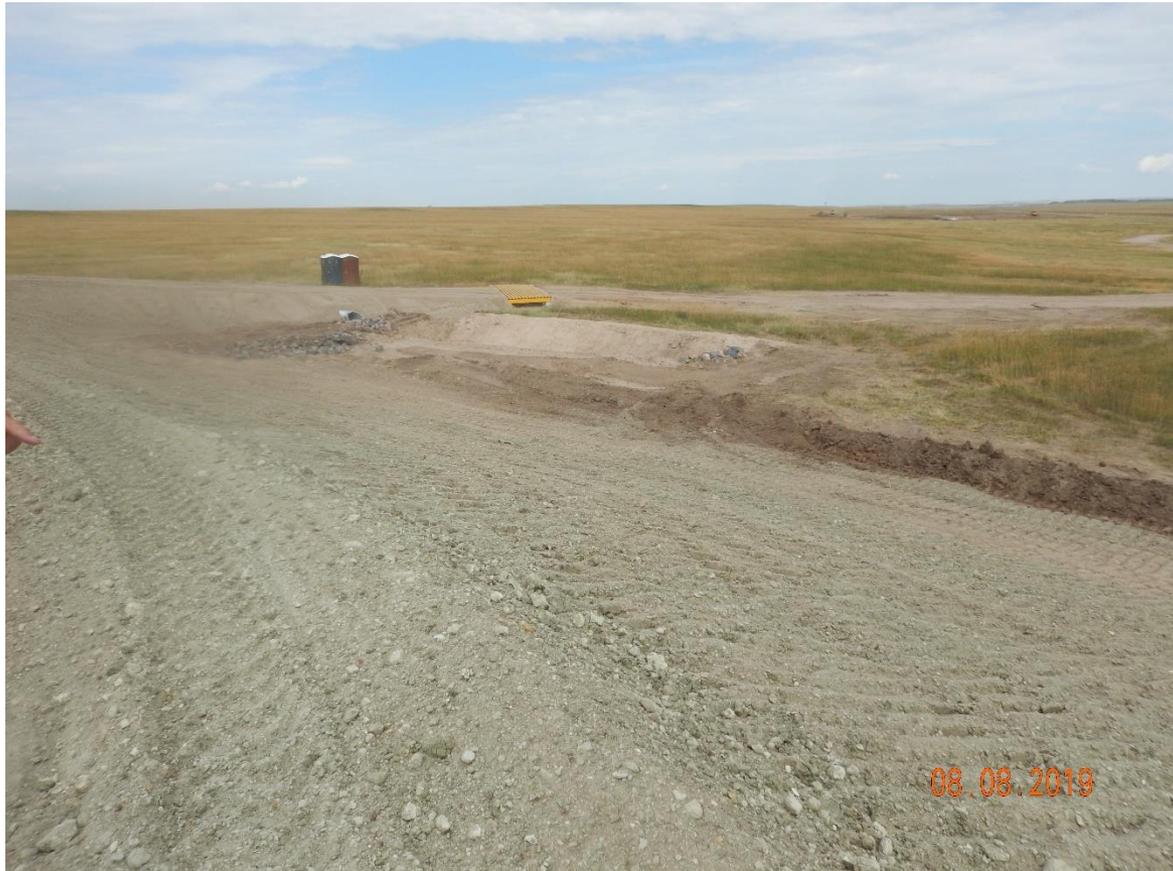
**Photo 8:** Photo taken from north end of the pad, facing north. Photo shows one of the three sediment traps along the perimeter of the location. Traps appear to be sufficient in size, however, sediment traps have not been constructed in accordance with good engineering practices; Berms and slopes at traps remain unconsolidated. BMPs missing inlet armoring/protection. Rock aggregate used for outlet protection appears too large in size to slow stormwater discharge, trap sediment and sufficiently stabilize outlet.

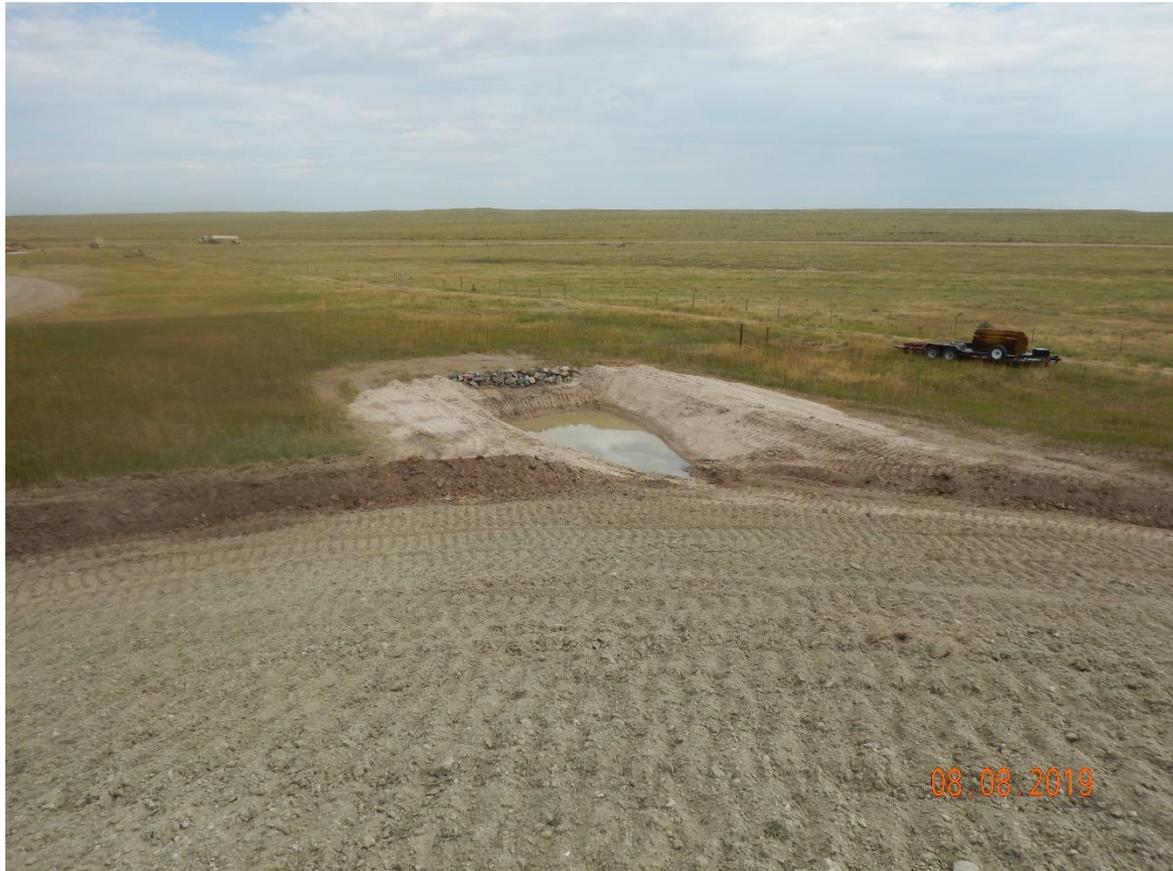
**Photo 9:** Photo taken from north end of the pad, facing northeast. Photo shows one of the three sediment traps along the perimeter of the location. See comments under photo 8.

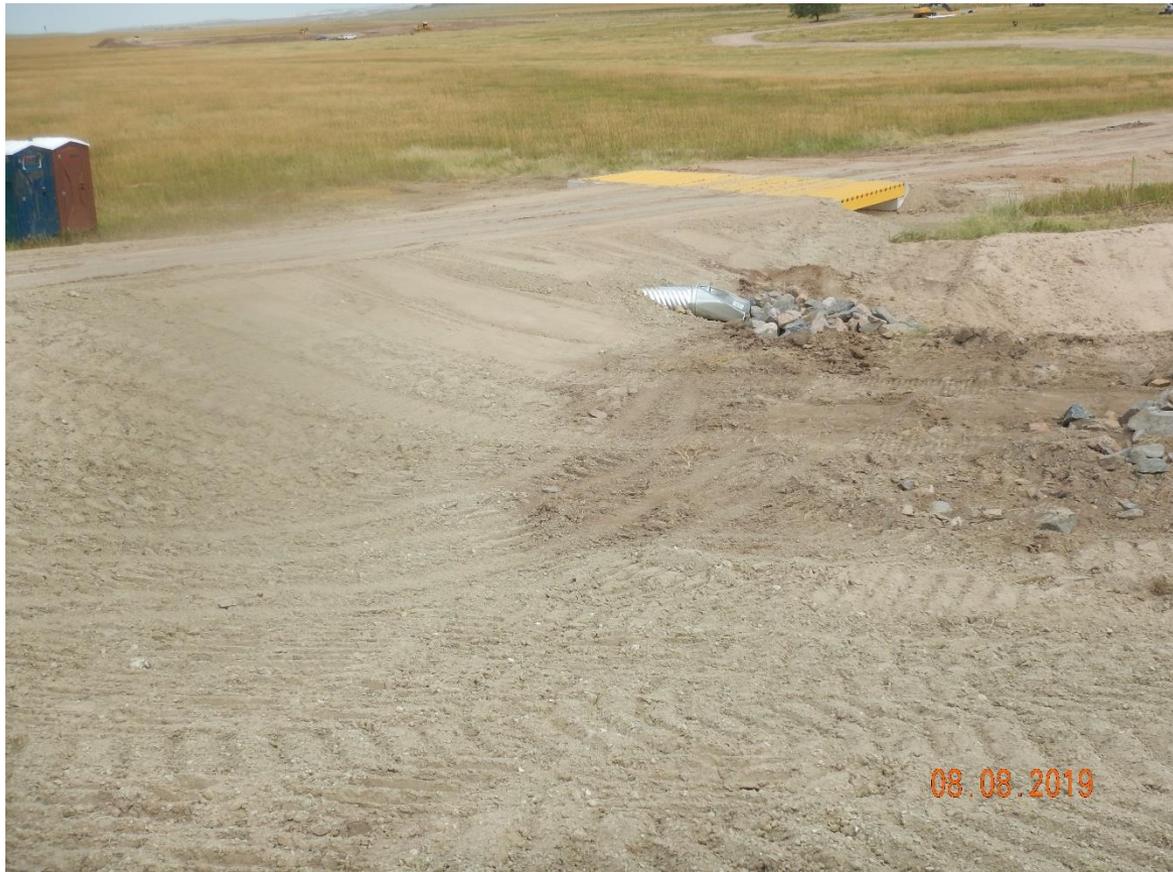
**Photo 10:** Photo taken from the north end of the location. Photo shows insufficient armoring/stormwater protection at culvert.

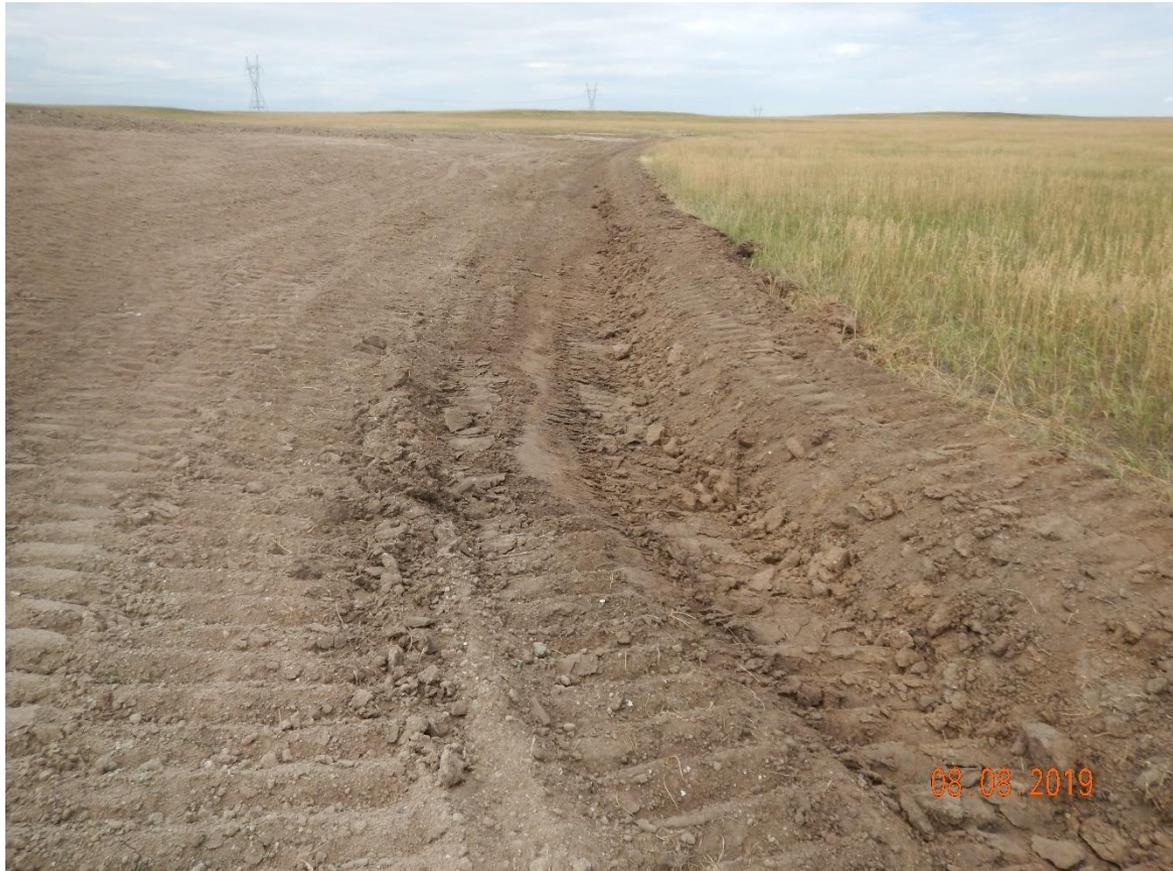
**Photo 11:** Photo taken from the north end of the location, facing west. Photo shows tracking on slopes and perimeter stormwater diversion ditch/berm have not been installed in accordance with good engineering practices. See comments under photos 5 and 7.

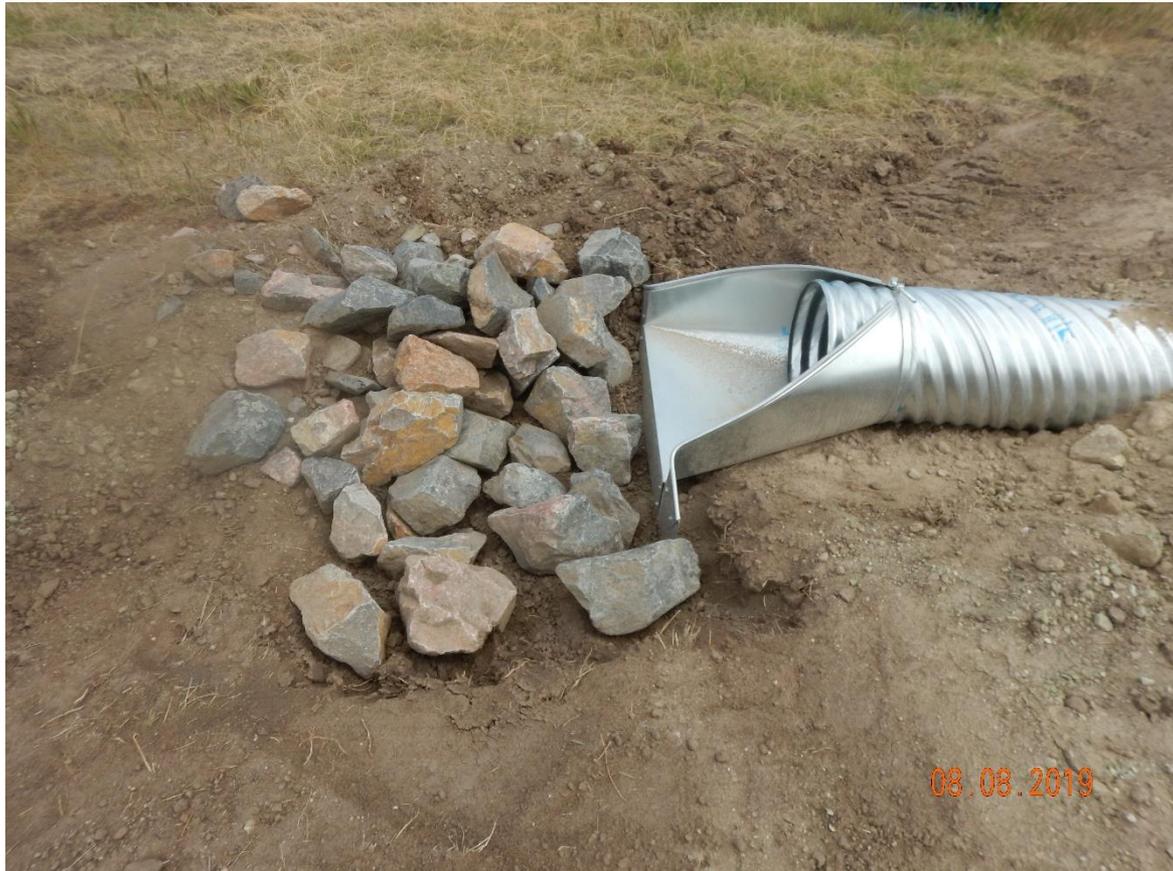
**Photo 12:** Photo taken from the culvert on the north end of the location. See comments under photo 10.

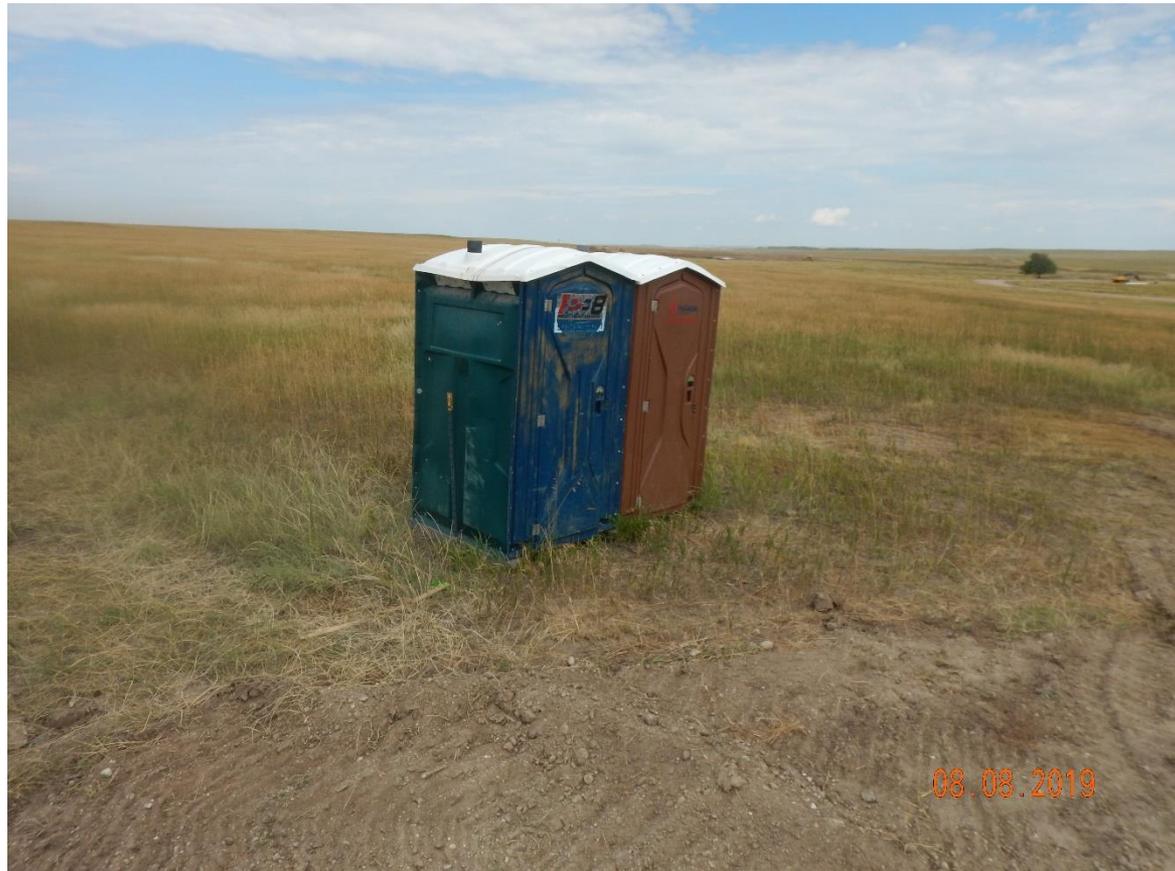
**Photo 13:** Photo of porta-johns on the north end of the location. Porta-johns appear to have been sufficiently secured.
