Laramie Energy LLC
API # 077-08645
Inspection # 696600459

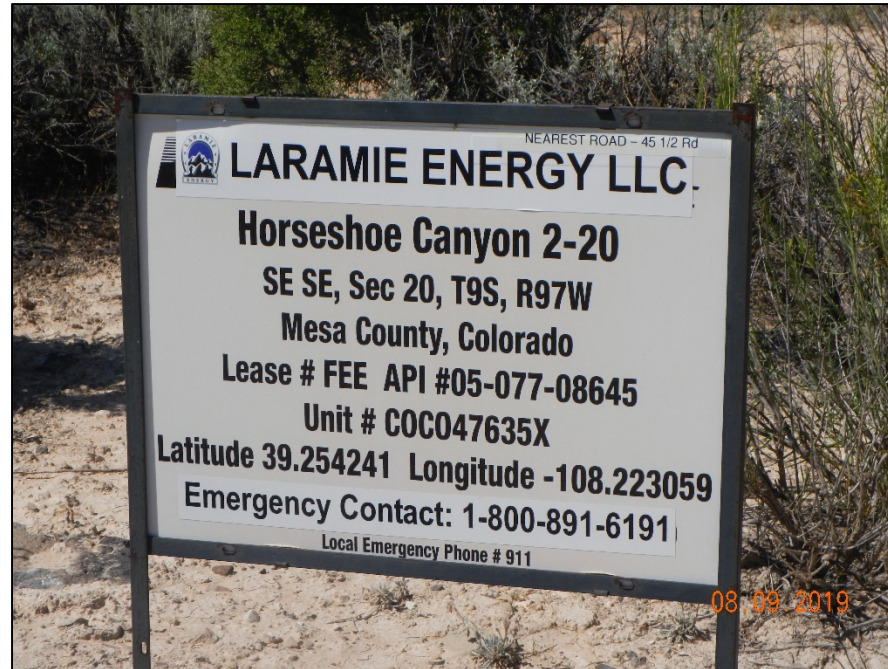
Photo #1 Battery sign is posted at the entrance to location

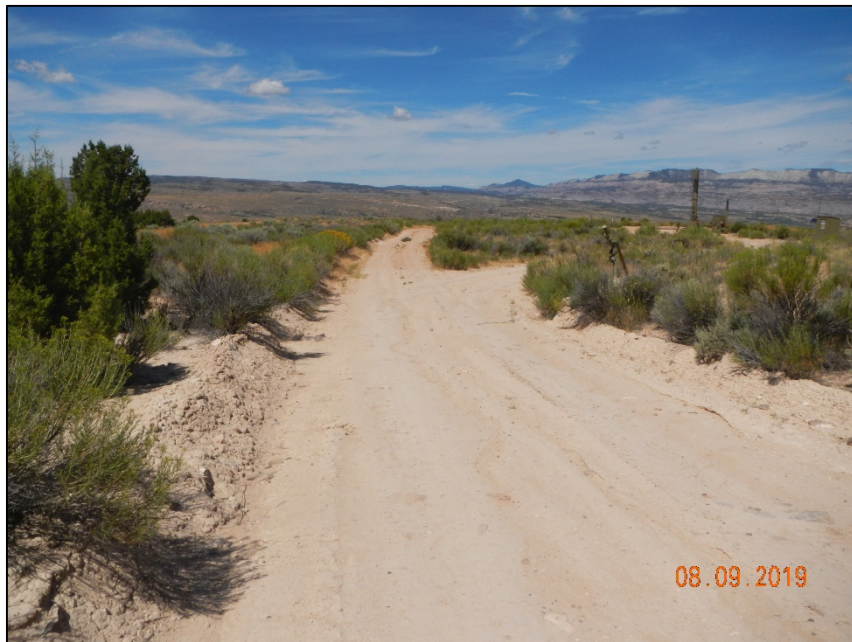
Photo #2 Photo at entrance of location.

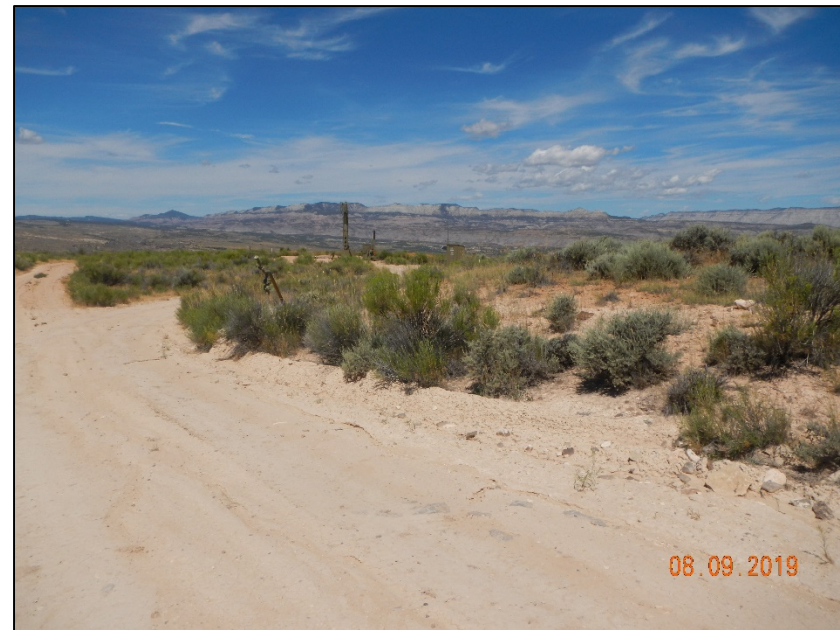
Photo #3 Photo at entrance of location.

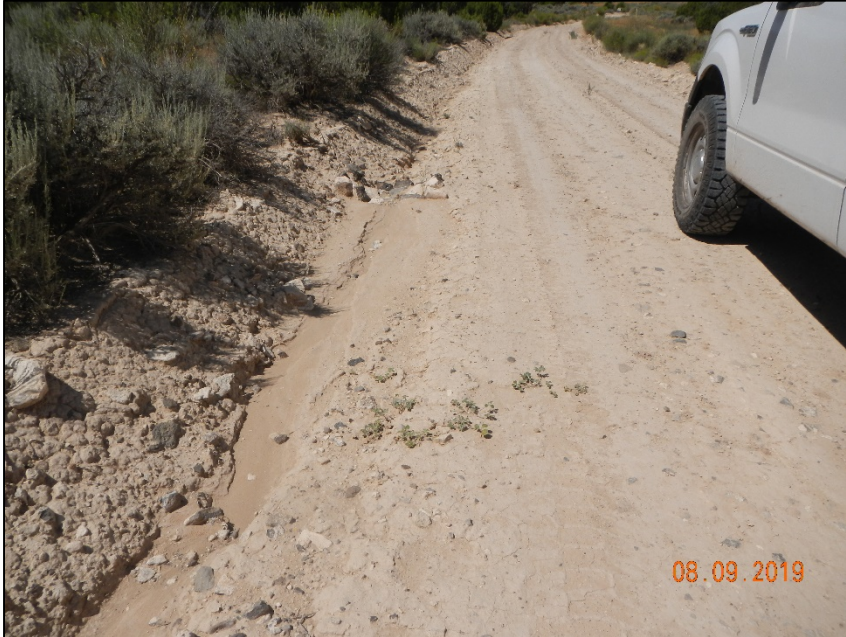
Photo #6 Erosion sediment moving down access road. BMP's need maintenance.

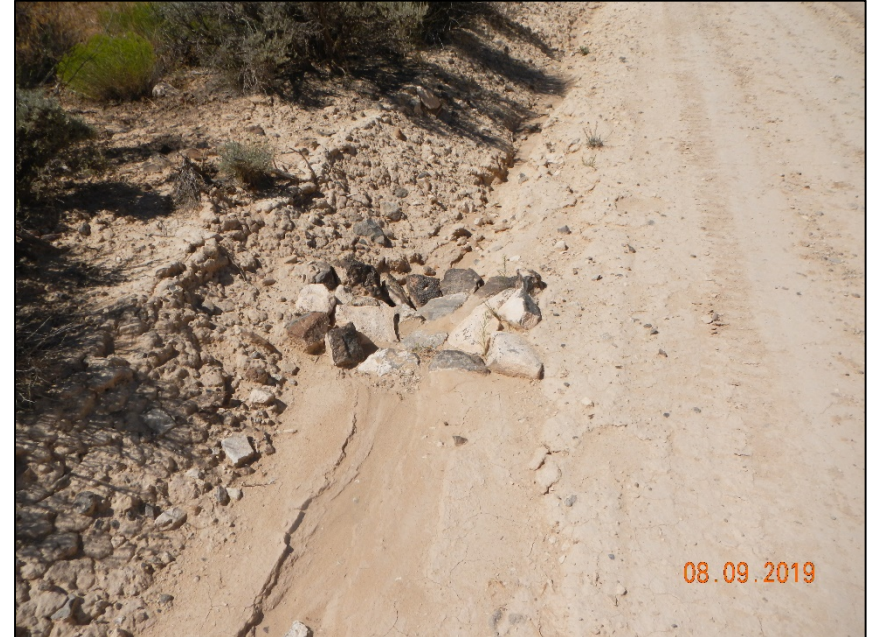
Photo #7 Erosion sediment moving down access road. BMP's need maintenance.

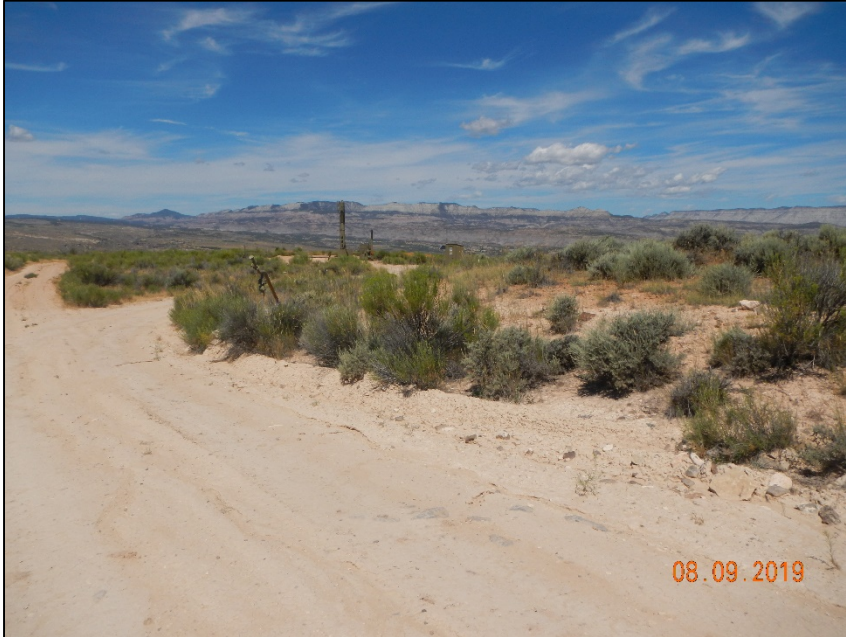
Photo #8 Erosion sediment moving down access road at entrance to location. BMP's need maintenance or are not in place.

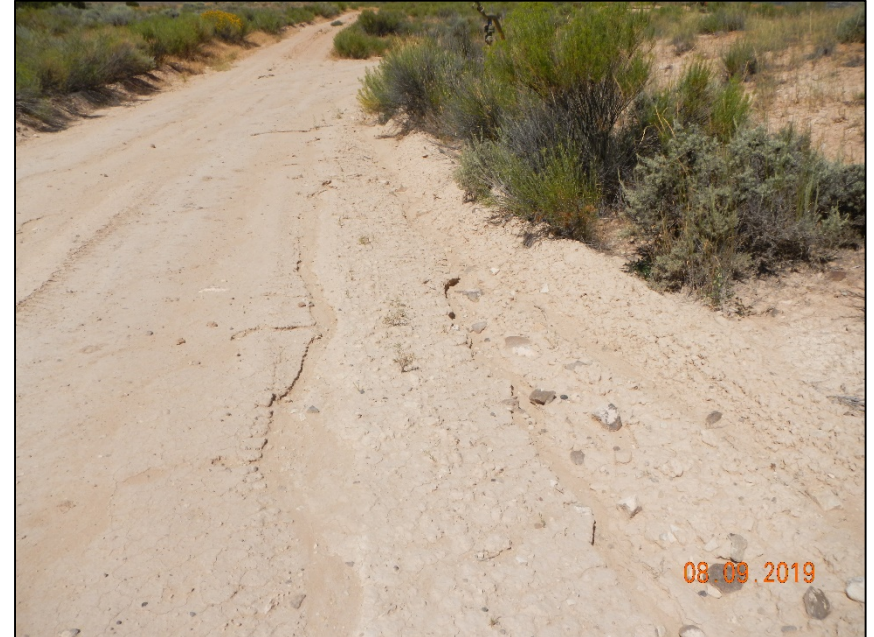
Photo #9 Erosion sediment moving down access road at entrance . BMP's need maintenance or are not in place.

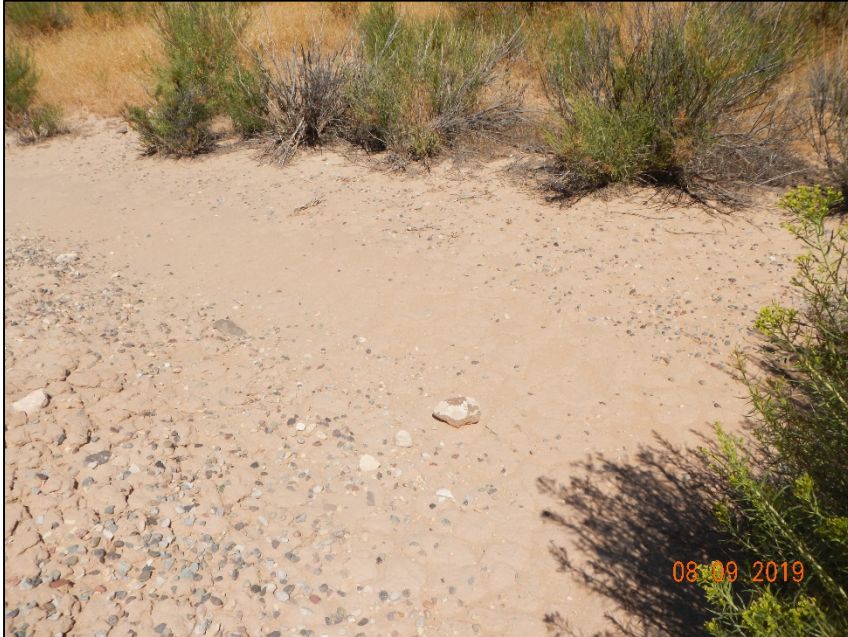
Photo #10. Erosion moving sediment off location by the Separator and tank battery. Sediment is choking out vegetation. No BMP's in place at time of inspection.

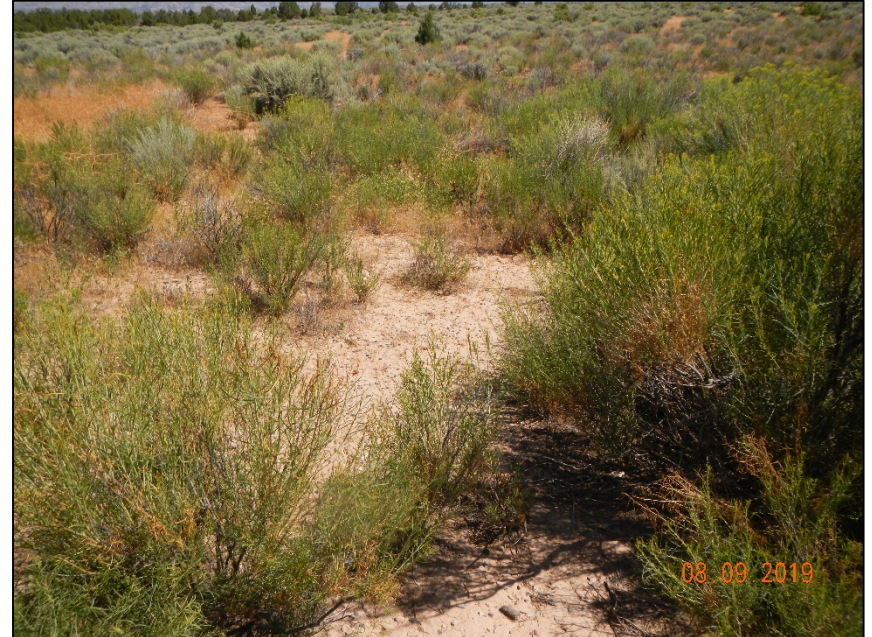
Photo #11. Erosion moving sediment off location by the Separator and tank battery. Sediment is choking out vegetation. No BMP's in place at time of inspection.
