Inspection Photos
Operator: Enduring Resources
Location/API #: 067-07473
Date: 8-5-2019

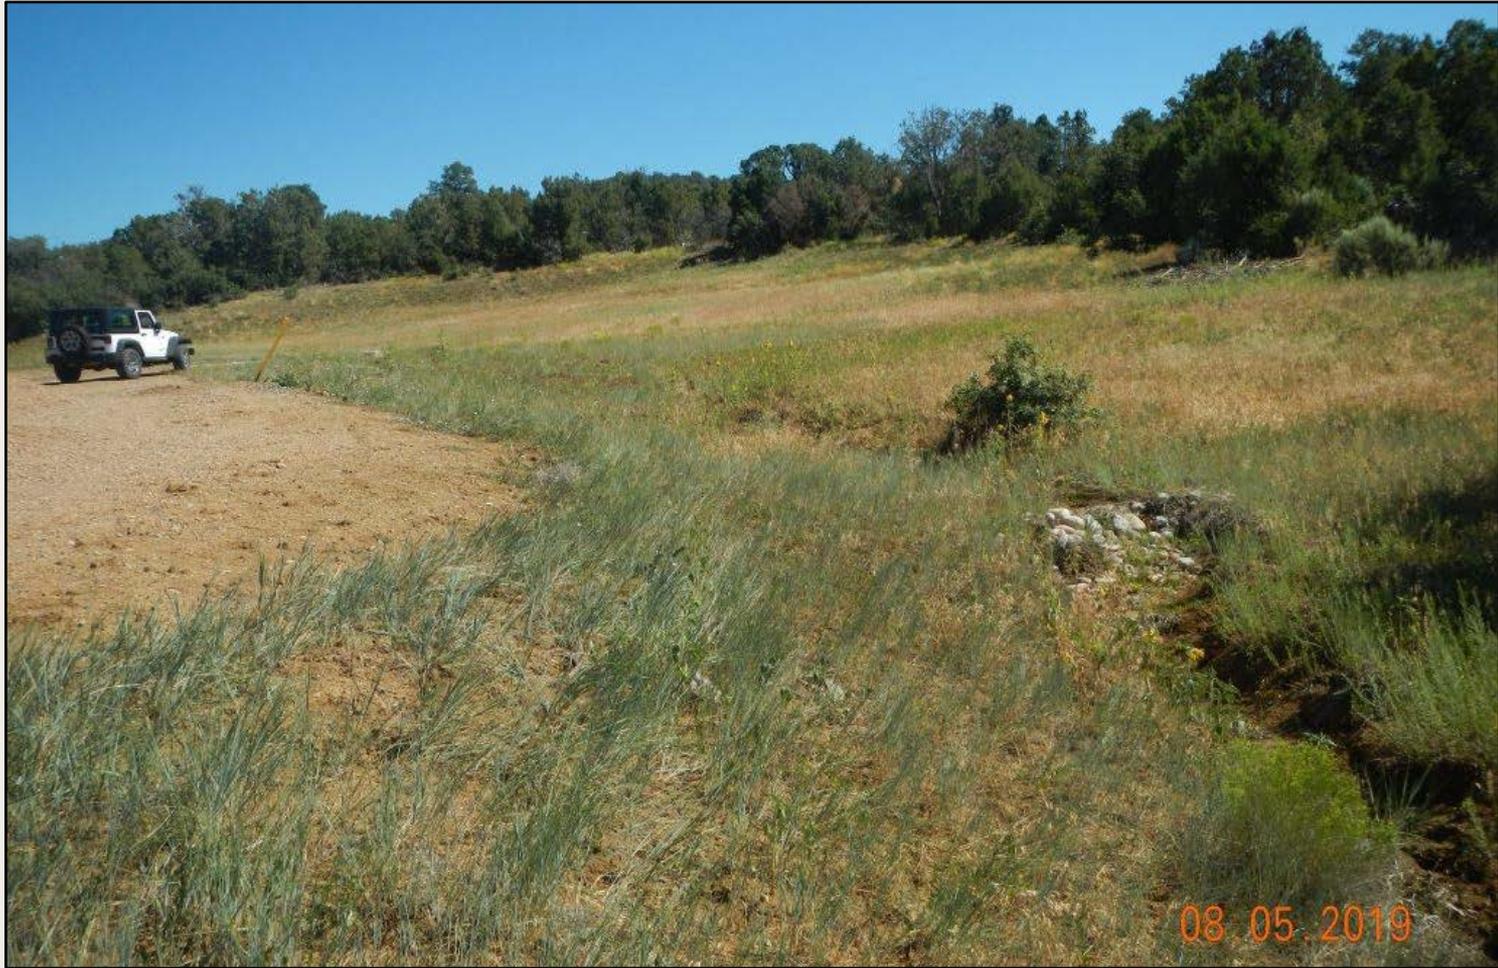
Photo 1. View of the eastern project area from the southeastern edge facing northward.

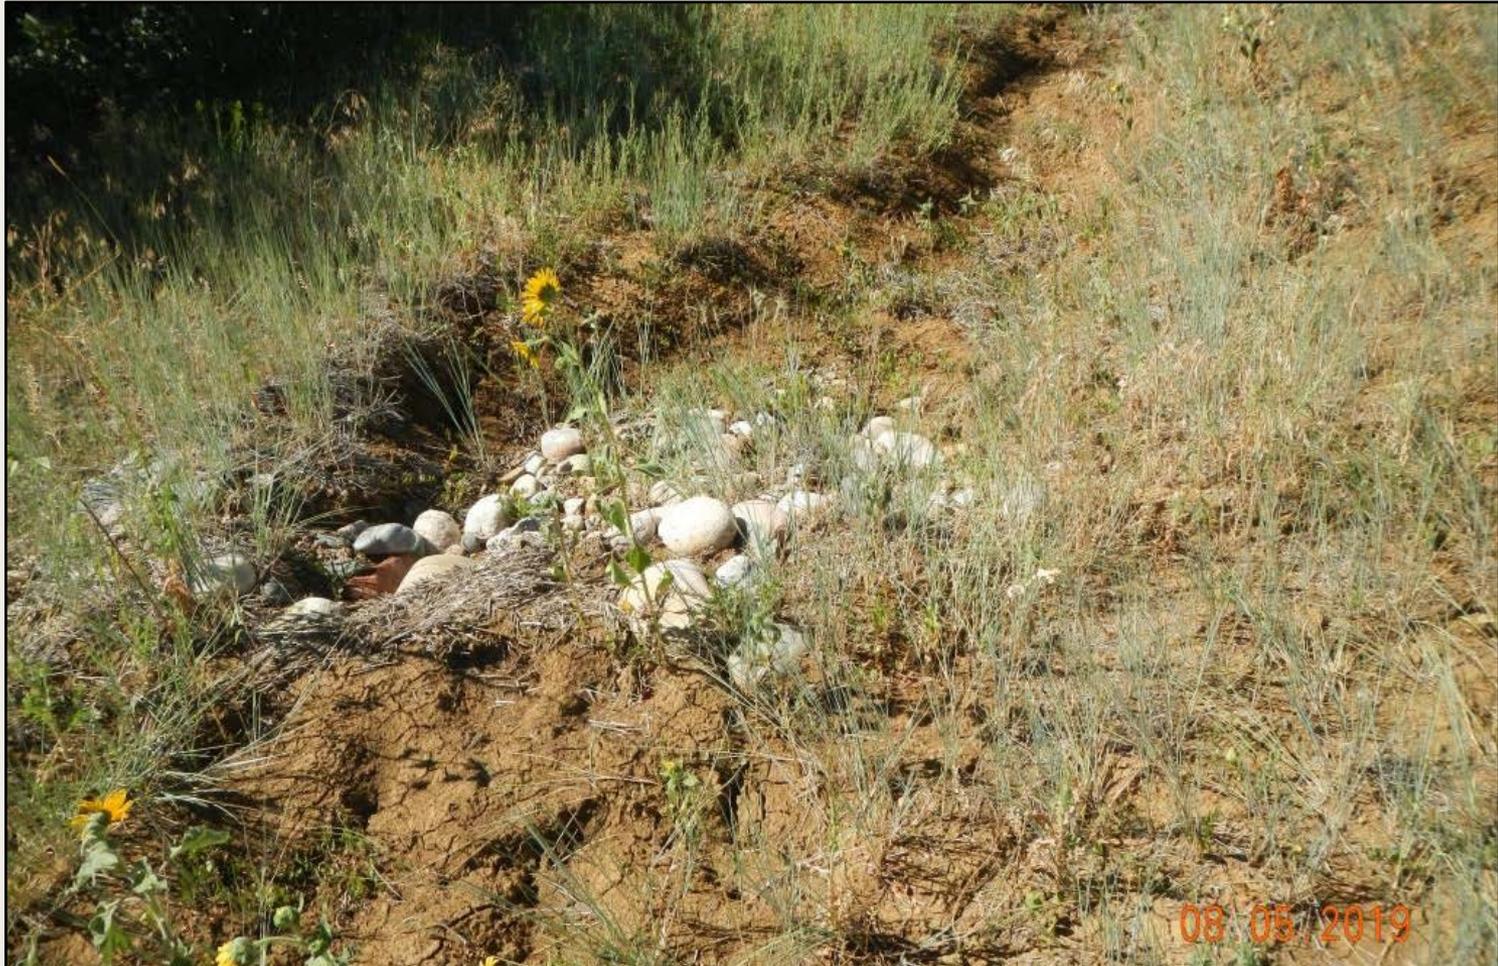
Photo 2. View of BMP that is not sufficient and erosion is continuing within the southeastern project area.

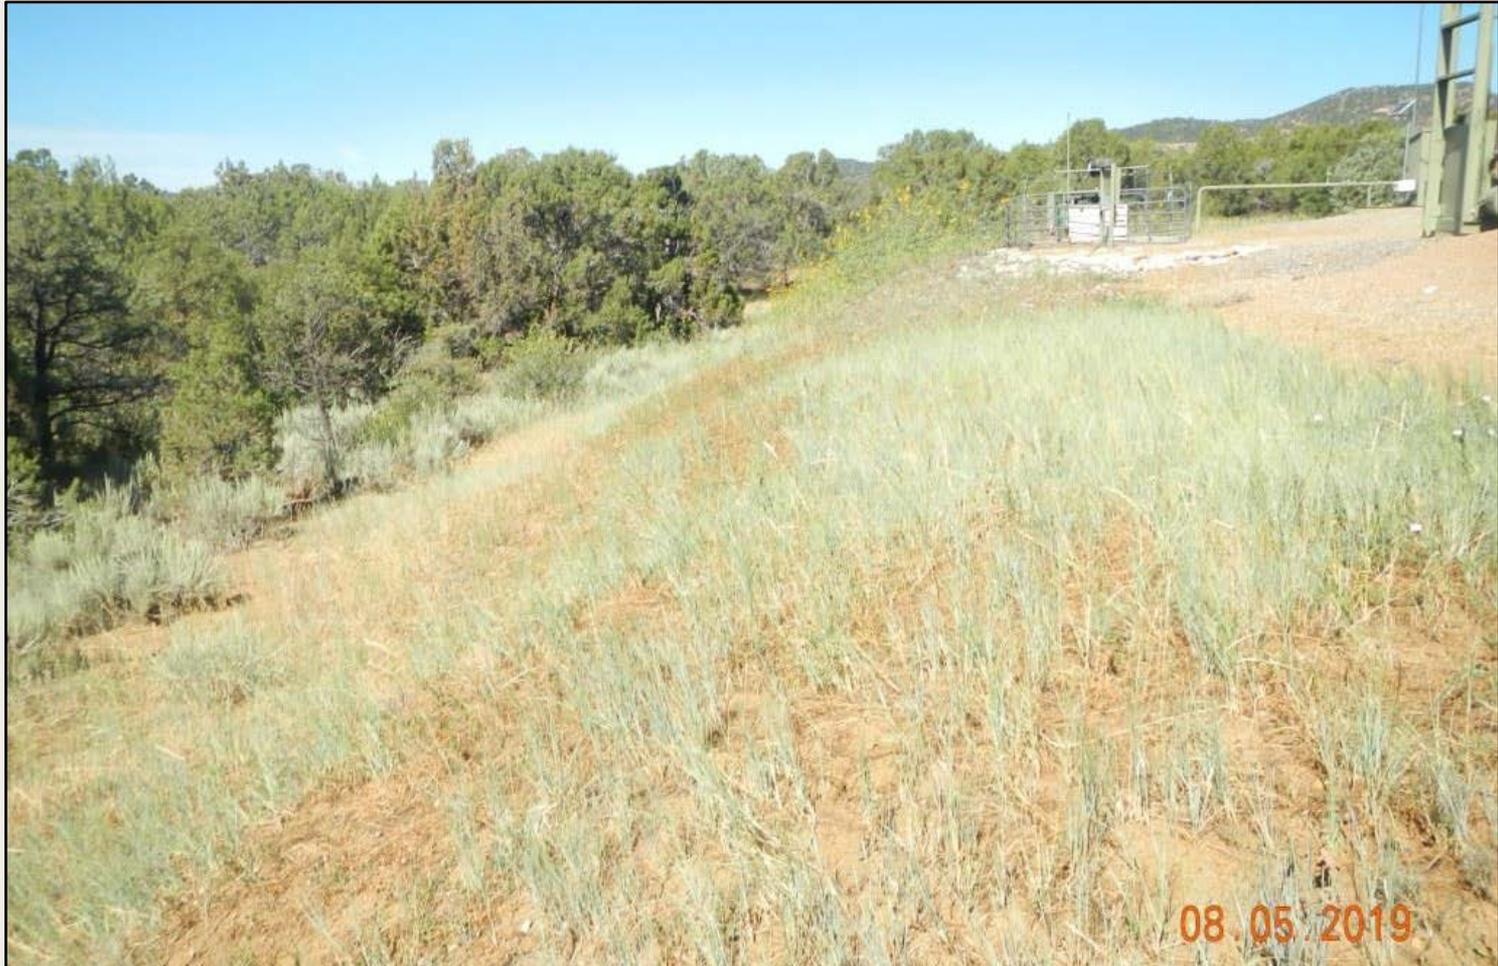
Photo 3. View of the southern project area from the southeastern corner facing westward.
