Inspection Photos
Location Name: Ridgeview 32-16-1
Location ID: 430051

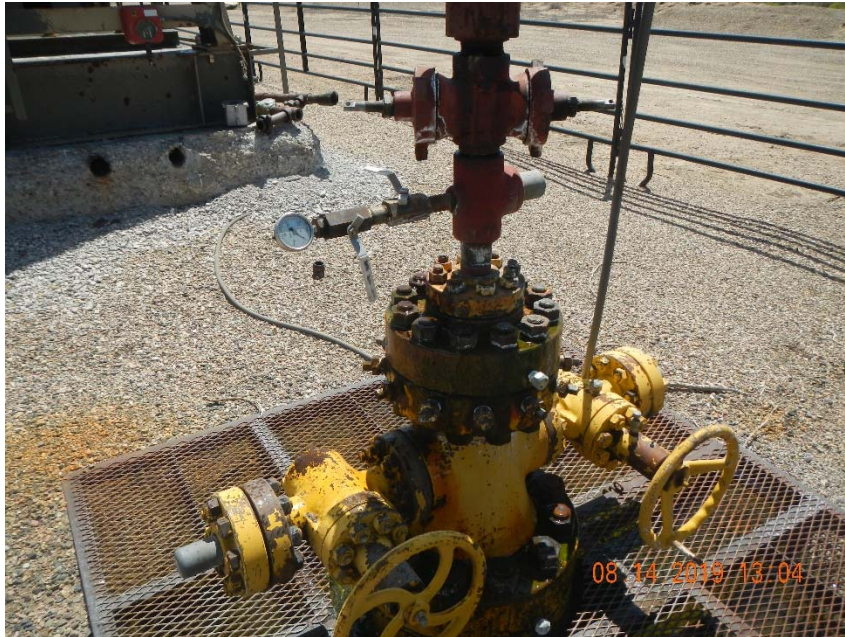
Photo 1. Ongoing leak occurring at wellhead.

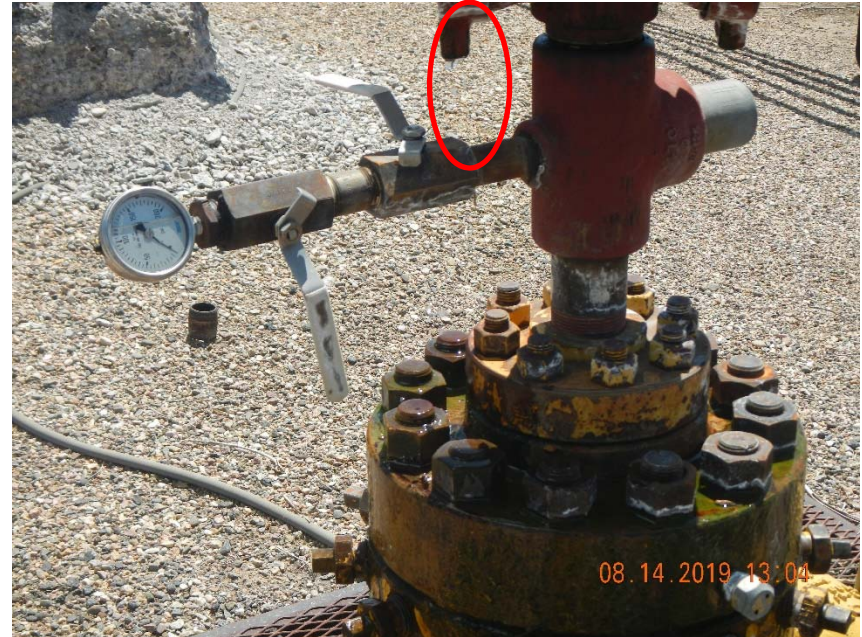
Photo 2. Close up of photo 1, leaking area circled in red.

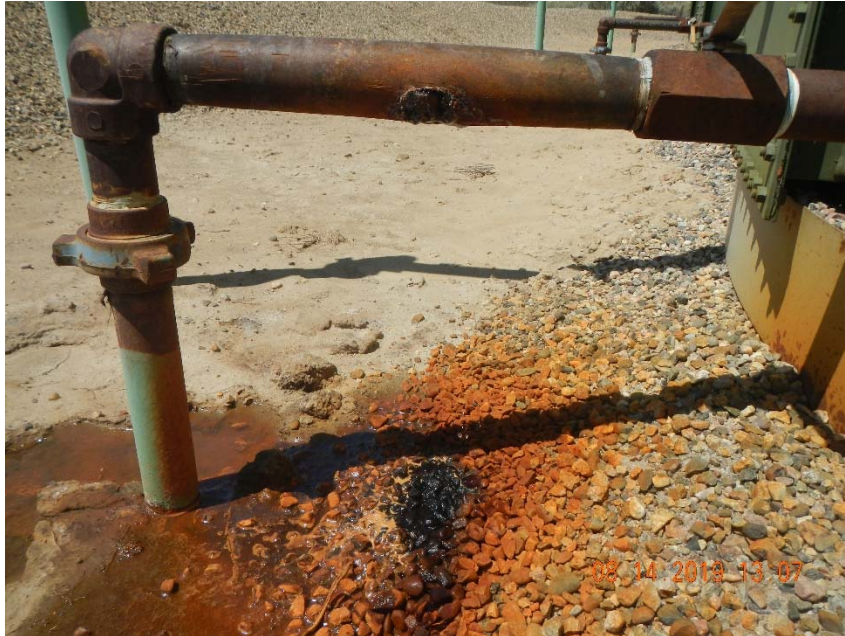
Photo 3. Ongoing leak occurring at tank flowline.

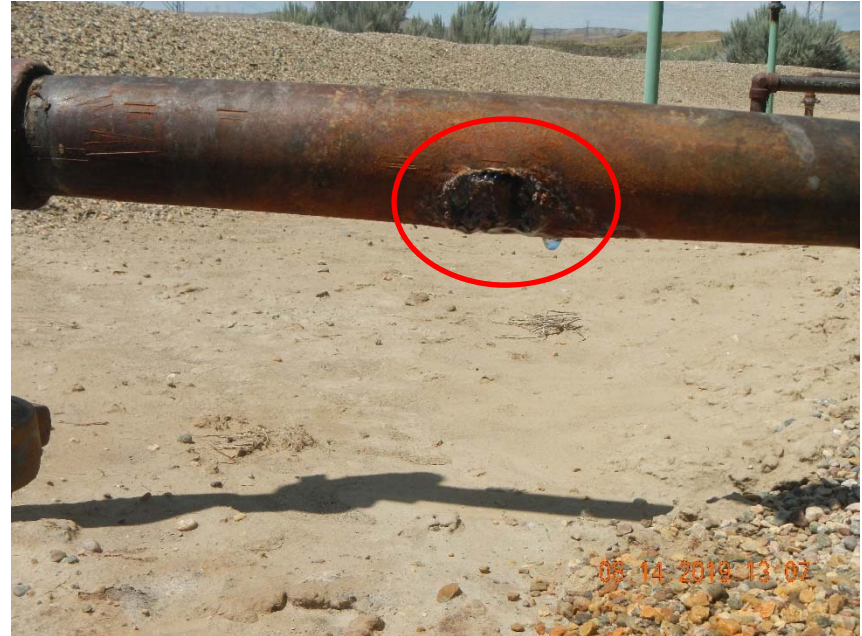
Photo 4. Close up of photo 3, leaking area circled in red.

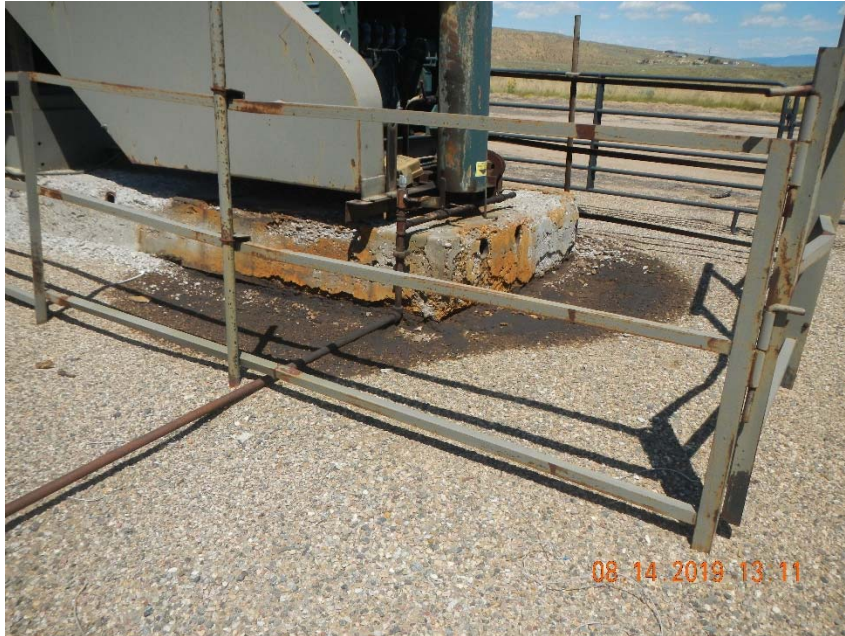
Photo 5. Stained soil at pump jack motor.

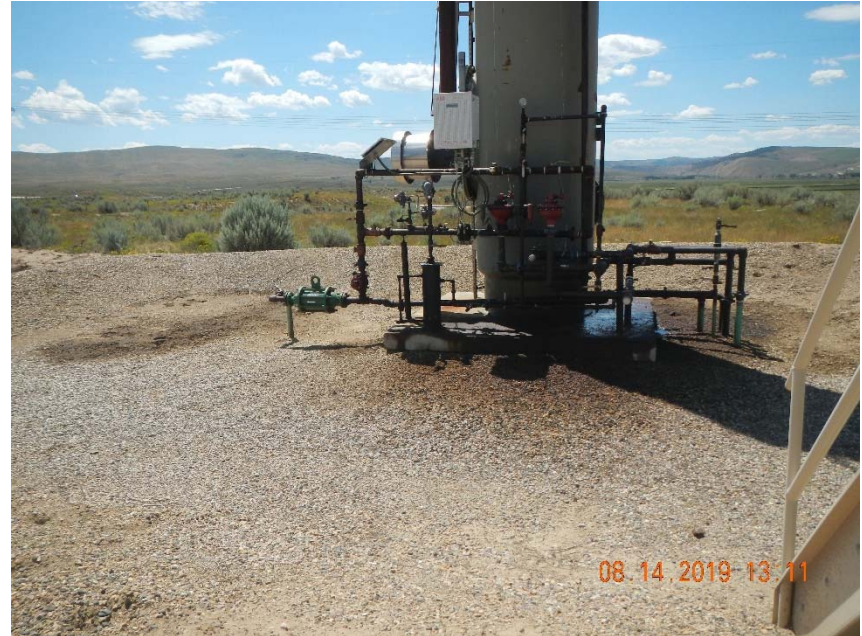
Photo 6. Stained soil and free fluid at separator.

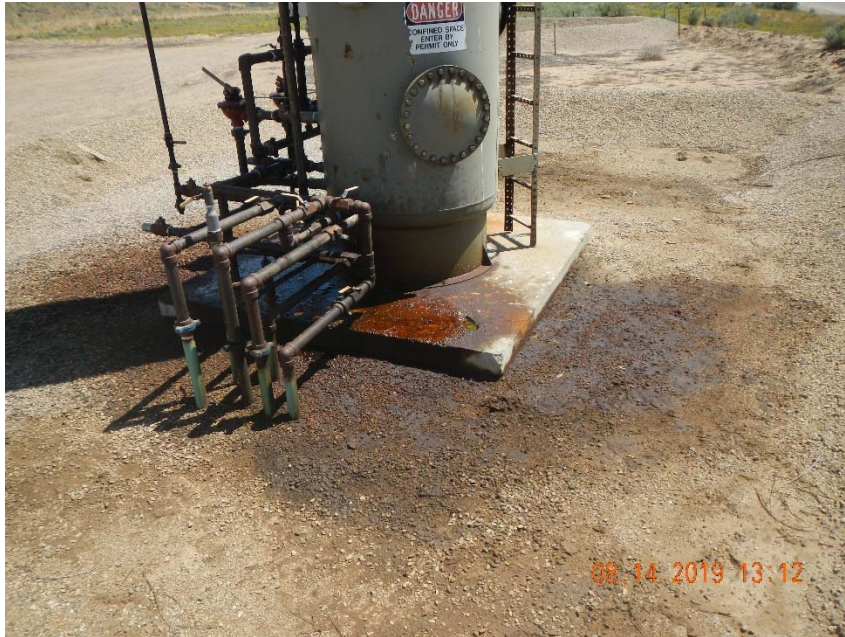
Photo 7. Stained soil and free fluid at separator.

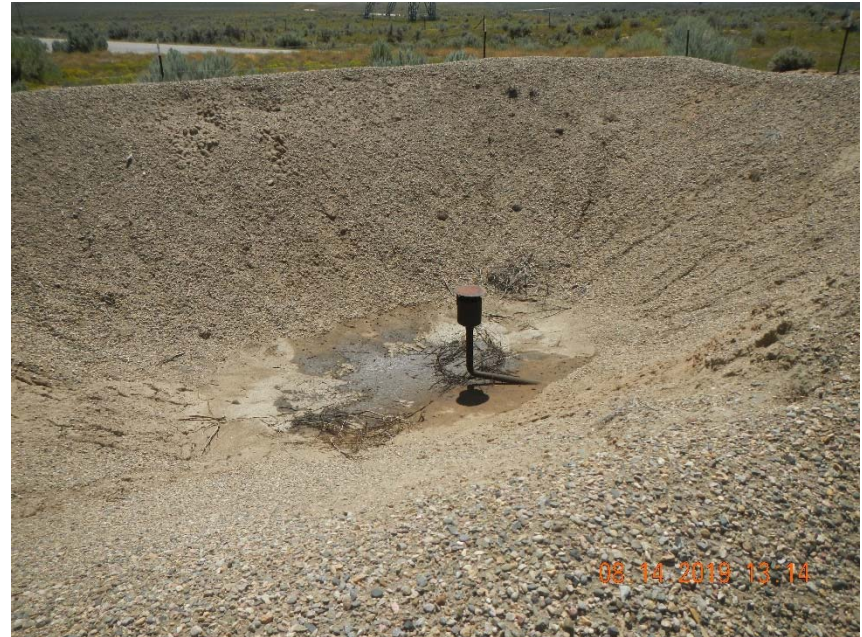
Photo 8. Stained soil in flare pit.
