Inspection Photos

API: 05-009-06554

Operator: LORENTZ OIL & GAS

Inspection Date: 8/14/2019

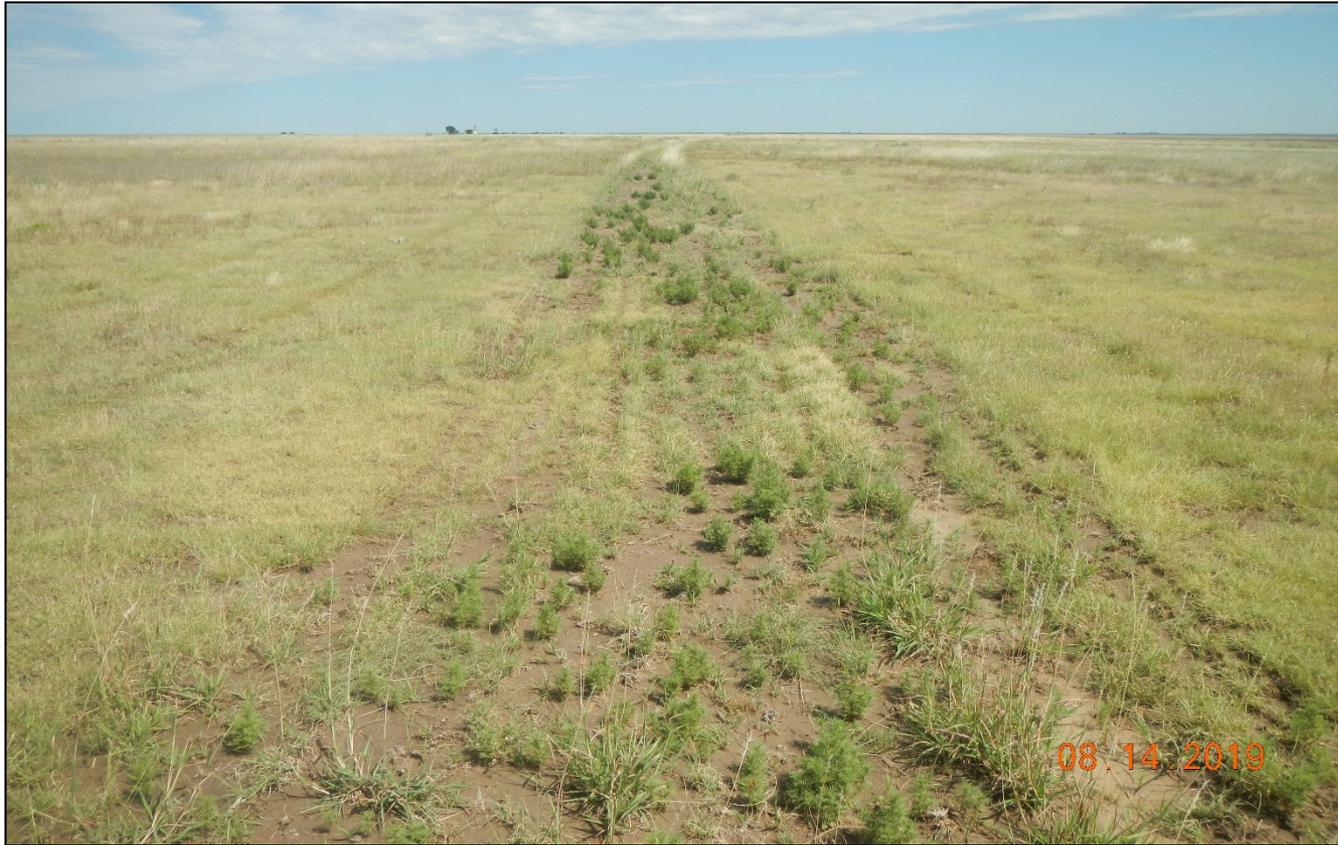
Photo 1. It appears the access road was reclaimed and vegetation is establishing.

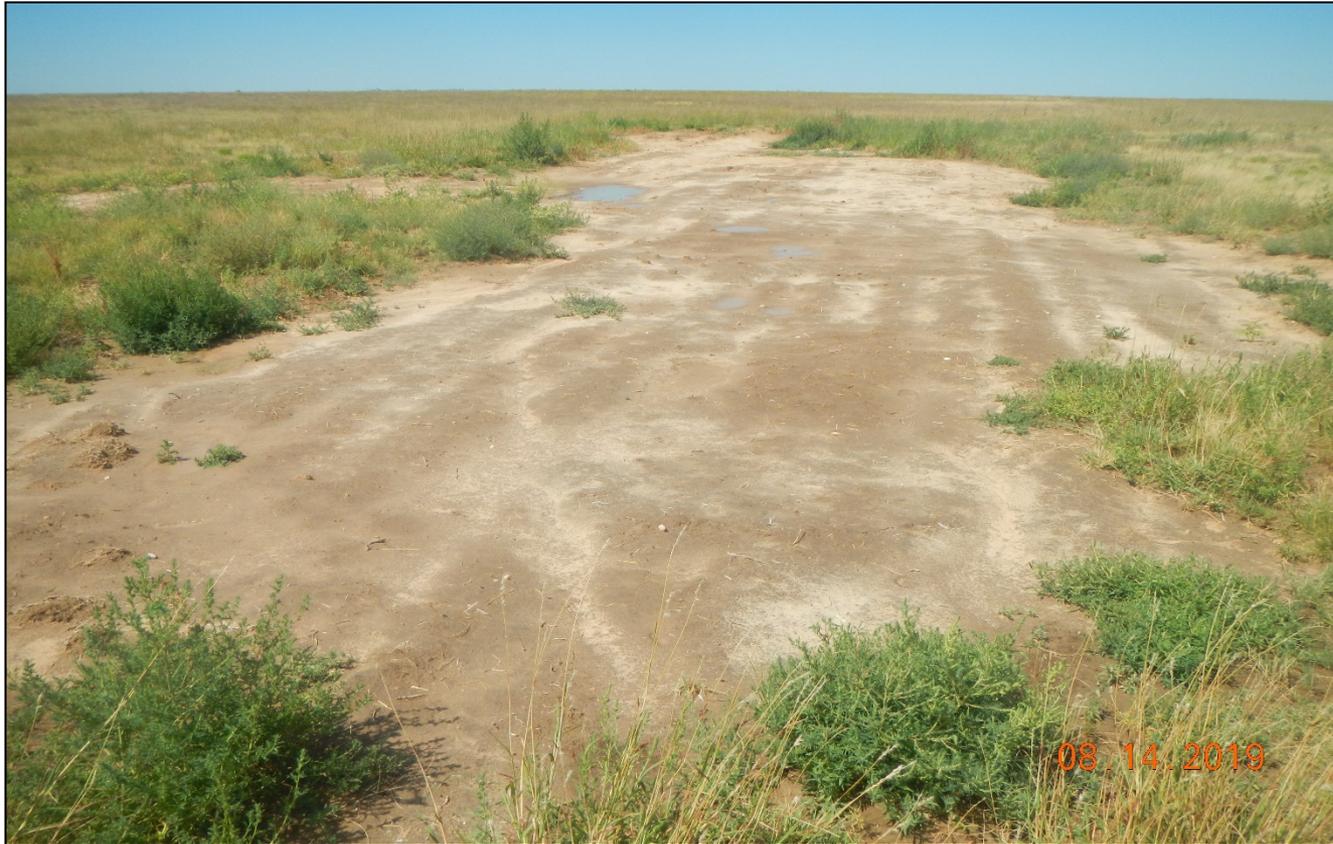
Photo 2. It appears the location was decompacted. This area does not have vegetation establishing. Not sure if and when it was seeded. There may be soil issues.

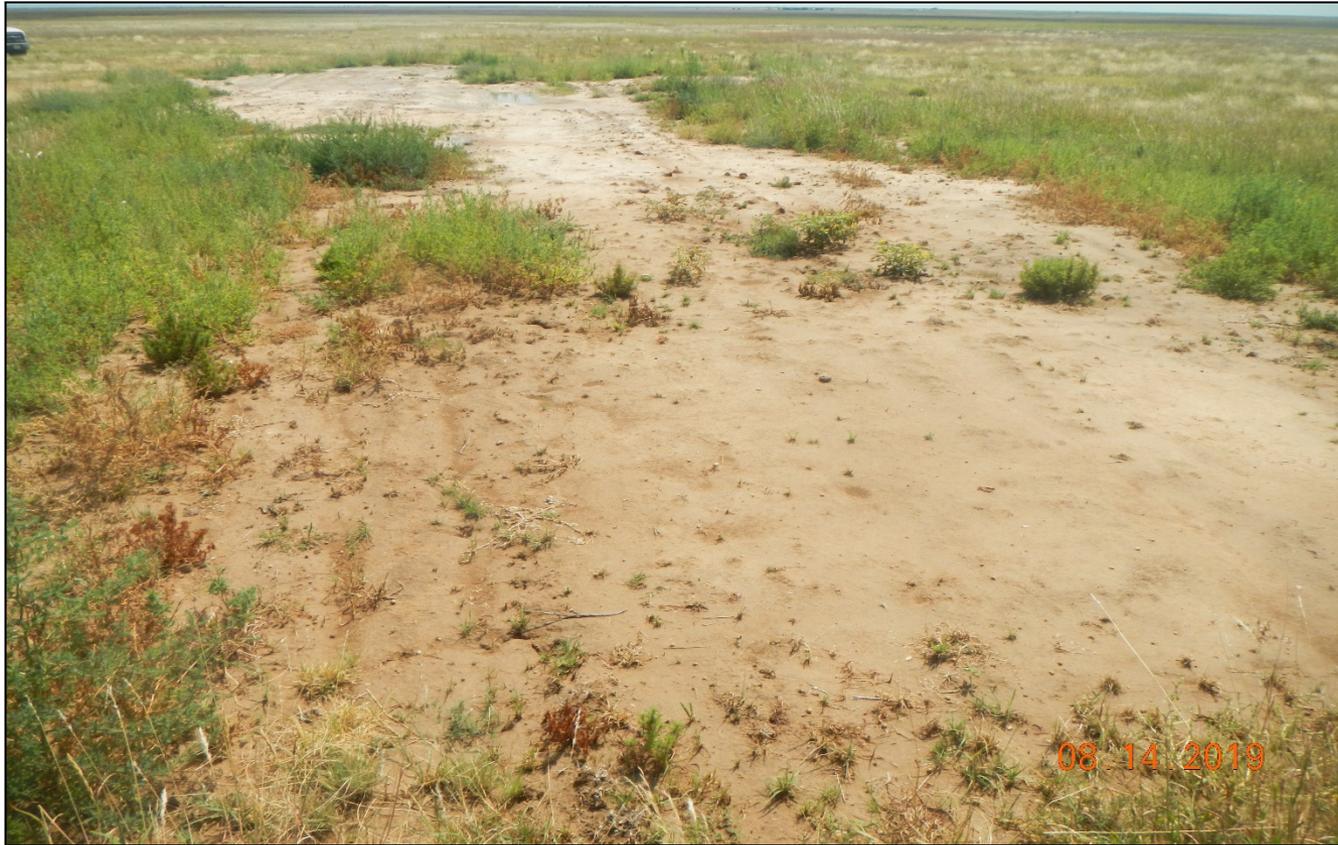
Photo 3. Facing east at the location. This area is bare of vegetation.

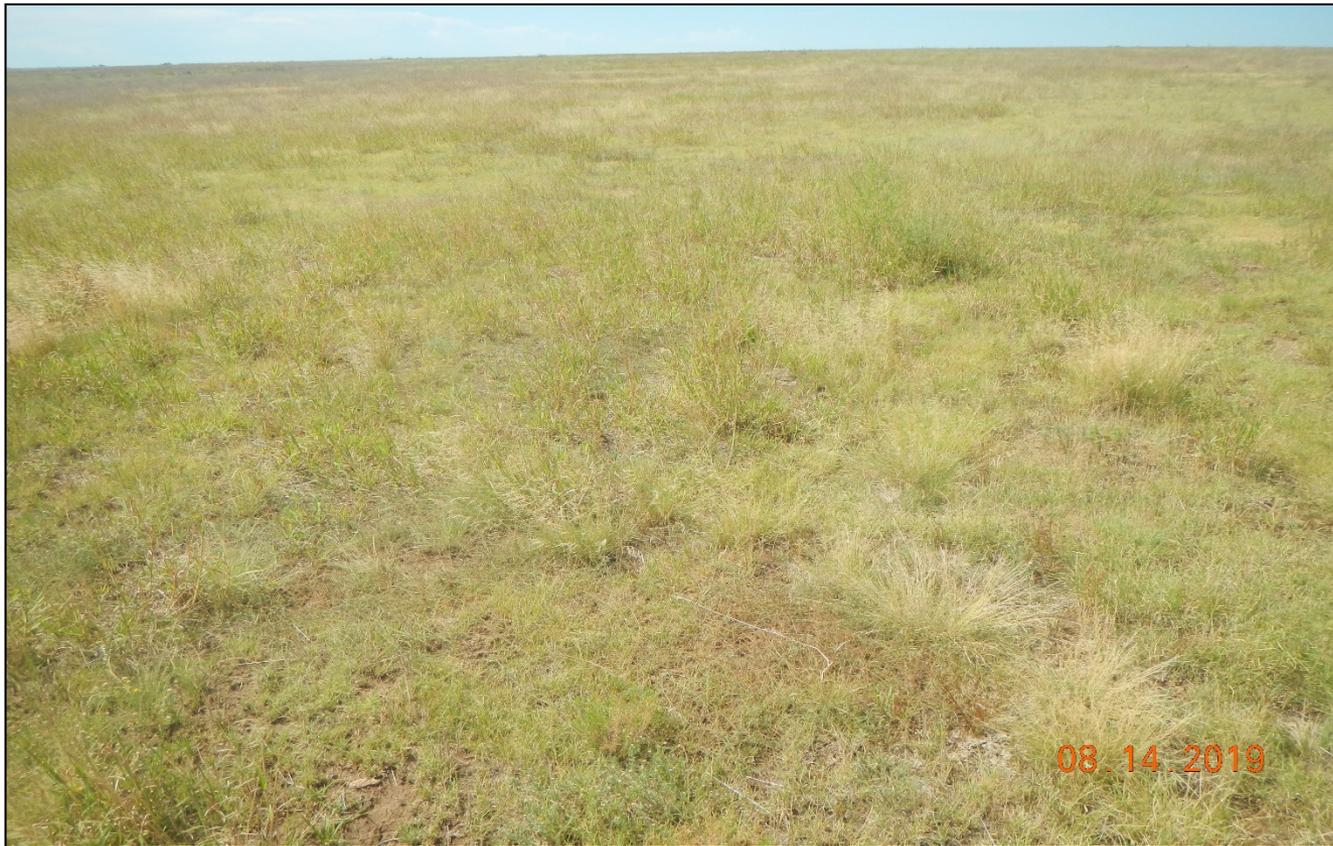
Photo 4. Facing south at the surrounding pasture adjacent pasture.
