Inspection Photos

Operator: Hilcorp Energy
Location/API #: 067-09948
Date: 8-14-2019

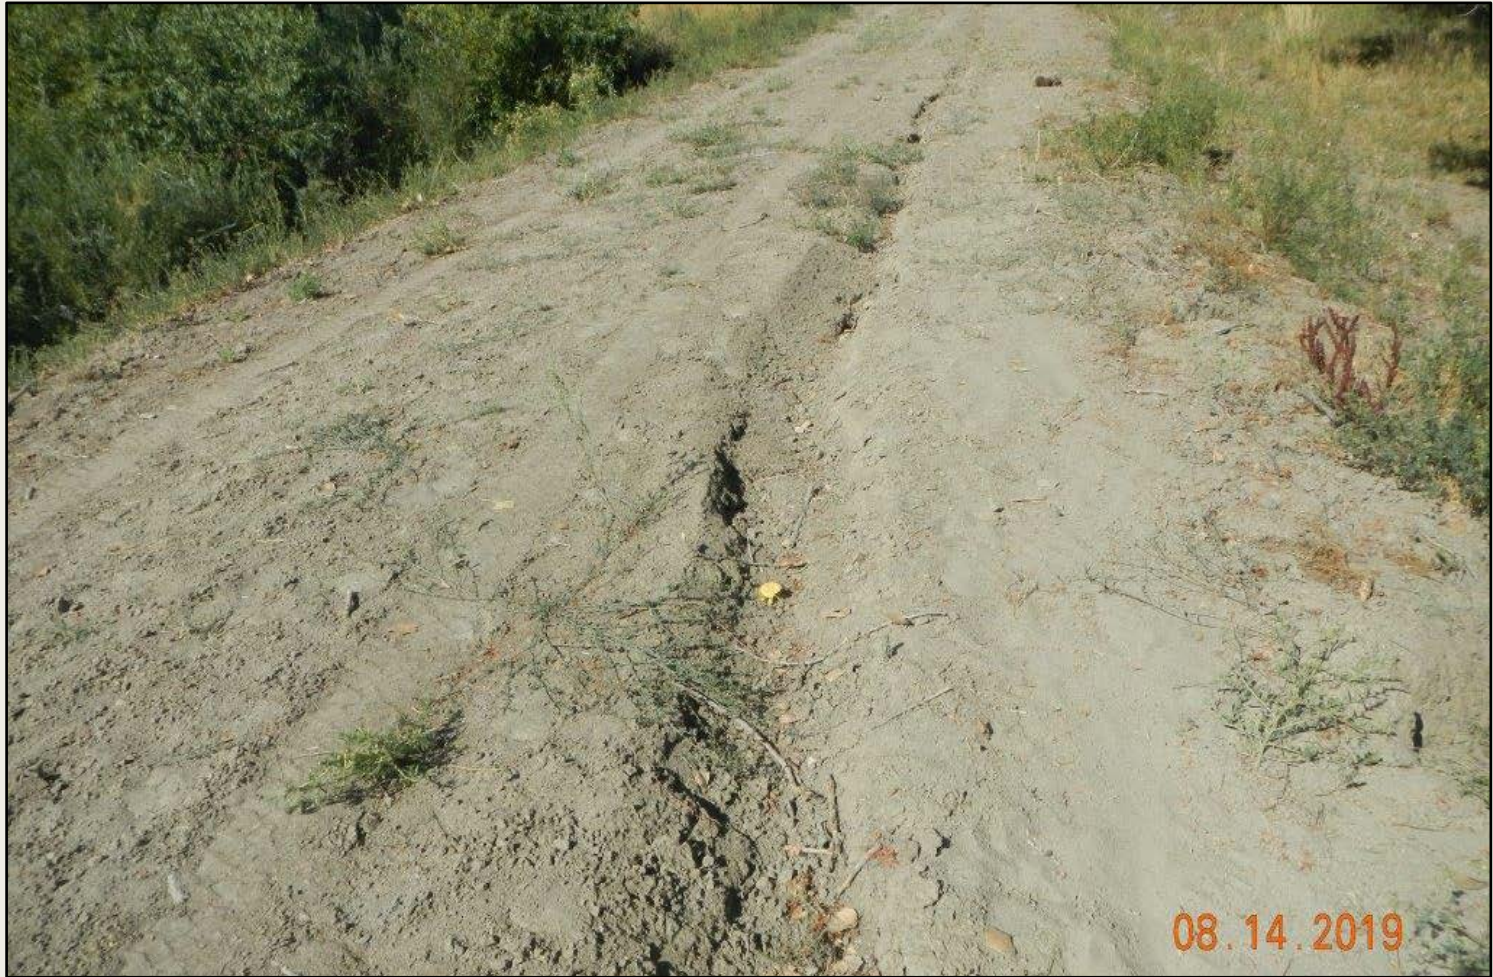
Photo 2. View of erosional channel forming within the access road slope.

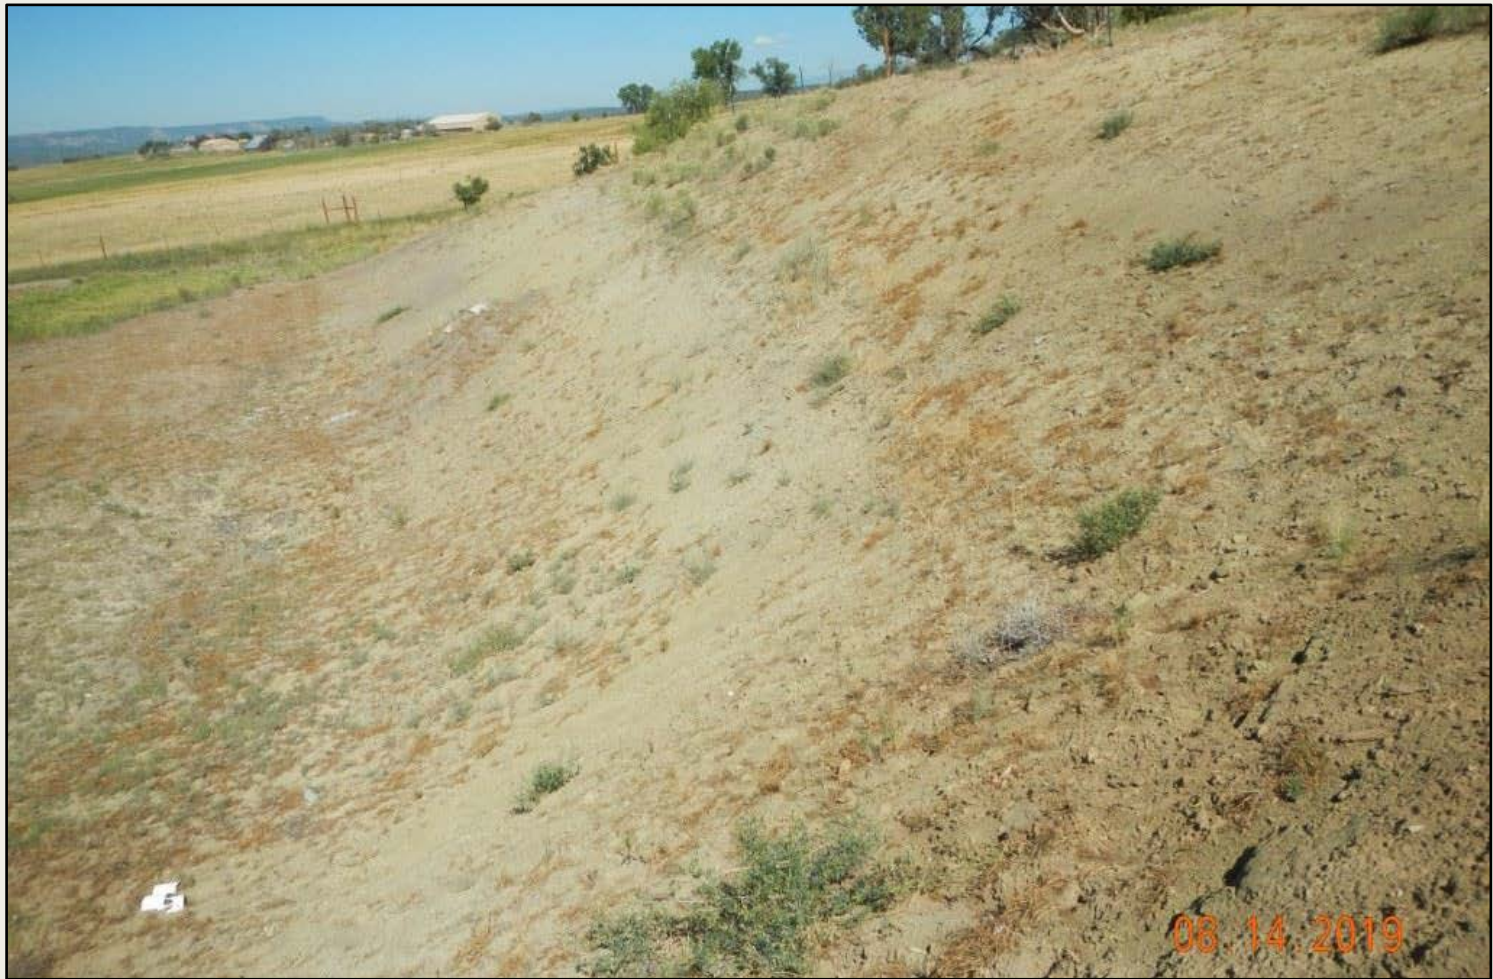
Photo 3. View of bare soils on the northern cut-slope.

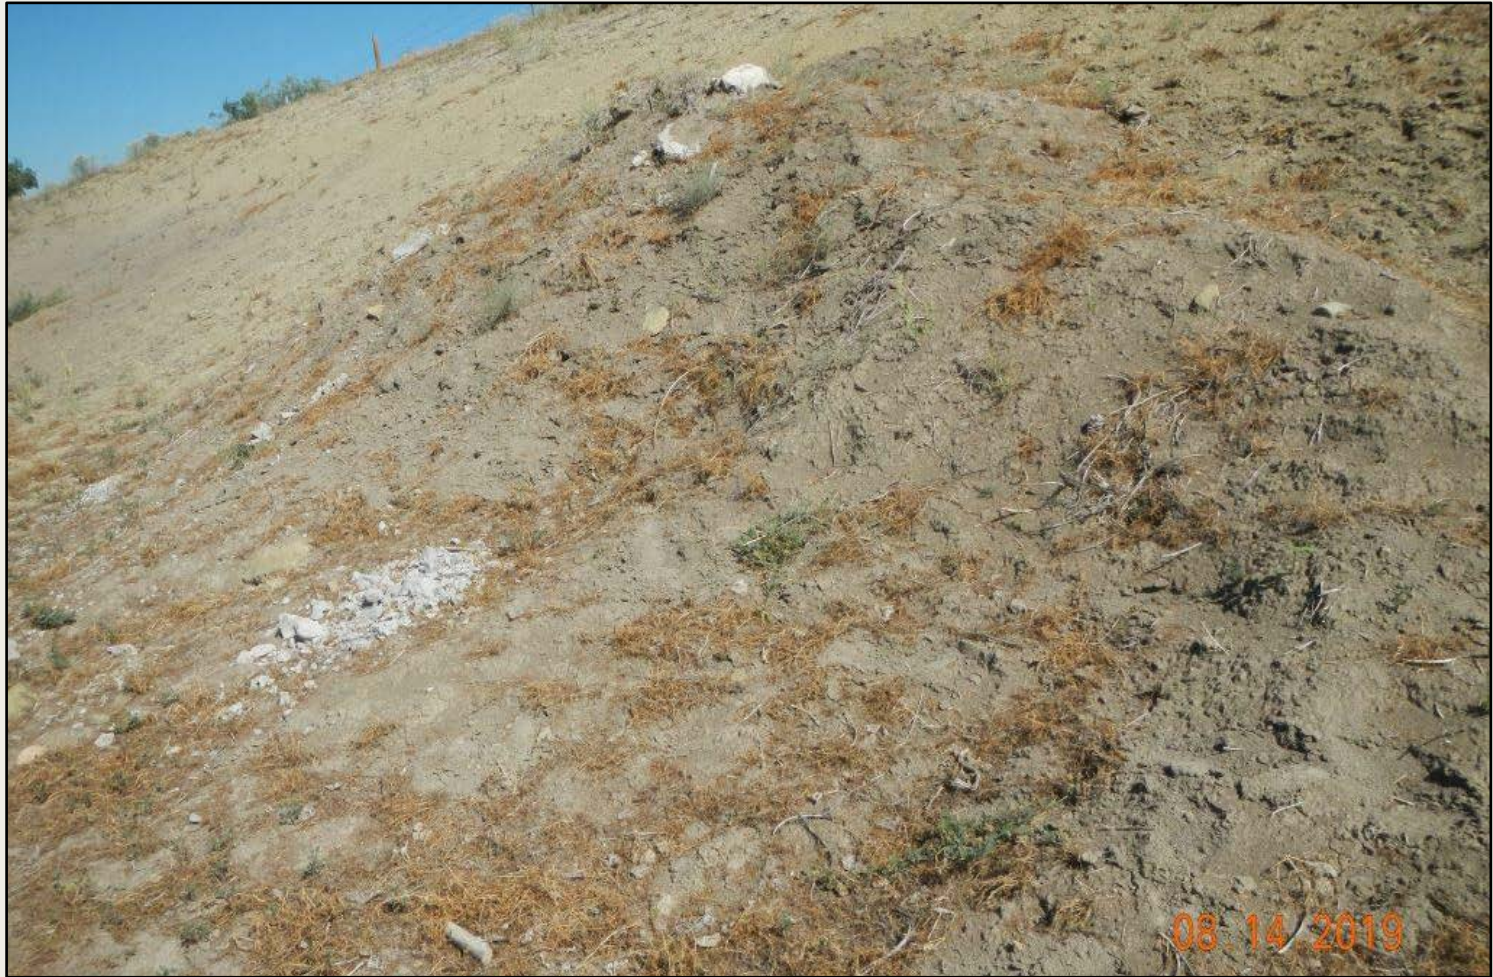
Photo 4. View of what appears to be cuttings debris placed on the northern cut-slope.

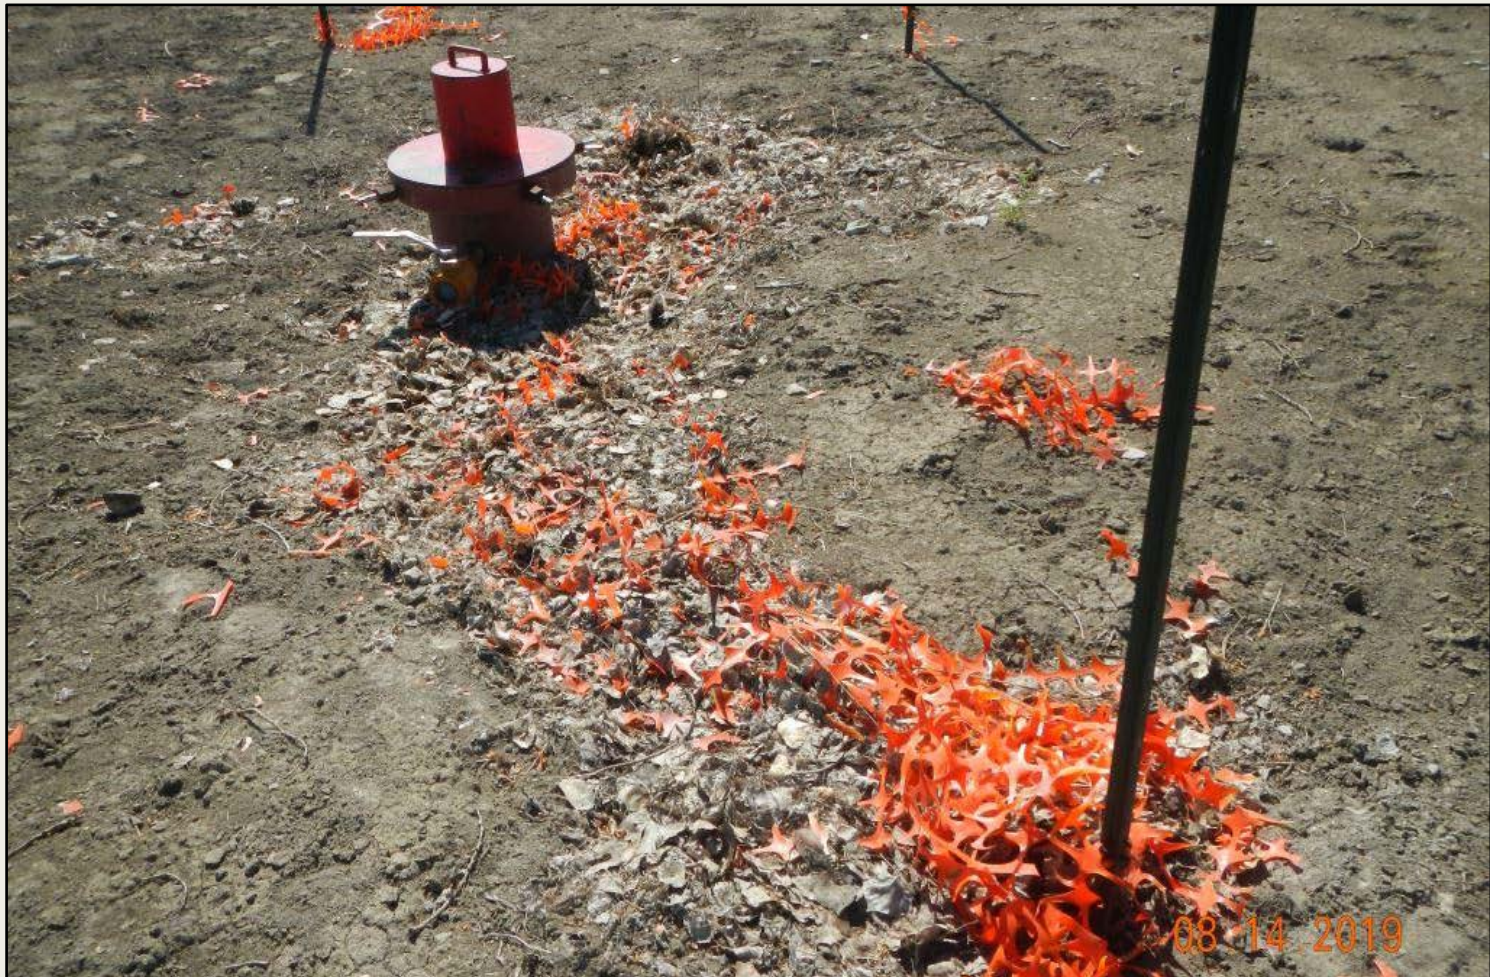
Photo 5. View of plastic fencing debris around wellhead location.

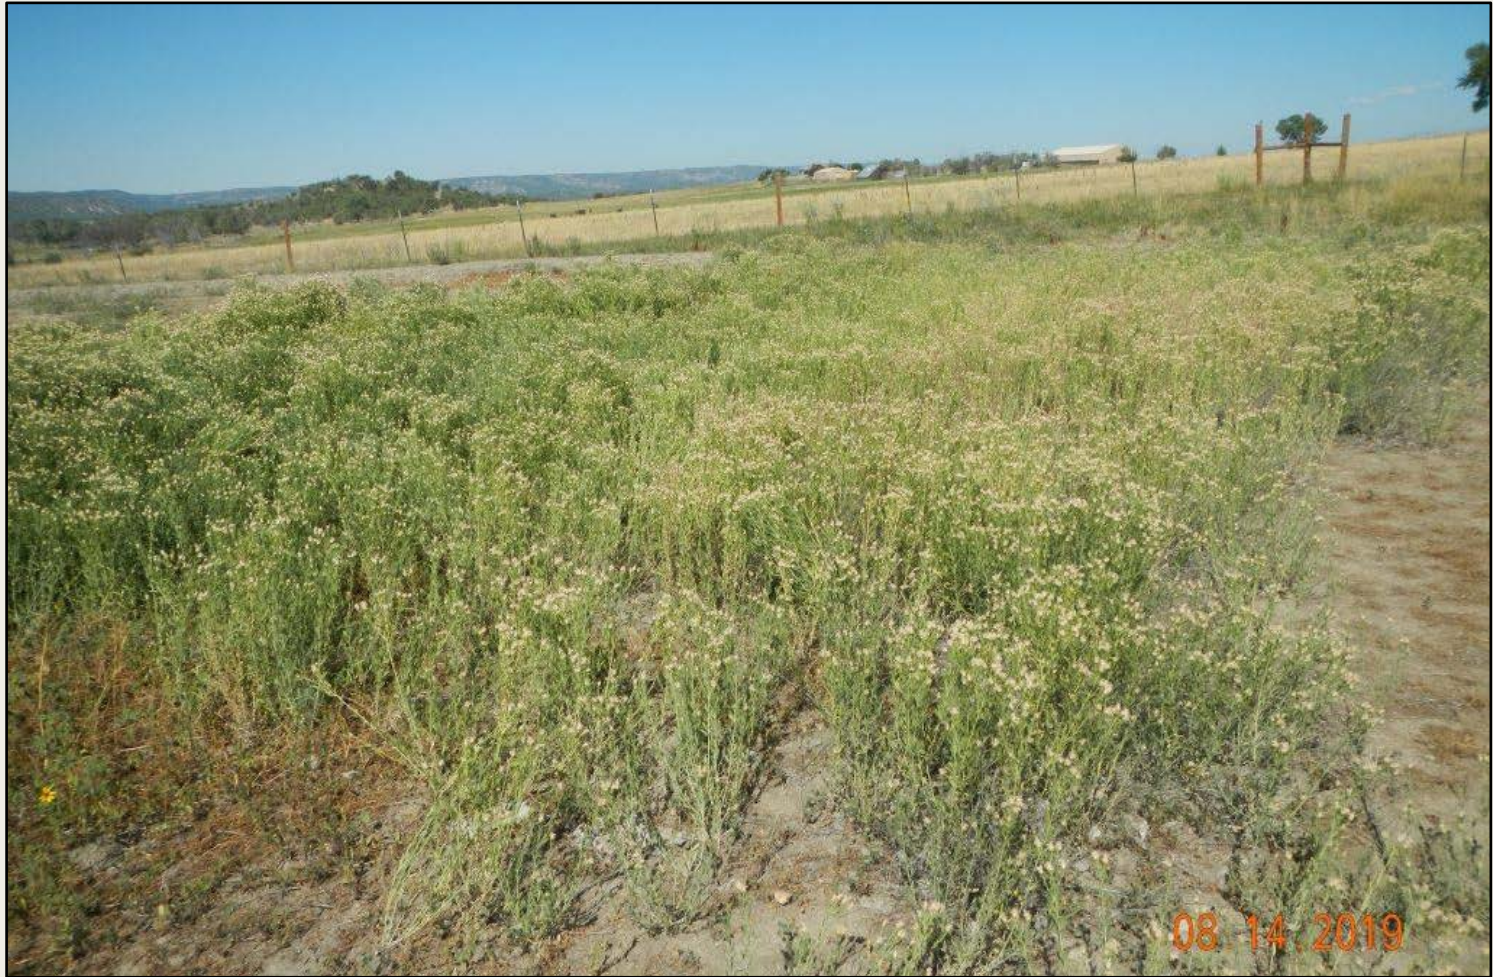
Photo 6. View of dense Russian knapweed (*Rhaponticum repens*) infestation in the northwestern project area.

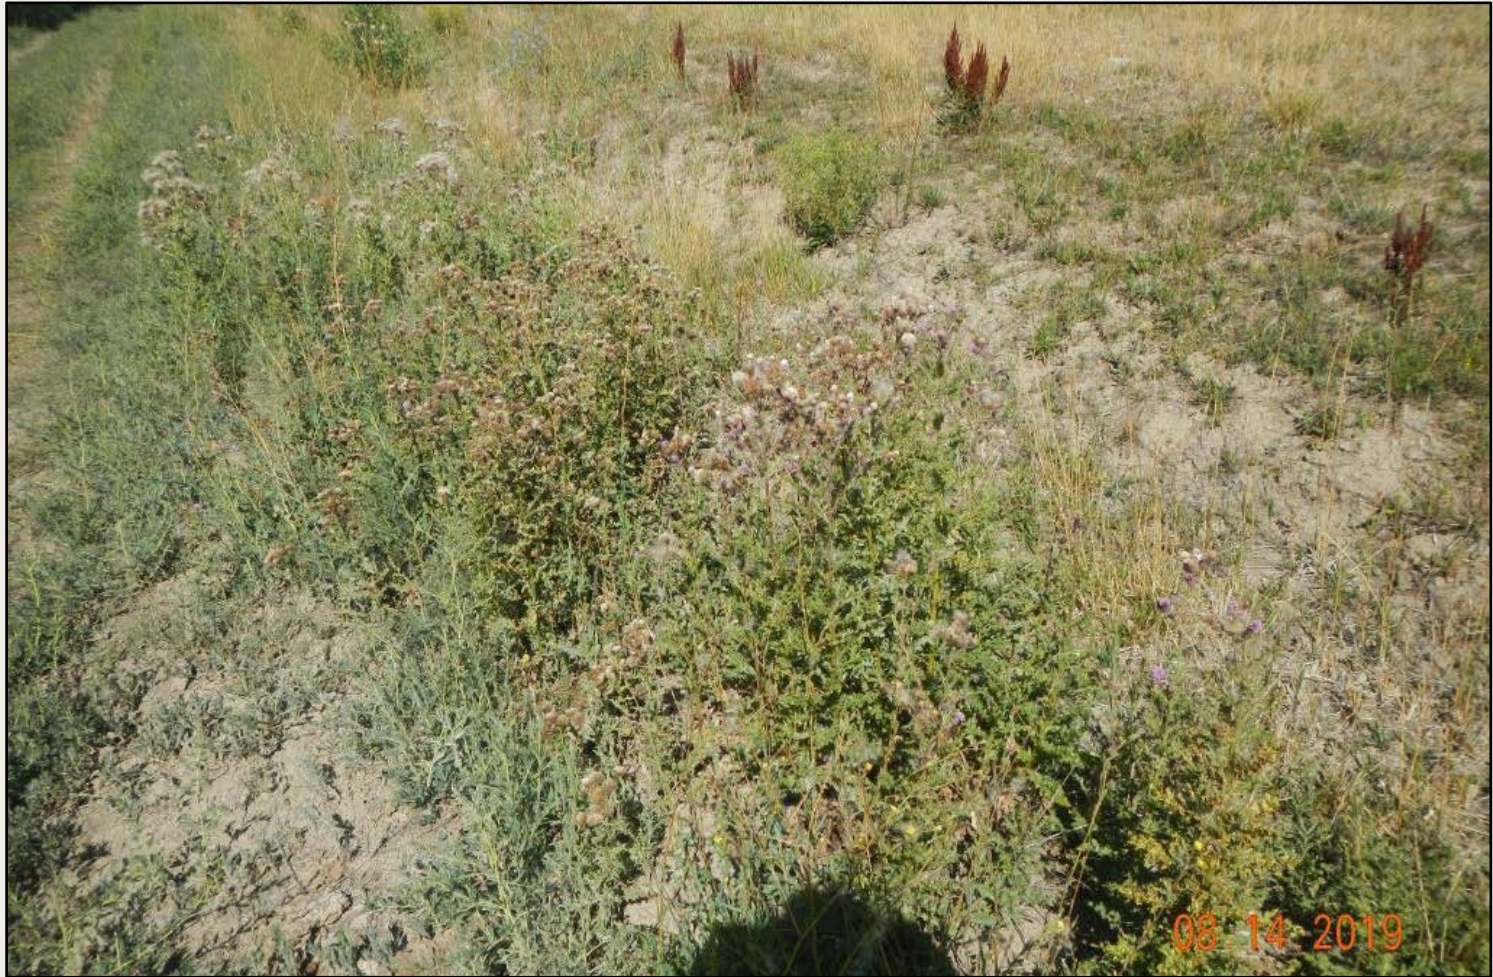
Photo 7. View of Canada thistle (*Cirsium arvense*) infestation on the access road.

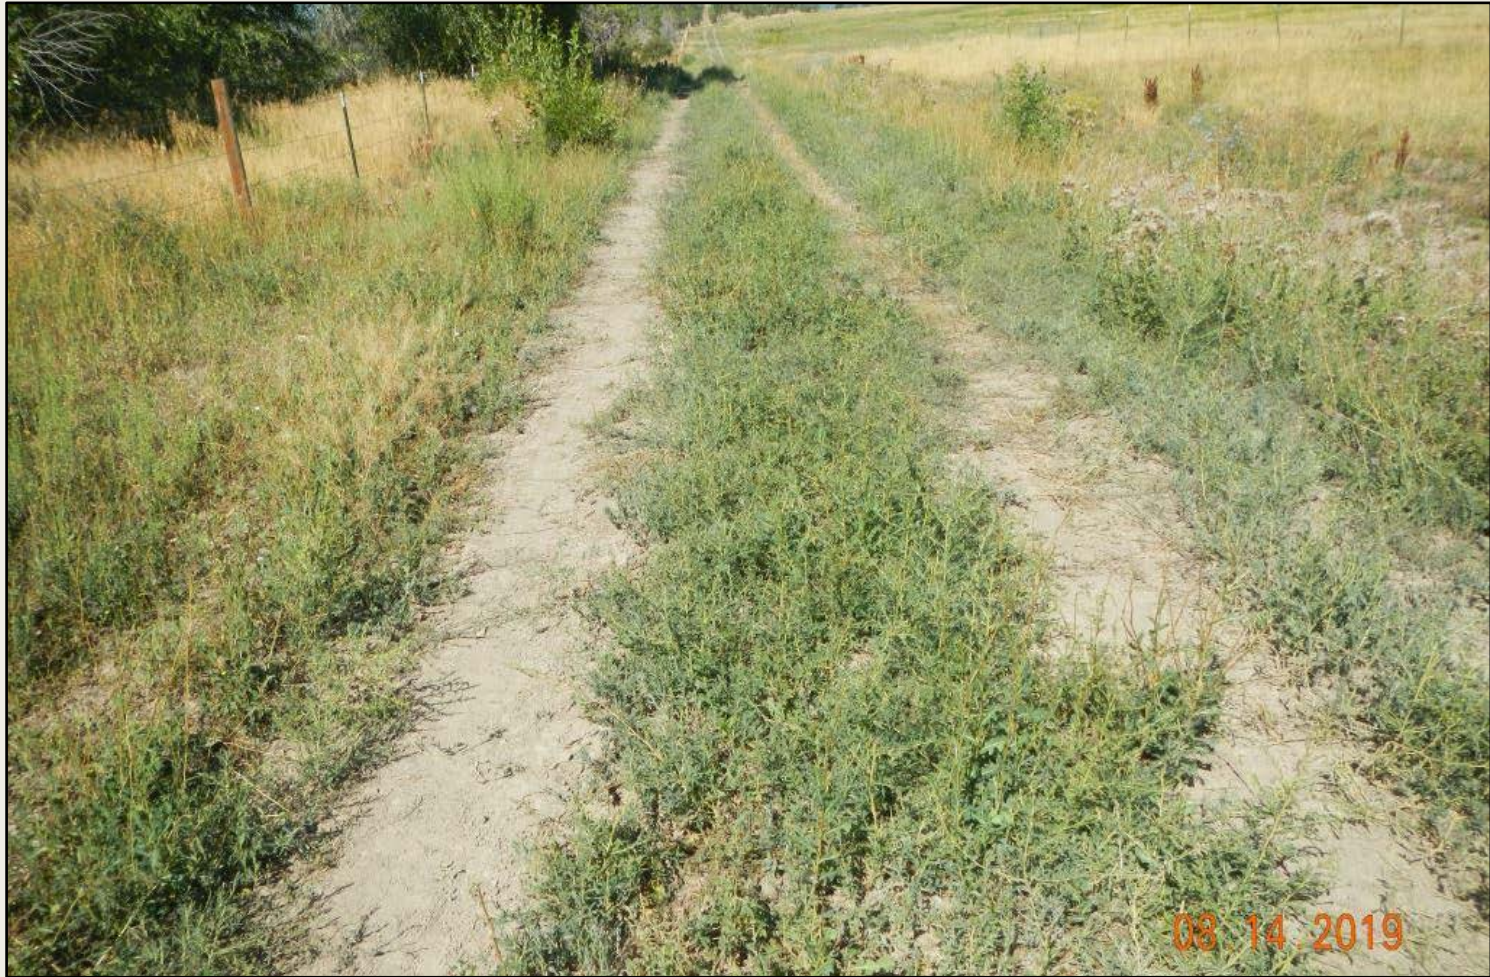
Photo 8. View of weeds on the access road, largely kochia (*Kochia scoparia*).
