ELU 8908A-24 HO6 396

API: 05-103-11612

Inspection: 679705121

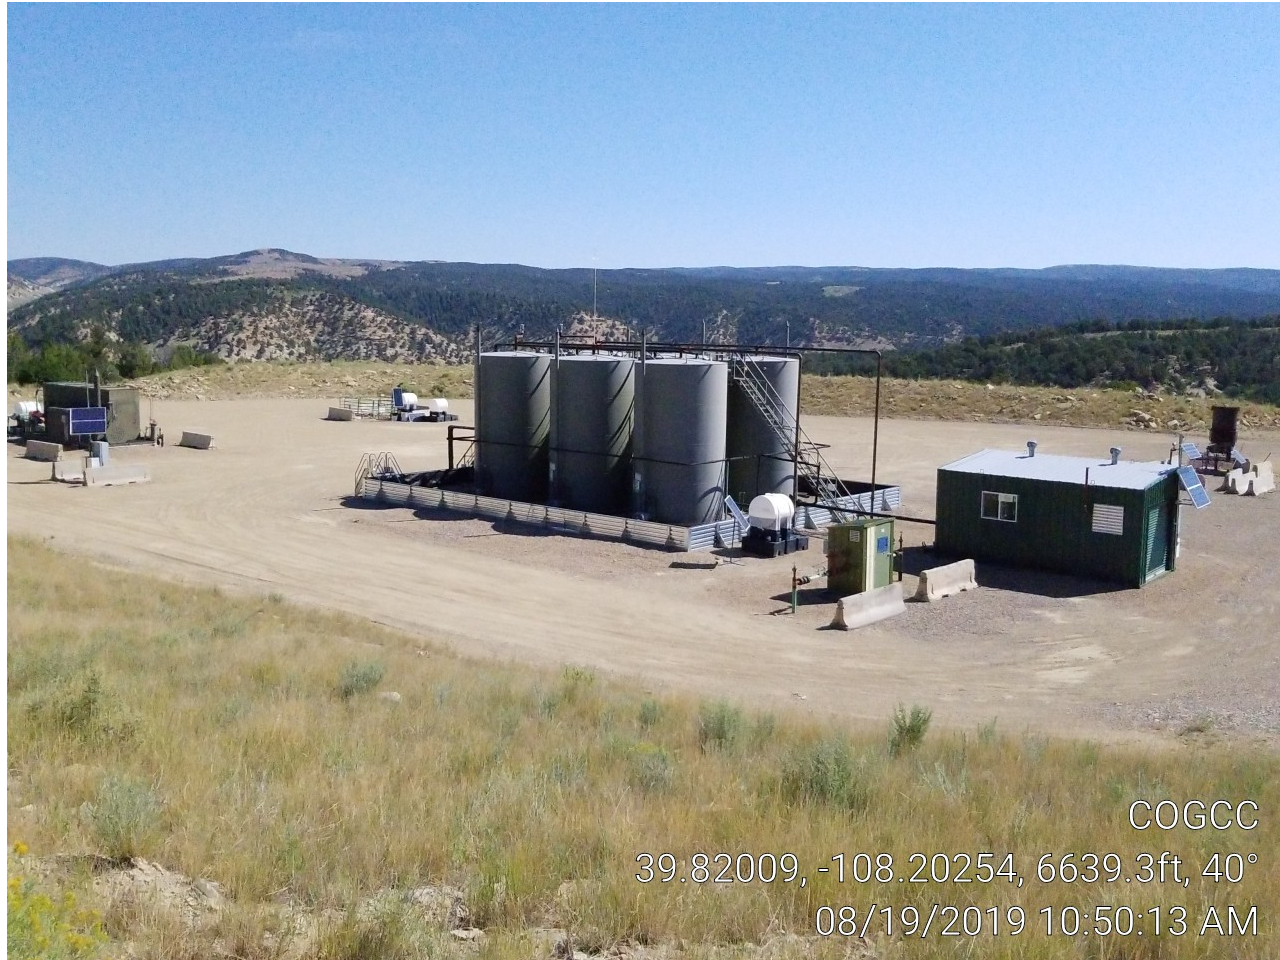
Photo 1. Location.

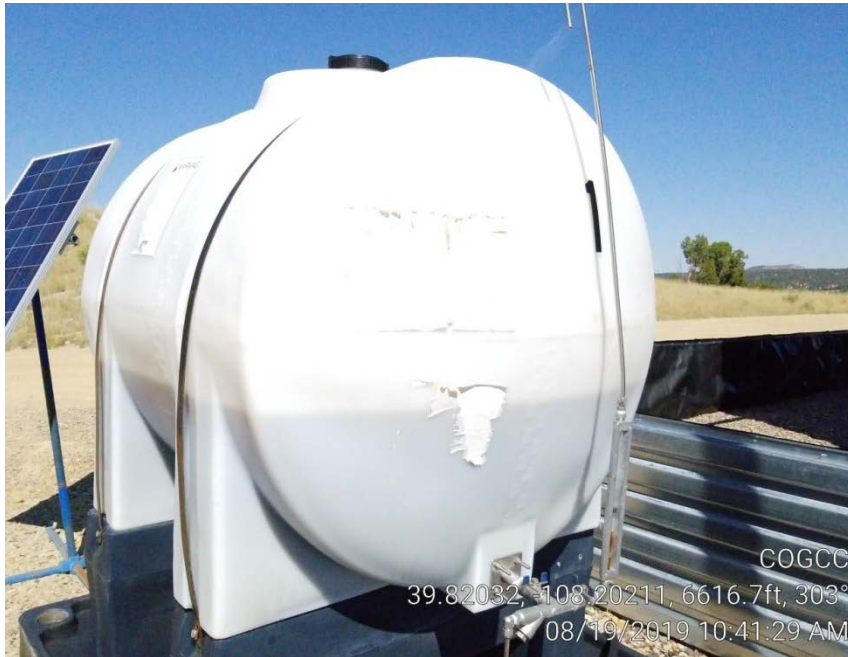
Photo 2. Container next to tank battery.

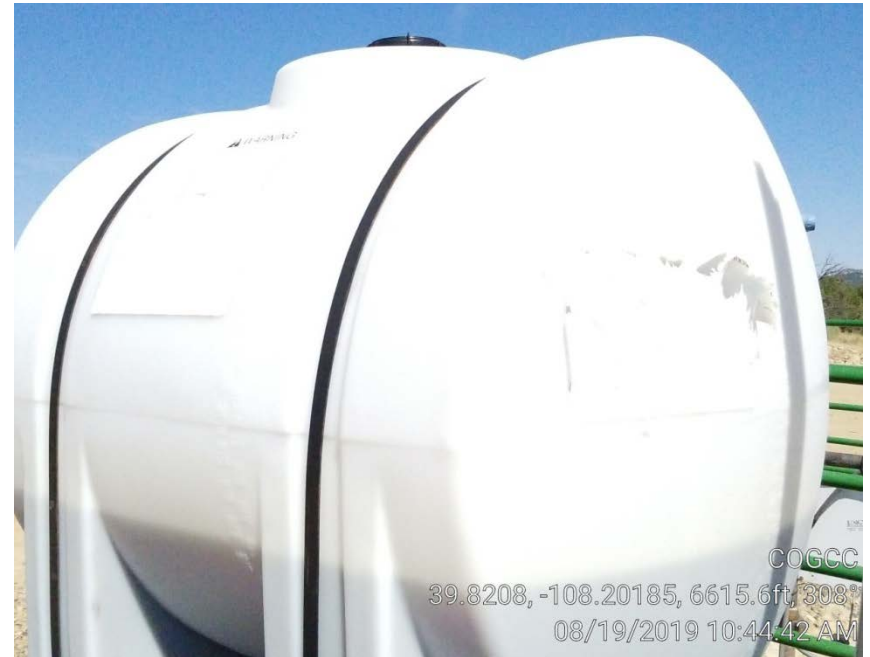
Photo 3. Container next to well head.
