# Interim Reclamation and Stormwater Inspection

August 14, 2019

Operator: VERDAD RESOURCES LLC - #10651

Inspection Photos  
Location Name: HDI KF /01-65-10 PAD  
Location ID: 453512

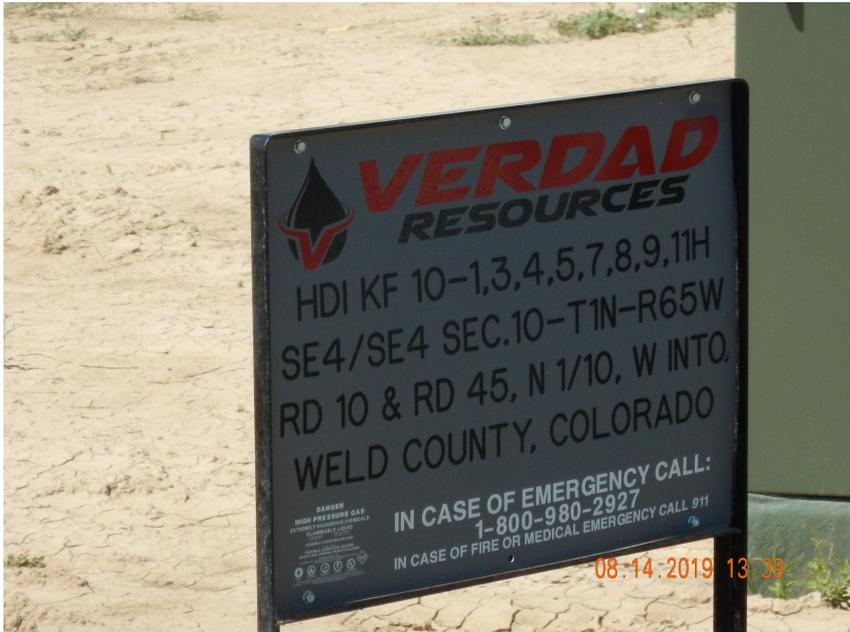
**Photo 1.** Photo taken from the entrance of the location, facing West. Photo illustrates the Operator sign.

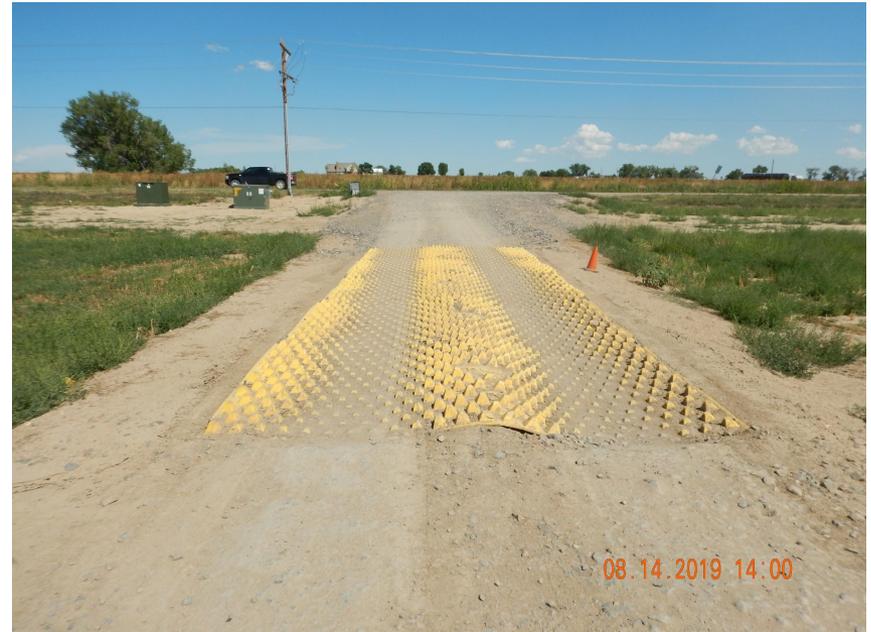
**Photo 2.** Photo taken from the entrance of the location, facing East. Photo illustrate the vehicle tracking device BMP is in need of maintenance and is not in proper functioning condition.

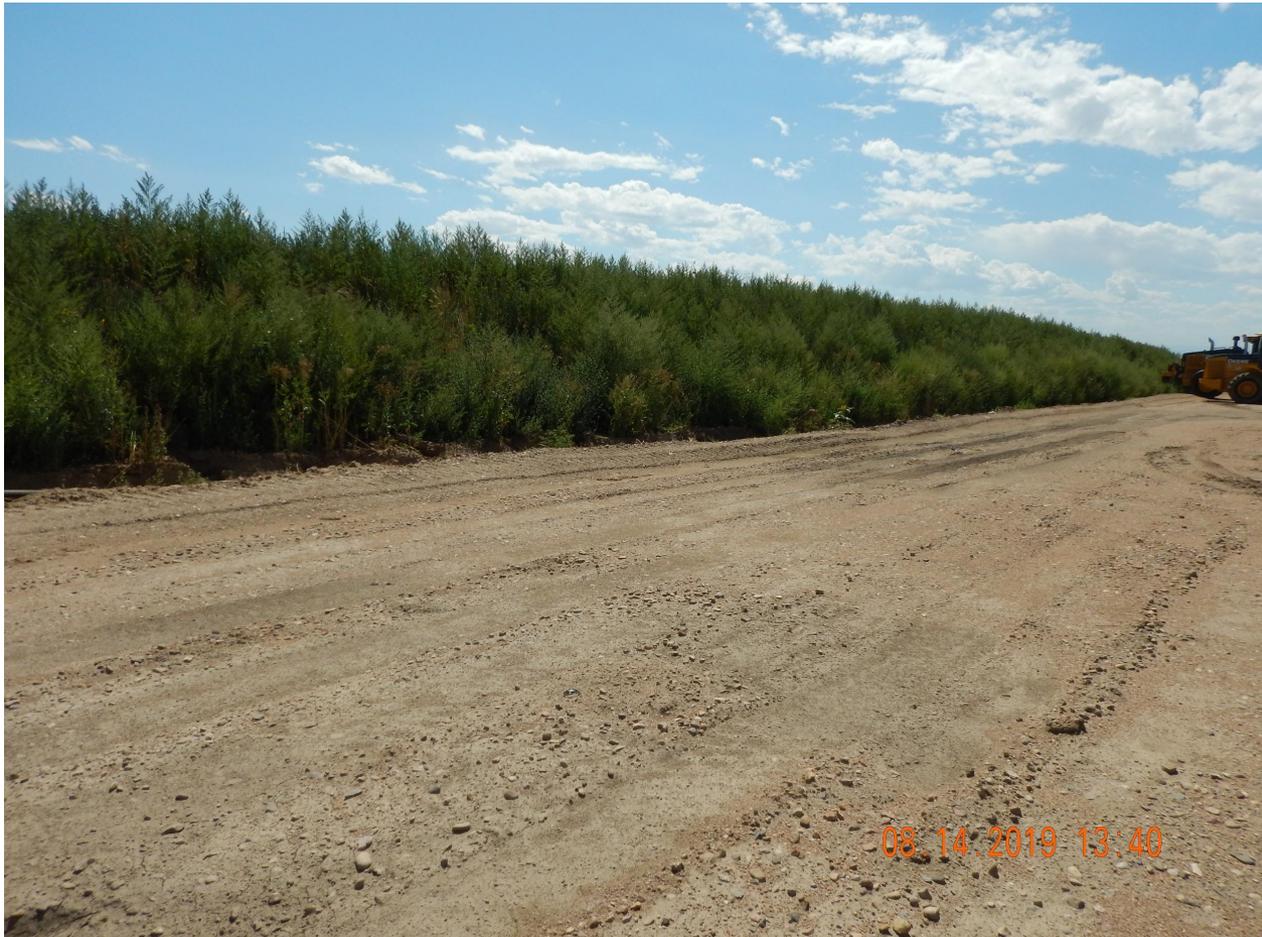
**Photo 3.** Photo taken from the southern well pad, facing West. Photo illustrates unmanaged weeds throughout the topsoil stockpile.

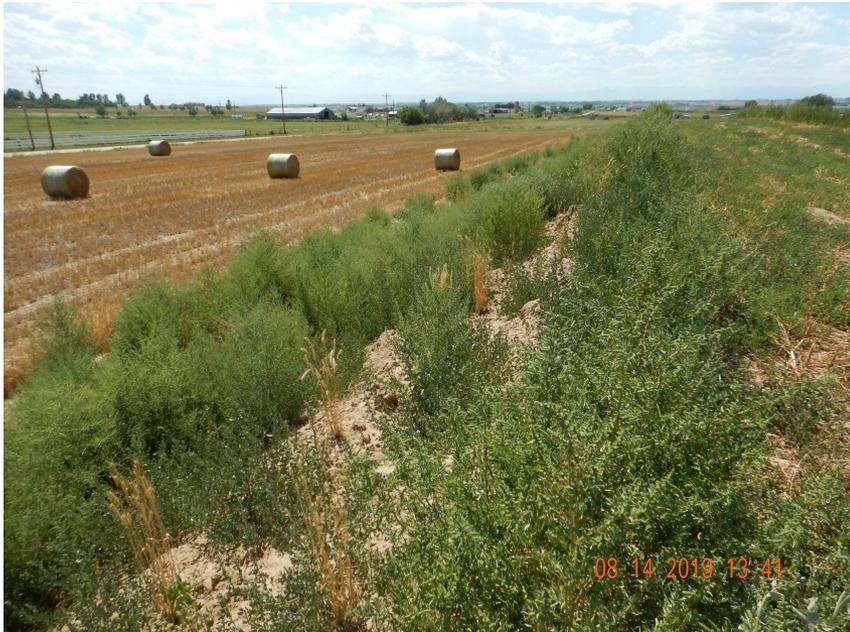
**Photo 4.** Photo taken from the topsoil stockpile, facing Southwest. Photo illustrates unmanaged weeds.

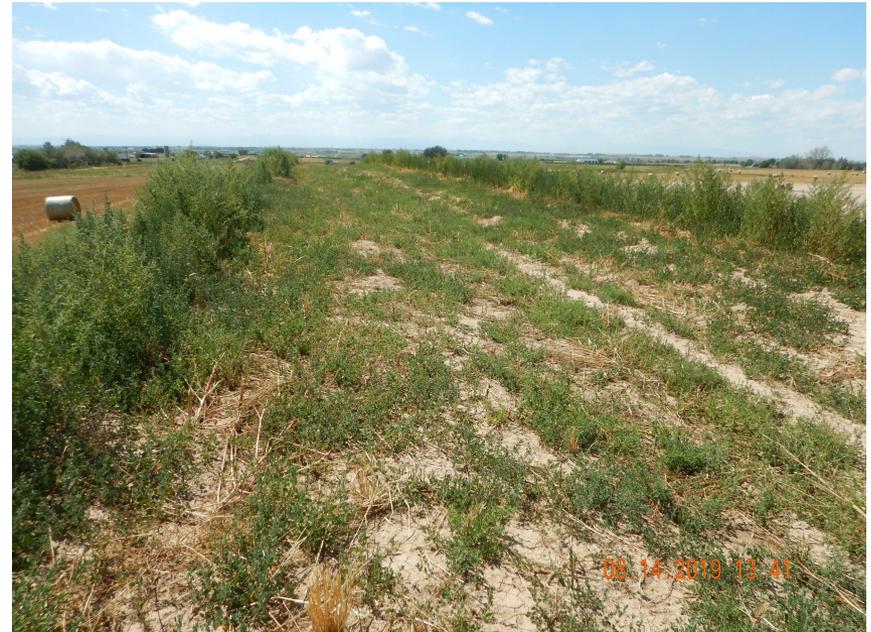
**Photo 5.** Photo taken from the topsoil stockpile, facing West. Appears the Operator has only mowed weeds on the top of the stockpile but not side slopes.

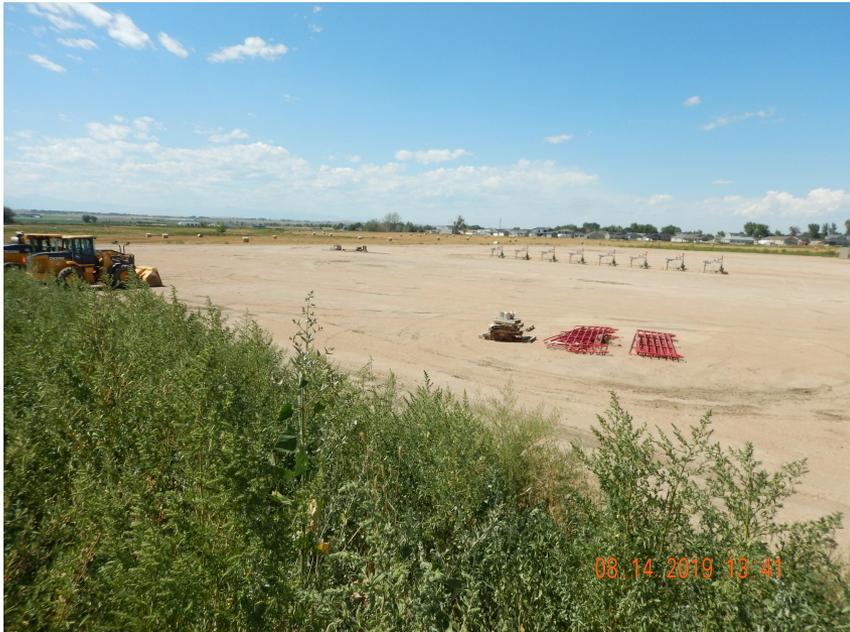
**Photo 6.** Photo taken from the topsoil stockpile, facing Northwest. Photo illustrates the current state of the well, as Interim Reclamation has not yet been performed.

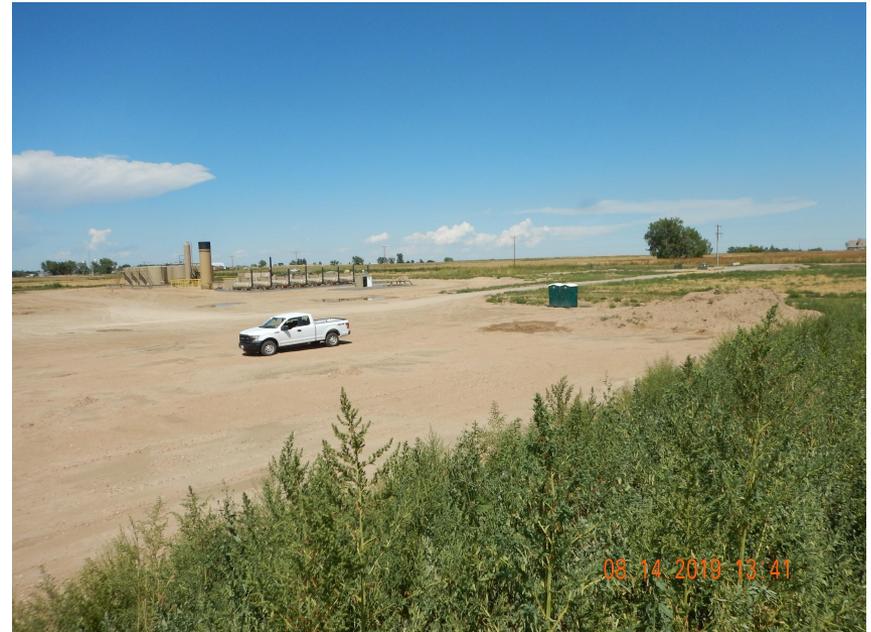
**Photo 7.** Photo taken from the topsoil stockpile, facing Northeast. See comments under Photo 6.

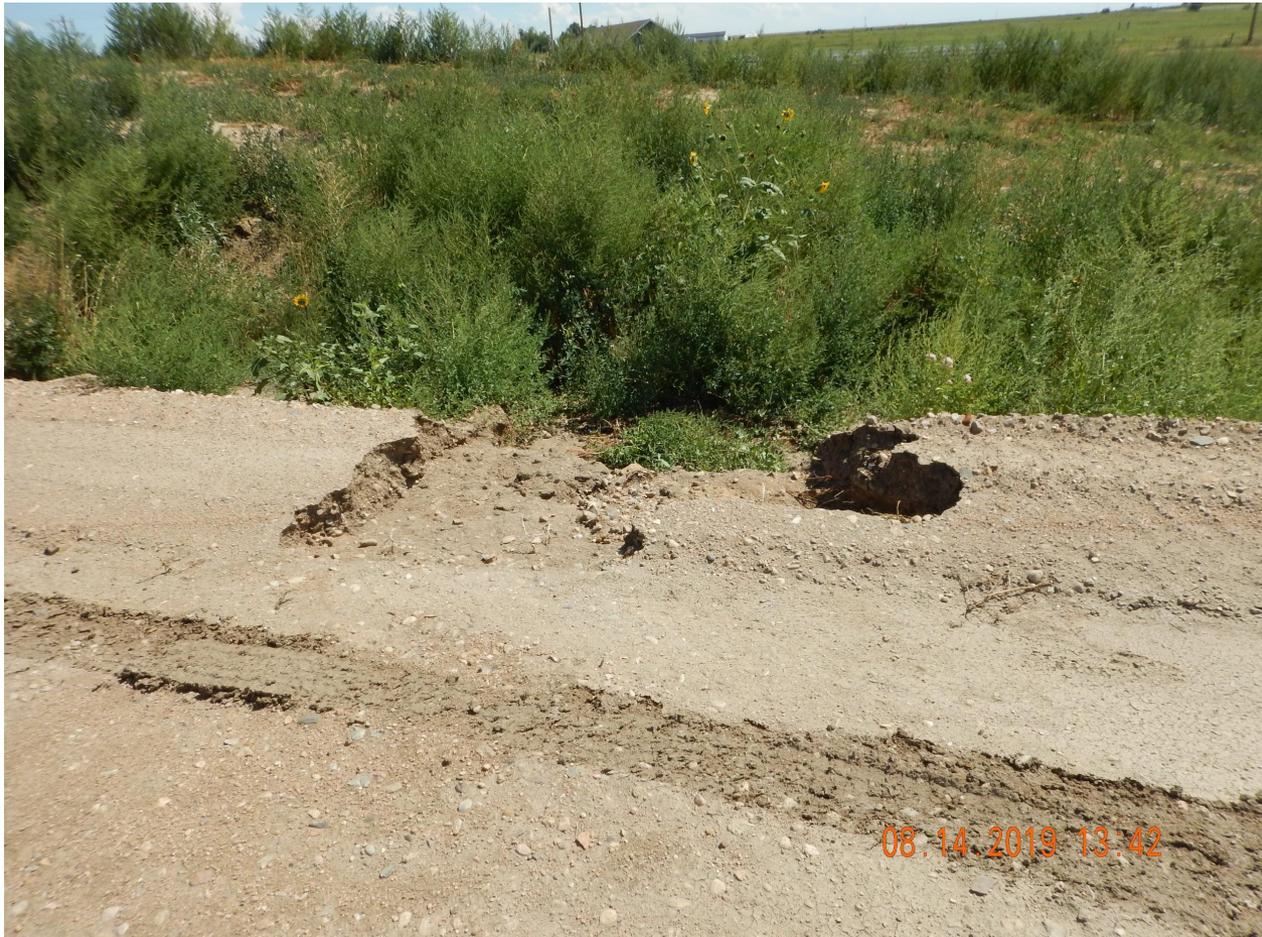
**Photo 8.** Photo taken from the southwestern well pad, facing South. Photo illustrates erosion that has not been repaired. Appears there was sediment discharge from location.

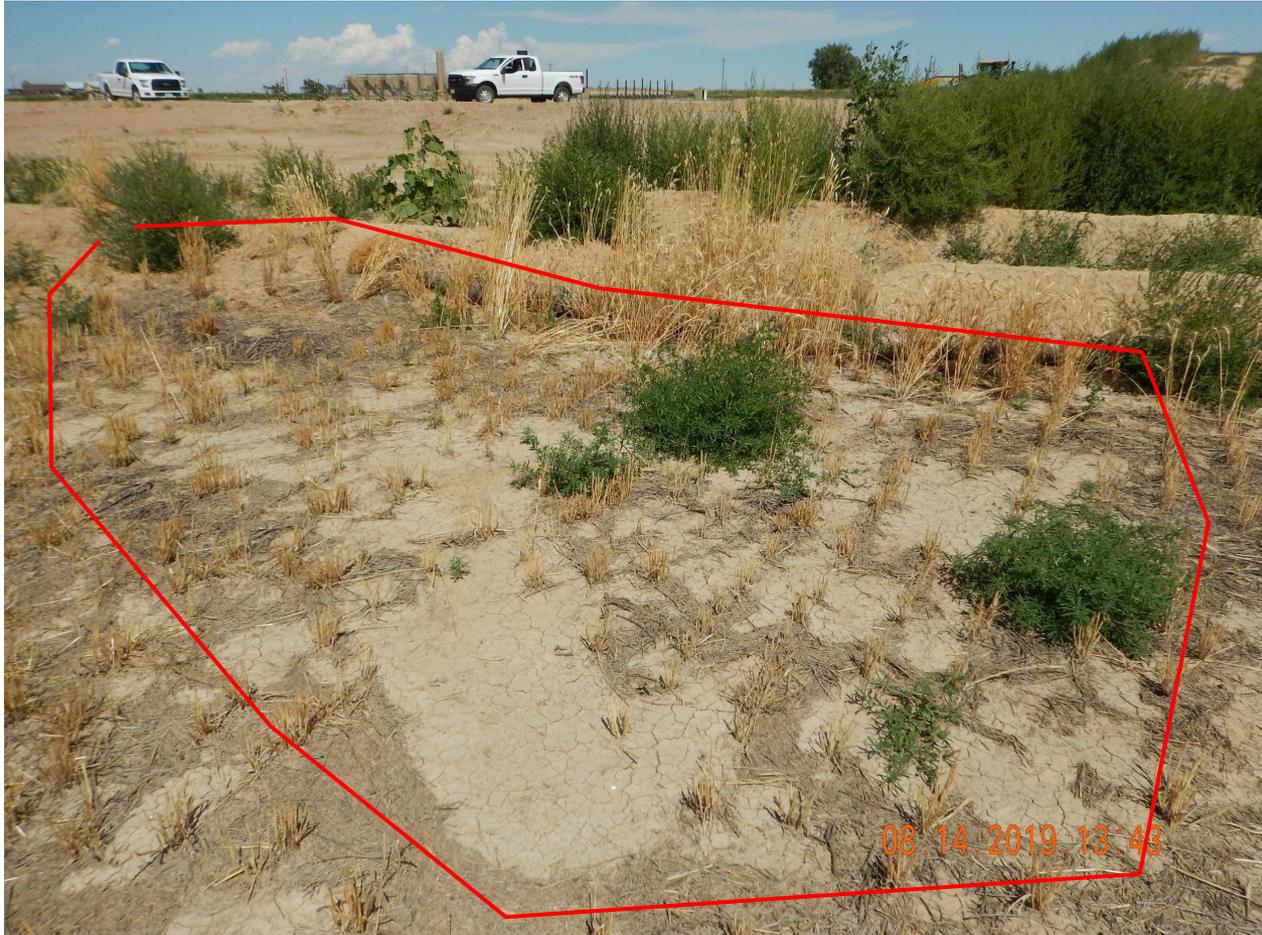
**Photo 9.** Photo taken from the southwestern perimeter of location, facing East. Photo illustrates sediment discharge beyond the perimeter BMP.

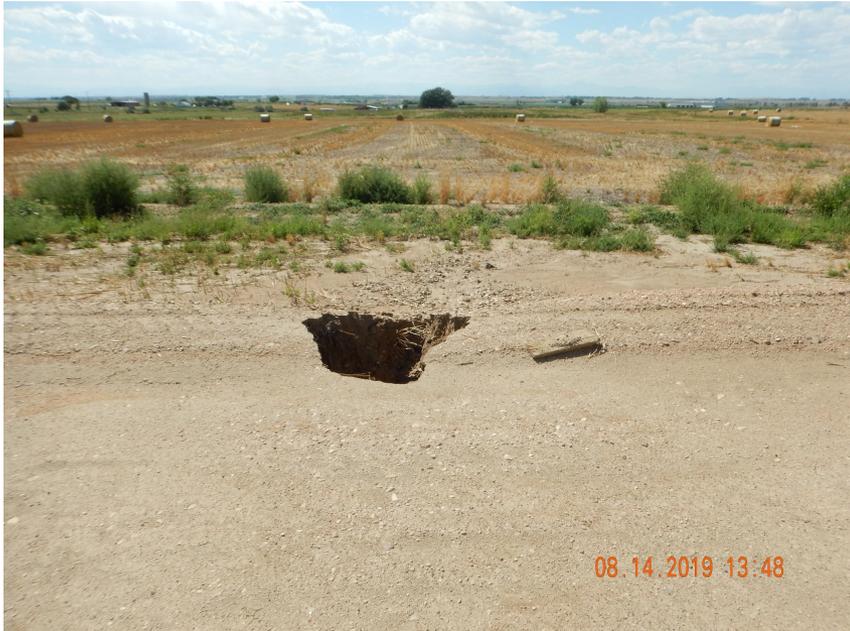
**Photo 10.** Photo taken from the western well pad, facing West. Photo illustrates erosion that has not been repaired.

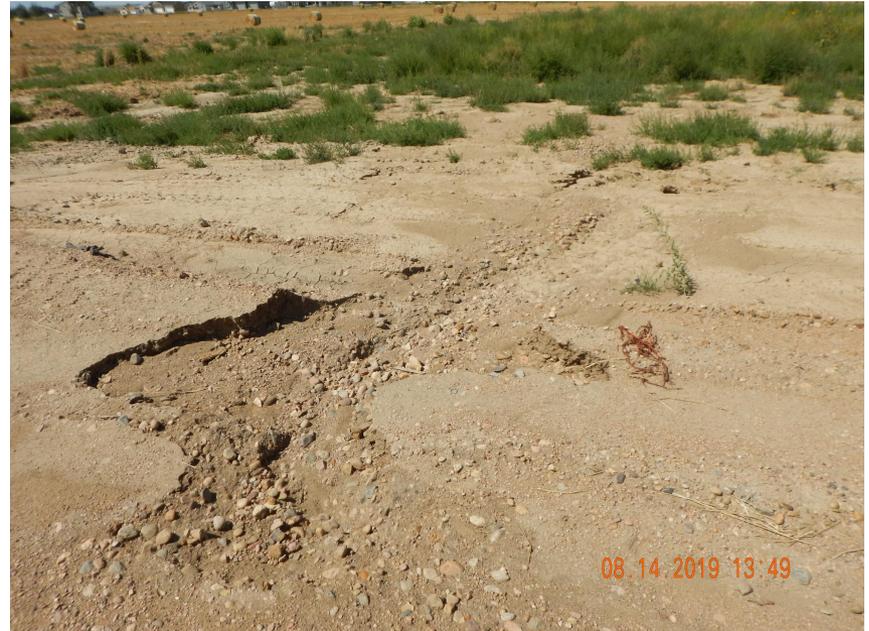
**Photo 11.** Photo taken from the northwestern well pad, facing Northwest. See comments under Photo 10.

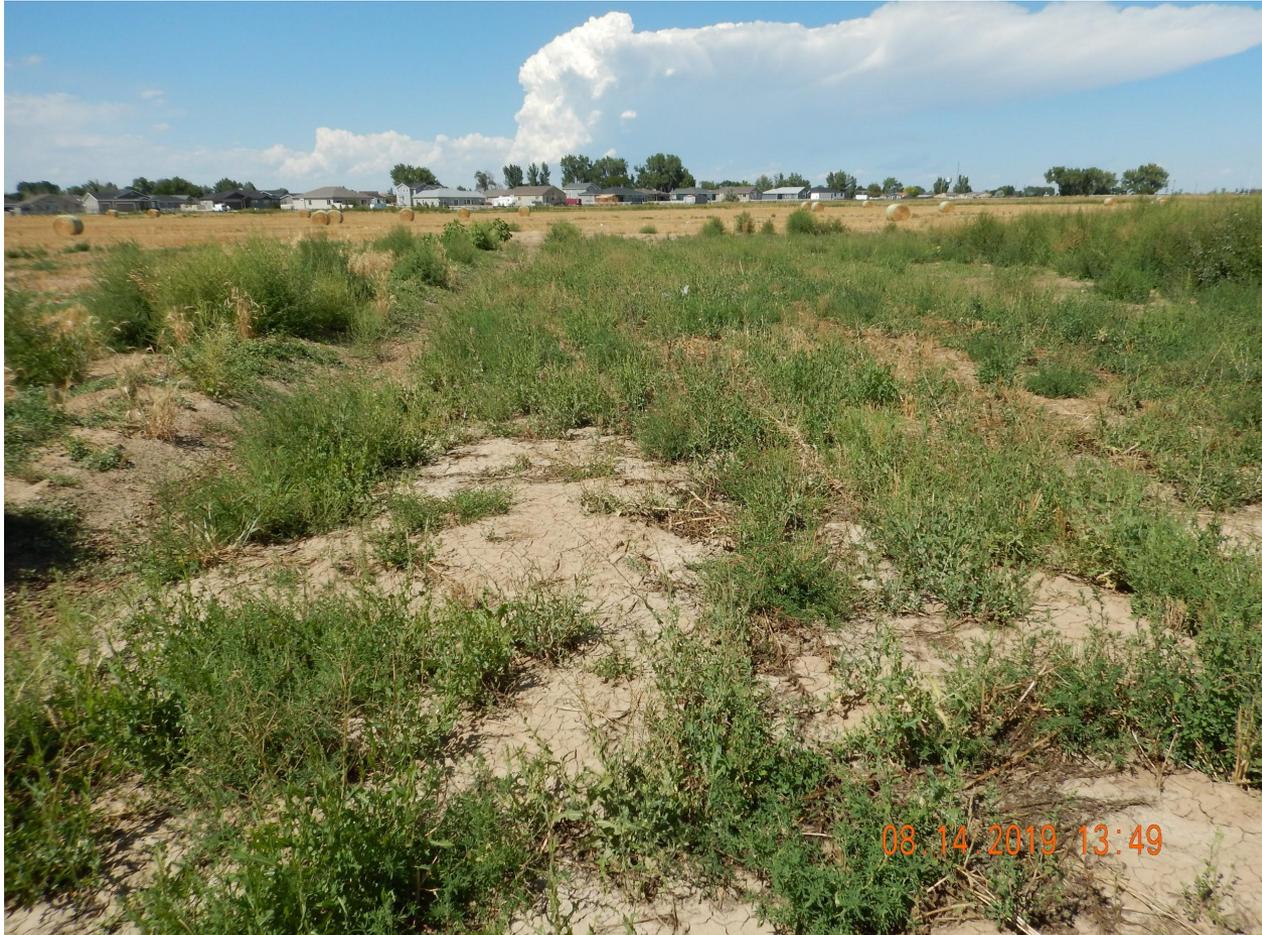
**Photo 12.** Photo taken from the western MLVT area, facing North. Photo illustrates unmanaged weeds.

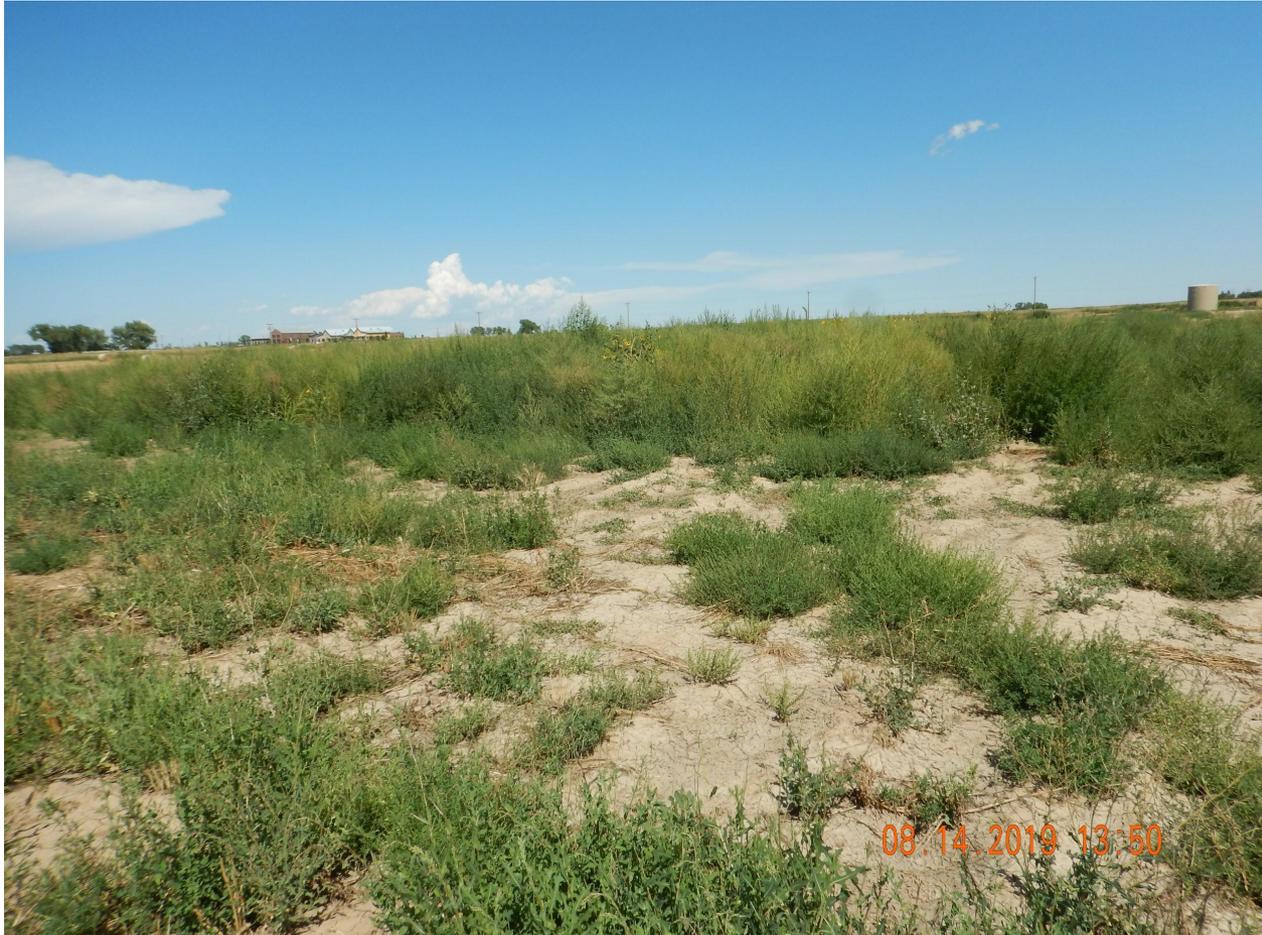
**Photo 13.** Photo taken from the western MLVT area, facing East. See comments under Photo 12.

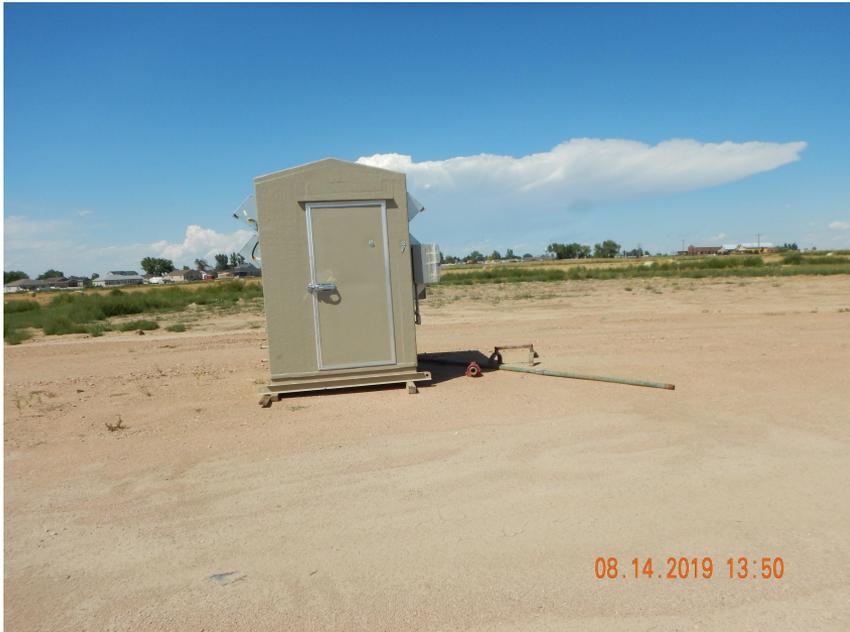
**Photo 14.** Photo taken from the northern well pad, facing North. Photo illustrates unused equipment on location.

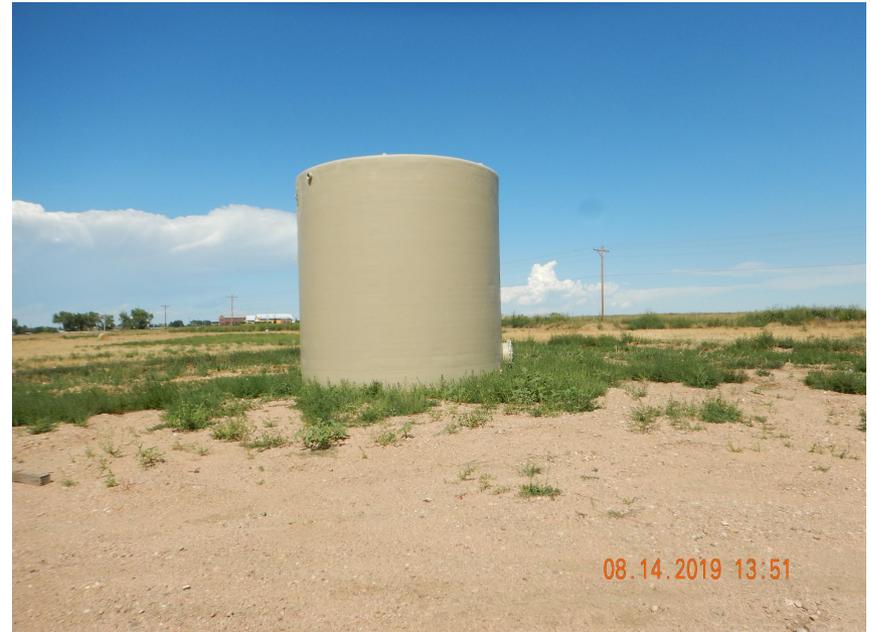
**Photo 15.** Photo taken from the northeastern well pad, facing Northeast. See comments under Photo 14.
