Inspection Photos
Location Name: OASIS 42-28
API#: 05-071-06427
INSP. #: 695101188

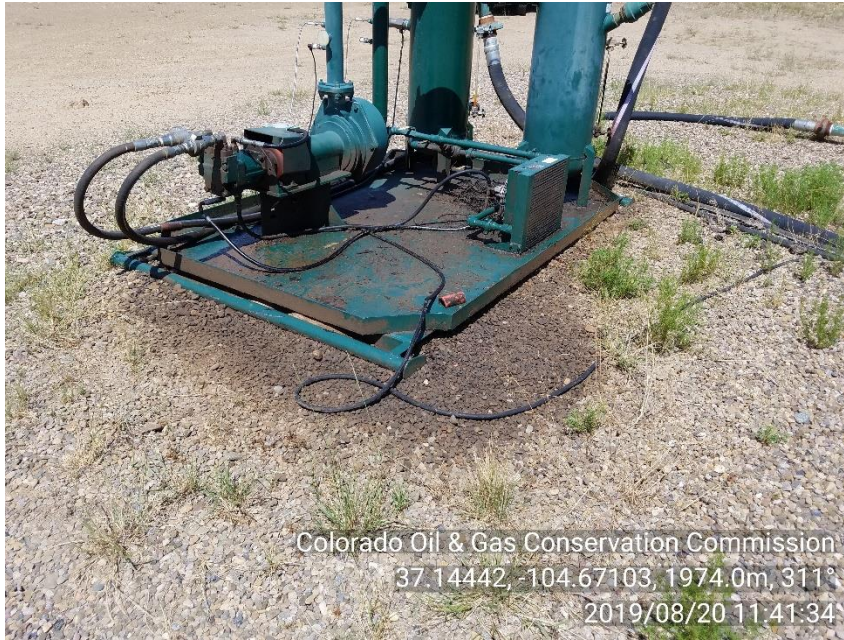
PHOTO 3: AREA OF IMPACTED SOIL NEAR COMPRESSOR.
Remove and dispose impacted material in approved manner, service and maintain equipment and self inspect to prevent recurrence of conditions per 1002.f(2) and 907. CA DATE 9/20/19.

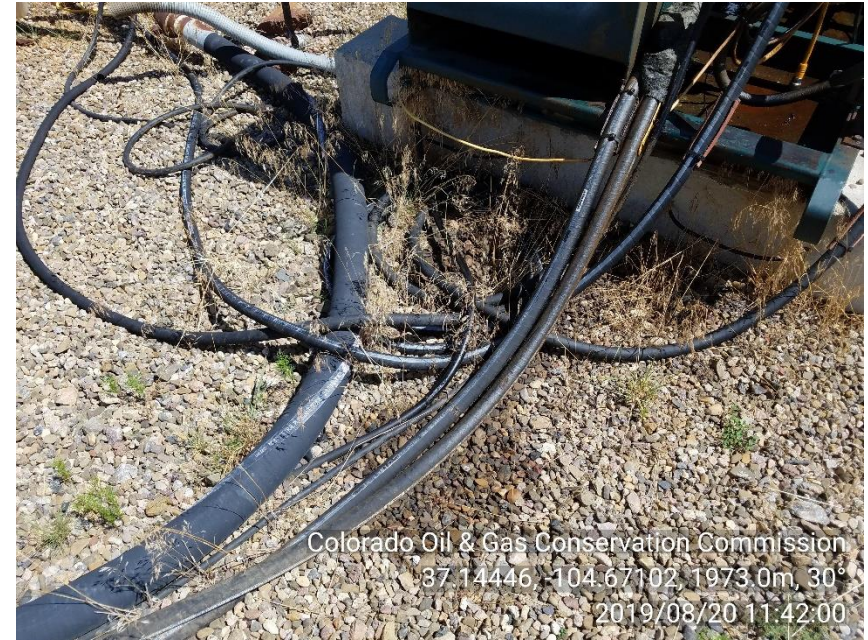
PHOTO 4: AREA OF IMPACTED SOIL NEAR HYDRAULIC CONNECTIONS ON DRIVEHEAD ENGINE SKID. Remove and dispose impacted material in approved manner, service and maintain equipment and self inspect to prevent recurrence of conditions per 1002.f(2) and 907. CA DATE 9/20/19.
