PA 333-33

Location # 334955

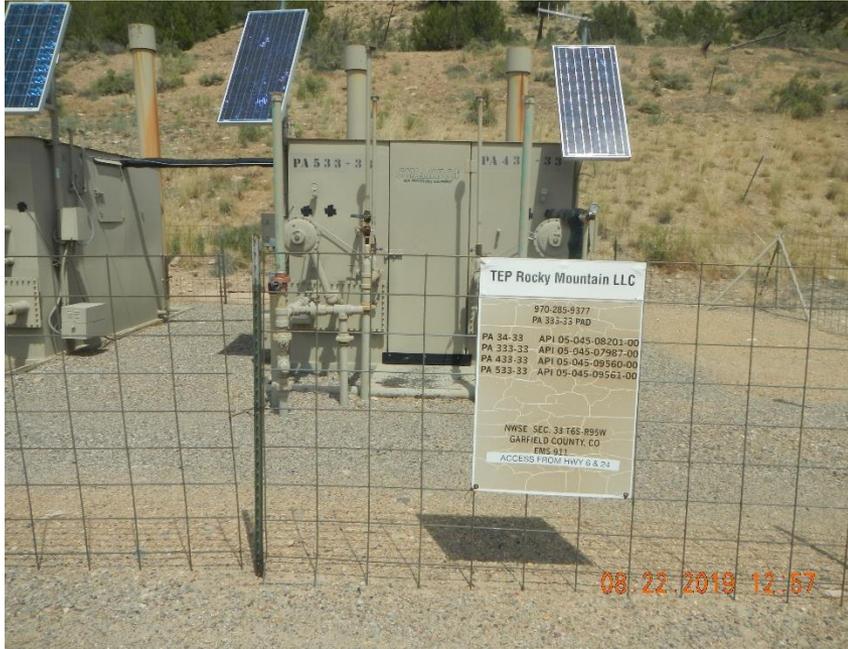
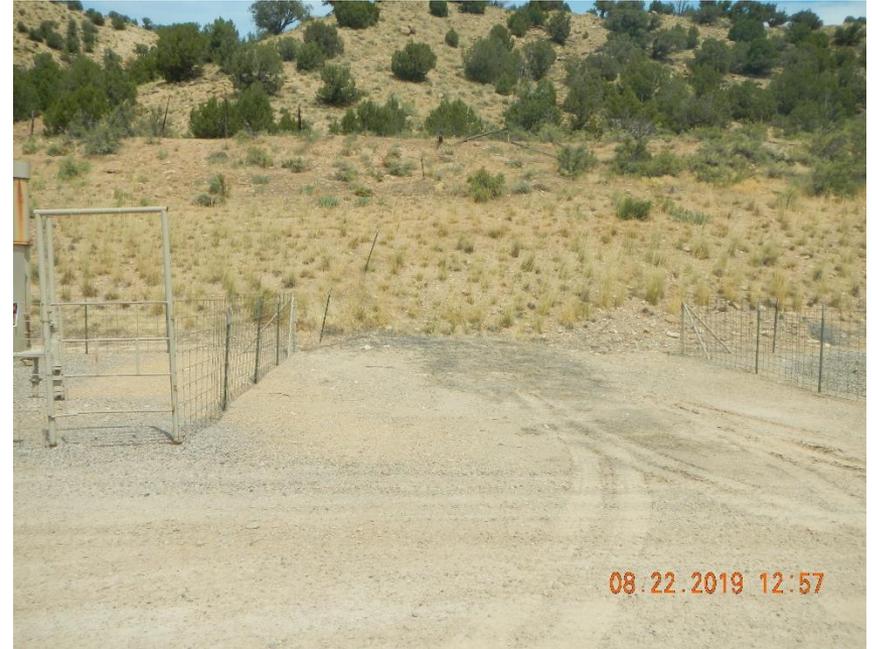
Weeds have been addressed from 1/8/2019 inspection # 689702382

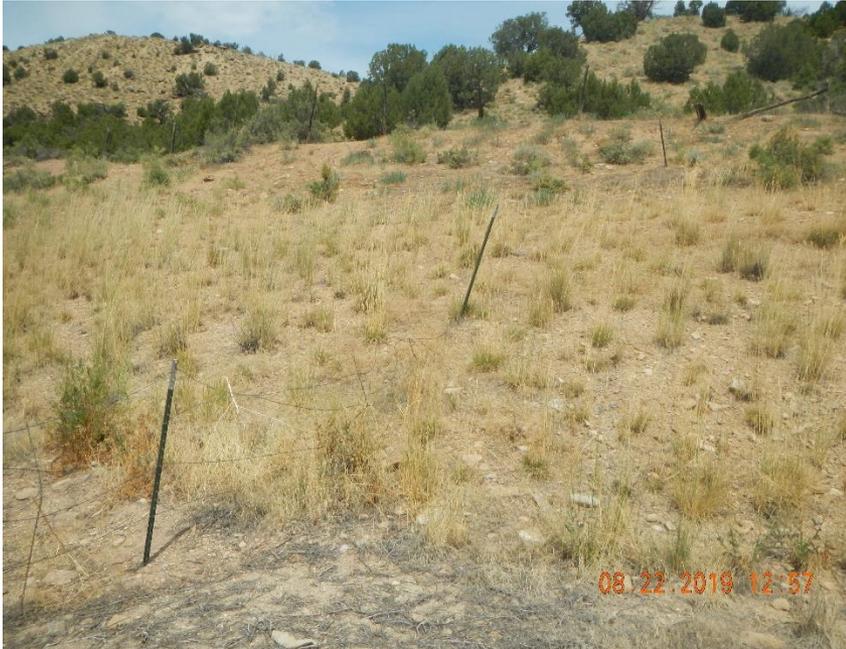
Barb wire fencing from separator fencing to location fencing is in disrepair.

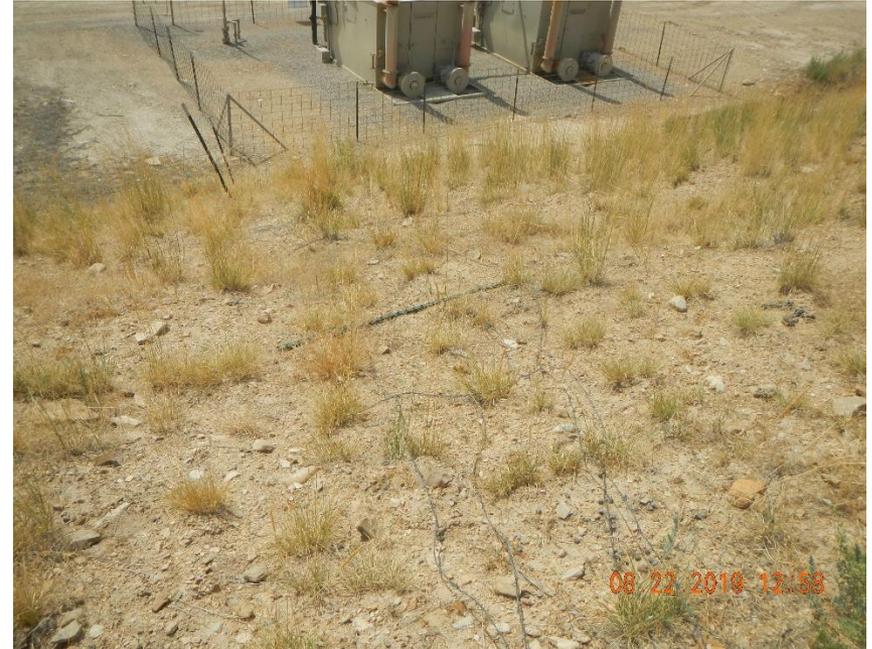
Barb wire fencing from separator fencing to location fencing is in disrepair.

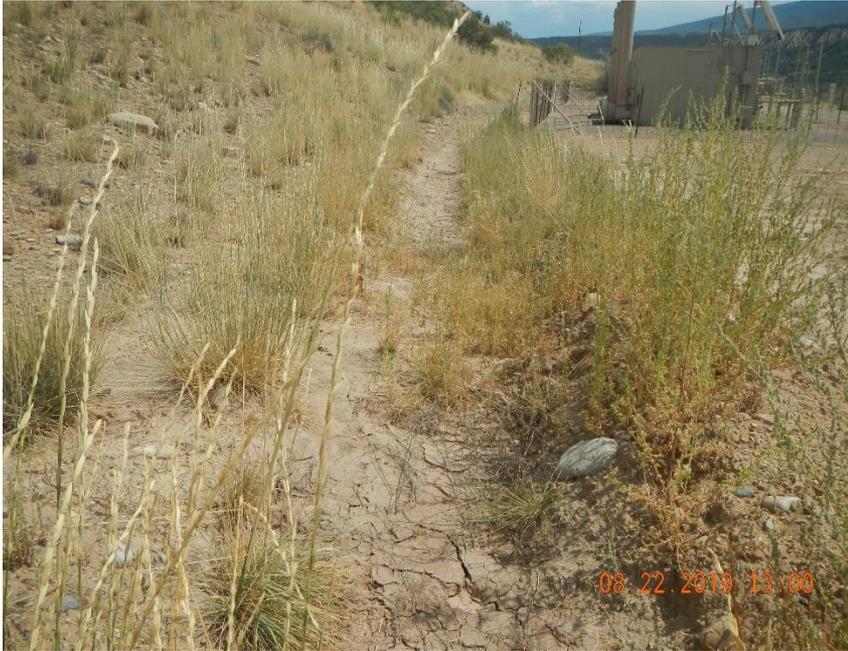
Sediment build up in diversion ditch.

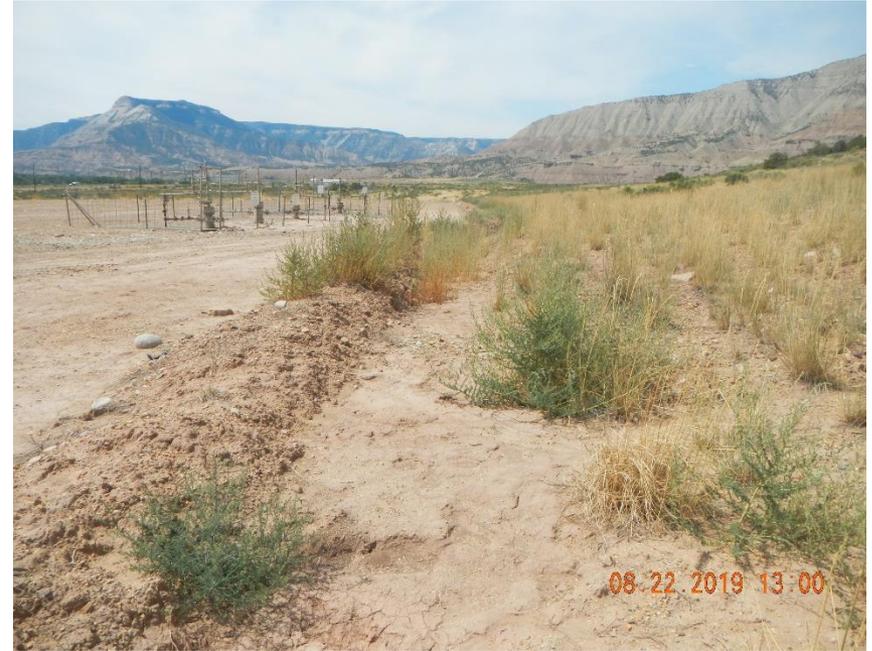
Sediment build up in diversion ditch.

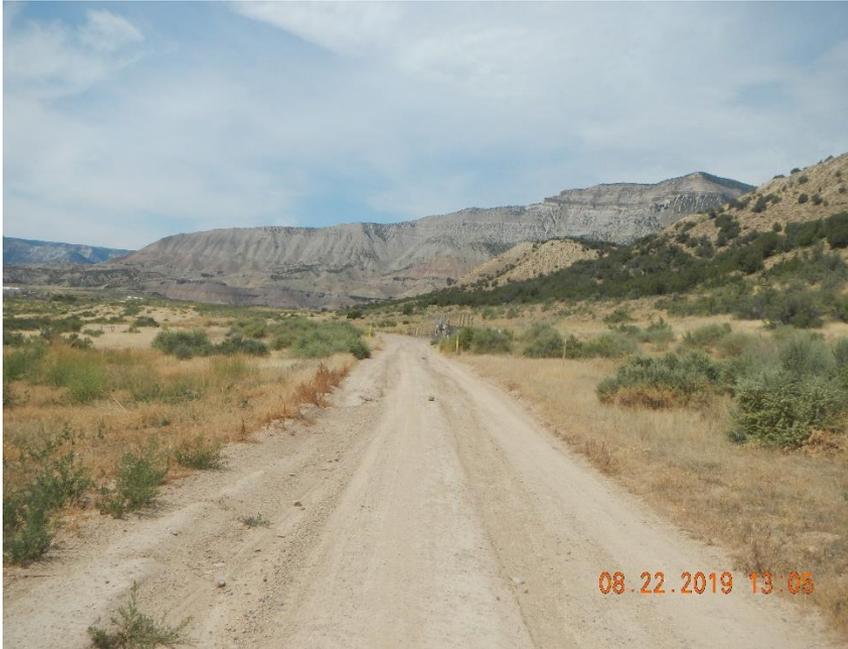
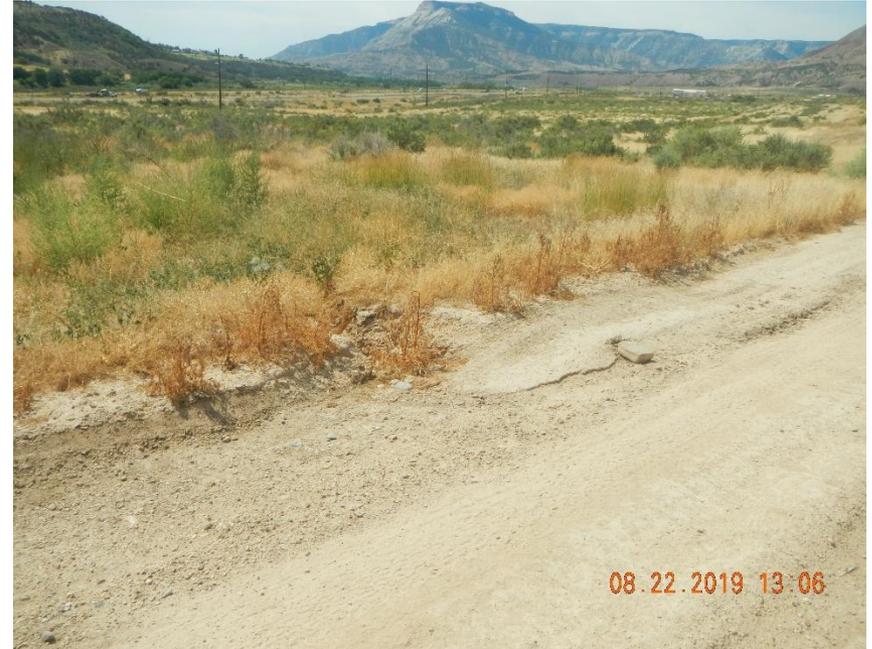
lease road from location # 323824 to location # 334955
Road rutted and needs maintained.

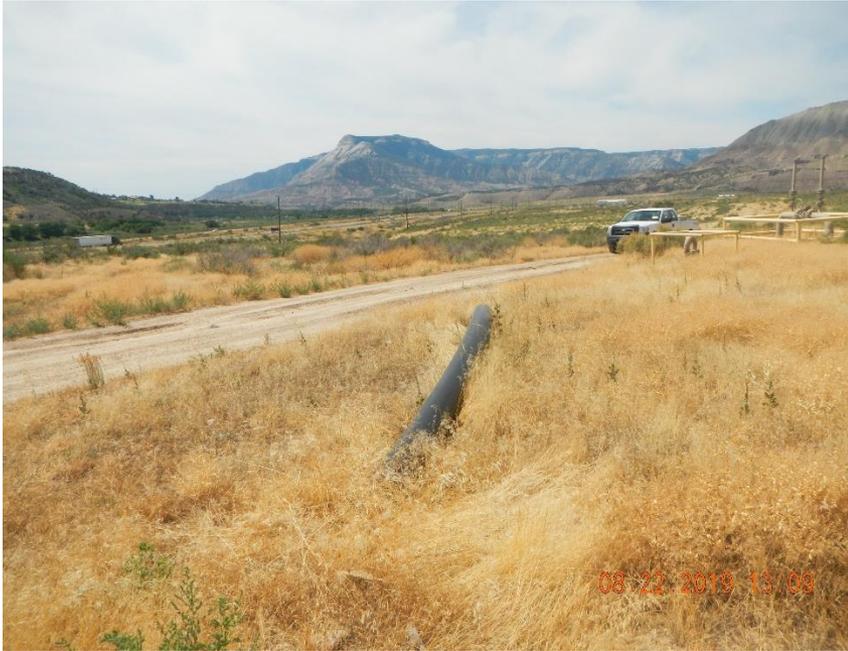
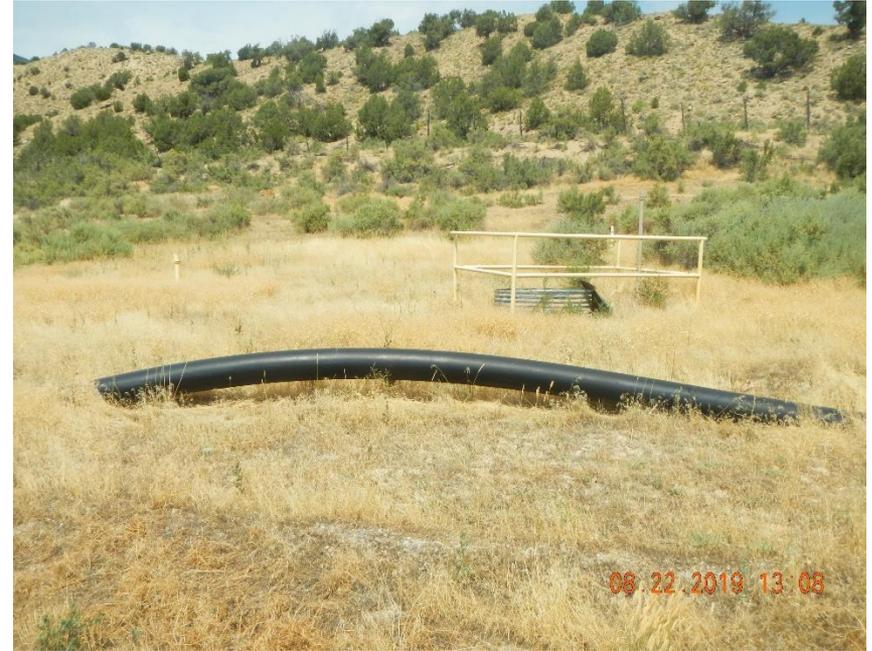
8" poly line running under lease road from location # 323824 to location # 334955.

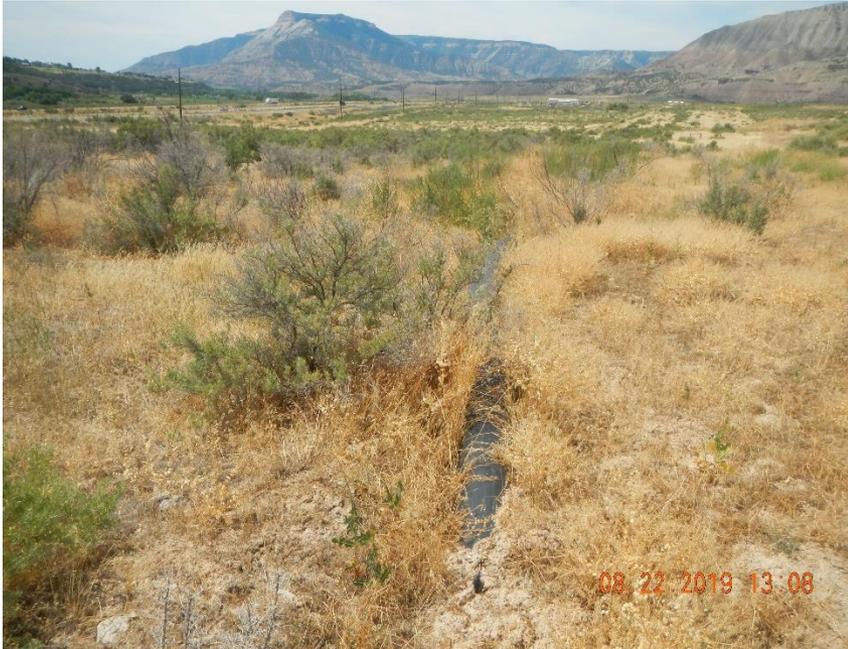
8" poly line running under lease road from location # 323824 to location # 334955.

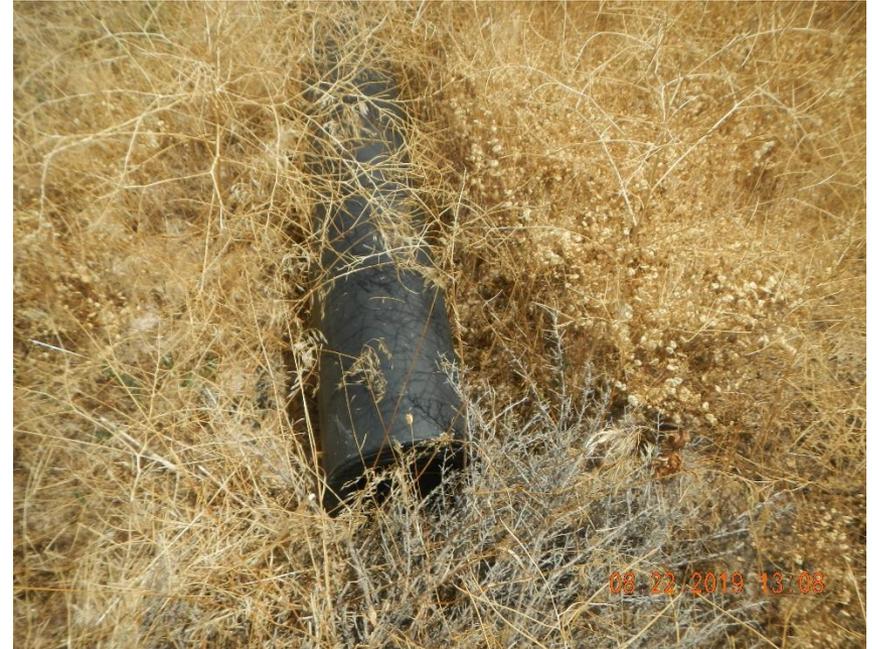
Line comes out on south side road is above ground with an open end.
