**Inspection Photos**  
**Location Name: Cleveland #2**  
**Location ID: 332884**

Colorado Oil and Gas Conservation Commission  
Aug 27, 2019 14:35:01

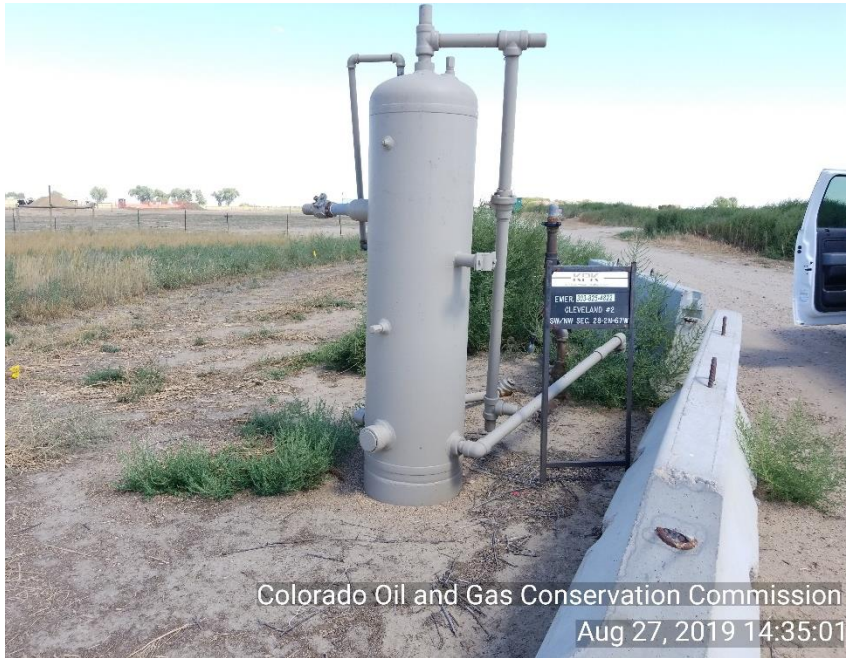
**Photo 1 WH Sign all production flow lines have been disconnected from WH and flow lines are closed on well head. Well is TA**

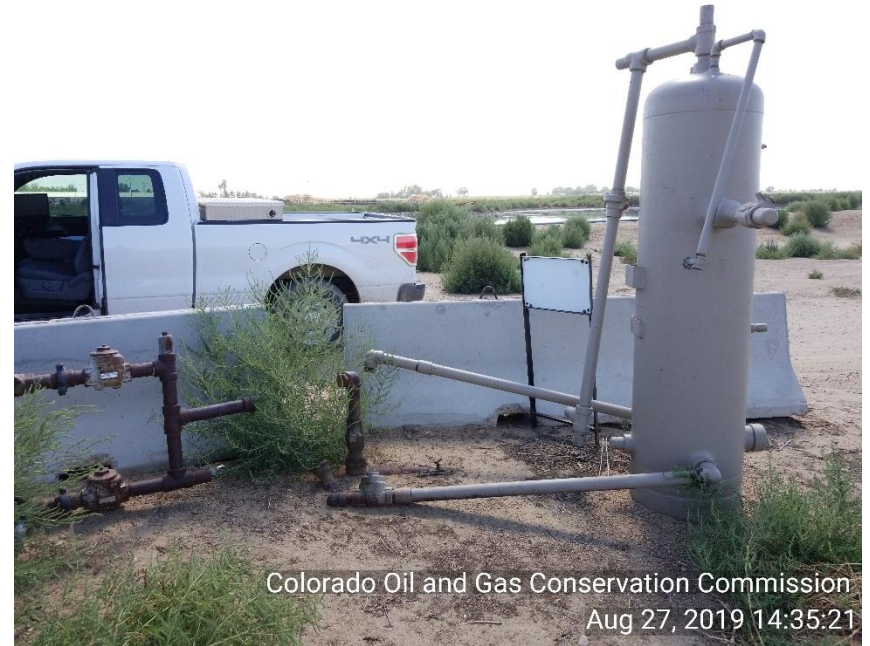
**Photo 2 Unused equipment: Separator**

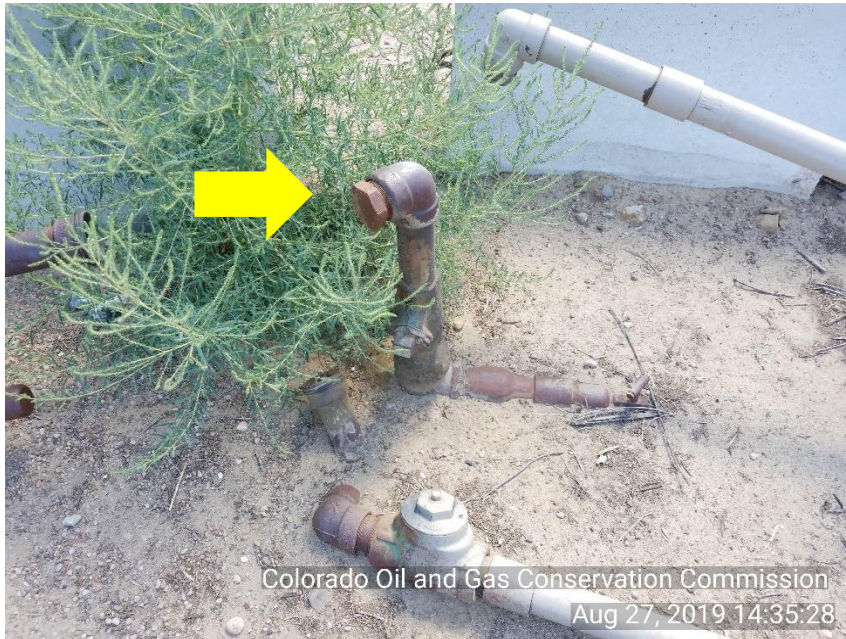
**Photo 3 Unused equipment: Unmarked, unused not LOTO riser.**

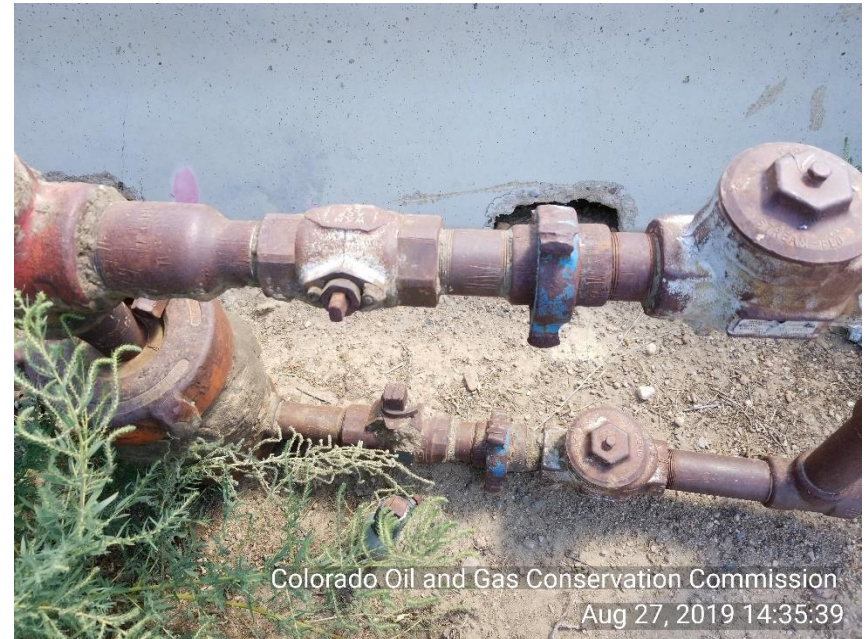
**Photo 4 Production flow lines on well head are closed.**

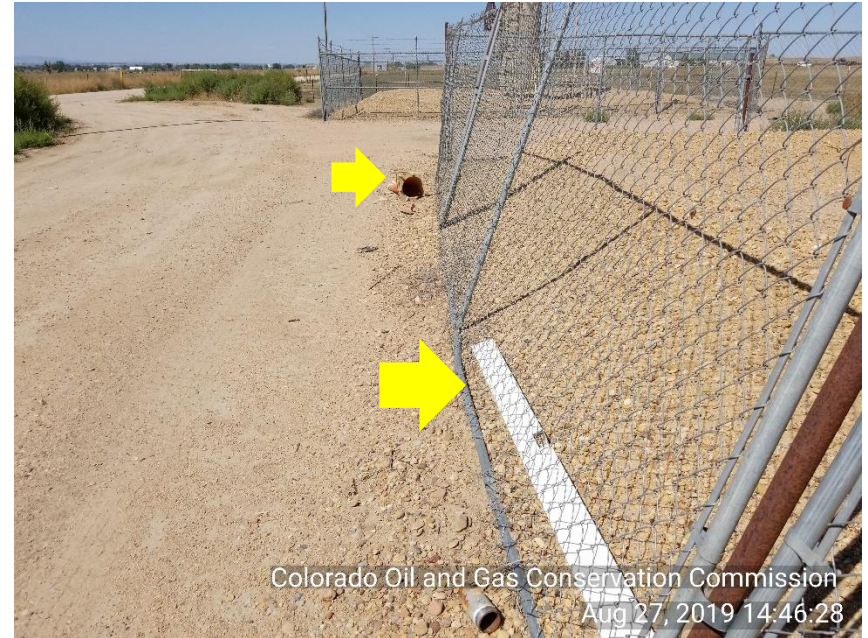
**Photo 6 Misc.. Trash**

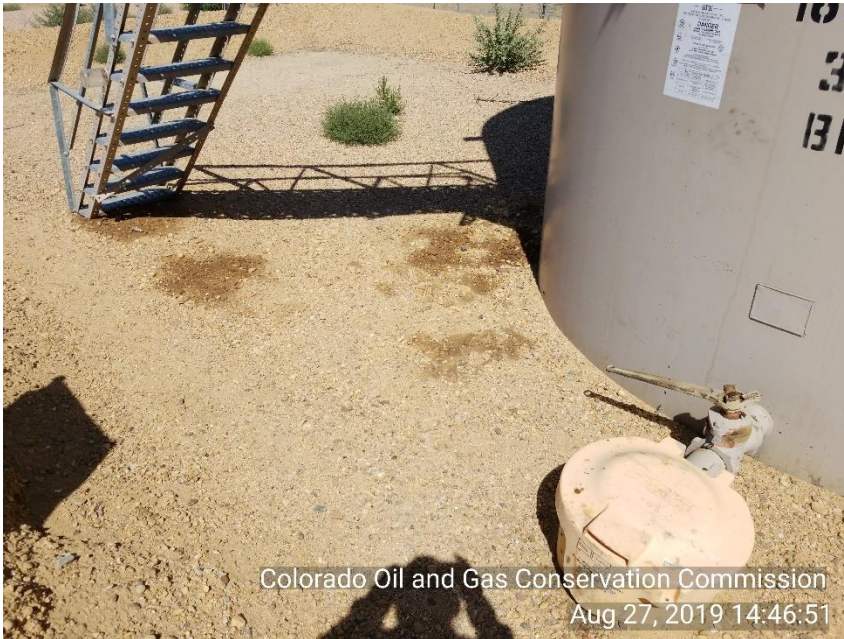
**Photo 7 Stained soil around Crude oil tank**

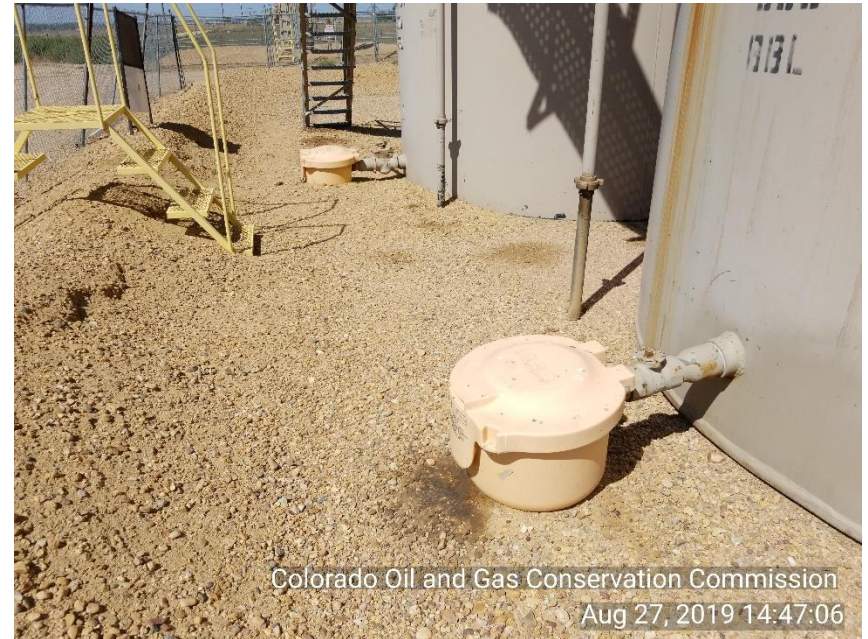
**Photo 8 Stained soil under produced water load line.**

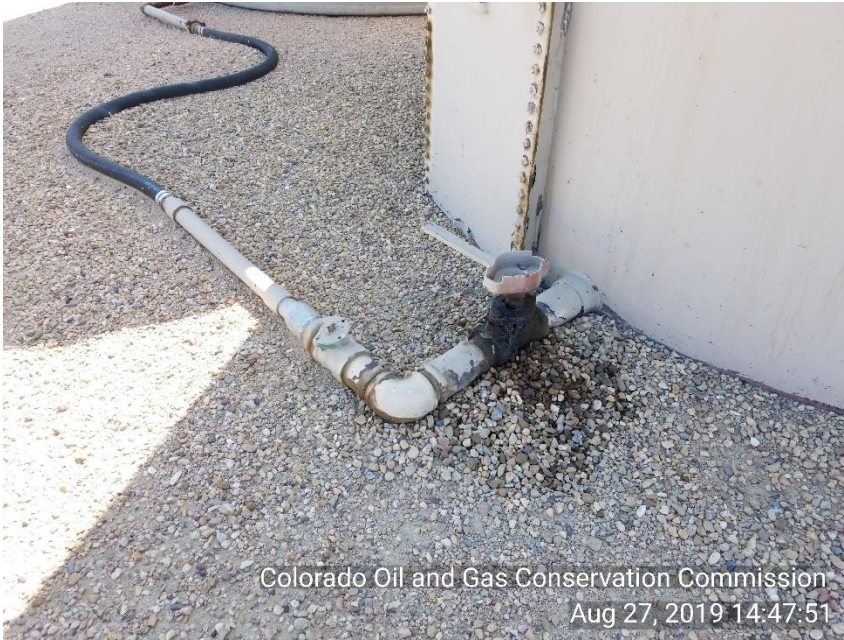
**Photo 9 Stained soil around produced water tank**

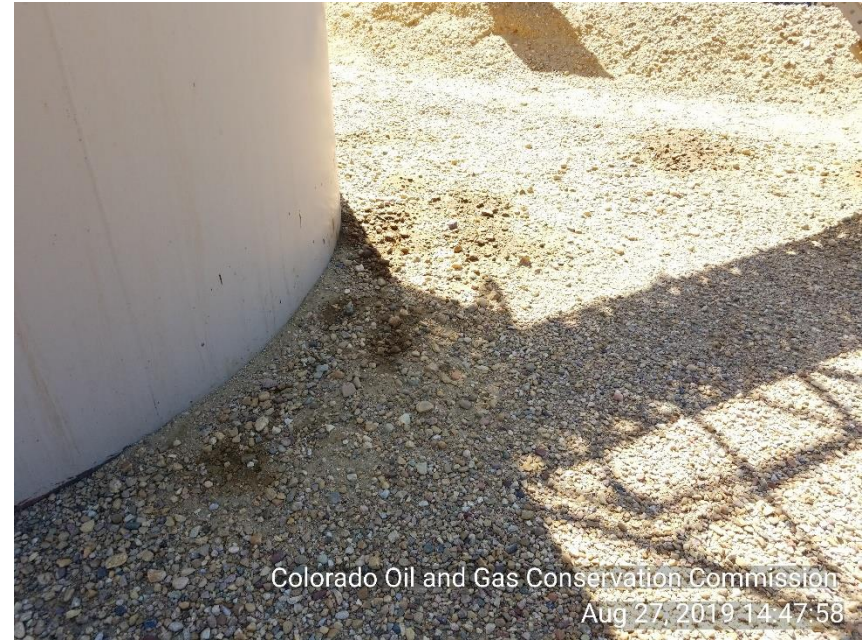
**Photo 10 Stained soil around crude oil tank.**

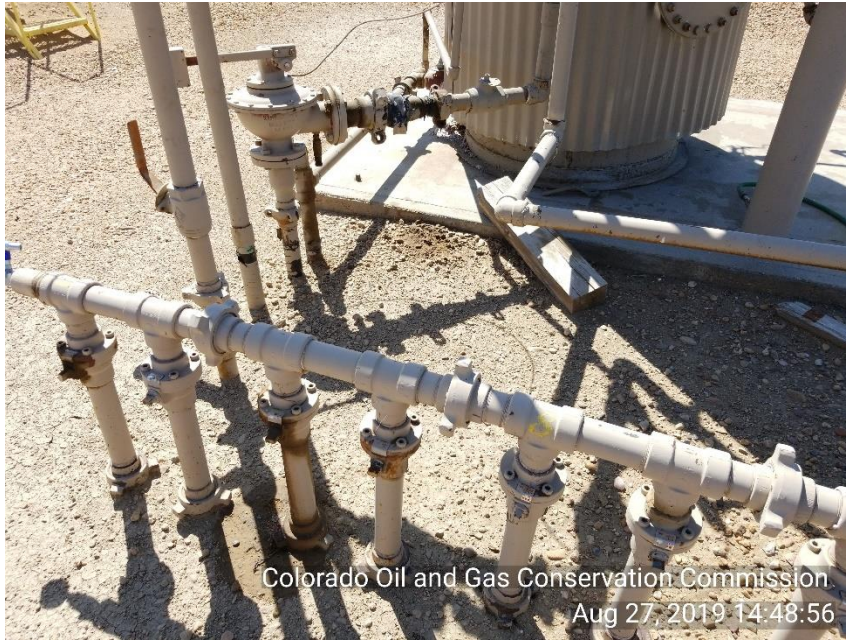
**Photo 11 Stained soil under Hoz sep piping**

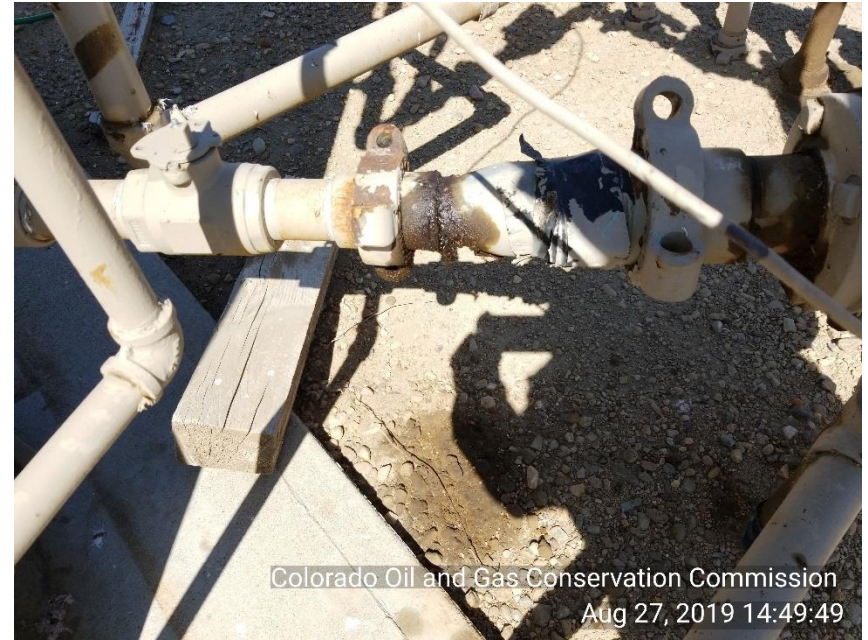
**Photo 12 Stained soil under Hoz sep piping. Mechanical issue 2" piping leaking.**

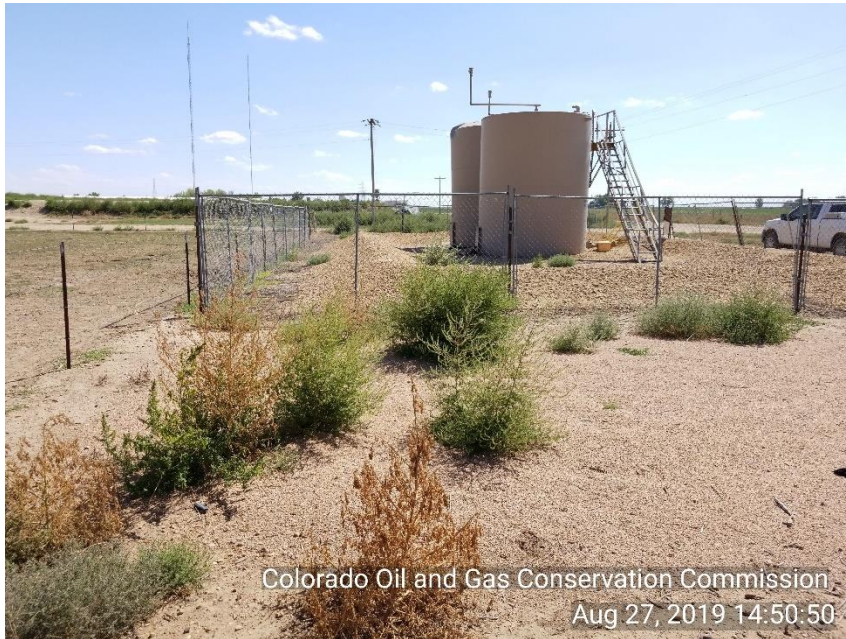
**Photo 13 Weeds on TNK BTRY site**

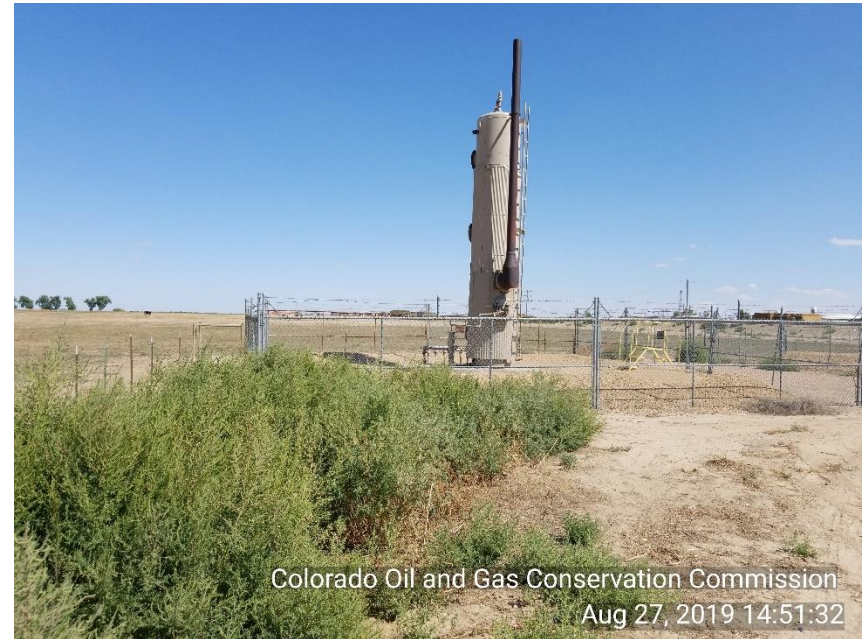
**Photo 14 Weeds on TNK BTRY site**

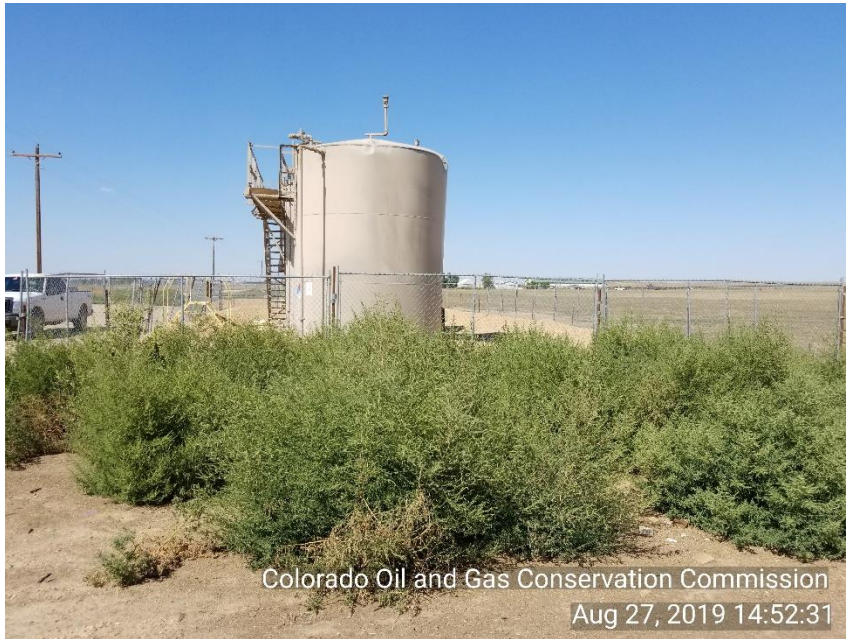
**Photo 15 Weeds on TNK BTRY site**
