# Inspection Photos

API: 05-041-06065

Operator: ULTRA RESOURCES INC

Inspection Date: 8/27/2019

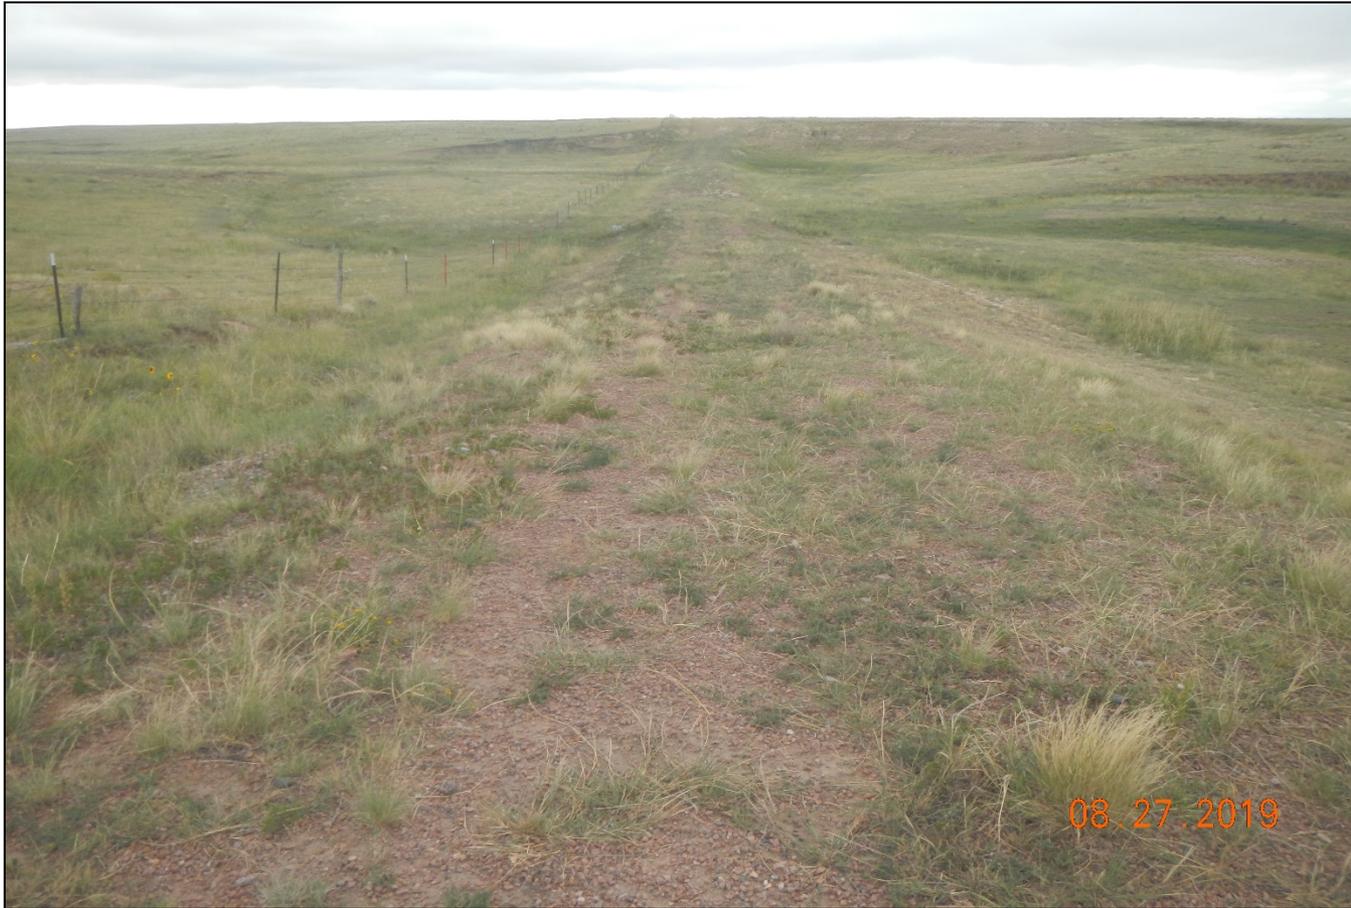
**Photo 1.** Facing south at the beginning of the access road.

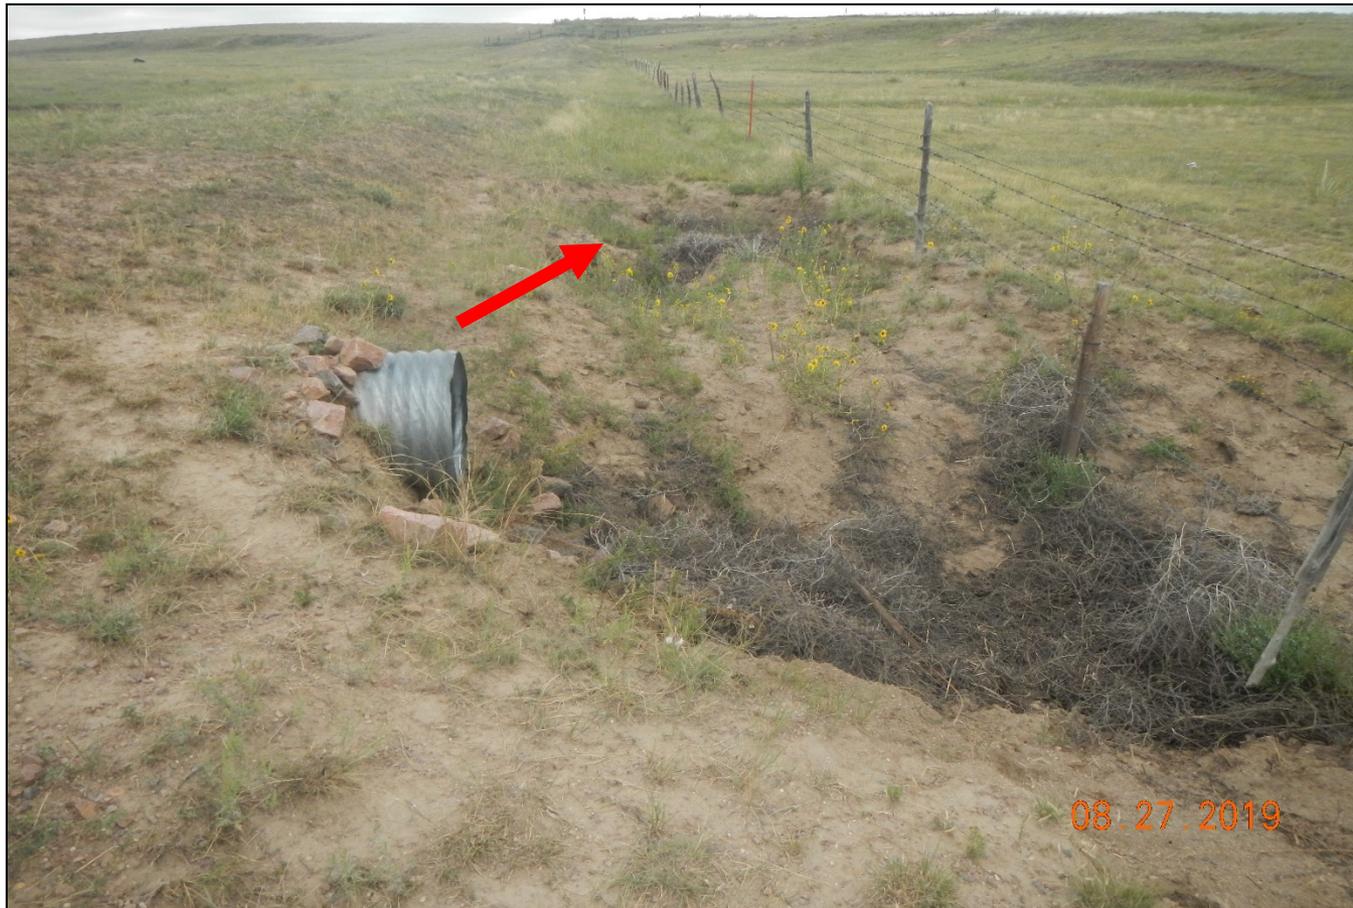
**Photo 2.** There is no outlet protection at the outlet of the culvert and signs of erosion.

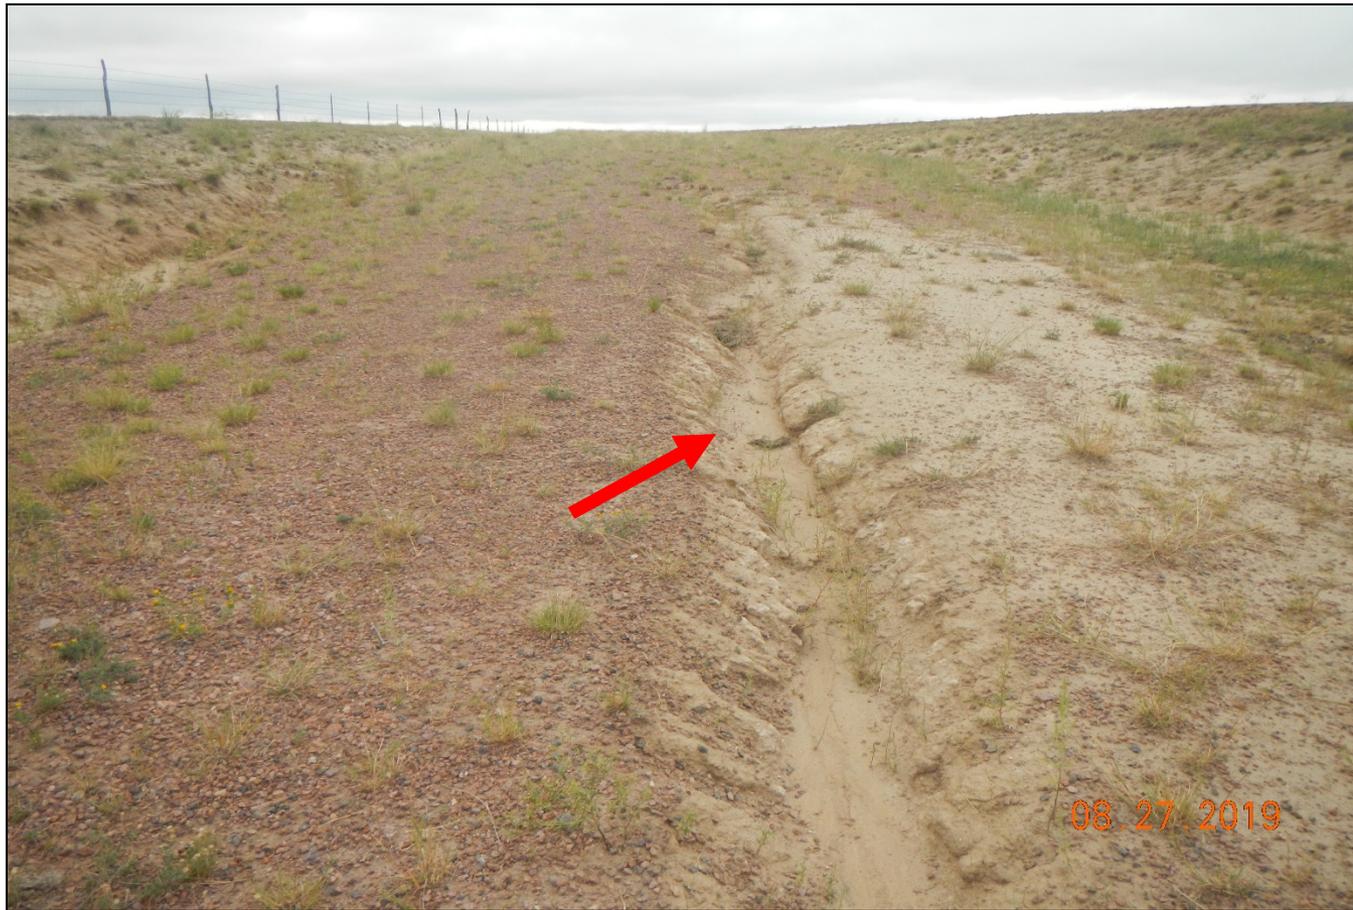
**Photo 3.** There is an erosion channel along the access road as it ascends the hill.

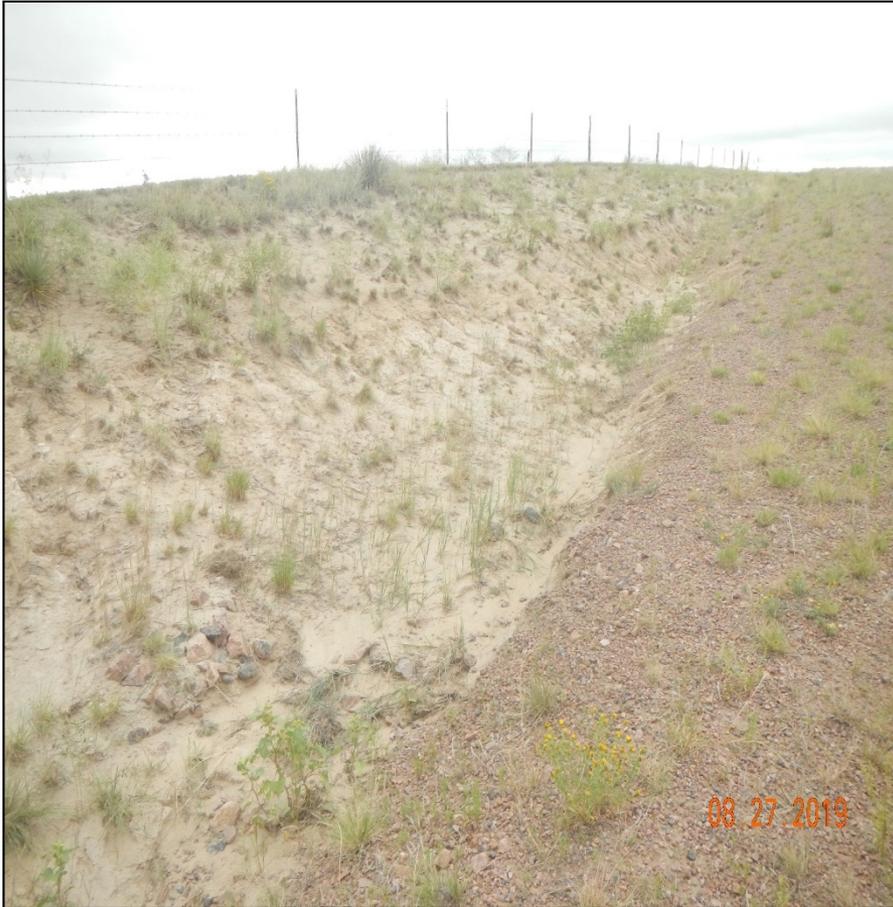
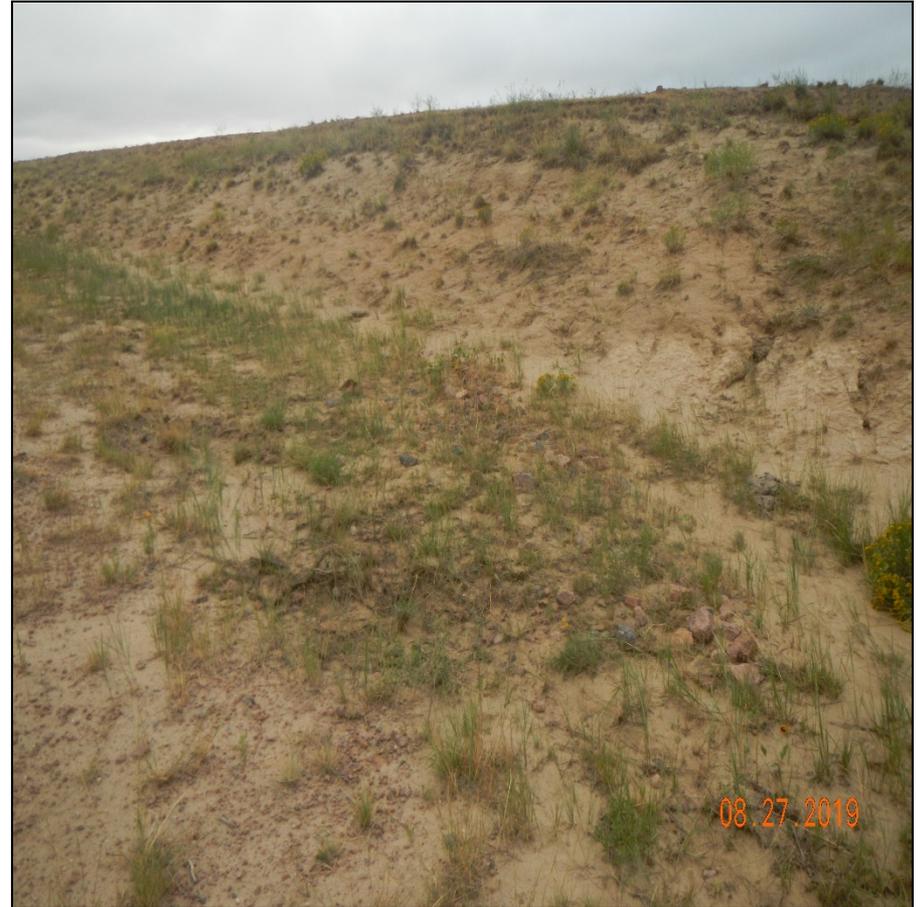
**Photo 4.** The sides of the access road as the road ascends the hill are not stabilized and no BMP's are present.

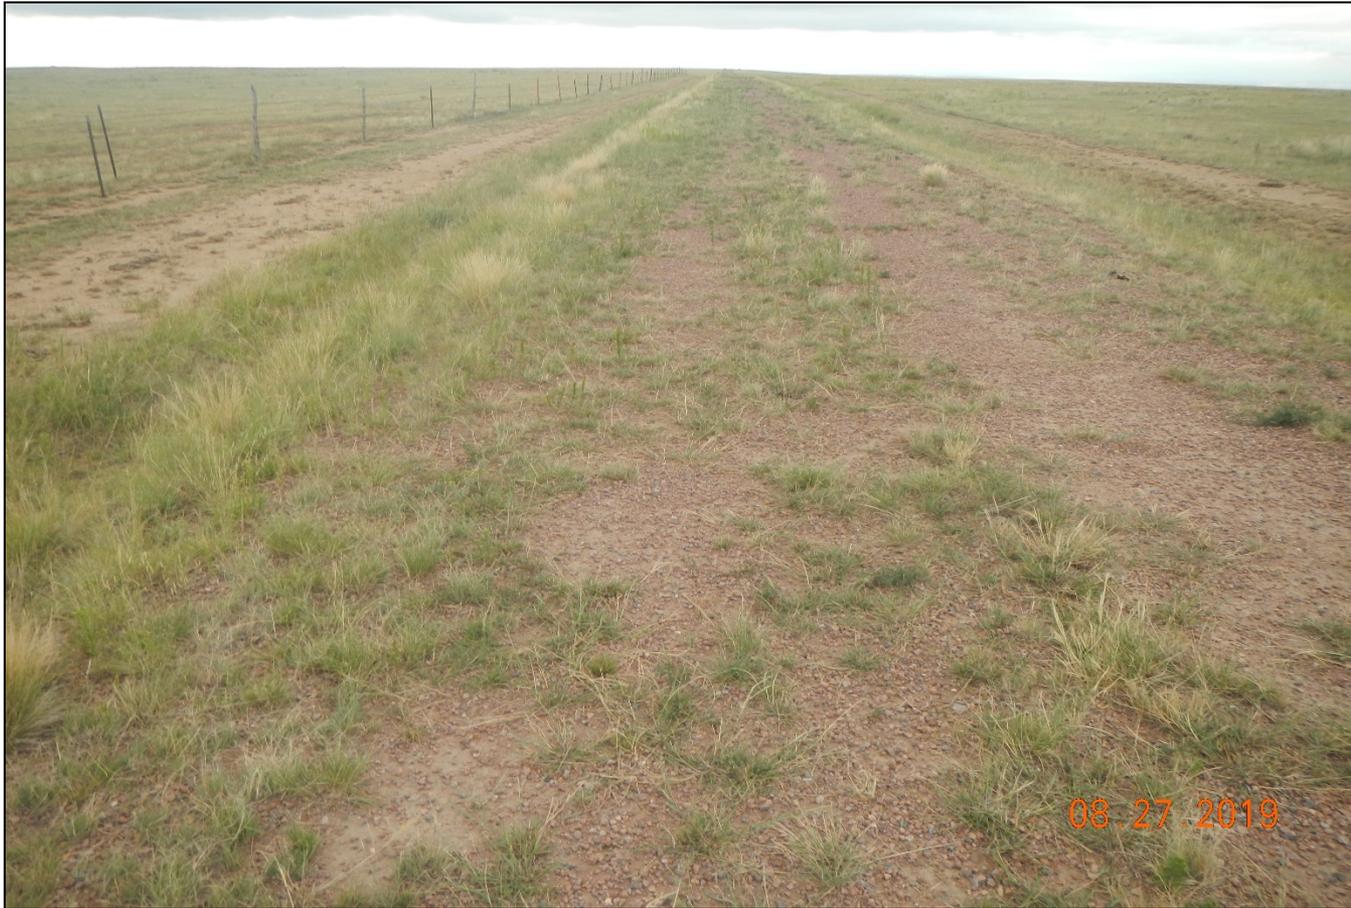
**Photo 5.** Facing south further along the access road.

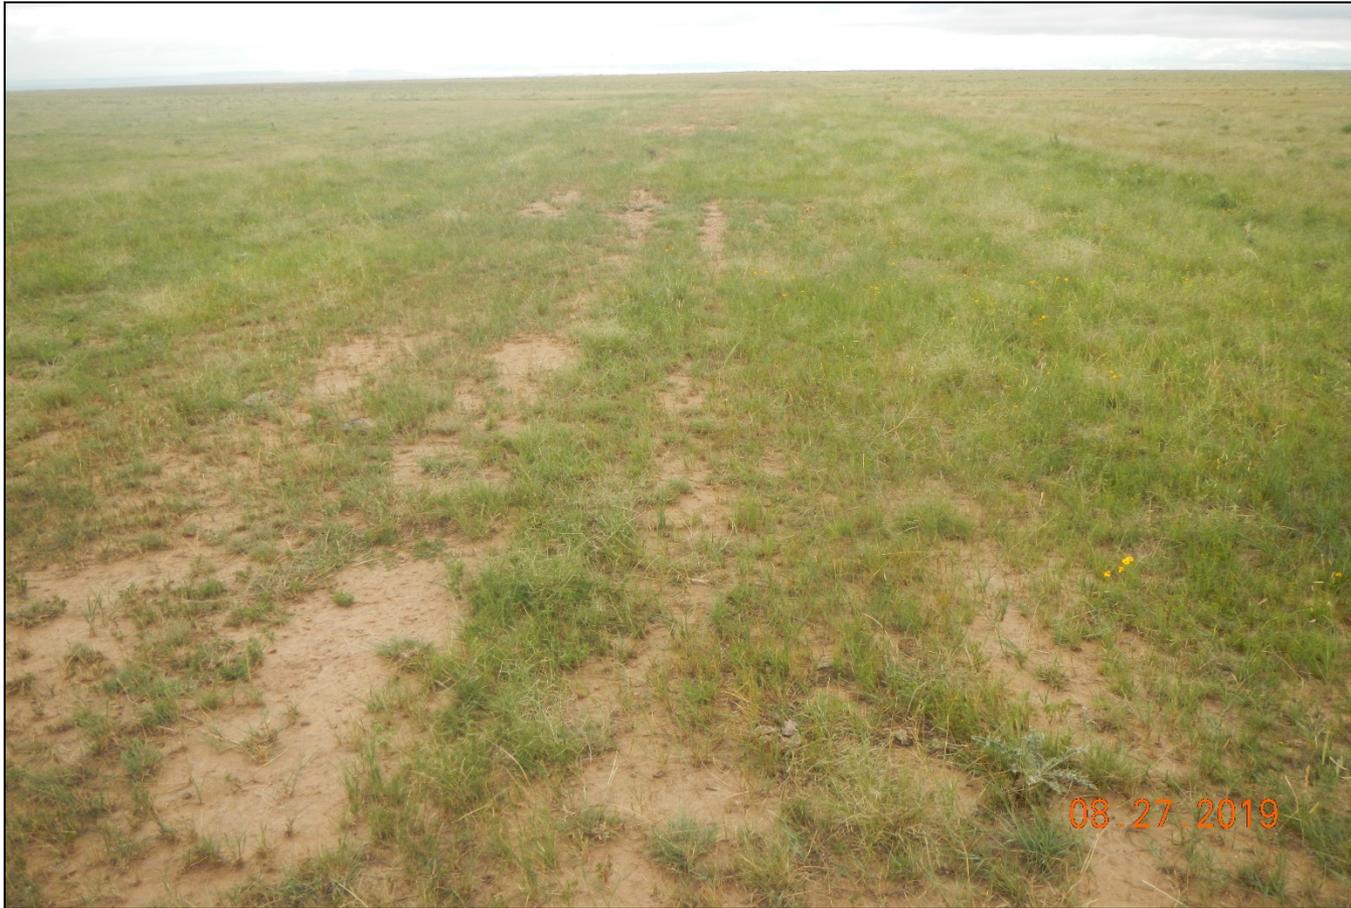
**Photo 6.** Facing southwest along the reclaimed access road.

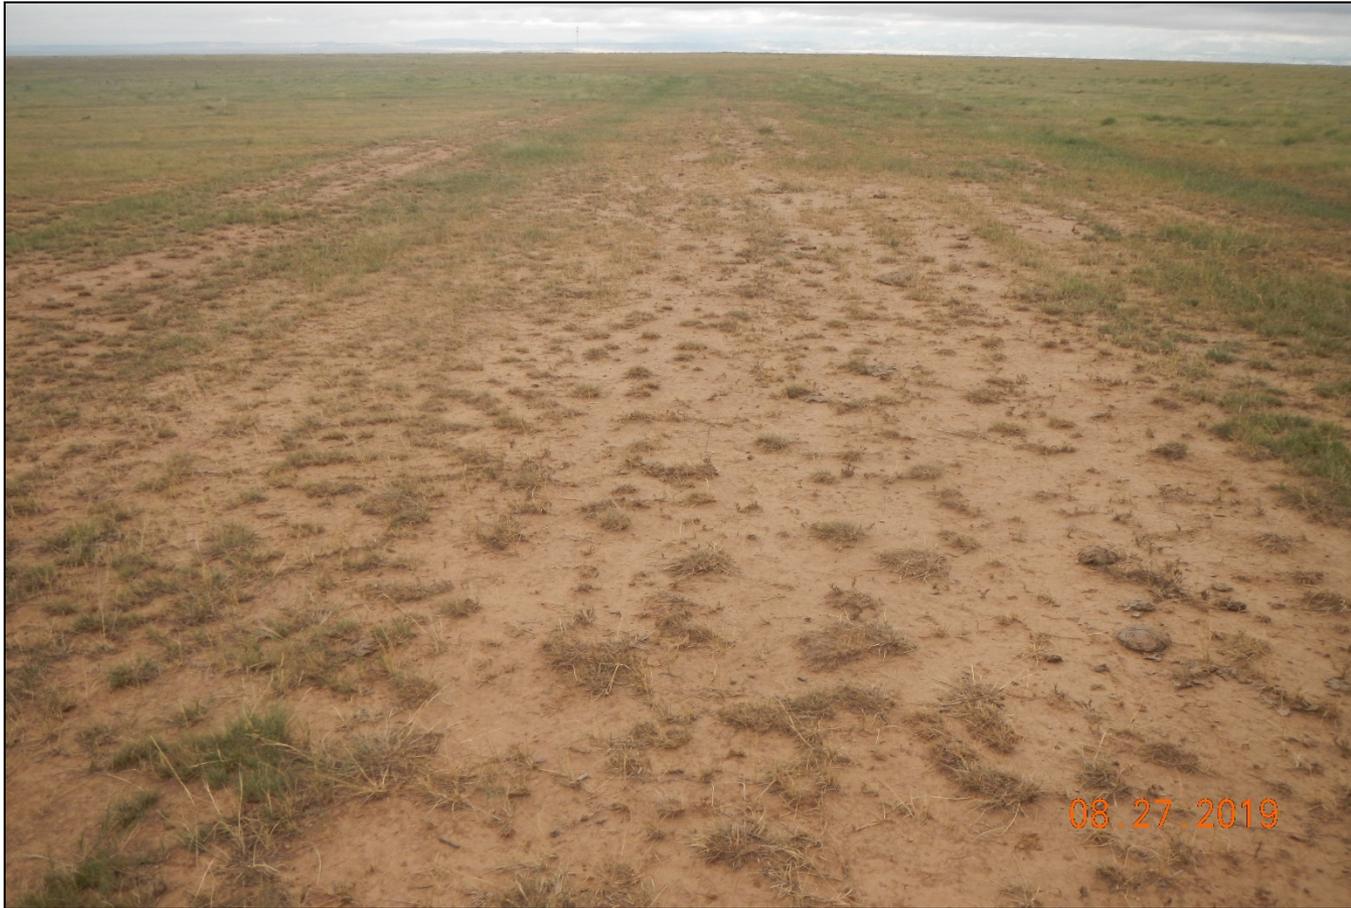
**Photo 7.** This area along the access road has not reached 80% vegetation cover.

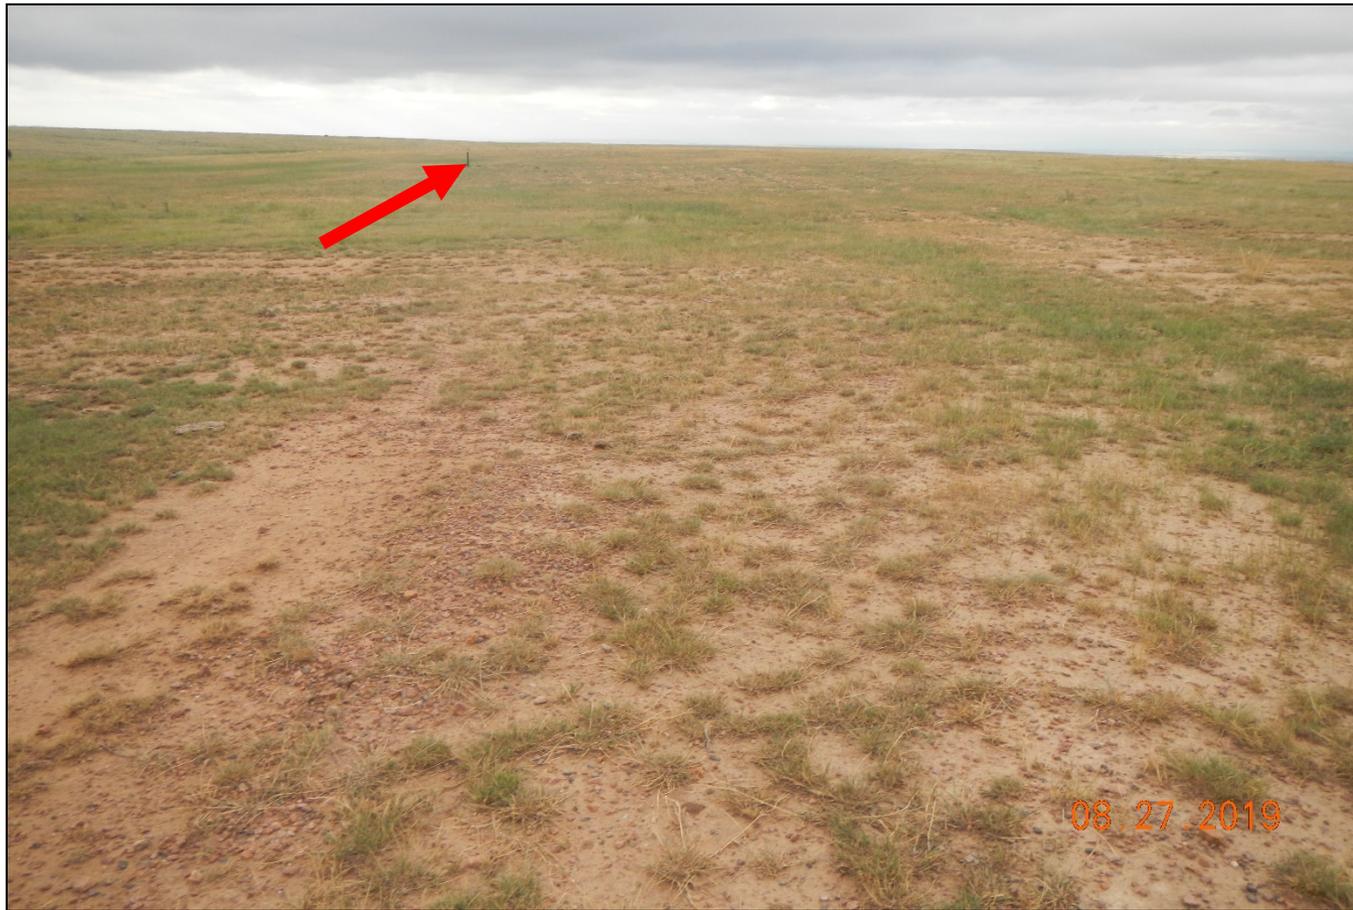
**Photo 8.** Facing south toward the location. Red arrow points to well marker.

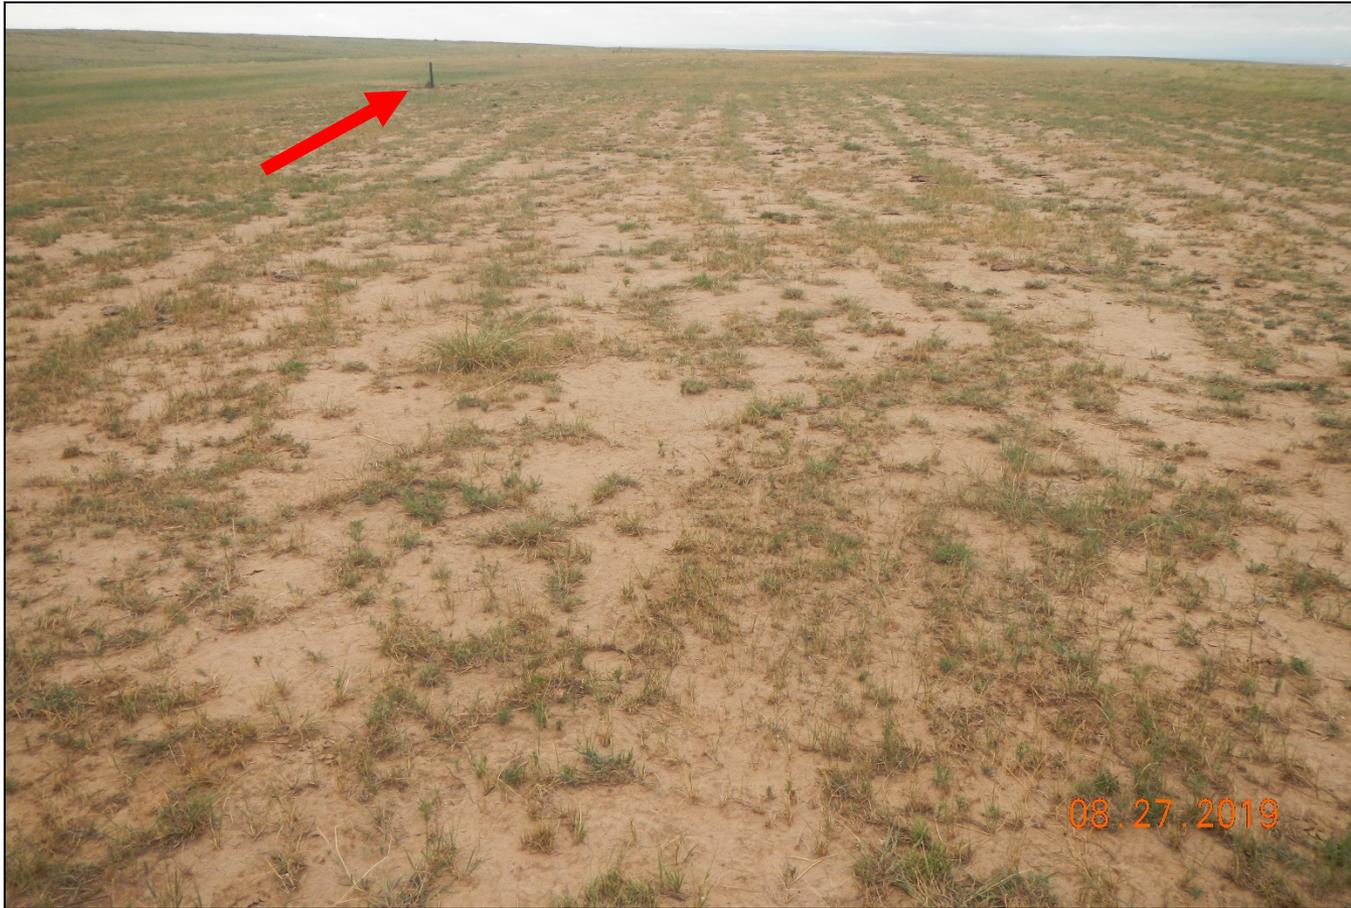
**Photo 9.** This area at the location has not reached 80% vegetation cover. Red arrow points to well marker.

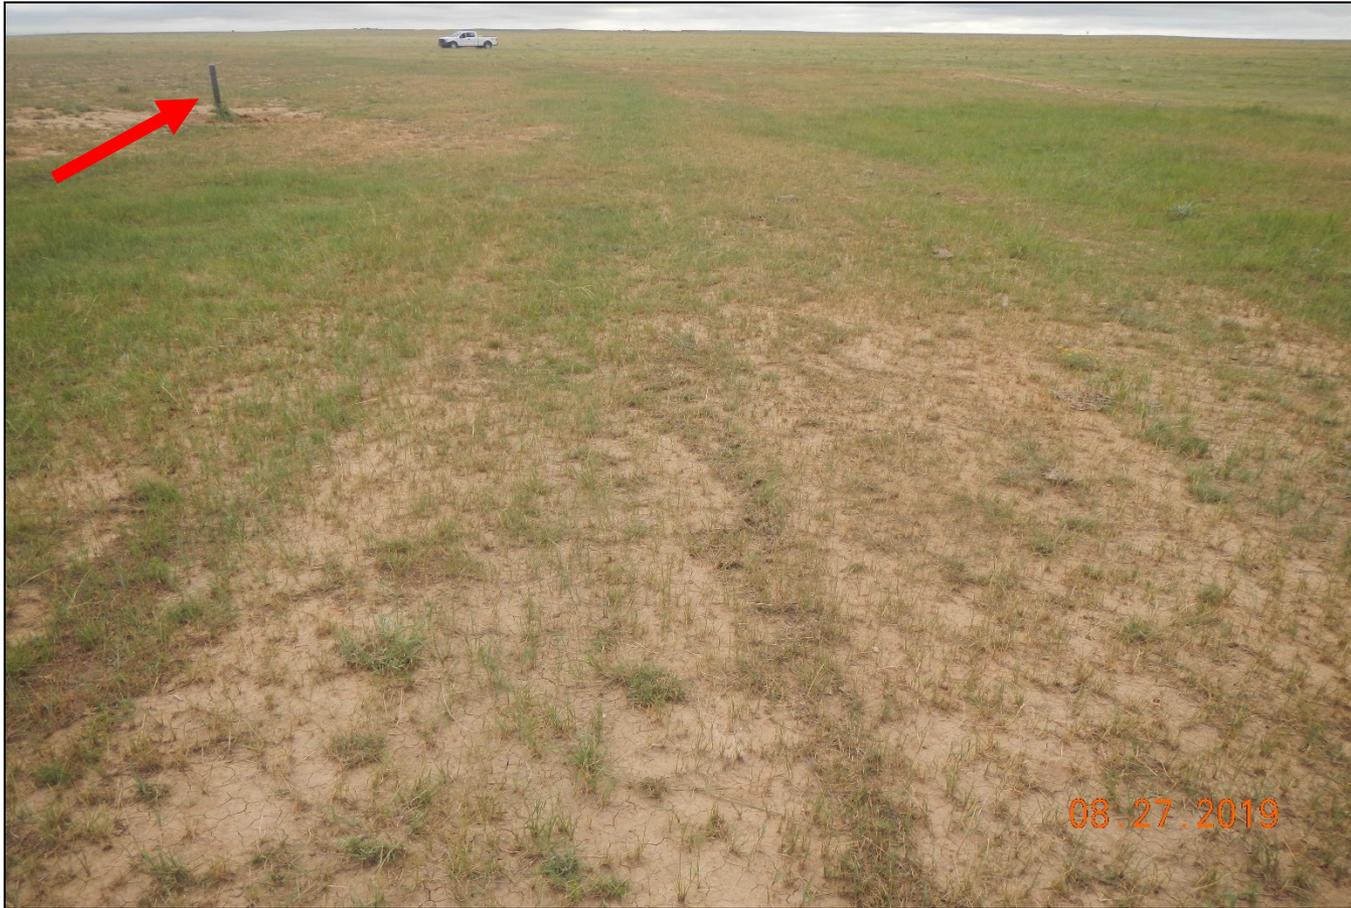
**Photo 10.** Facing north at the east side of the location. Vegetation is well established in this area. Red arrow points to well marker.

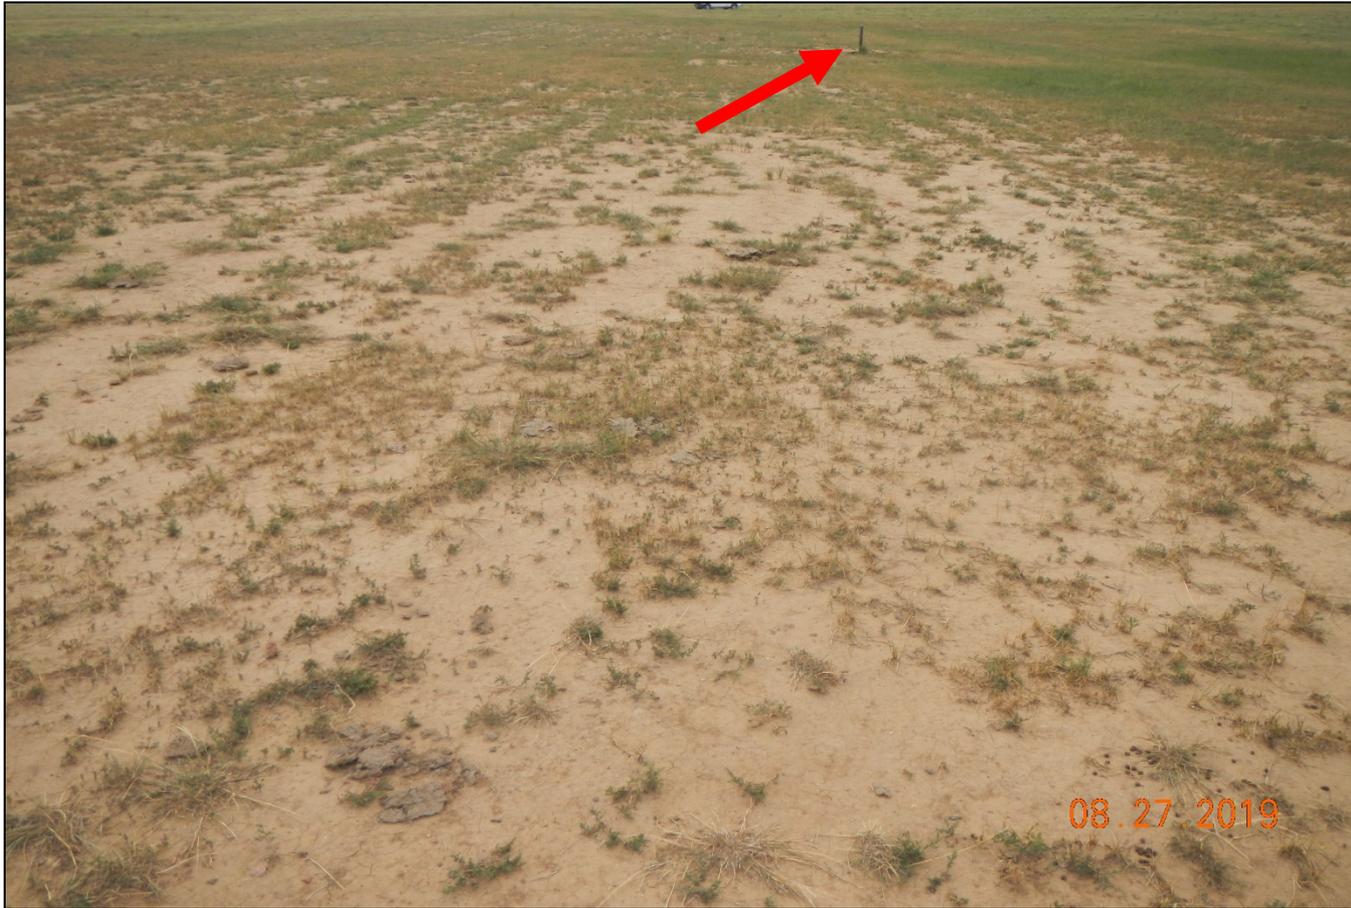
**Photo 11.** Facing north at the west side of the location. This area at the location has not reached 80% vegetation cover. Red arrow points to well marker.

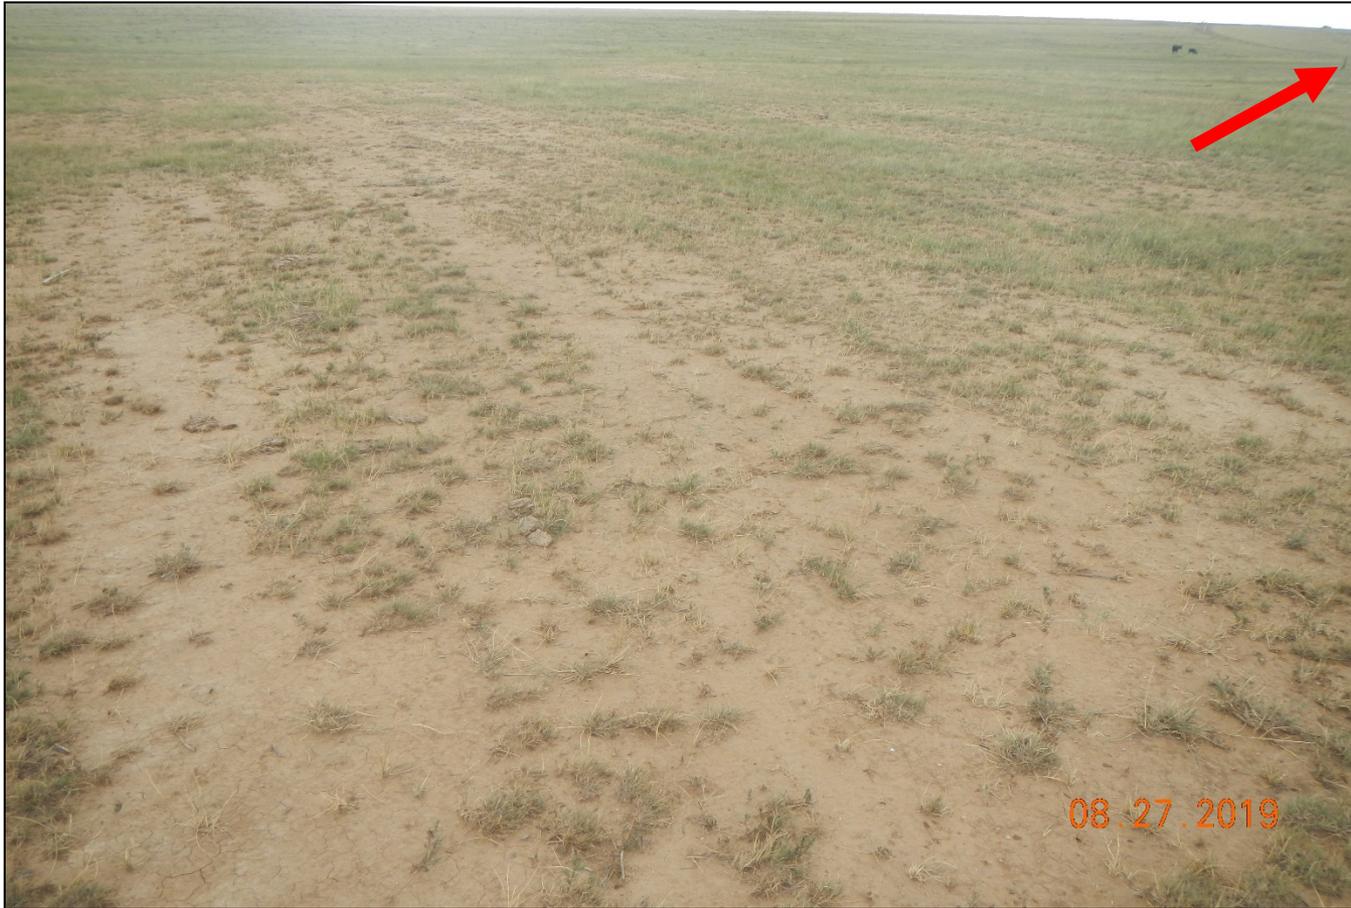
**Photo 12.** Facing southeast at the disturbance area northwest of the well site. Red arrow points to well marker.

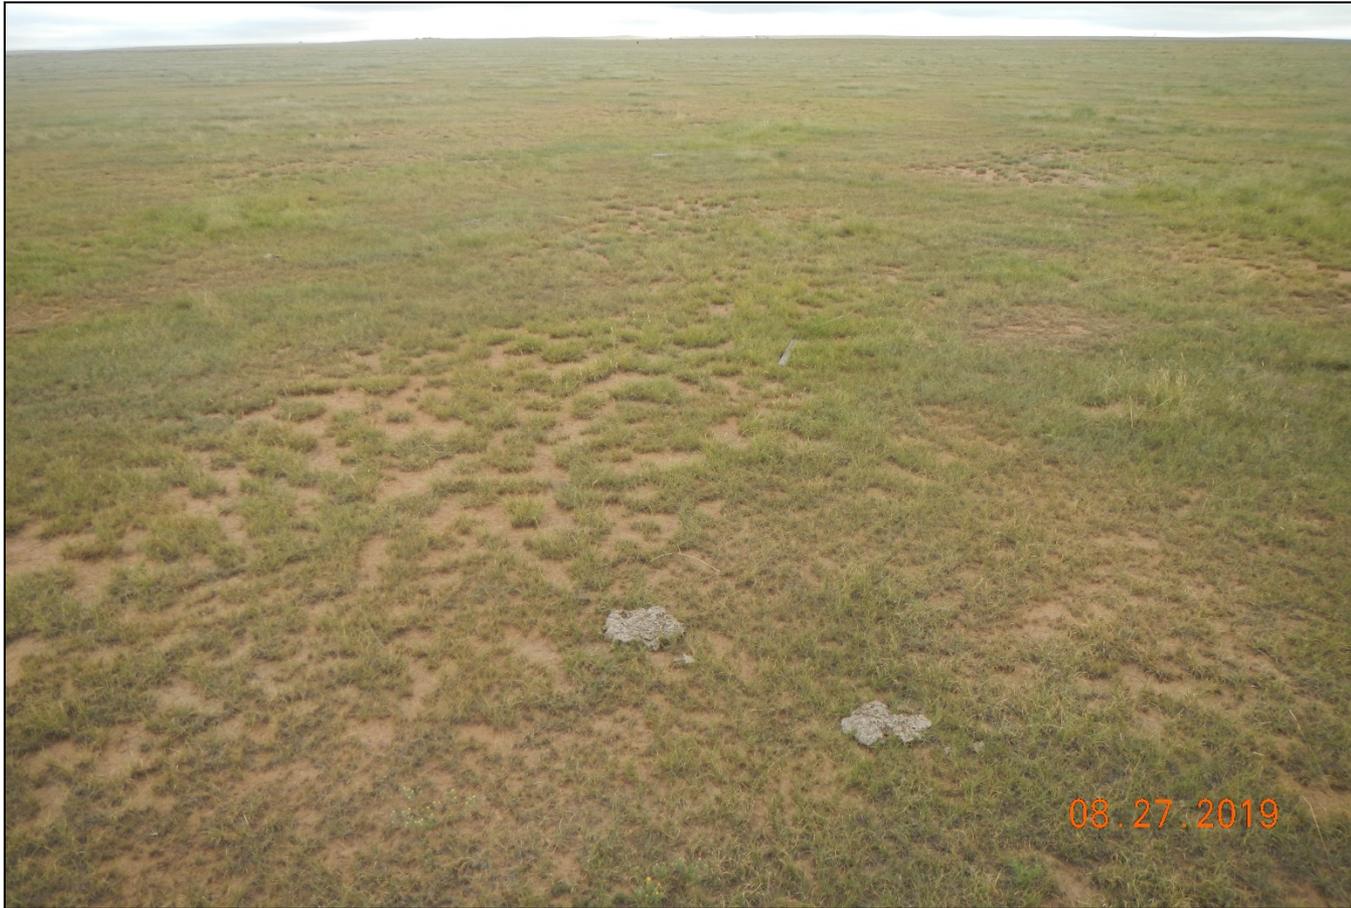
**Photo 13.** Facing north toward the surrounding undisturbed reference area.
