Inspection Photos

Loc#451938

Operator: Sandridge

Inspection Number: 692401289

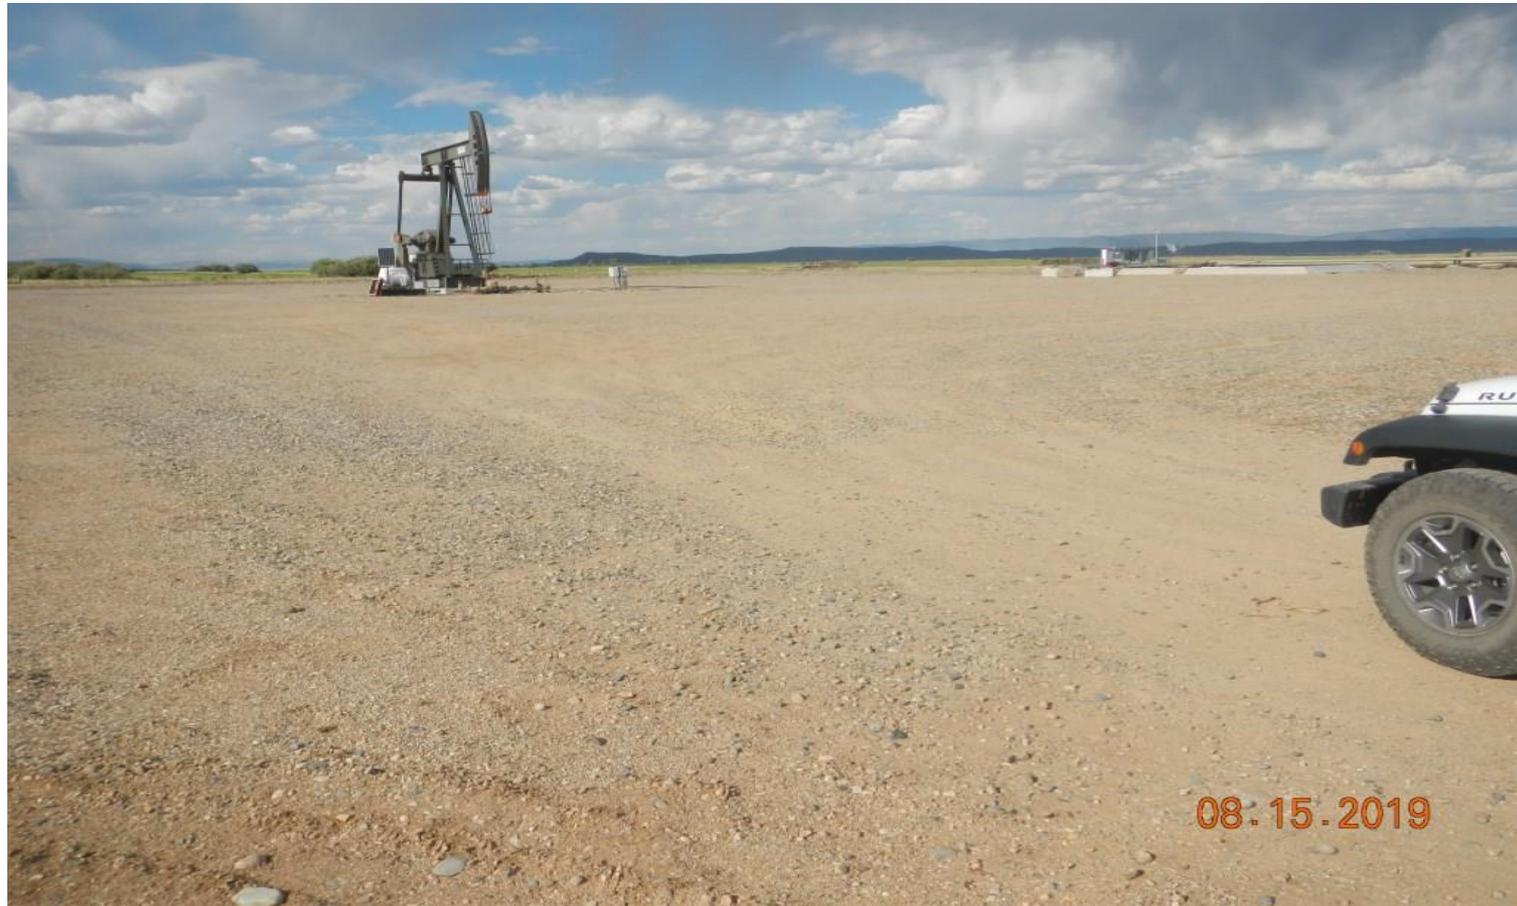
Photo#1:
Overview of Location to Northeast.

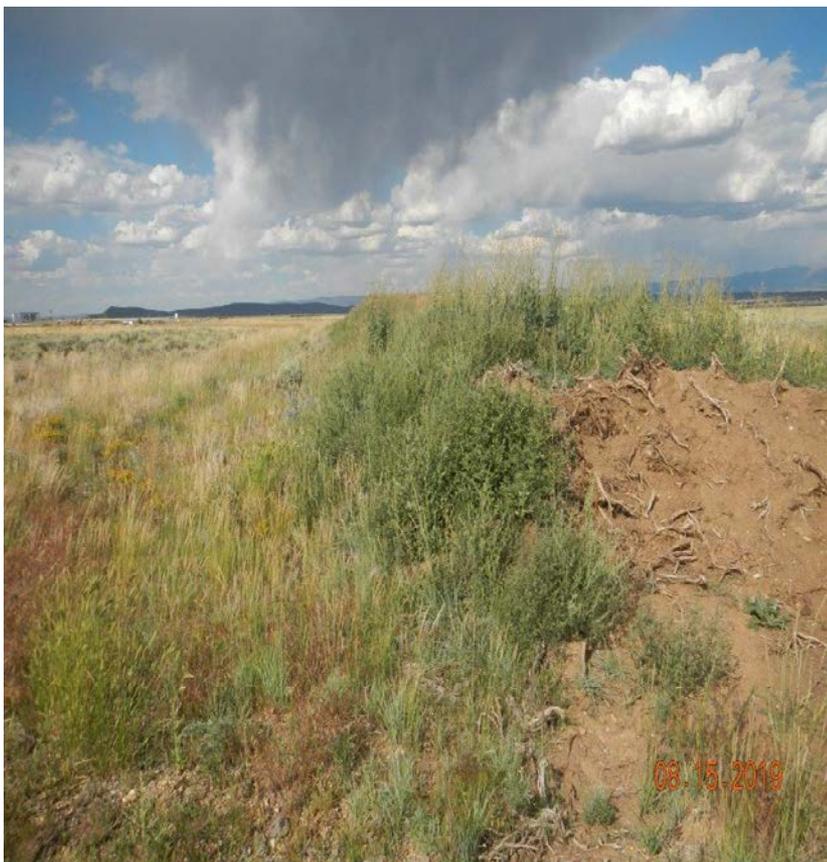
Photo#2:
Topsoil pile is weedy and not properly stabilized.

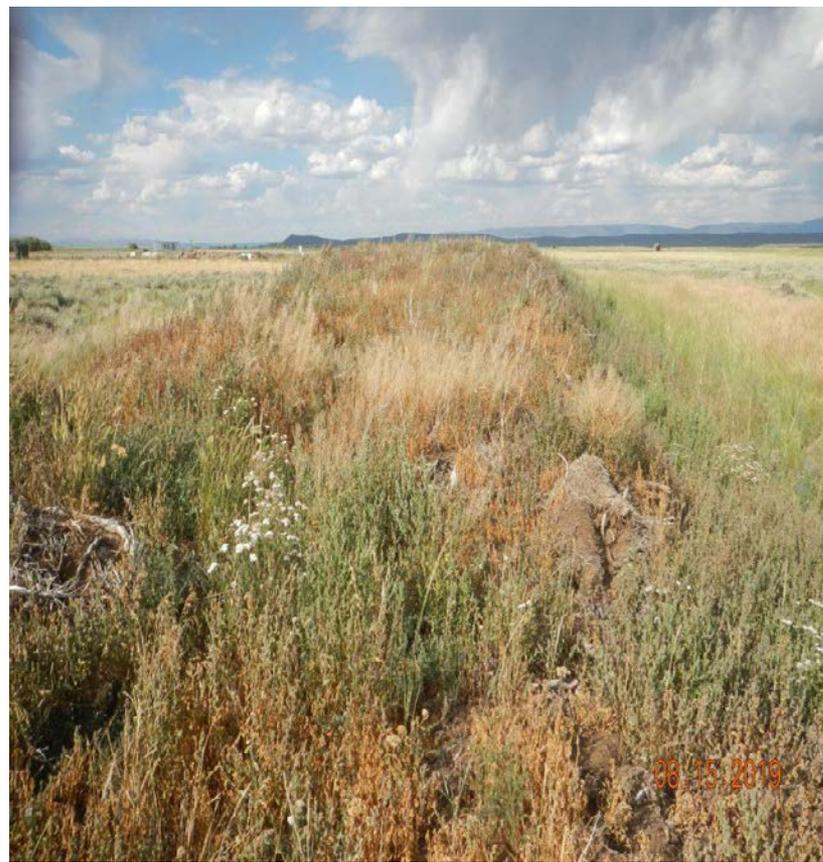
Photo#3:
Topsoil pile is weedy and not properly stabilized.

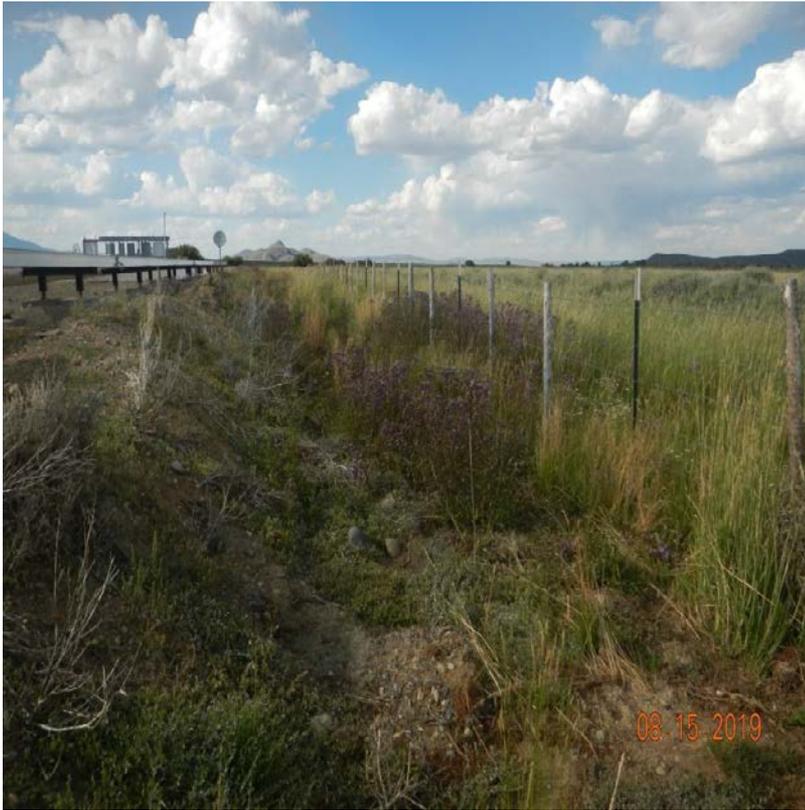
Photo#4:
Canada thistle established on site.

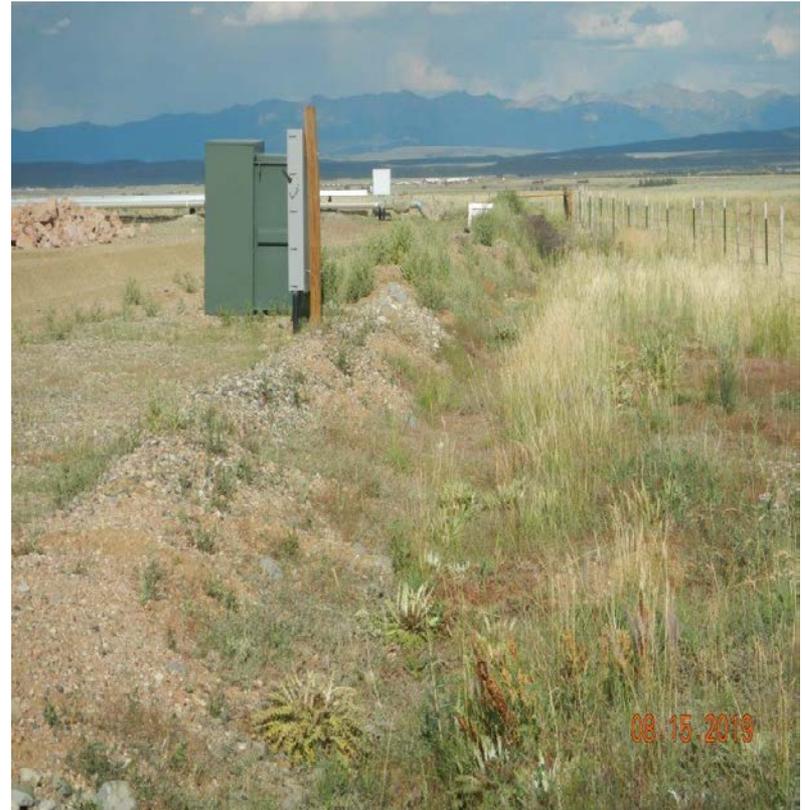
Photo#5:
Debris weeds on site.
