Interim Reclamation and Stormwater Inspection

Operator: KERR MCGEE OIL & GAS ONSHORE LP- #47120

Location ID: 441199

Inspection Document #: 697500533

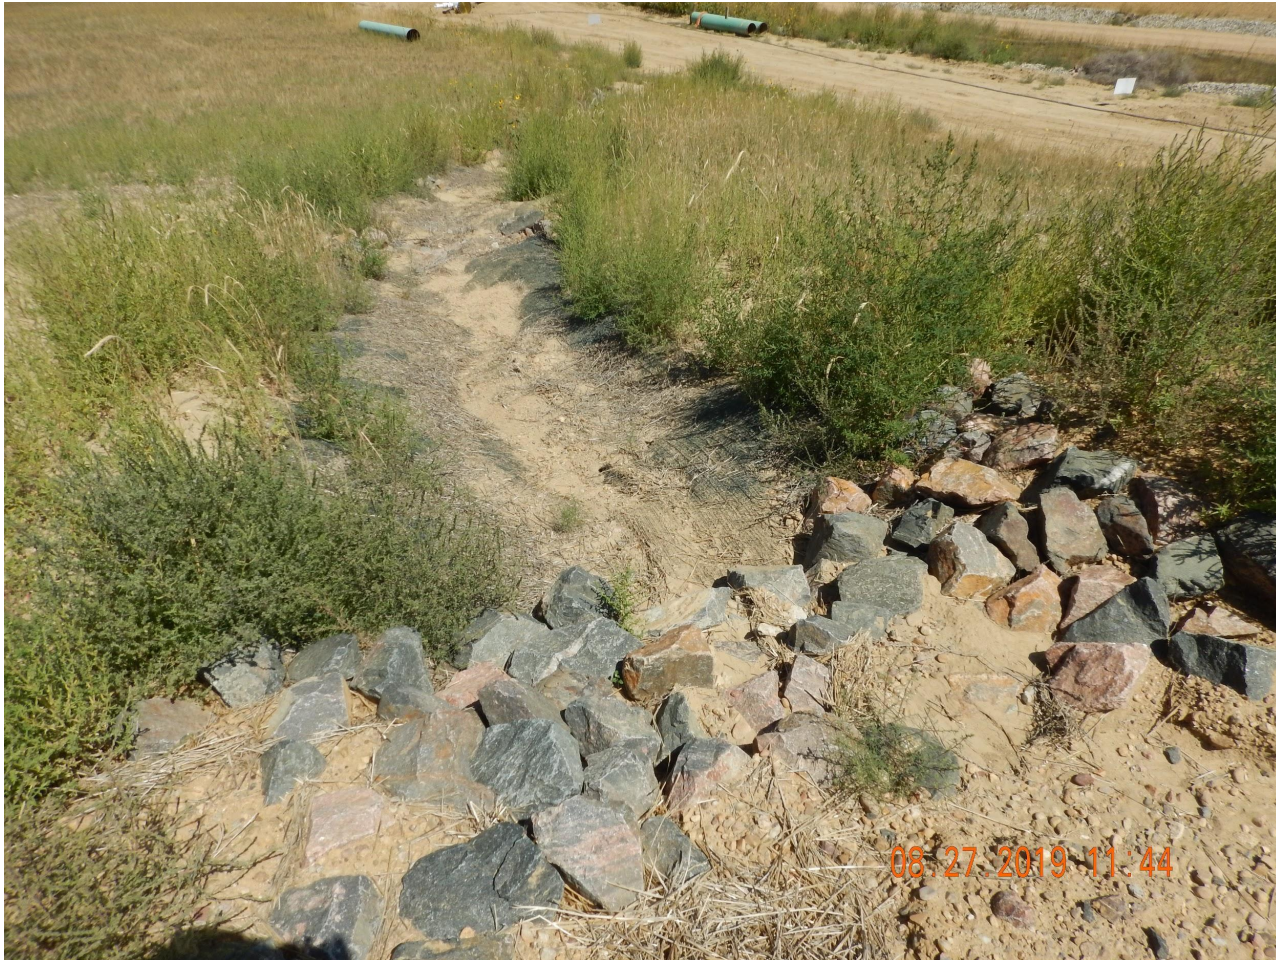
Photo 1. Photo taken of the northeast battery location, facing North. BMP maintenance is required. Also, the installed stormwater BMPs do not appear to be installed with good engineering practices, as the check dams are spaced too far apart to slow the velocity of stormwater runoff. Photo also illustrates unmanaged weeds.

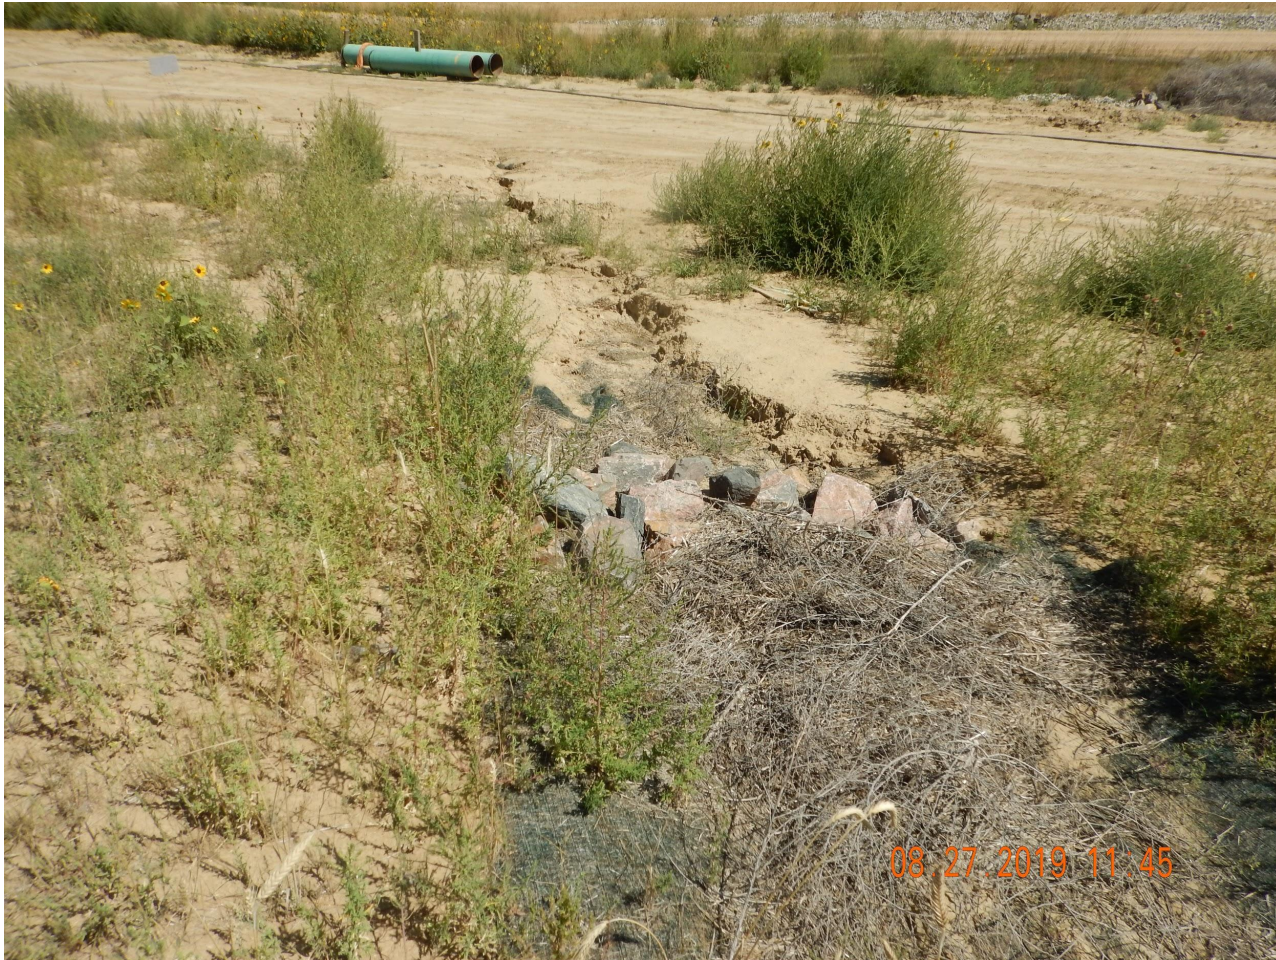
Photo 2. Photo taken at the end of the stabilized channel, facing East. Photo illustrates erosion and BMP maintenance is required.

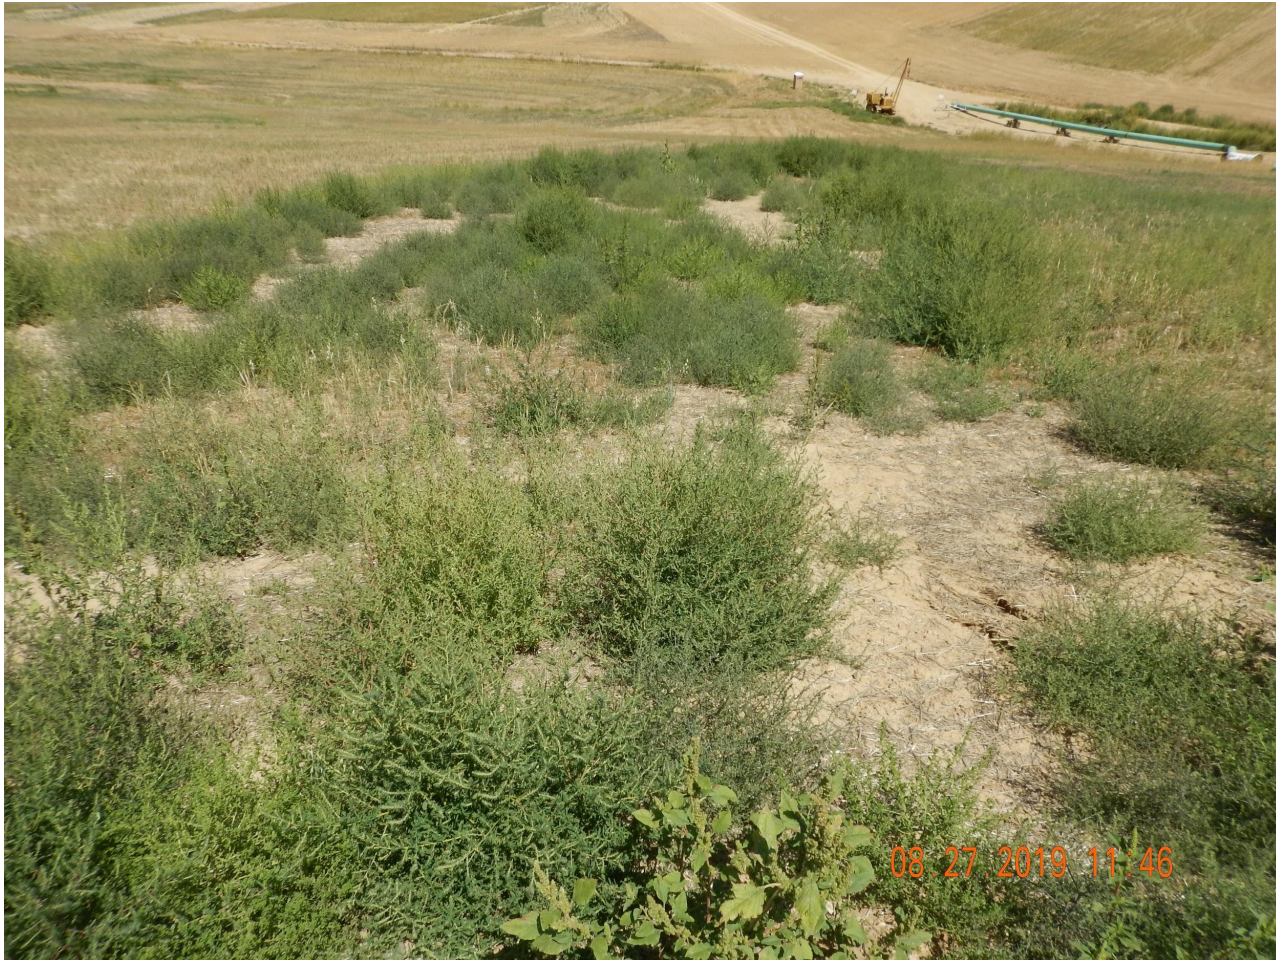
Photo 3. Photo taken from the northern facility, facing North. Photo illustrates an unknown disturbance within the Interim Reclamation area where weeds are not being managed.

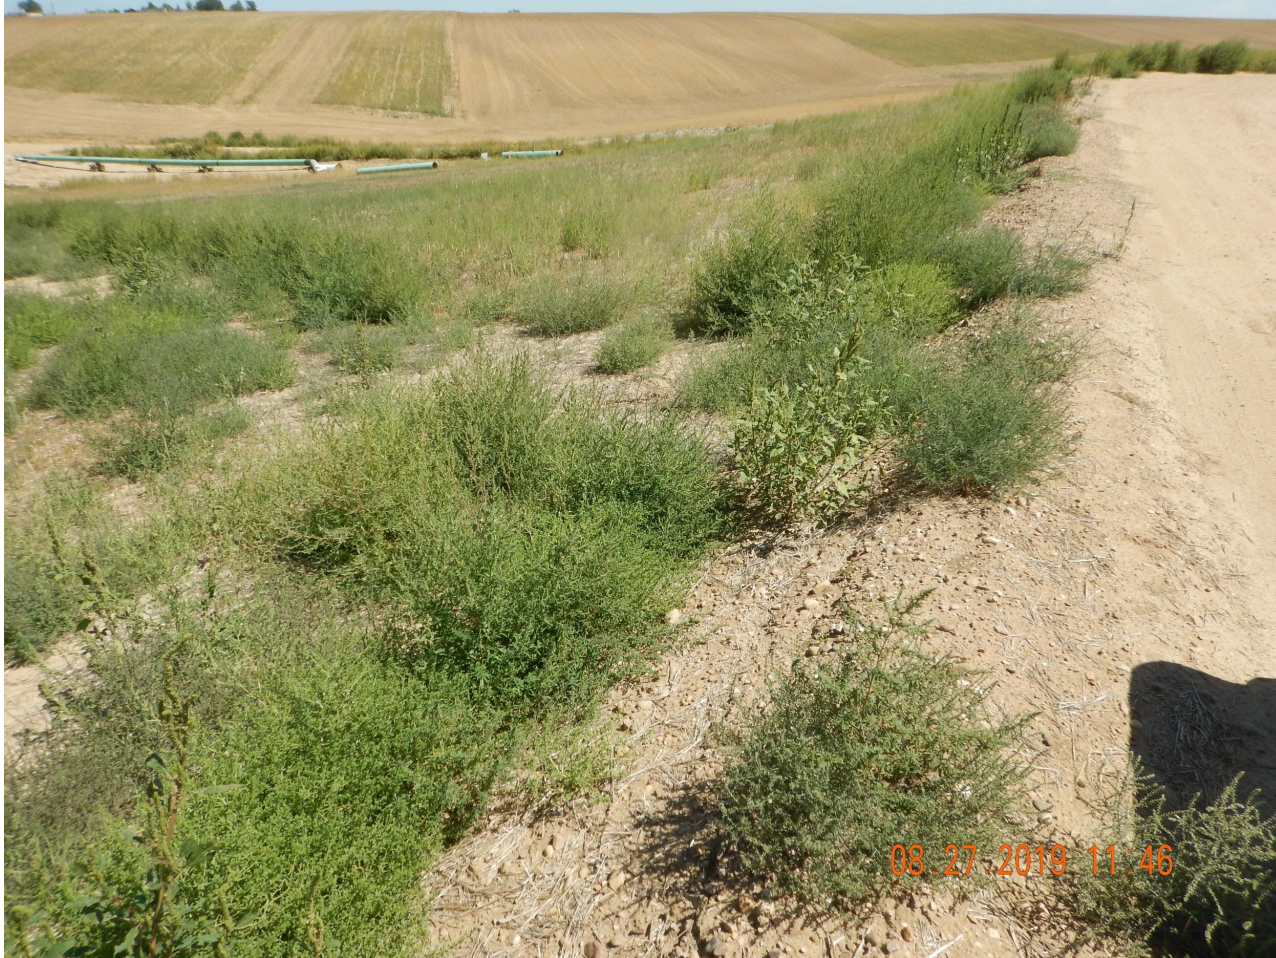
Photo 4. Photo taken from the northern facility, facing East. See comments under Photo 3.
