Inspection Photos
Location Name: DF Ranch PC GK 09-99HZ
Location ID: 419856

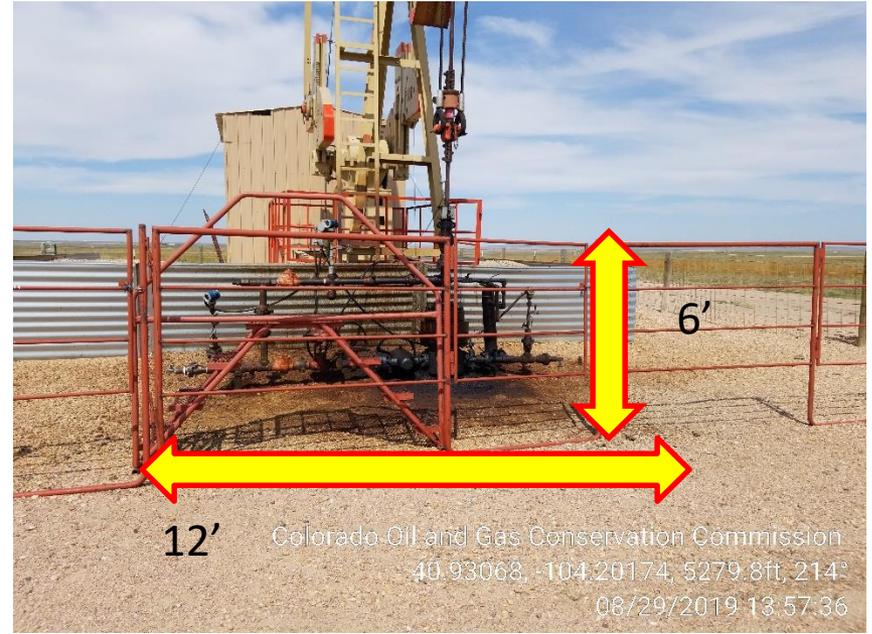
Photo 2 – Stained Soil at Wellhead approximately 12' x 6'

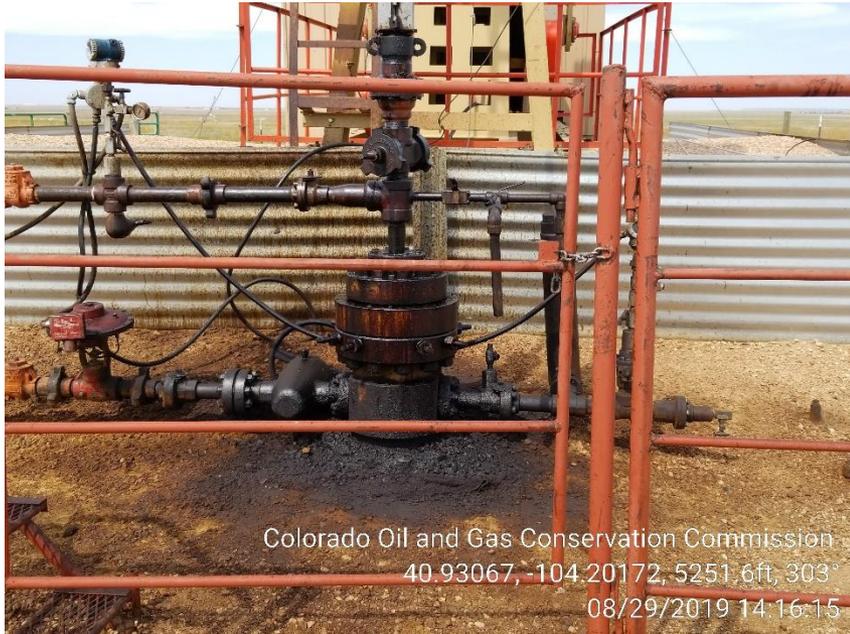
Photo 1 – Mechanical Conditions – Wellhead appears to be leaking onto the ground,

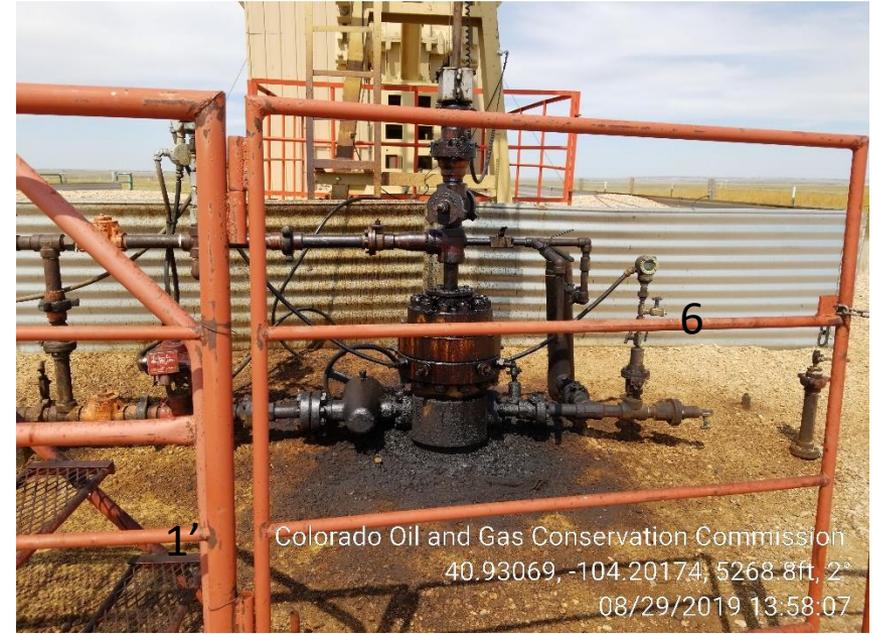
Photo 2 – Stained Soil at Wellhead approximately 12' x 6'
