Location Name: Coral Production Corp. - Peterson E-2  
Inspection Date: 08/28/2019

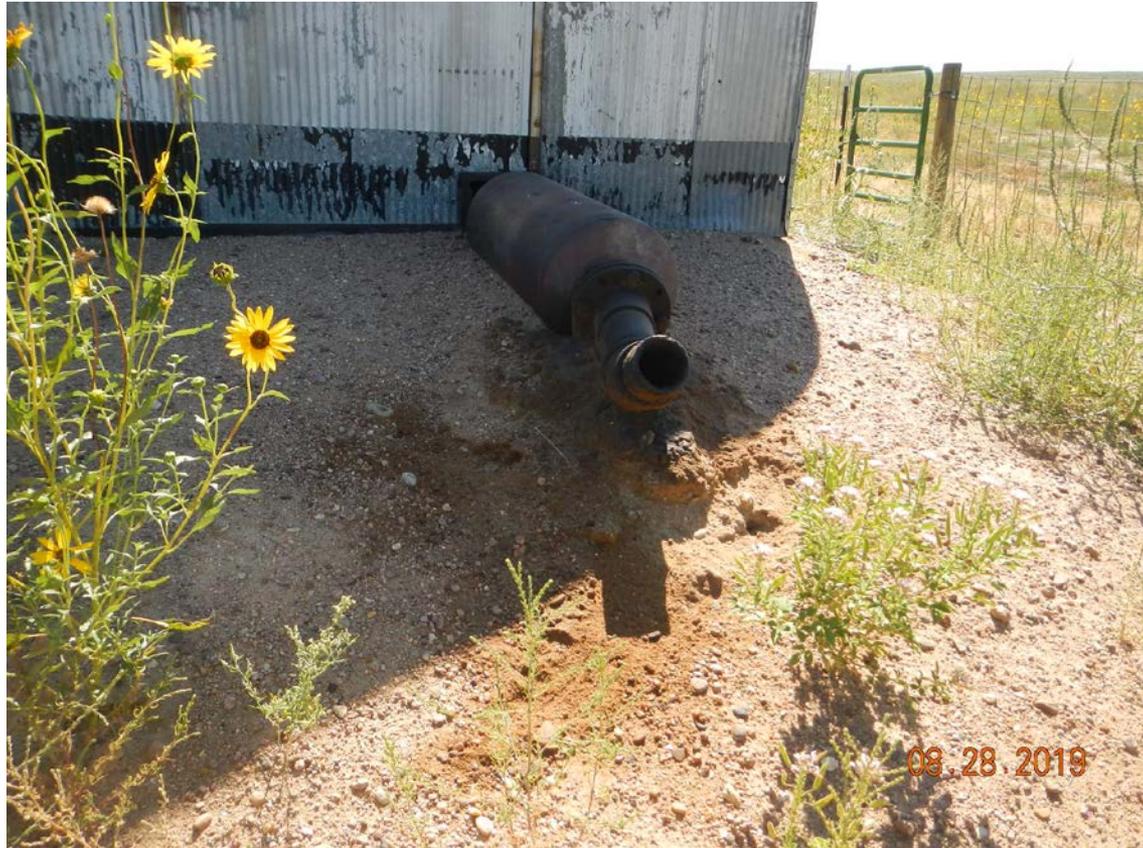
Photo # 2 - 05-121-07069 - Oil stained soil at exhaust

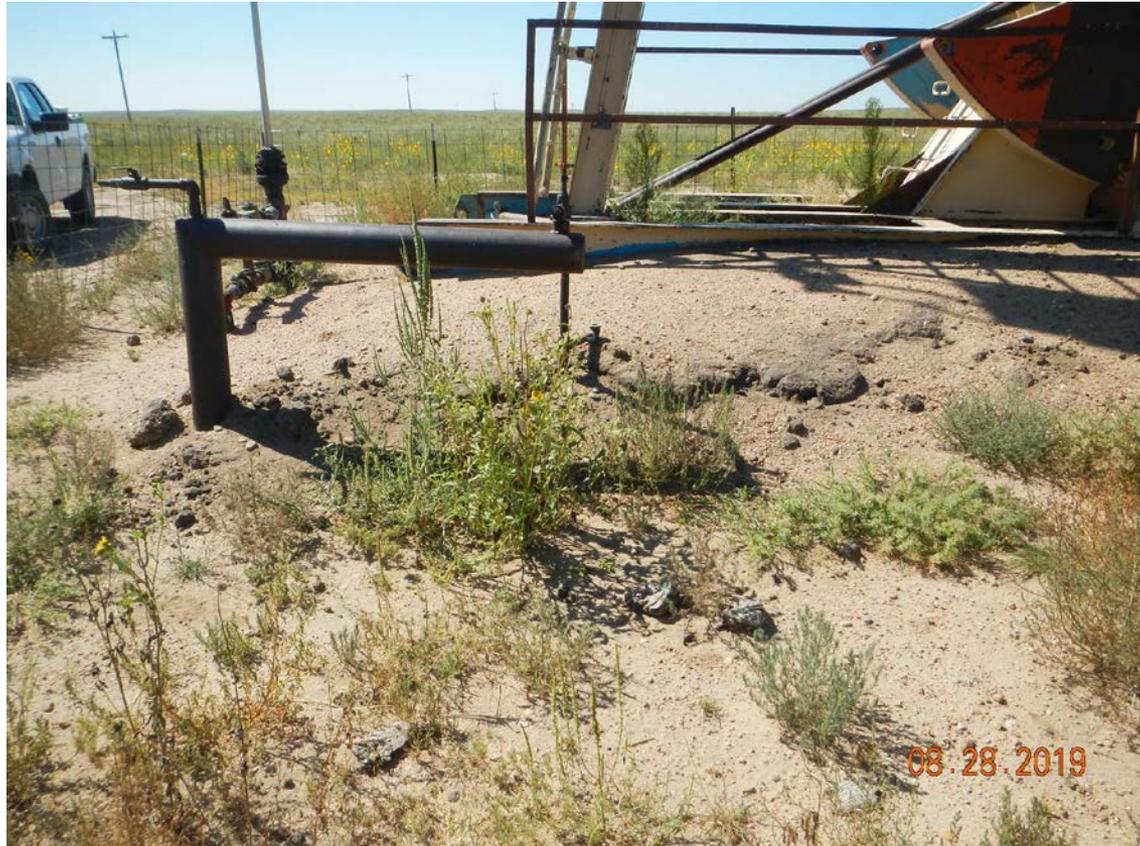
Photo # 3 - 05-121-07069 - Oil impacted soil near wellhead

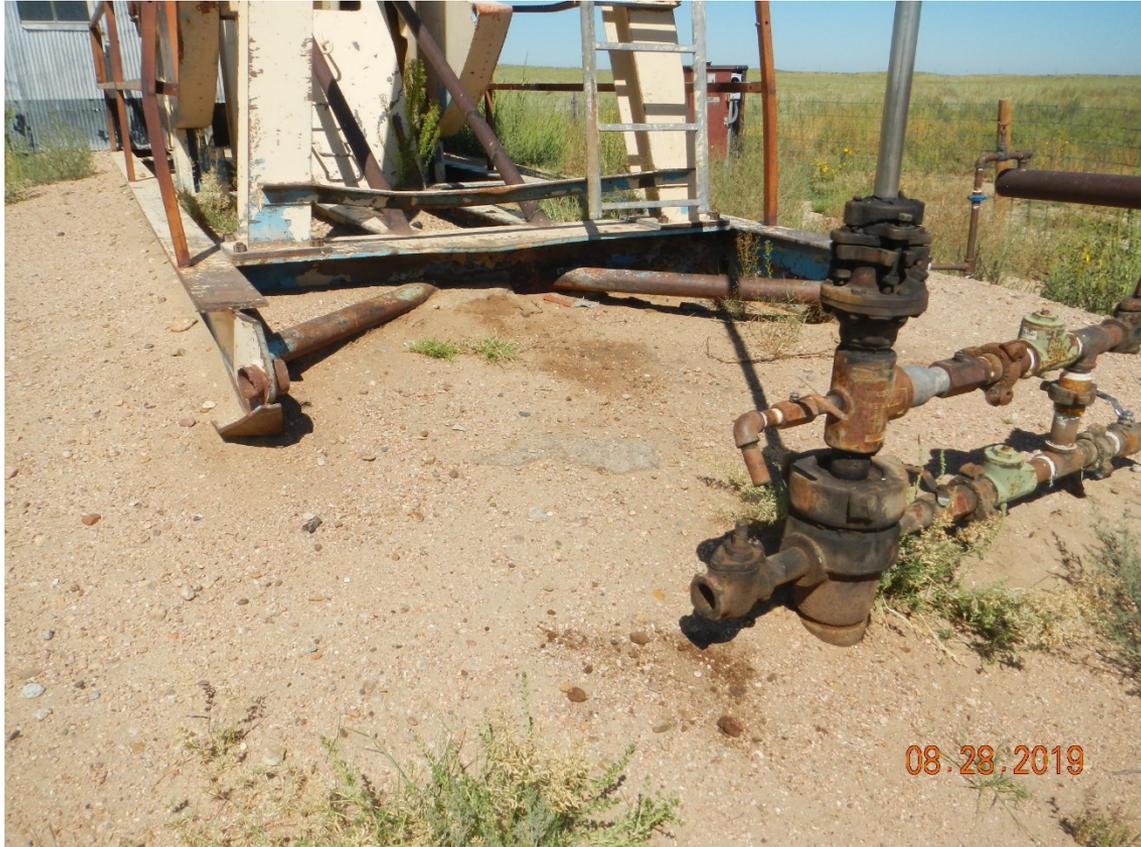
Photo # 4 - 05-121-07069 - Oil impacted soil near wellhead

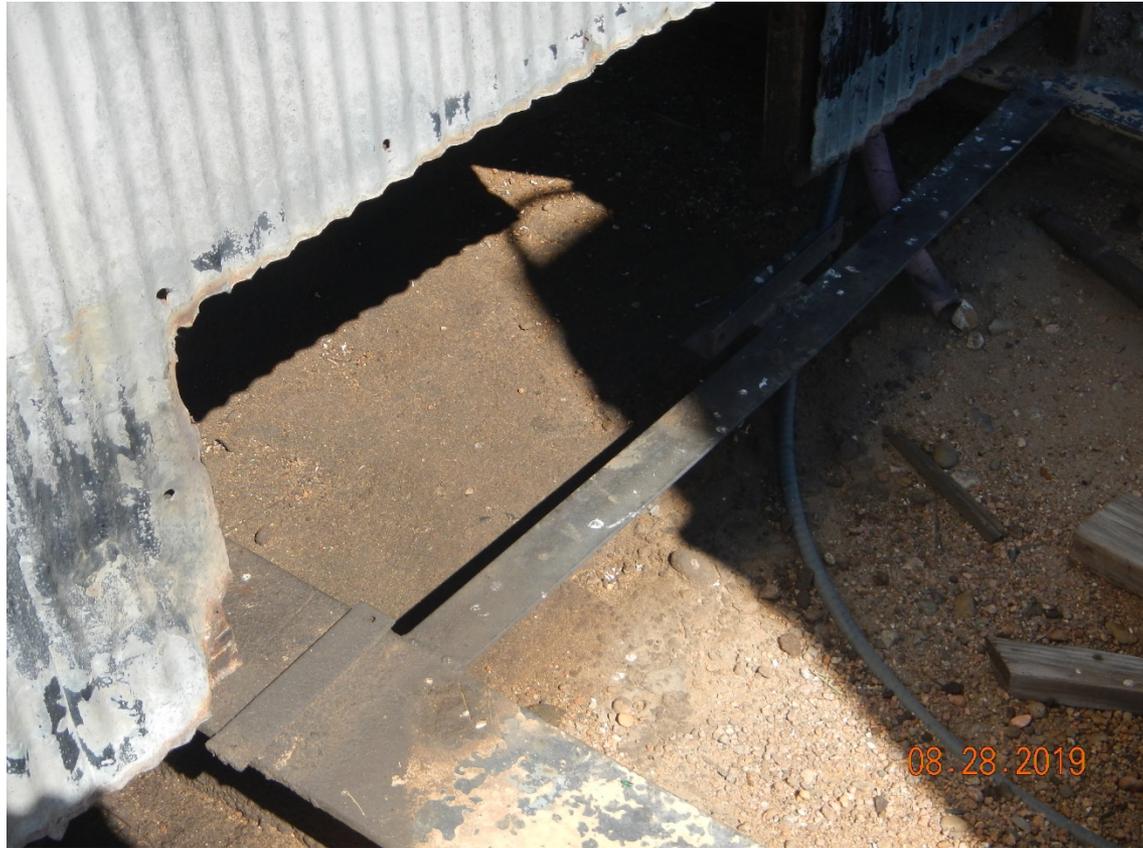
Photo # 4 - 05-121-07069 - Oil impacted soil near motor

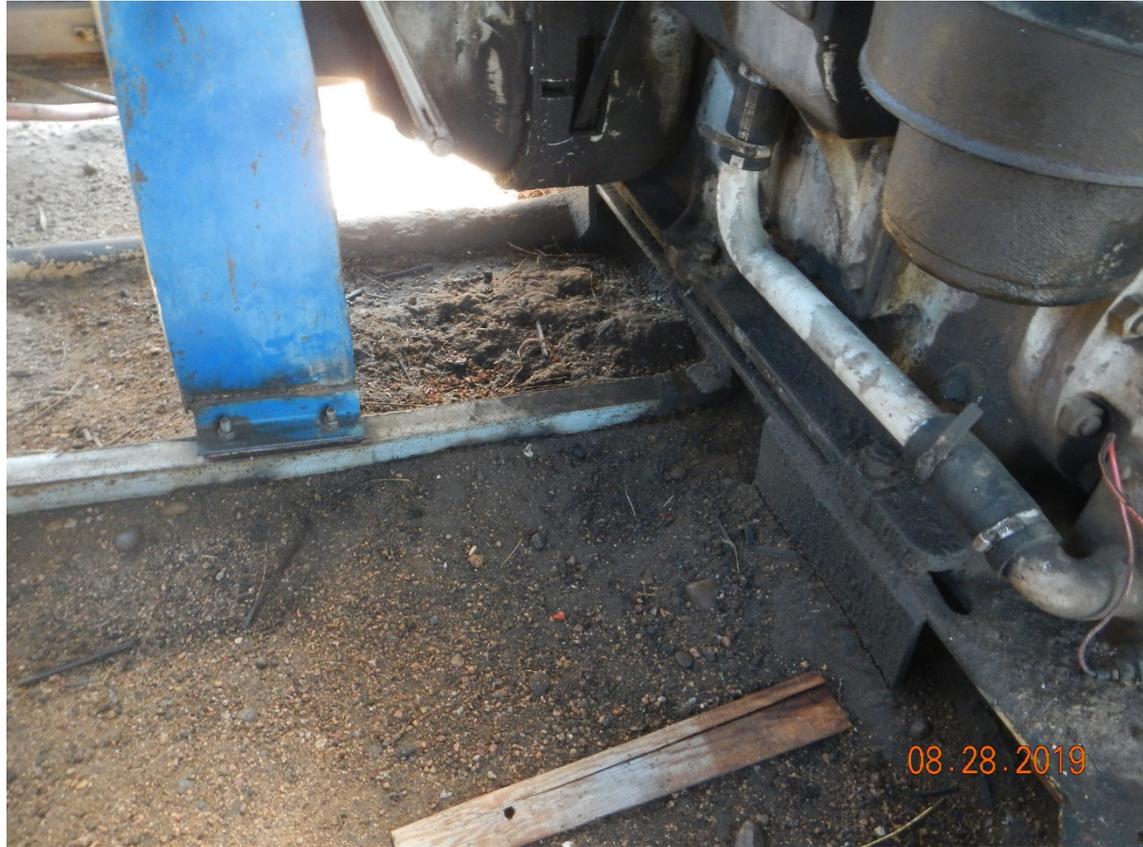
Photo # 4 - 05-121-07069 - Oil impacted soil near motor
