Inspection Photos  
Operator: Springdale Partners LLC  
Location: Springdale Unit 11 (Baney State 16-11)  
API #05-075-09268

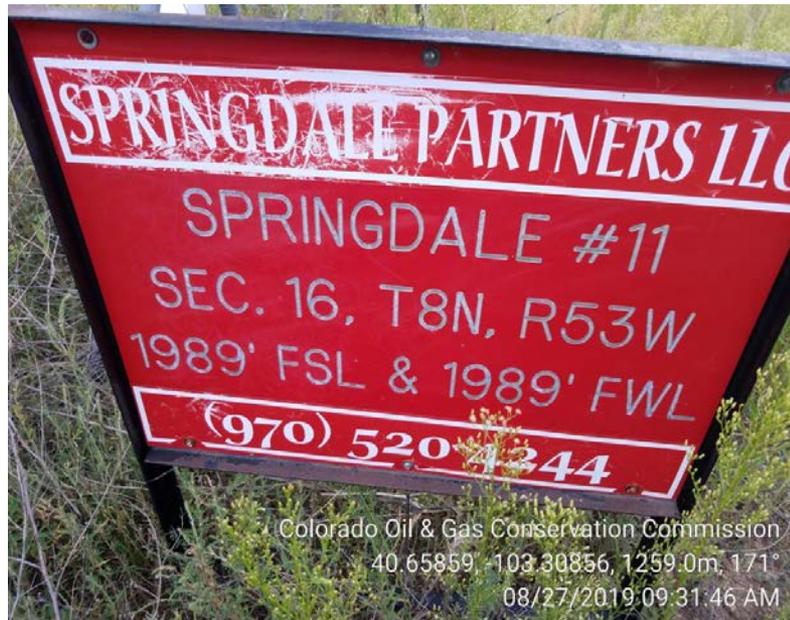
1. Lease sign, Non working Emergency number

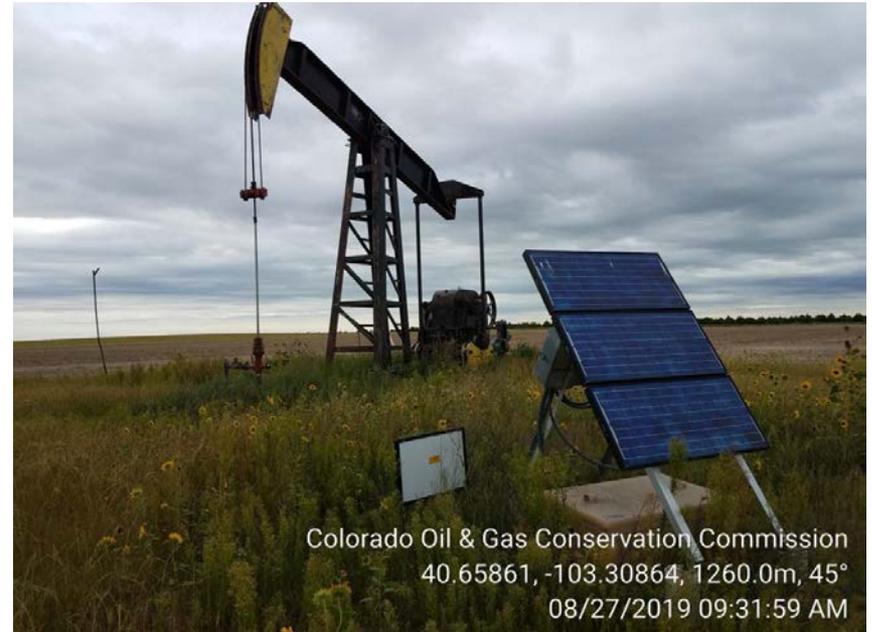
2. Unit, solar powered cathodic rectifier and vegetation

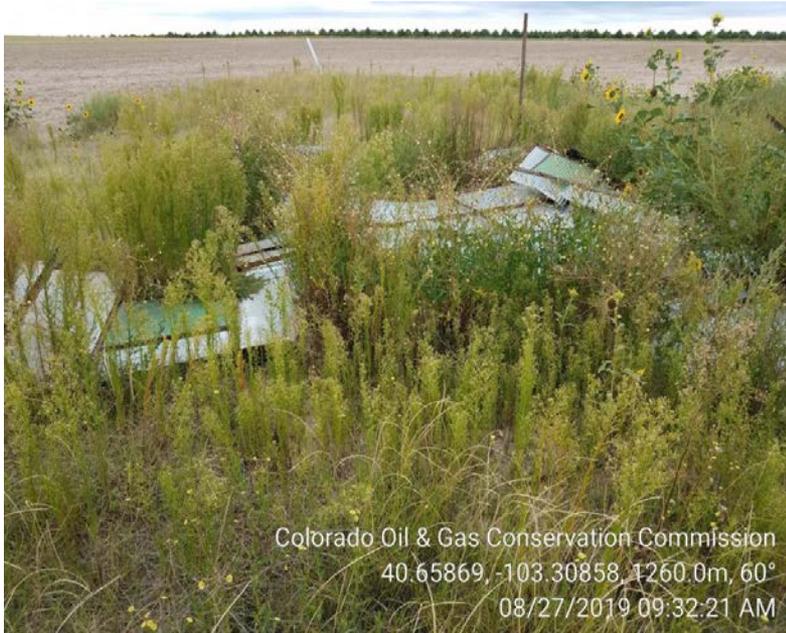
**3. Engine shed in pile by unit, weeds**

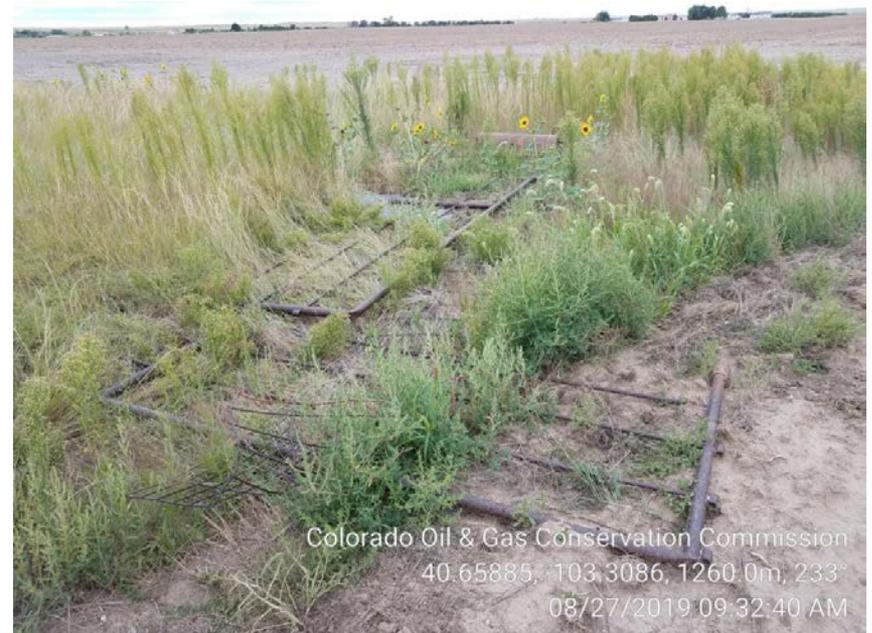
**4. Steel panels, pipe and scrubber in weeds**
