Inspection Photos
Location Name: Energy Mineral Unit B#1
Location ID: 318873

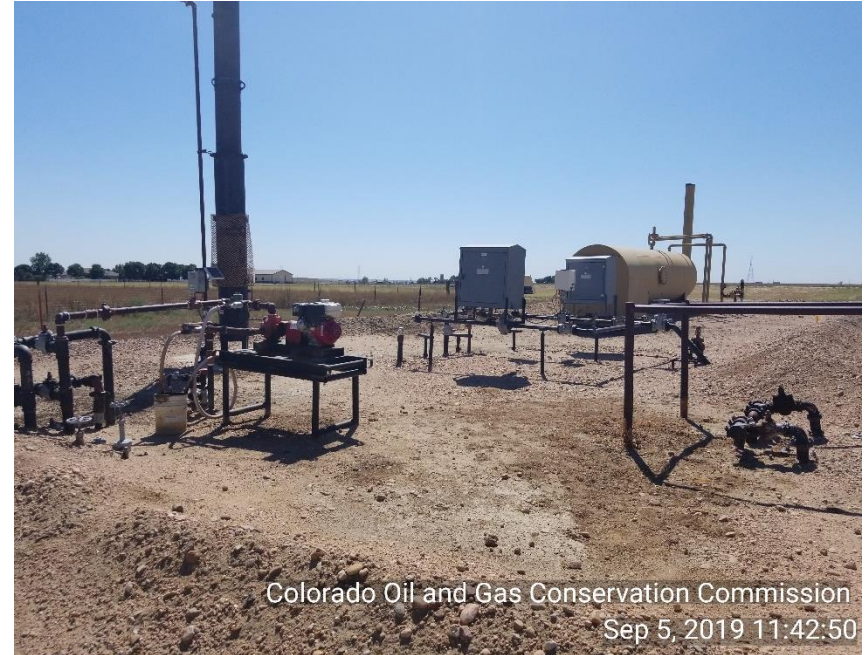
Photo 2 Weeds and stained soil appear to have been removed.

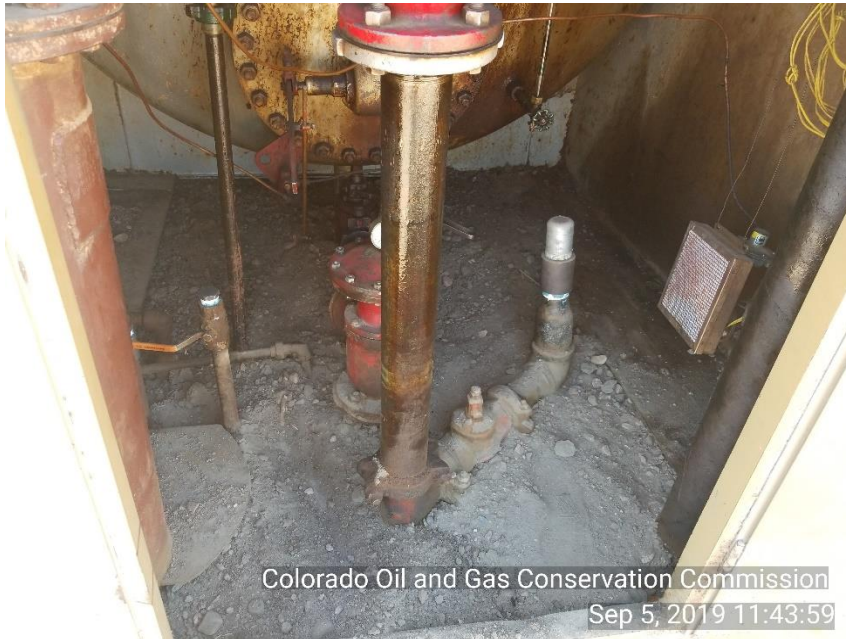
Photo 3 Stained soil appears to have been removed from separator

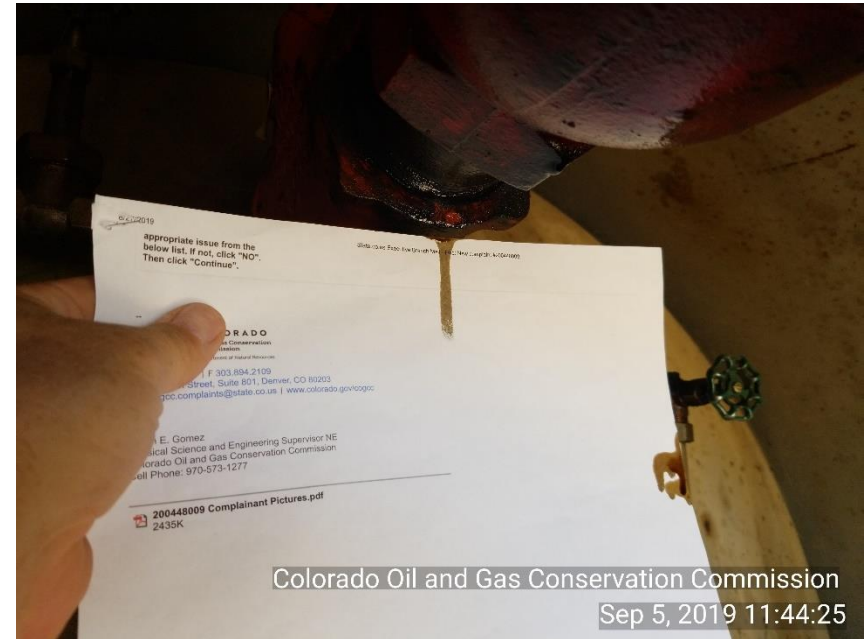
Photo 4 Mechanical issues in separator house appear to not have been address pipes visibly leaking at time of inspection.

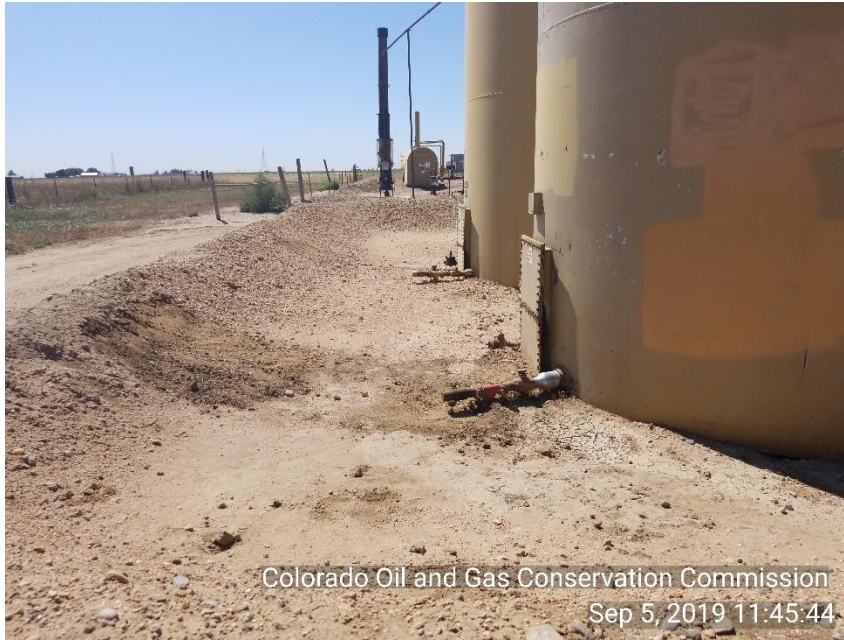
Photo 5 Stained soil appears to have been removed from crude oil tank load lines

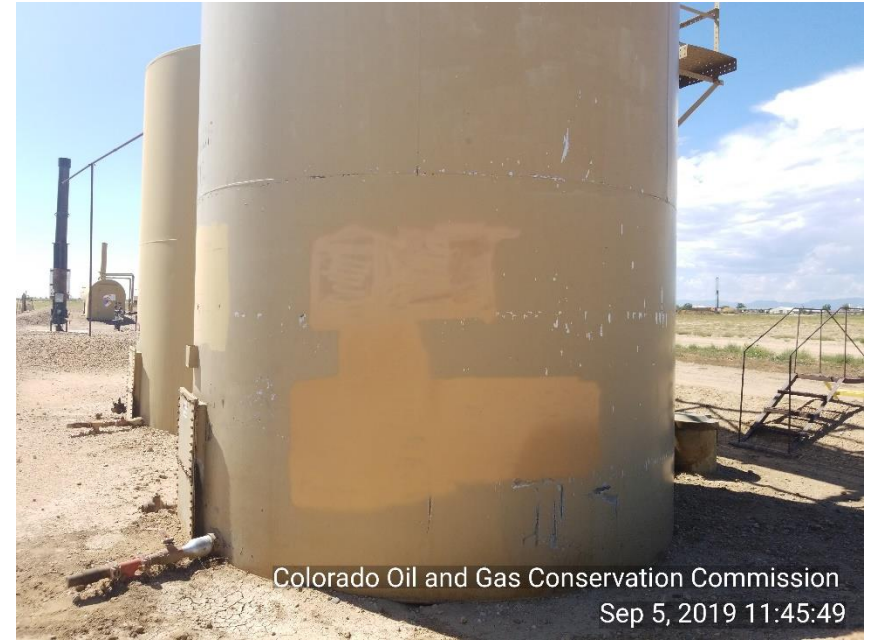
Photo 6 OUT OF SERVICE on crude oil tanks appears to have been painted over

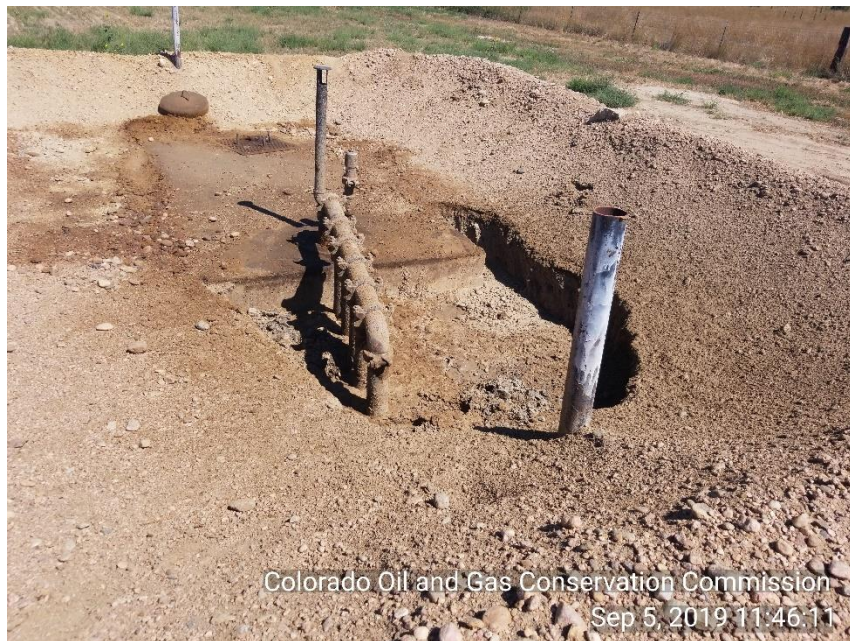
Photo 7 Produced water tank spill/ stained soil has not been addressed

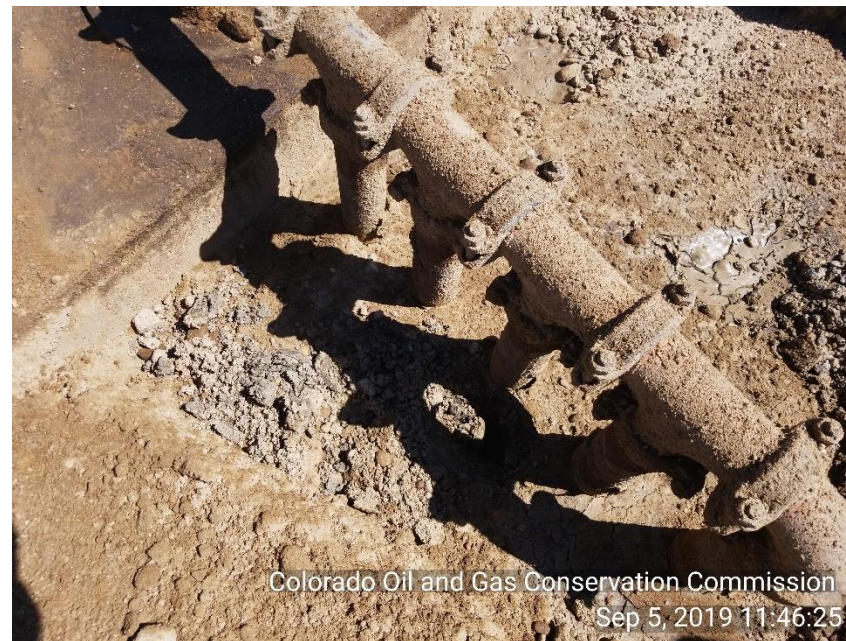
Photo 8 Produced water tank it appears crew has started to hydrovac stained soil. At time of inspection stained soil and grey material are still present.

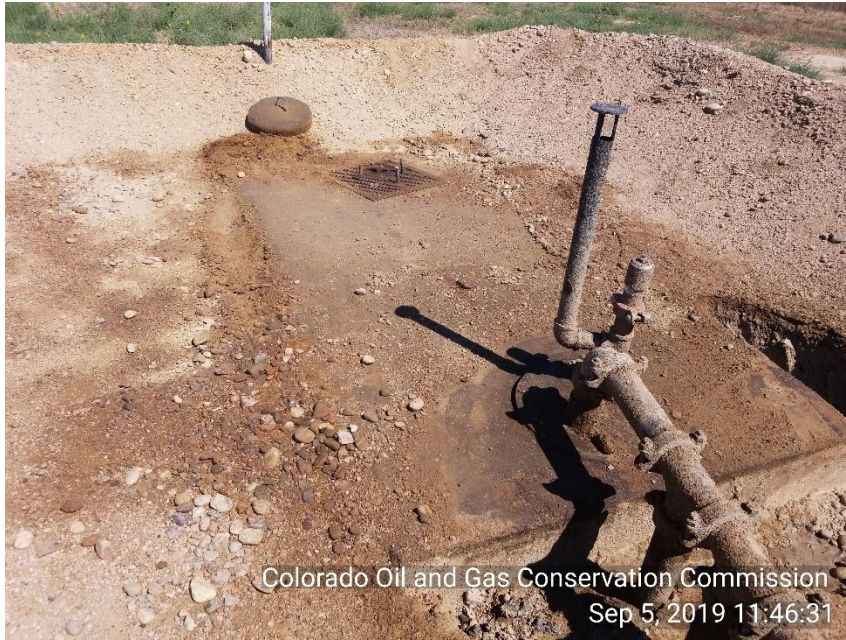
Photo 9 Produced water tank spill/ stained soil has not been addressed
