**Inspection Photos**  
**Location Name: Ferguson 2-25**  
**Location ID: 319714**

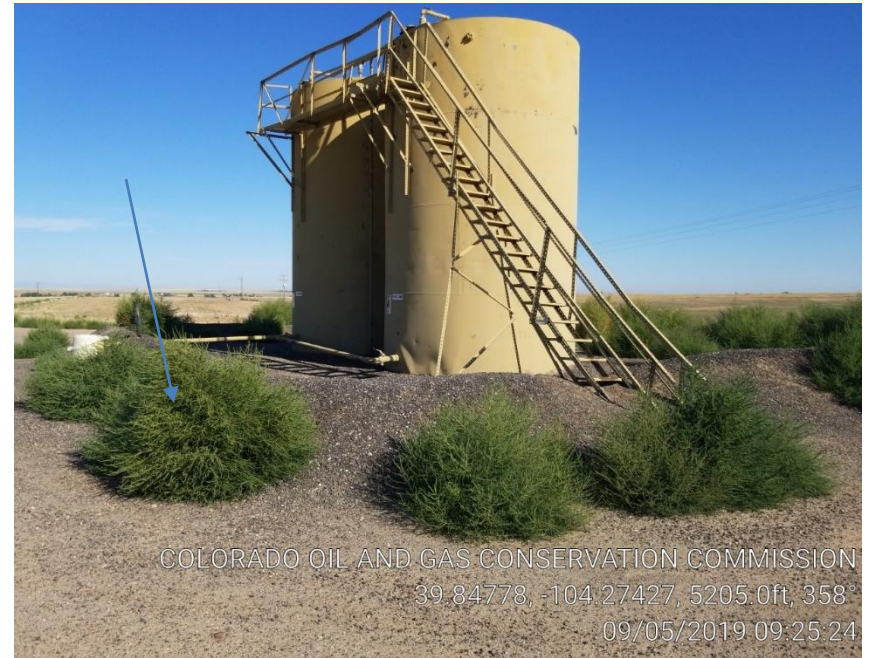
**Pic 2 weeds**

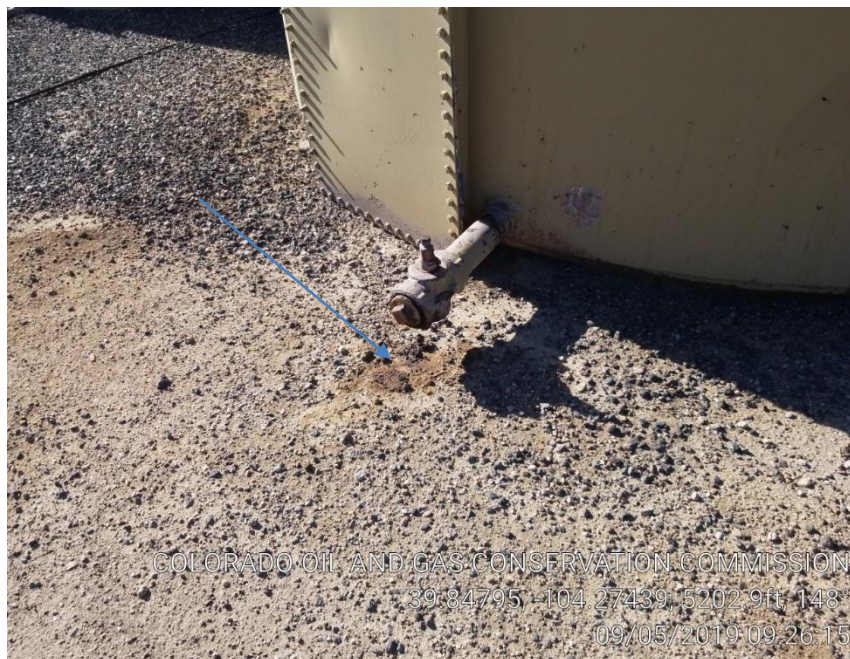
**Pic 3 stained soil/mechanical conditions**

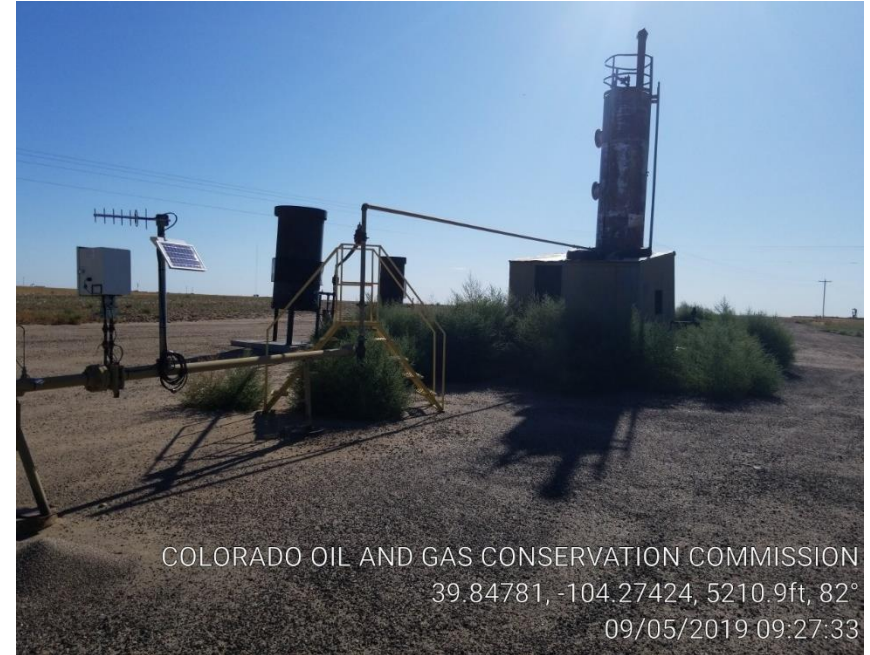
**Pic 6 weeds**

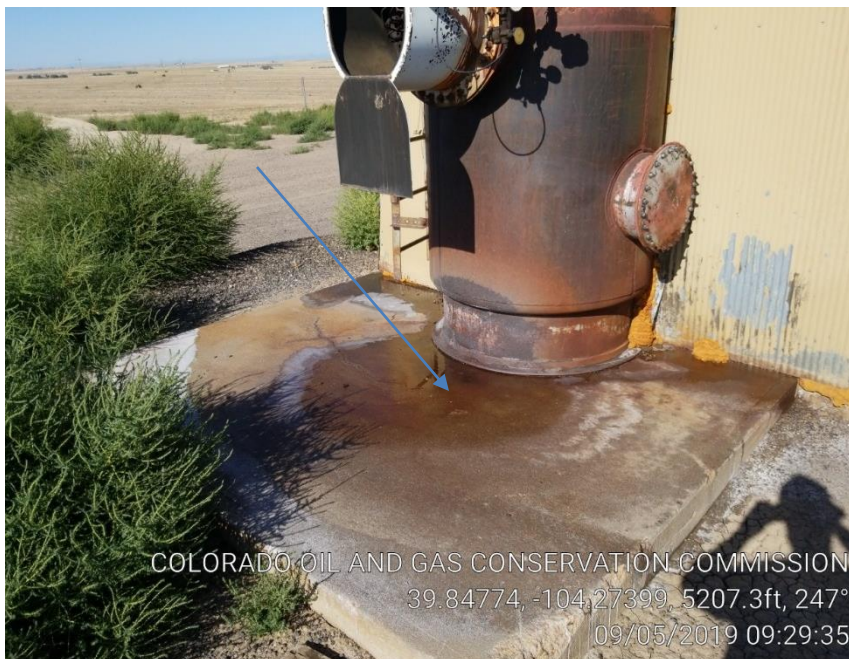
**Pic 7 leak/spill**

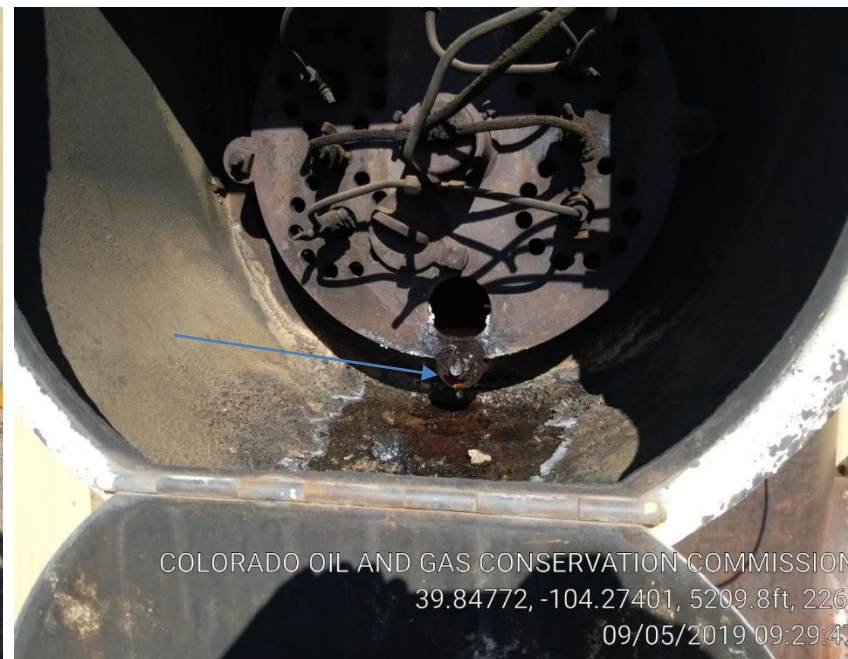
**Pic 8 leak/spill**

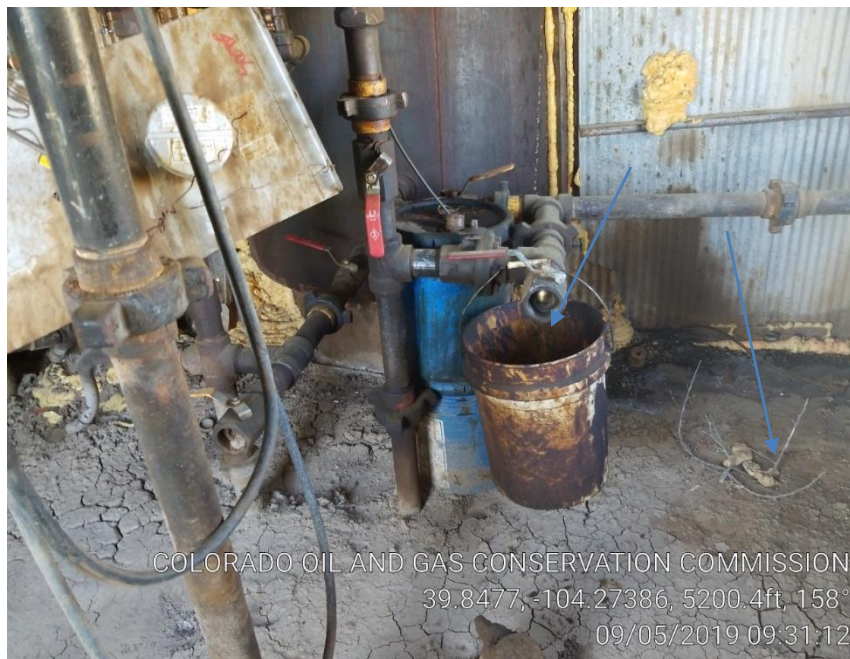
**Pic 9 trash/spill/leak**

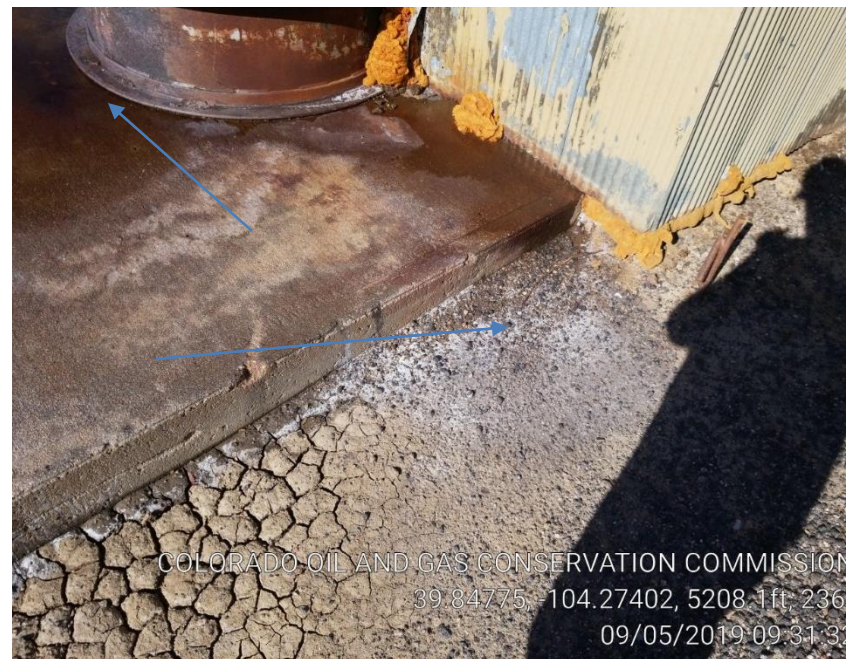
**Pic 10 spill/leak**

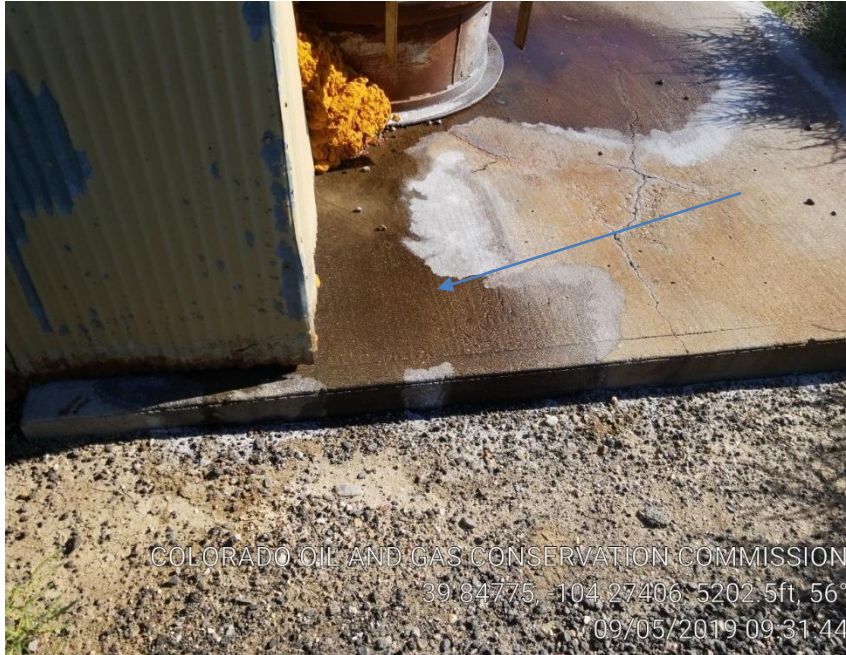
**Pic 11 spill/leak**

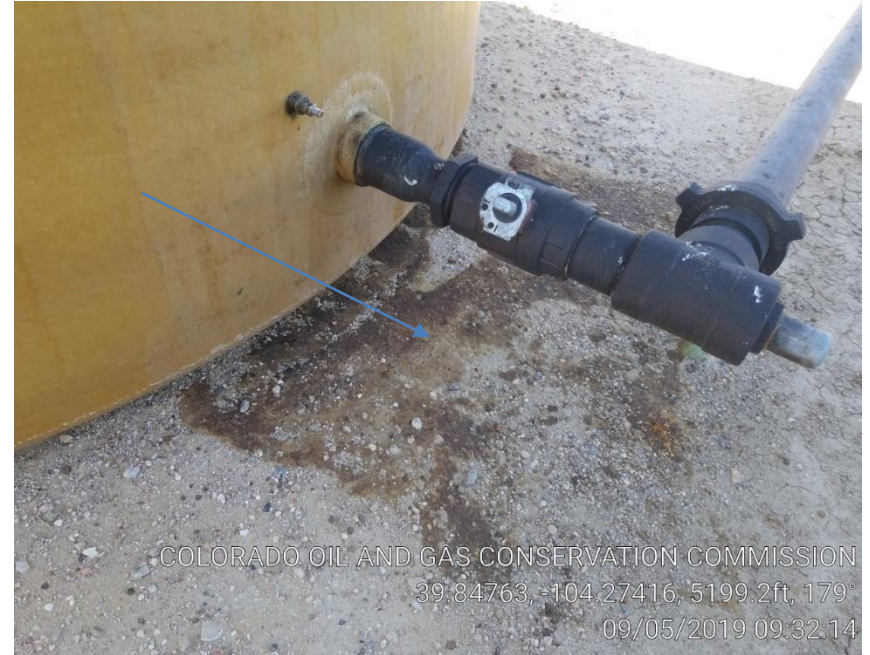
**Pic 12 stained soil/mechanical conditions**

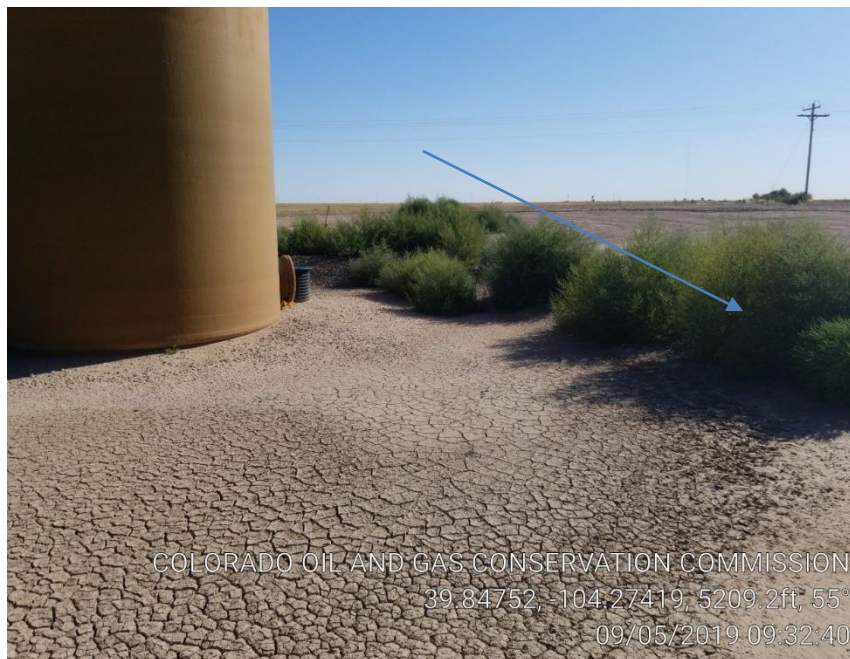
**Pic 13 weeds**

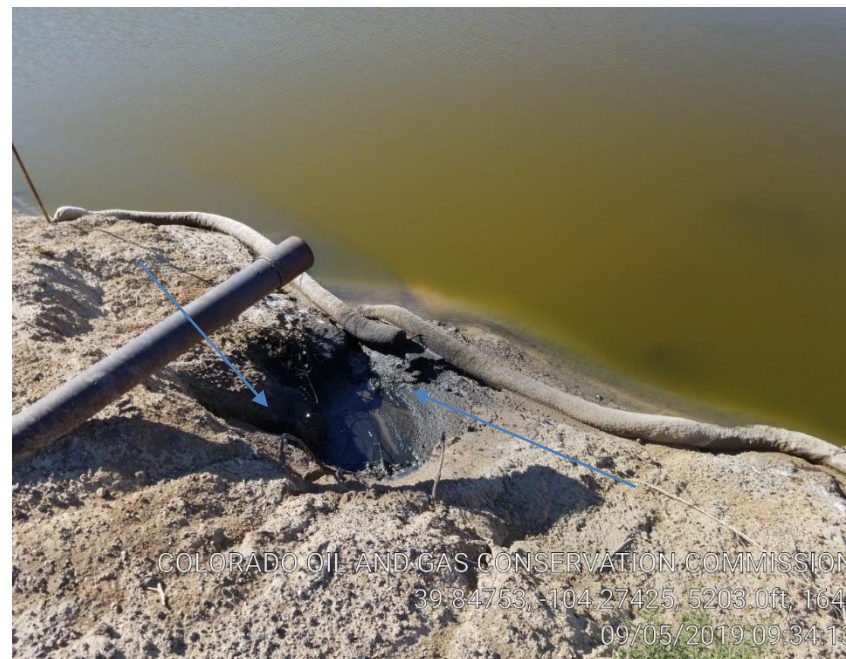
**Pic 14 hydrocarbons in pit / stained soil**

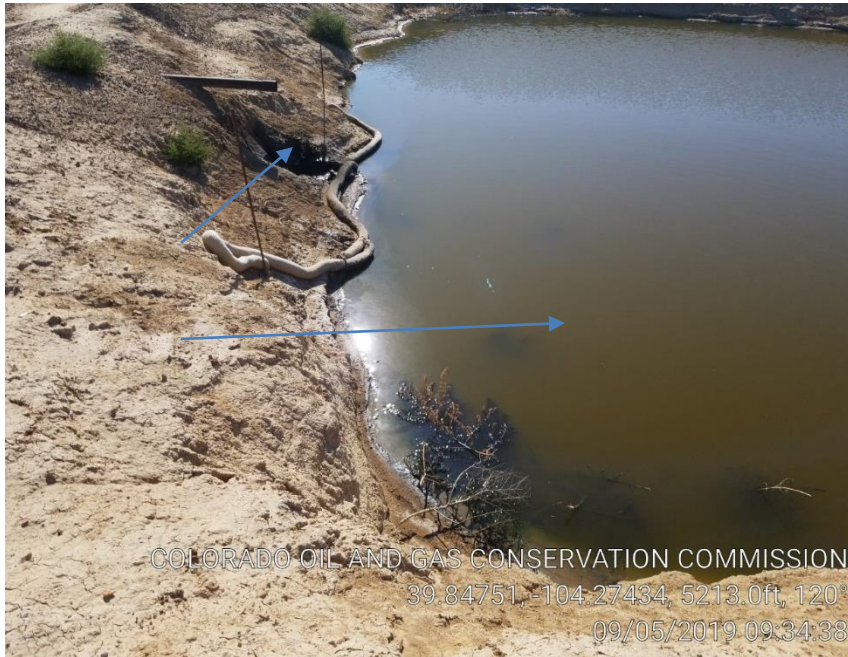
**Pic 15 hydrocarbons in pit/stained soil**

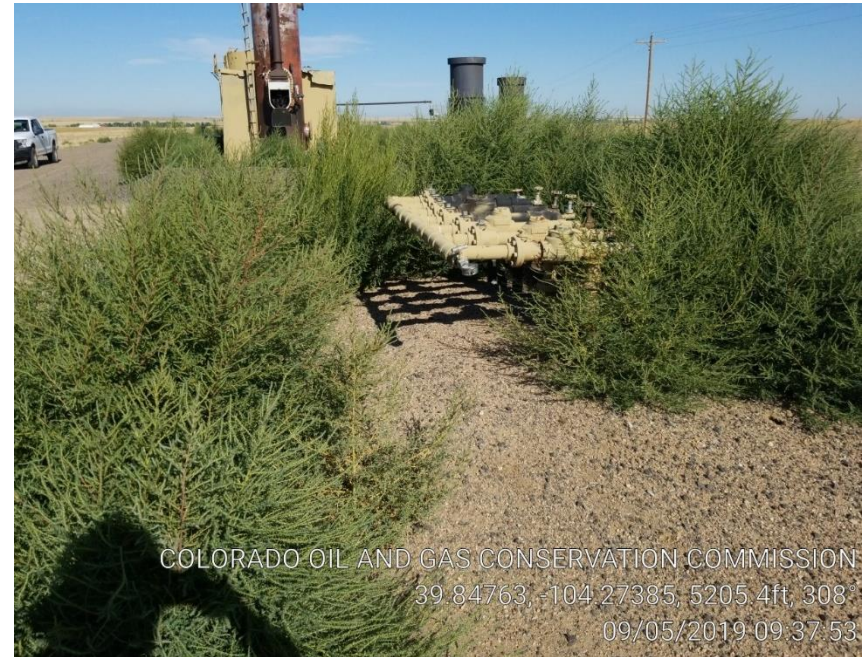
**Pic 16 weeds around manifold**
