Inspection Photos
Location Name: Eagle Hill 1-32
Location ID: 466705

COLORADO
Oil & Gas Conservation
Commission
Department of Natural Resources

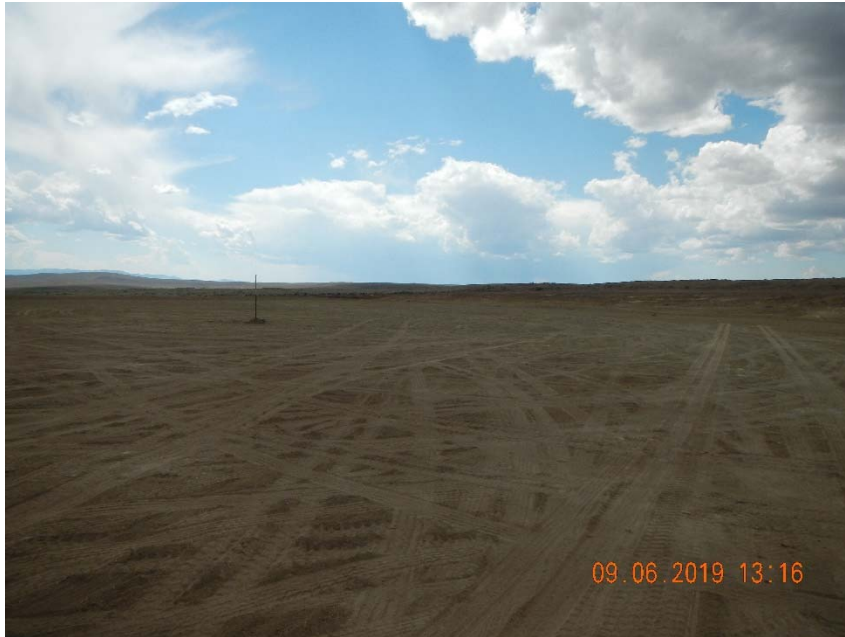
Photo 1. Overview of location taken at entrance facing southwest. No stormwater controls apparent.

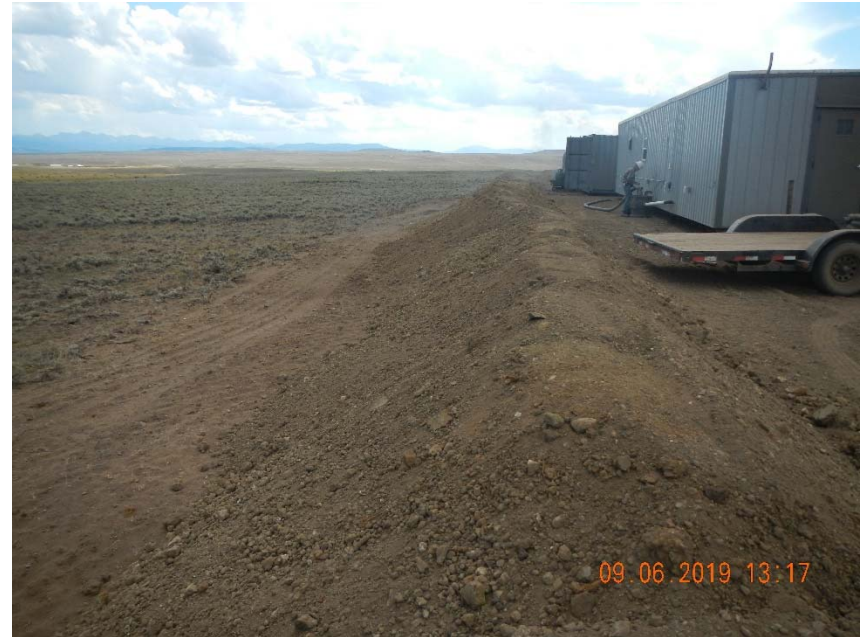
Photo 2. Non-compacted perimeter berm, no stormwater controls apparent.

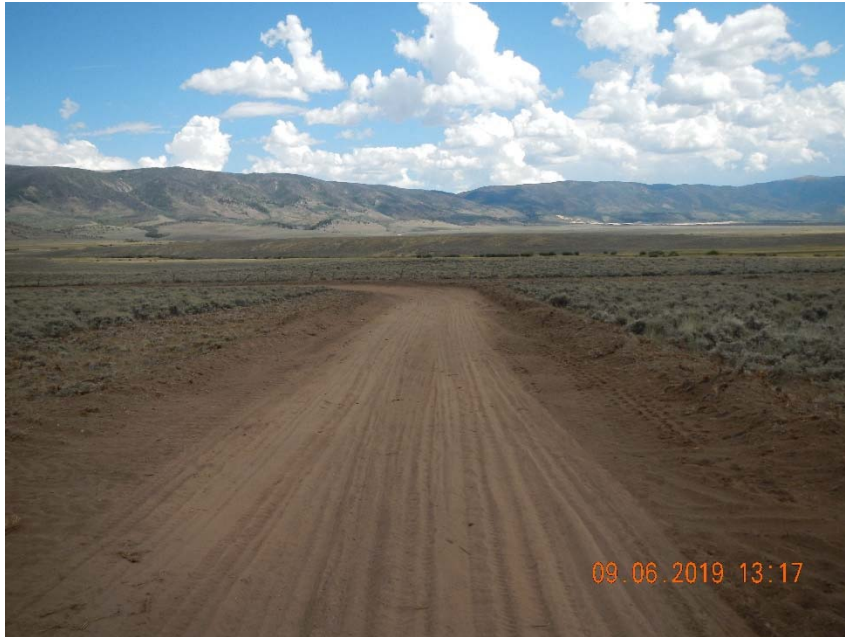
Photo 3. Access road coming into location. No stormwater controls apparent.

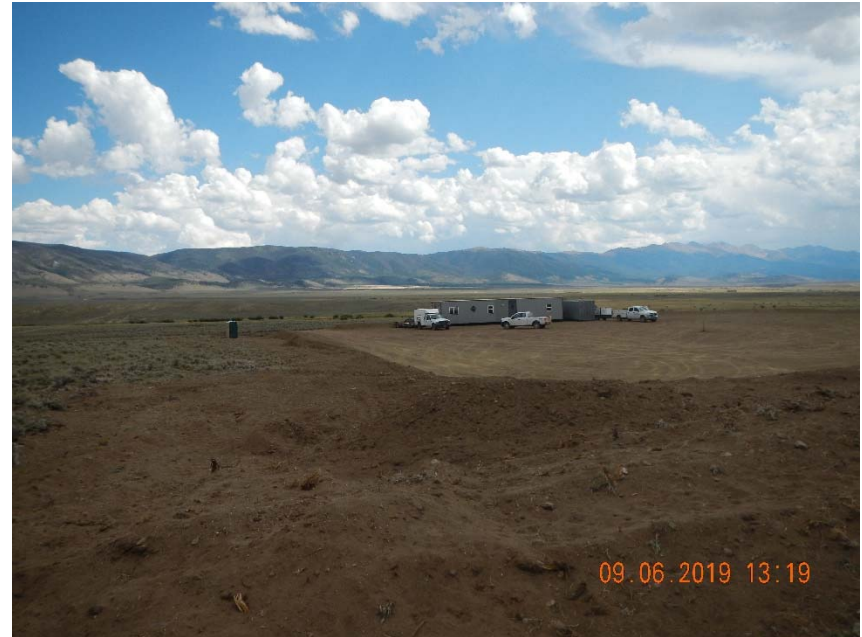
Photo 4. Overview of location from northwest corner of disturbance looking southeast. No stormwater controls apparent.

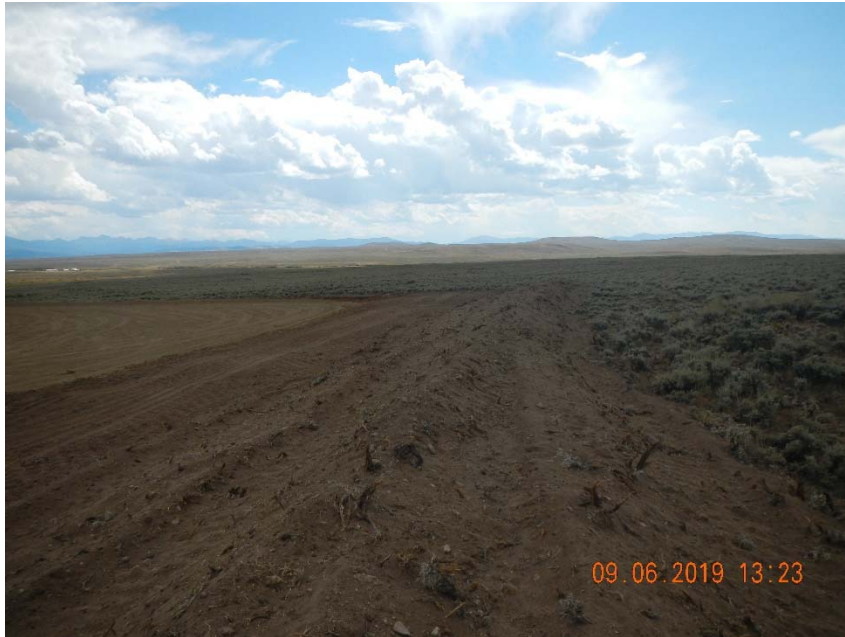
Photo 5. Possible topsoil. No stormwater controls or topsoil protections apparent.

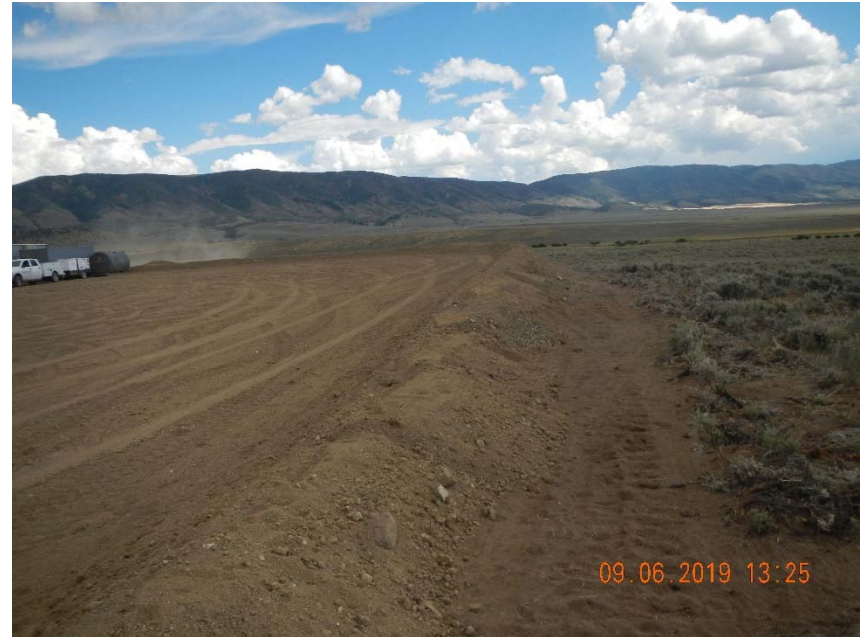
Photo 6. Overview of location from southwest corner looking southeast. No stormwater controls apparent.

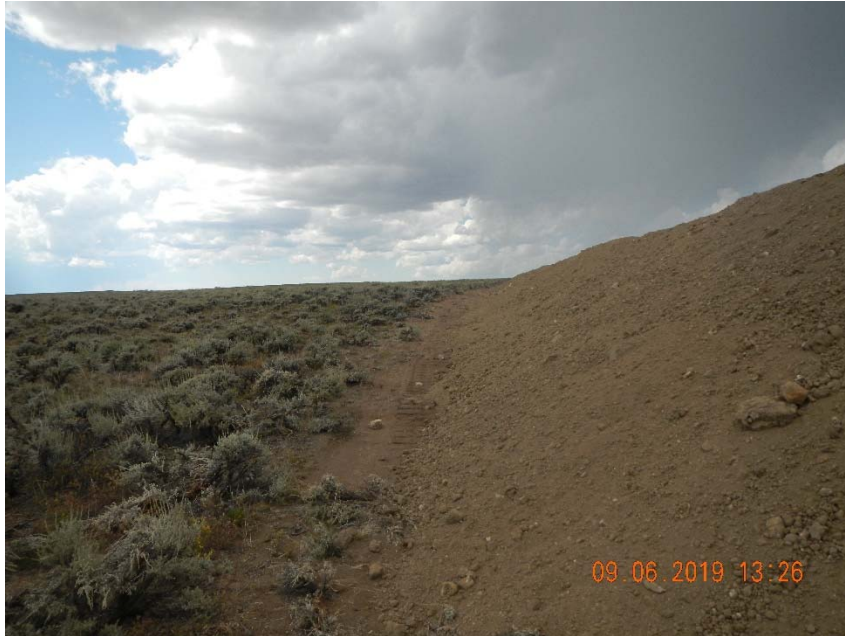
Photo 7. South side of location. No stormwater controls apparent.

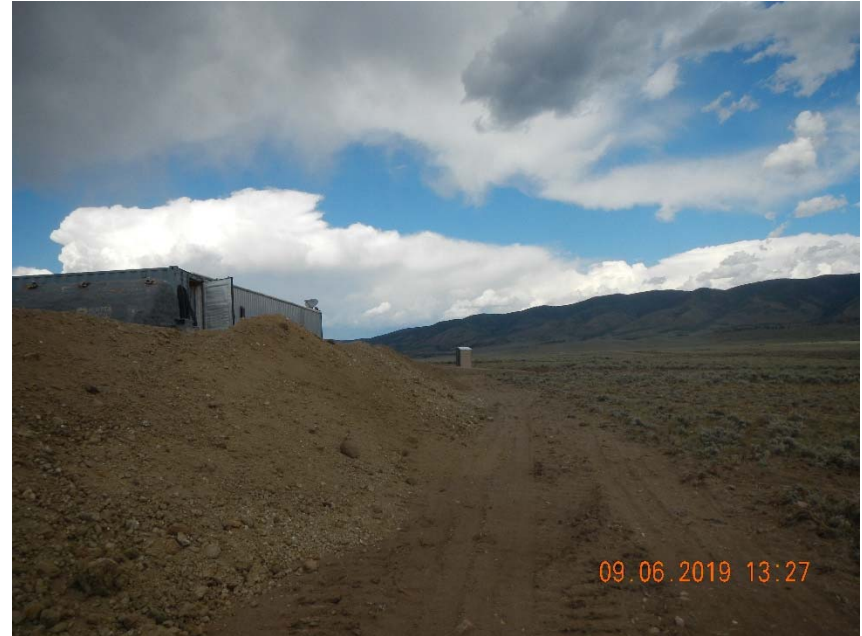
Photo 8. East side of location looking north. This is area designated for cuttings disposal onsite in Form 2. No stormwater controls apparent.

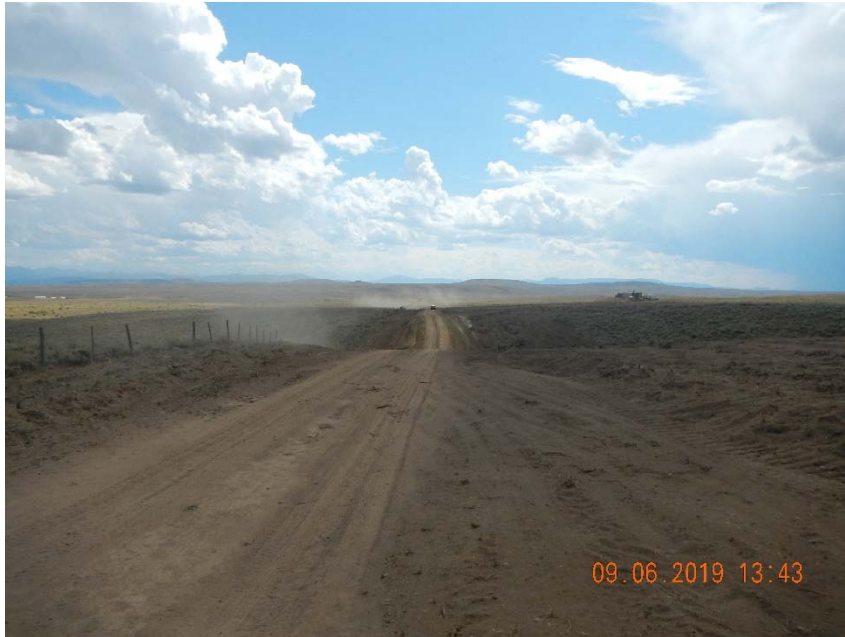
Photo 9. Access road before drainage crossing. Dust from contractors vehicles and my own vehicle visible in photo. No stormwater controls apparent.

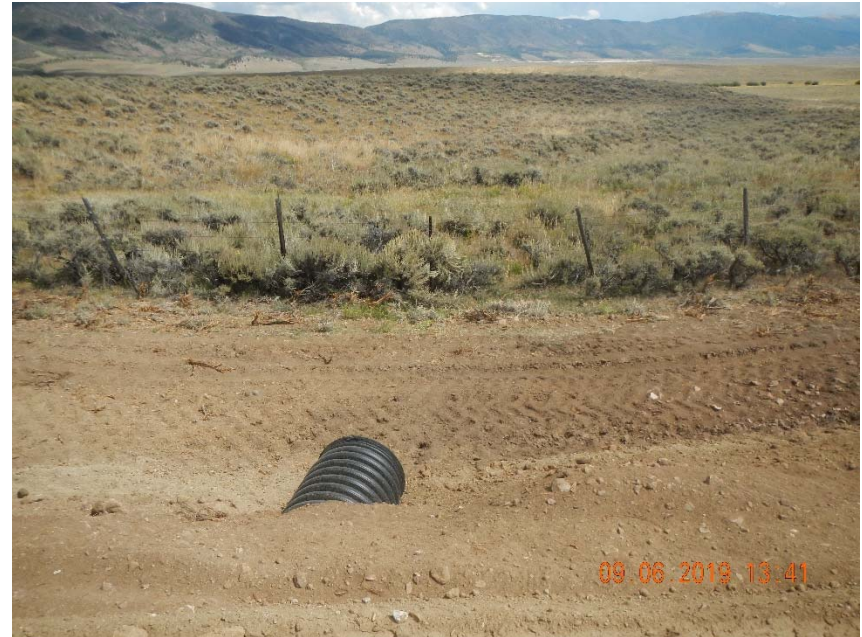
Photo 10. No stormwater controls apparent in drainage crossing.

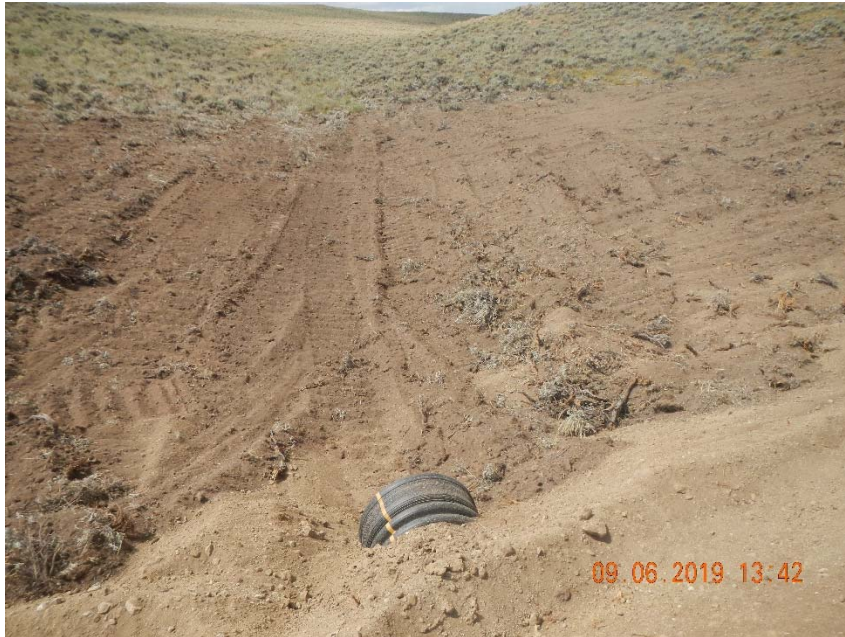
Photo 11. No stormwater controls apparent in drainage crossing.

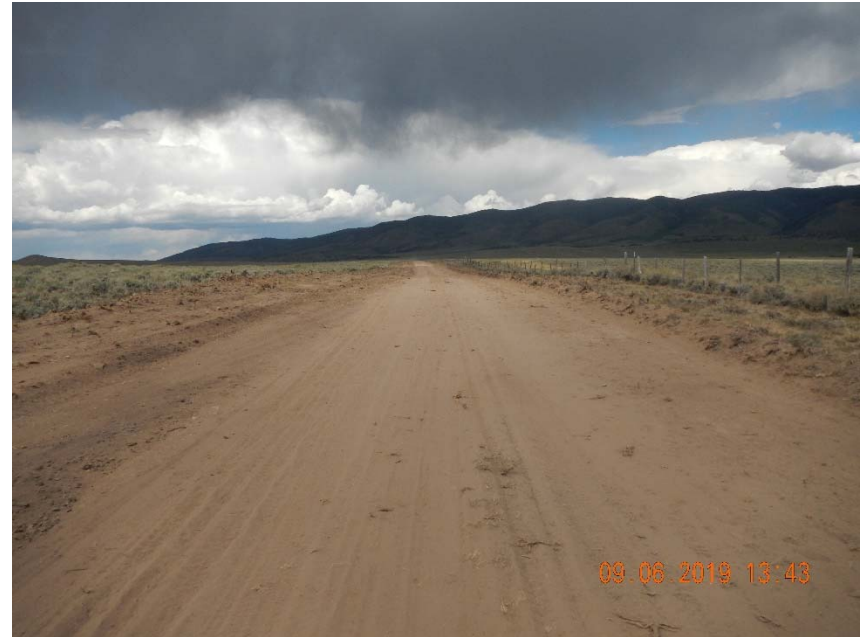
Photo 12. Access road with no stormwater controls apparent.
