Inspection Photos
Operator: BP America
Location/API #: 067-07526
Date: 8-29-2019

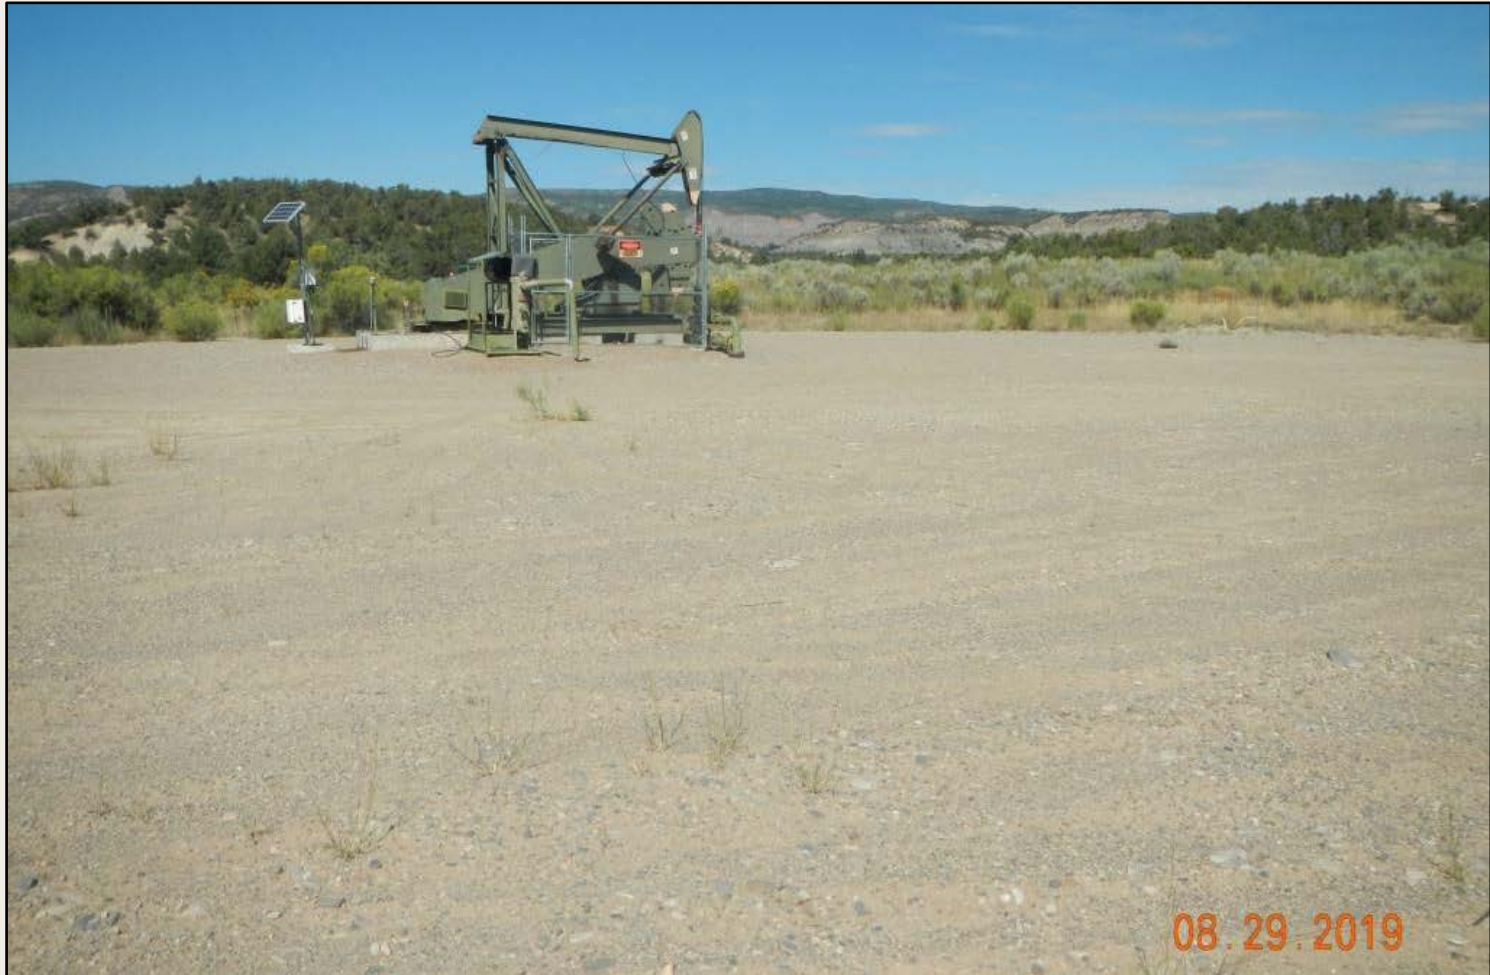
Photo 1. View of the project area from the southwestern corner facing center.

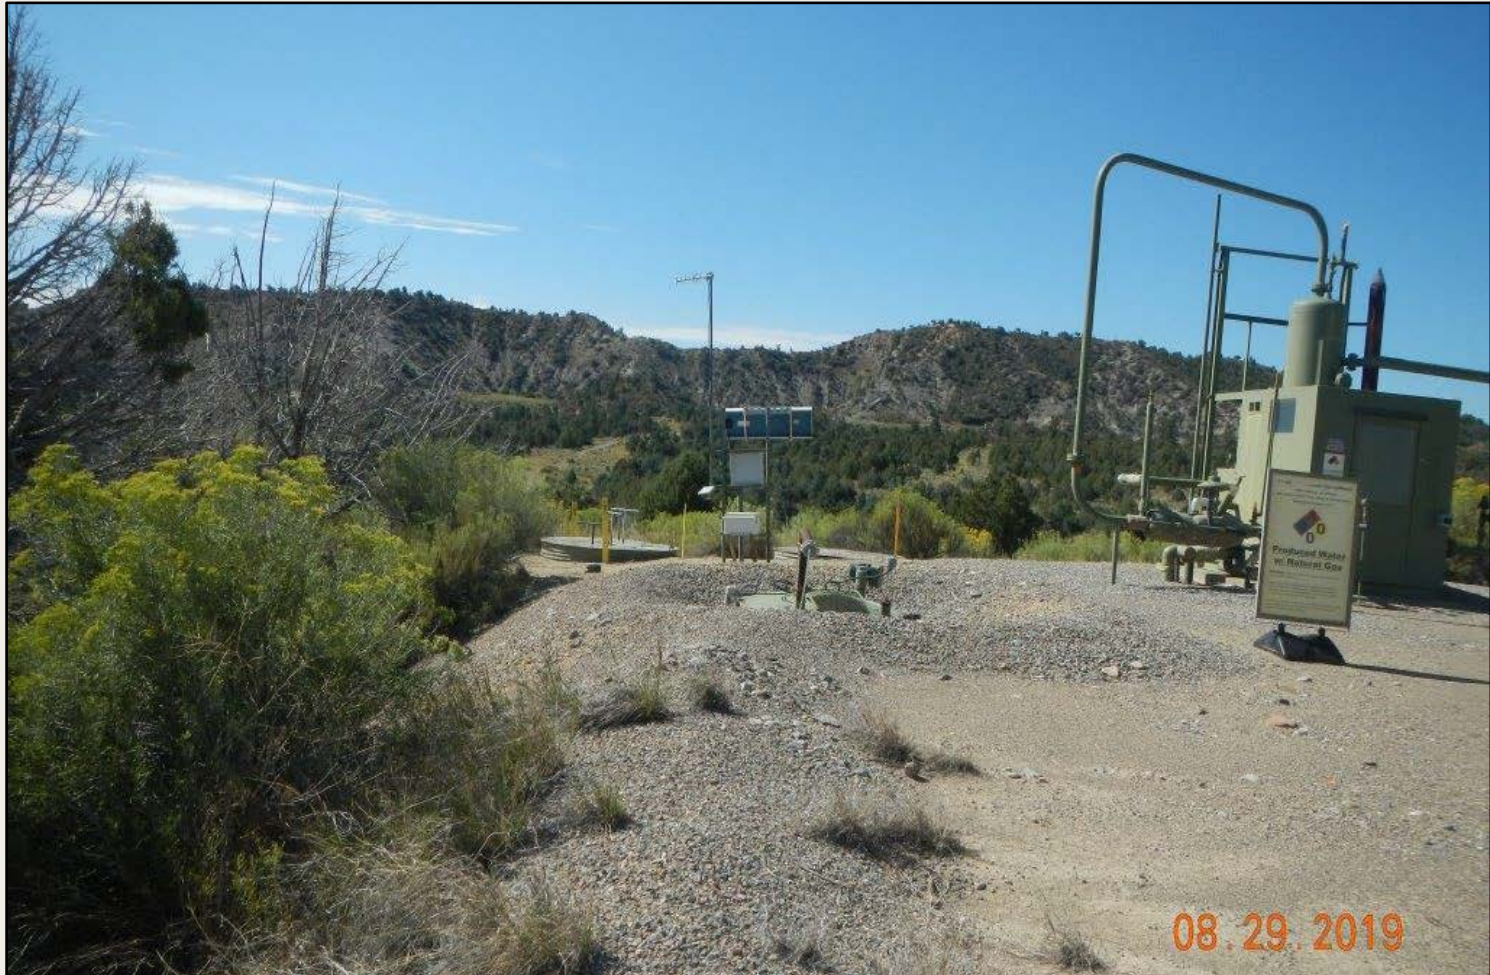
Photo 2. View of the southern fill slope from the southeastern edge facing westward.

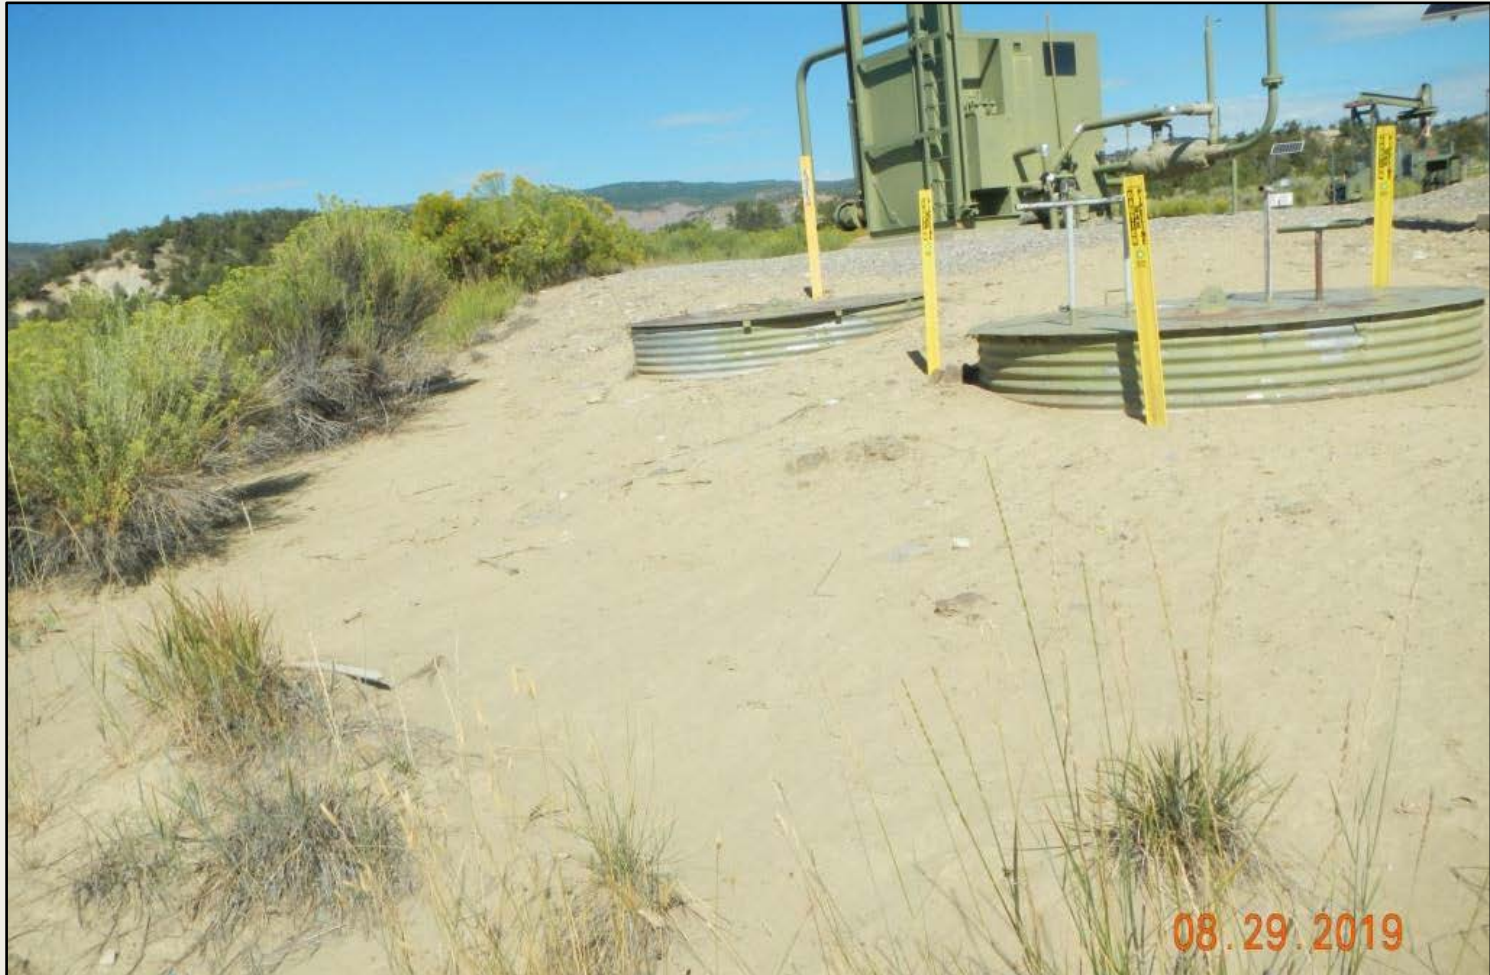
Photo 3. View of bare and unstabilized soils within the southeastern project area. Stabilization/revegetation is needed here.

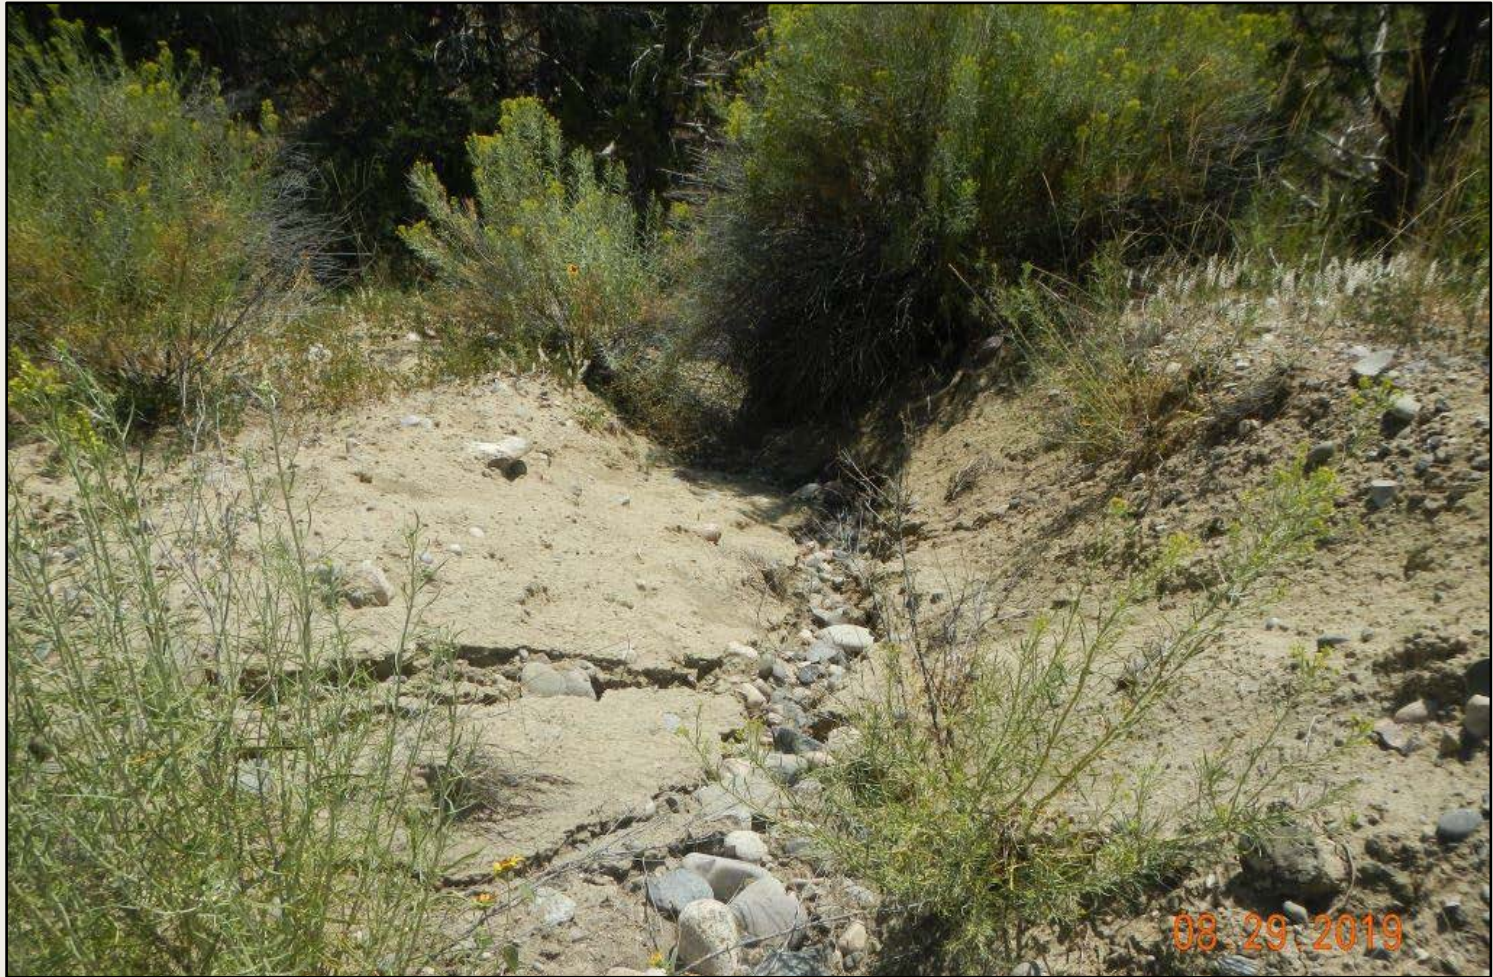
Photo 4. View of erosional channel within the eastern project area. Cobbles in channel are not adequate stormwater controls.

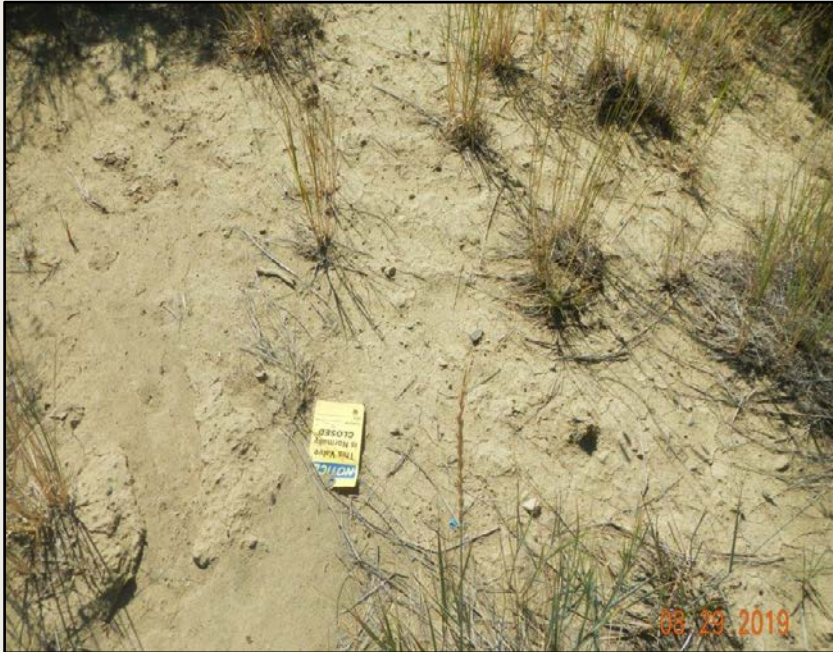
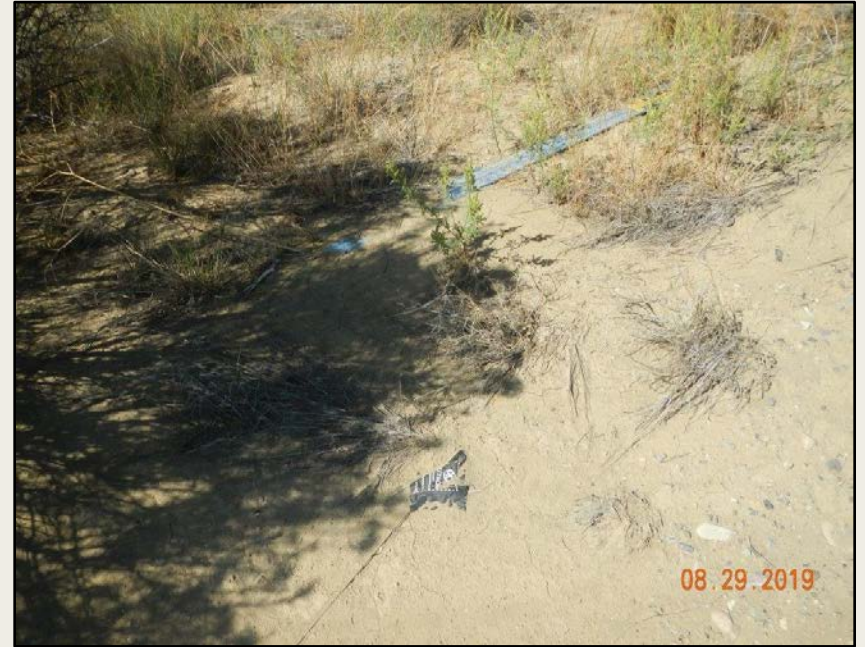
Photos 5 and 6. View of waste and debris observed within the southeastern project area.

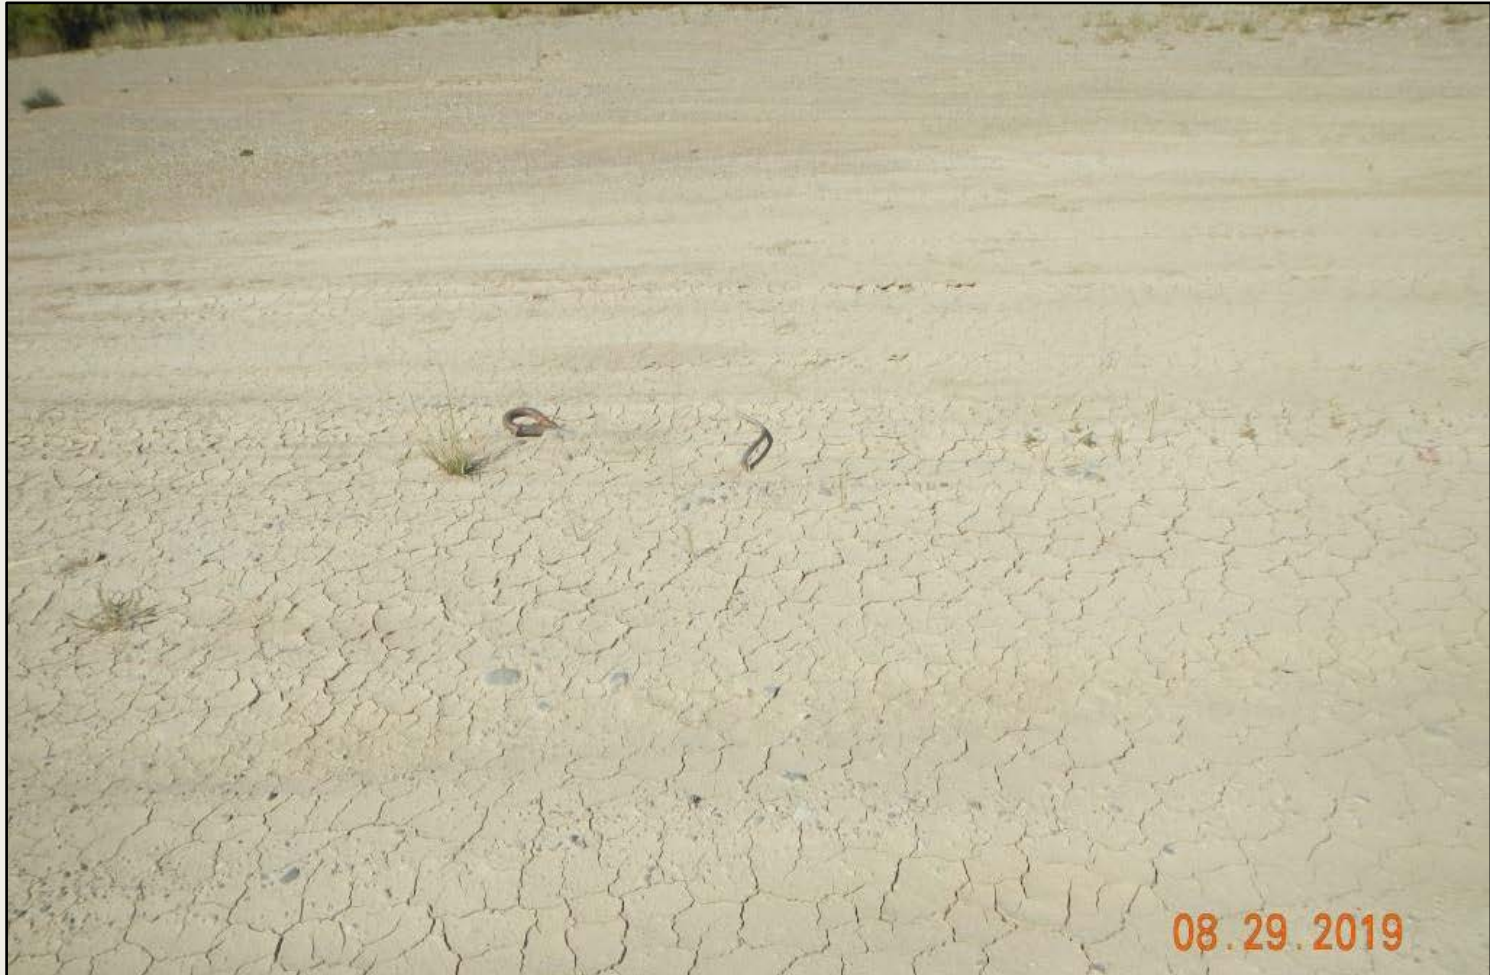
Photo 7. View of unmarked rig anchor within the project area.

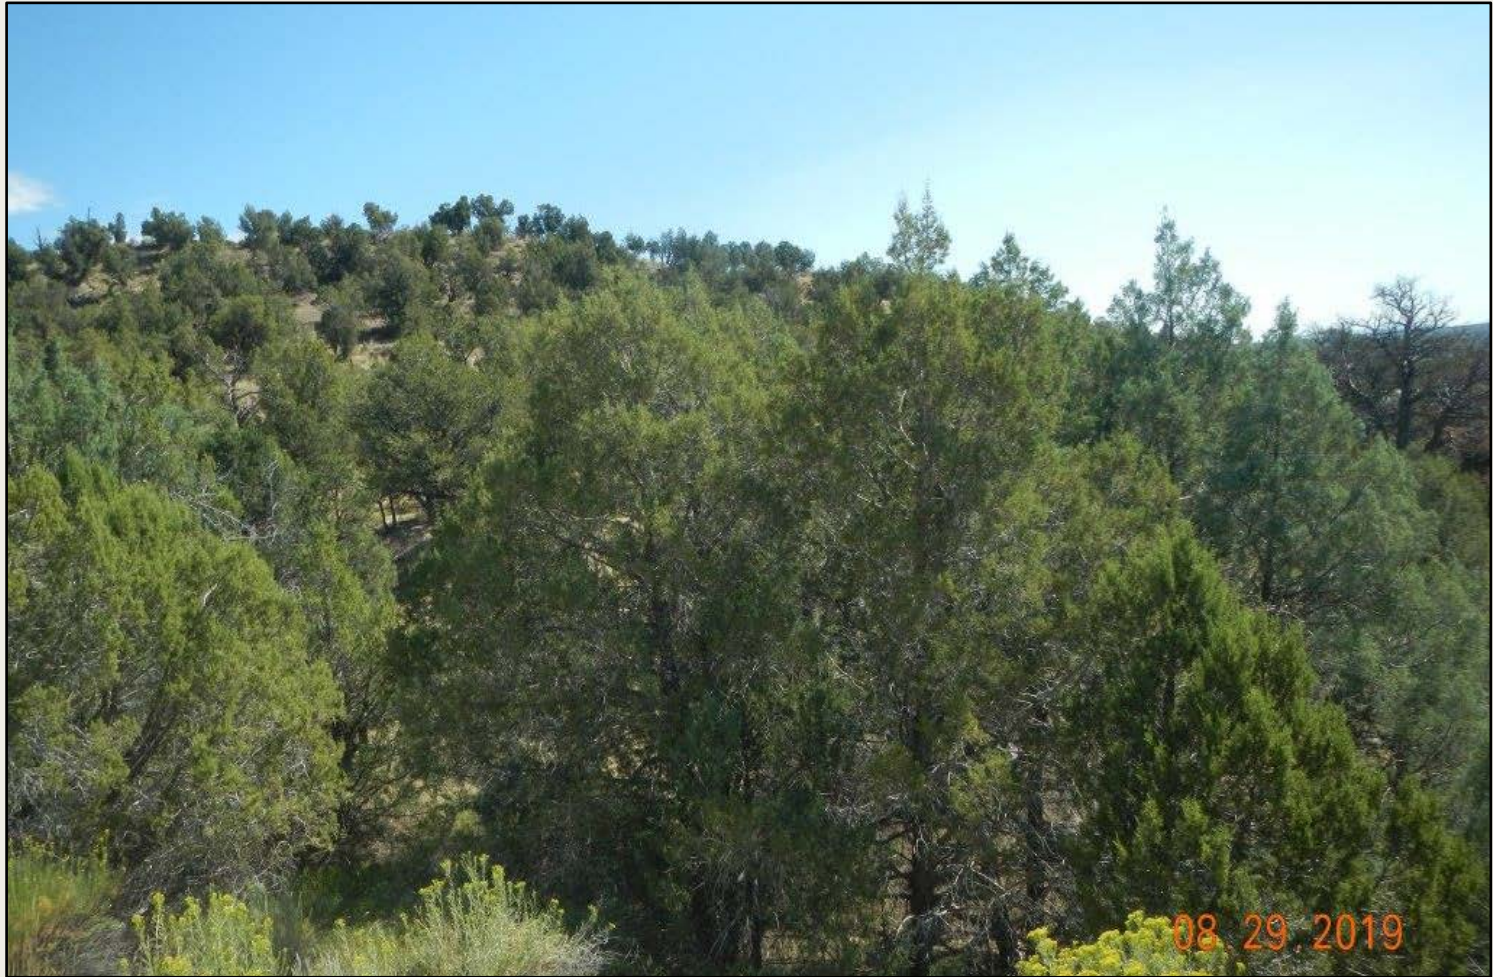
Photo 8. View of reference area facing eastward. Vegetation is comprised of pinyon juniper woodland.
