Inspection Photos
Location Name: 596-33C Pad
Location ID: #335880
Inspection Date: August 30, 2019

COLORADO

Oil & Gas Conservation
Commission

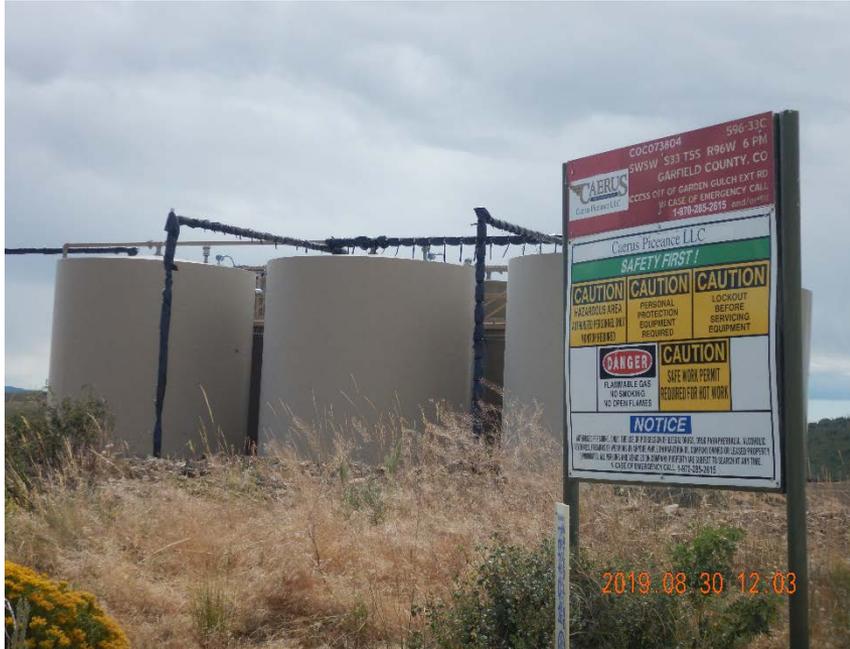
Photo #1 – Facility sign.

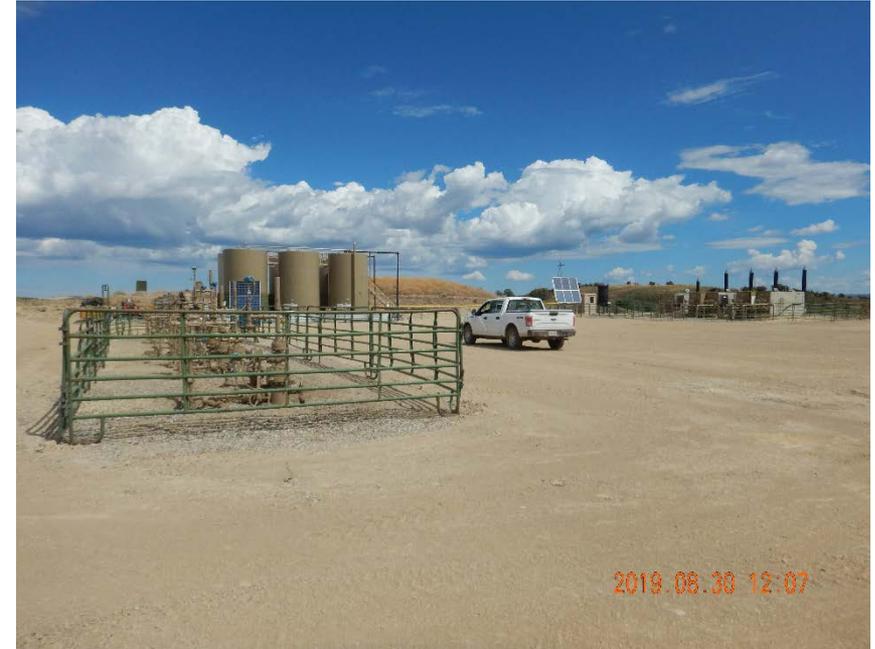
Photo #2 – Overview of location from southwest.

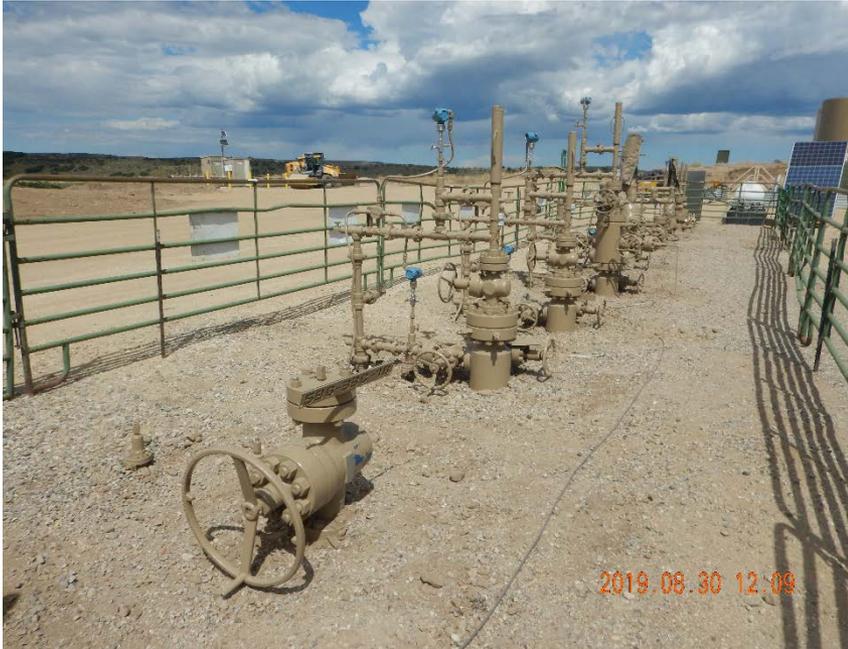
Photo #3 – Overview of fenced wellhead area from southeast. No localized accumulations of oil-stained soil were observed in wellhead area on inspection date.

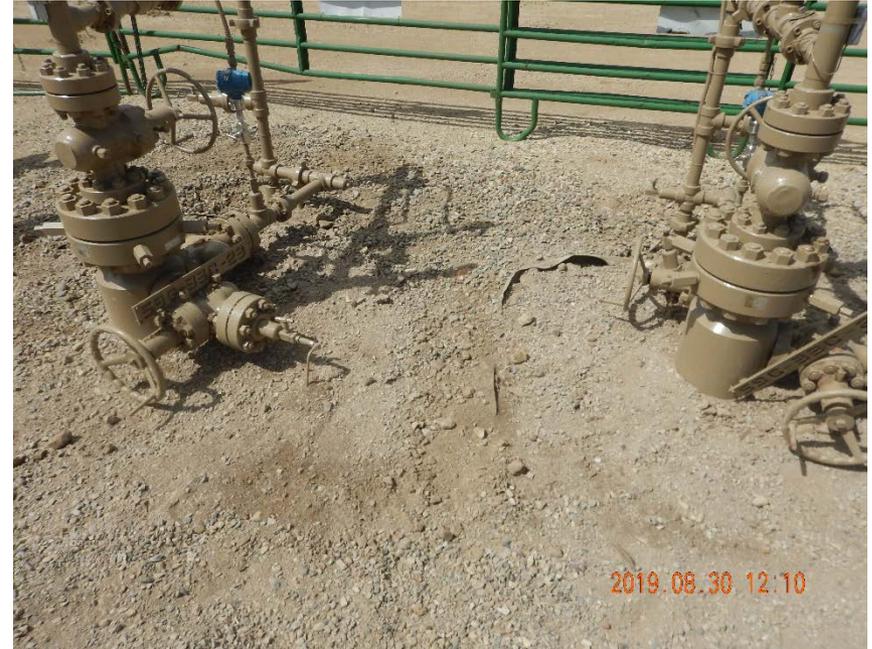
Photo #4 – Close-up view of backfilled well cellars.

Note well cellars have been backfilled to prevent wildlife access.

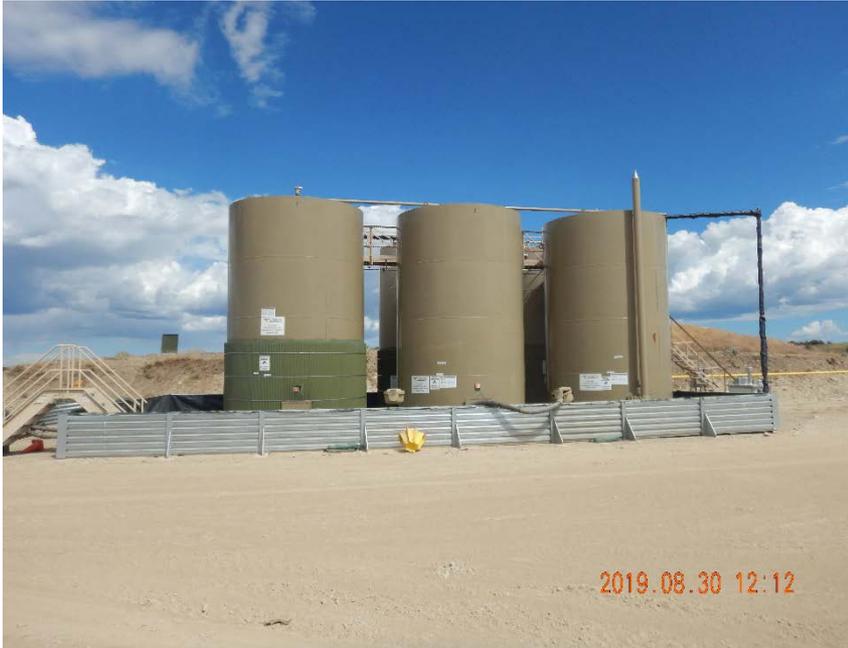
Photo #5 – View of tank battery on north side of location.

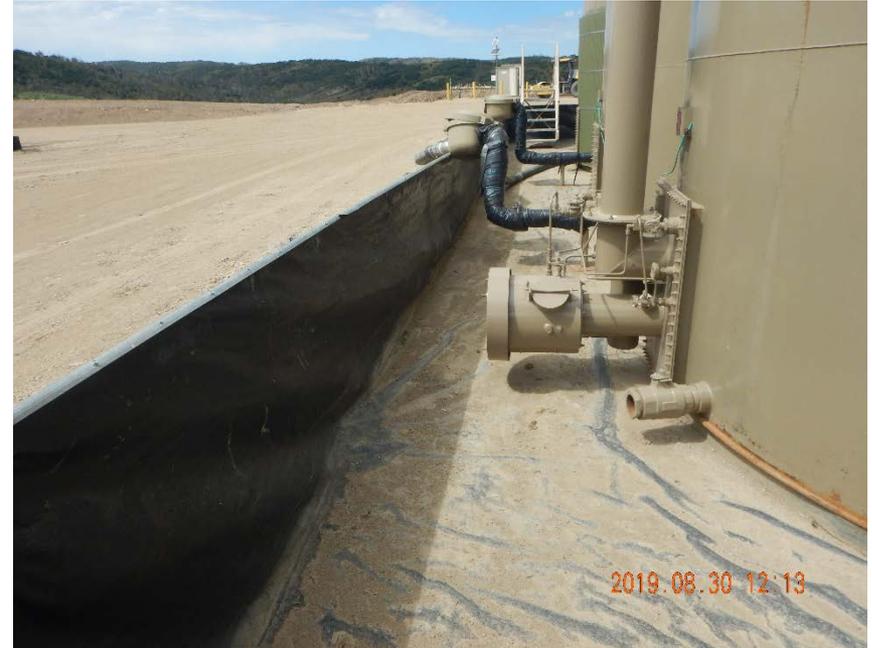
Photo #6 – View inside of tank battery secondary containment on south side.

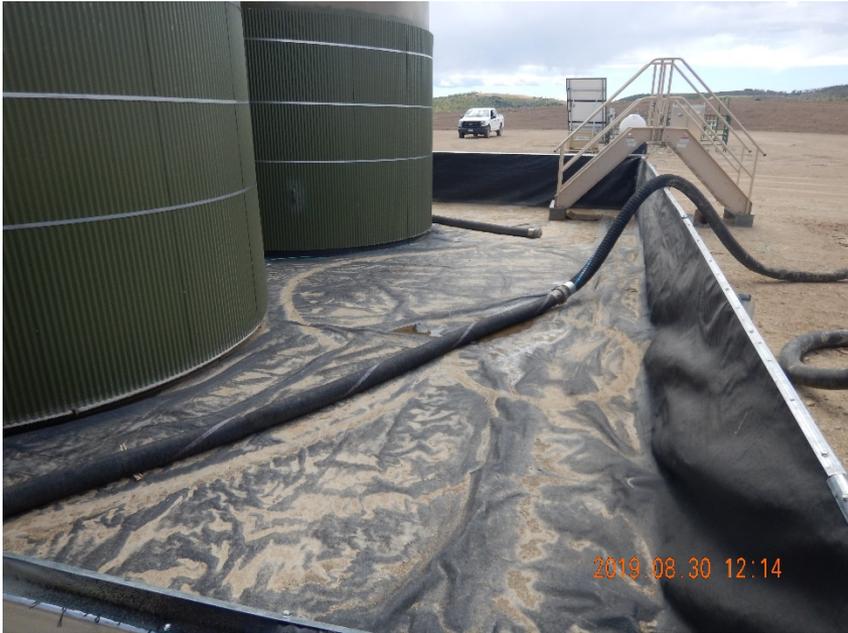
Photo #7 – Hoses stored on west side of tank battery secondary containment with metal fittings in direct contact with liner.

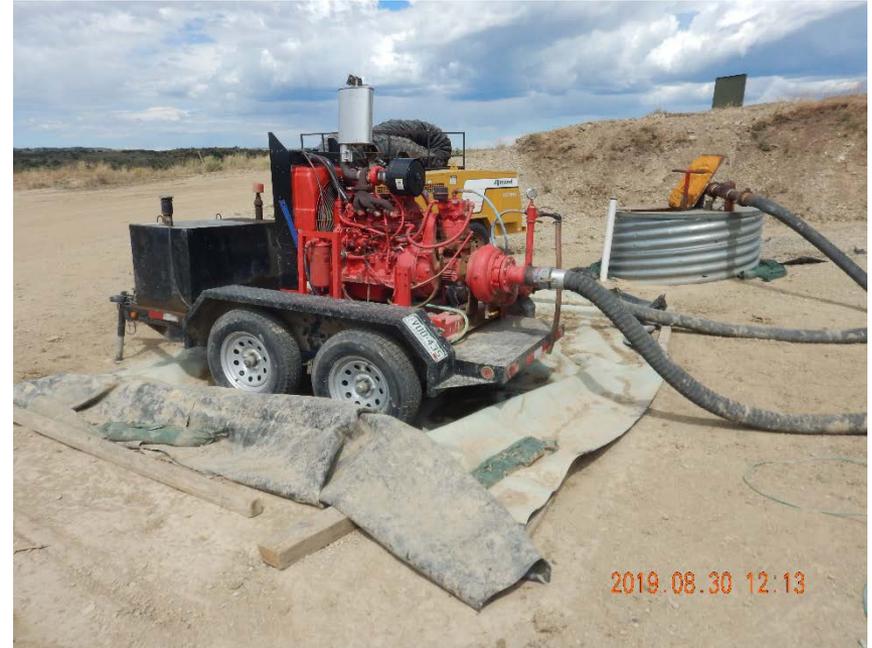
Photo #8 – Trailer pump on top of liner located west of tank battery.

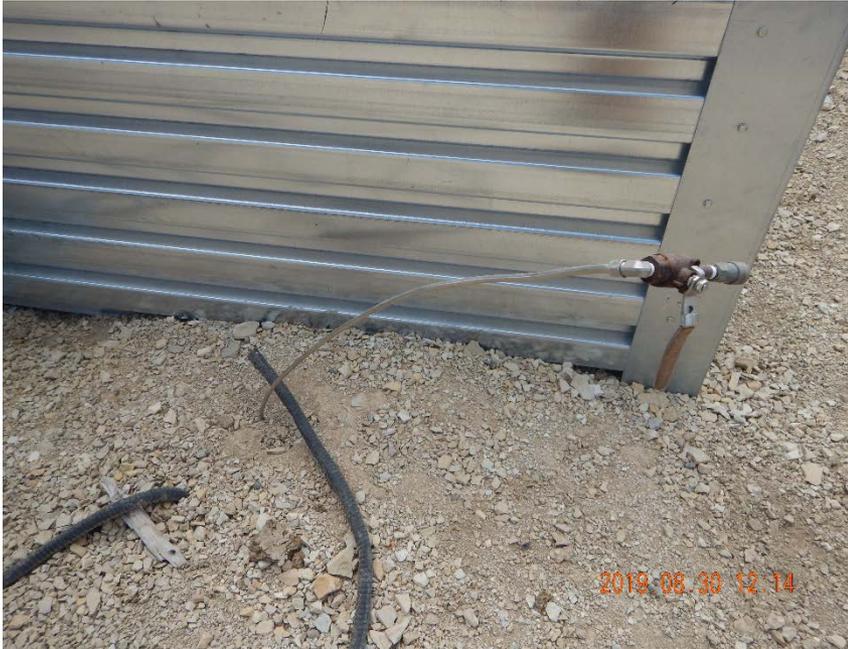
Photo #9 – Unused, unmarked, and uncapped ¼” riser located northwest of tank battery. Operator was instructed to LO/TO and remove this riser in previous FIR (doc #690200036).

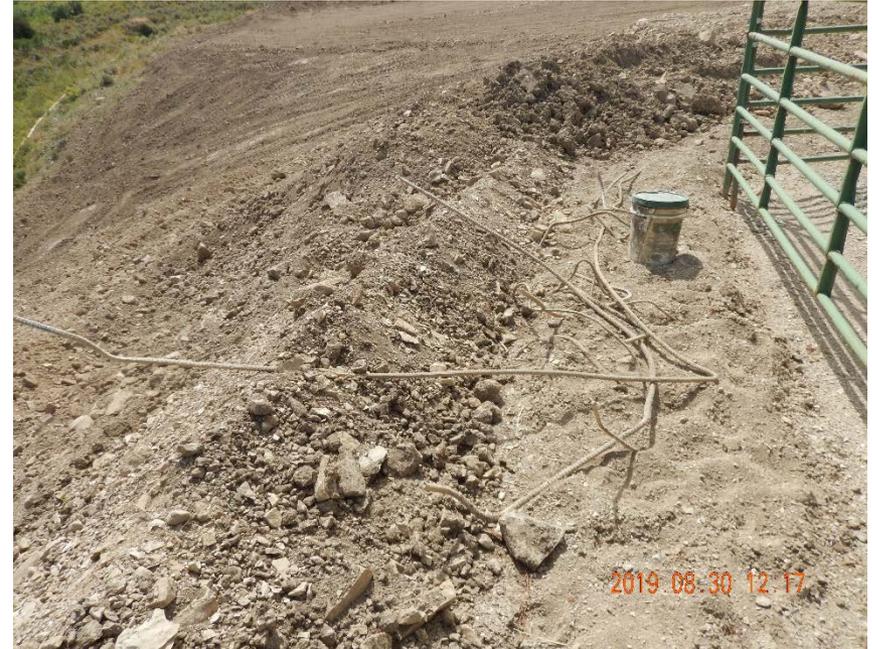
Photo #10 – Junk equipment and bucket located southeast of fenced separator area.

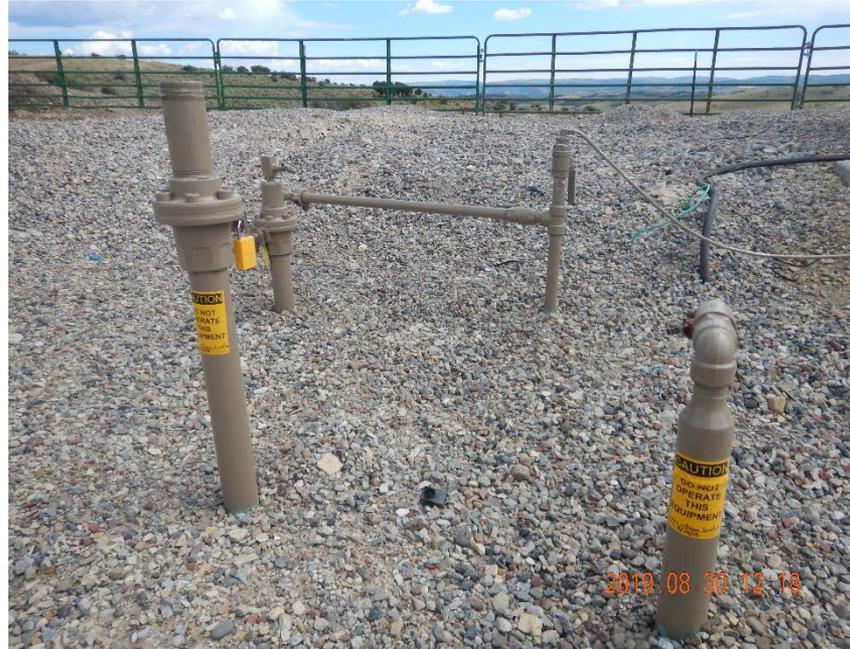
Photo #11 – Flowline risers north of separators have been LO/TO.
