Inspection Photos
Location Name: NW Corner of Weld County Roads 12 & 11
Spill/Release: 467047

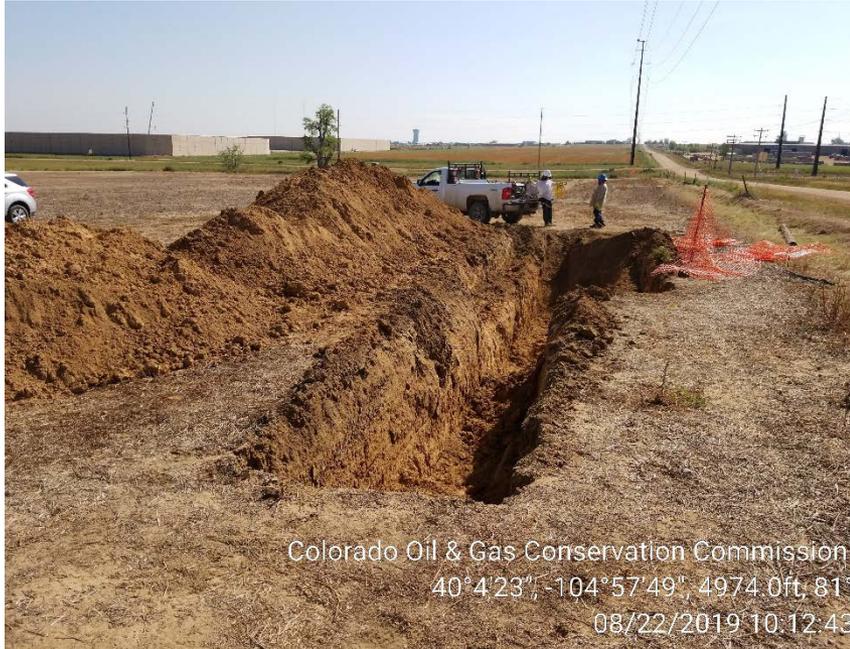
Excavation to expose failed section of flowline.

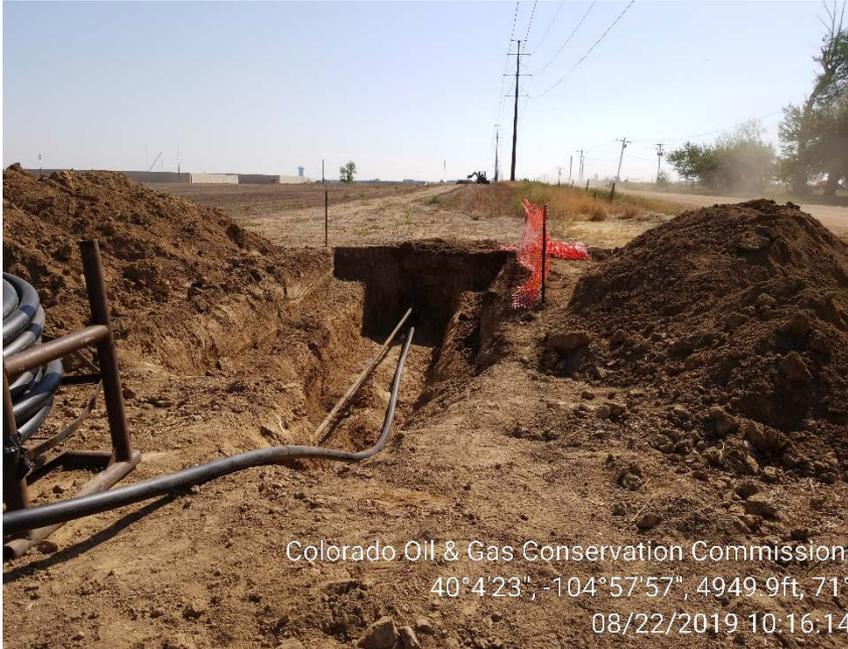
Excavation to expose failed section of flowline.

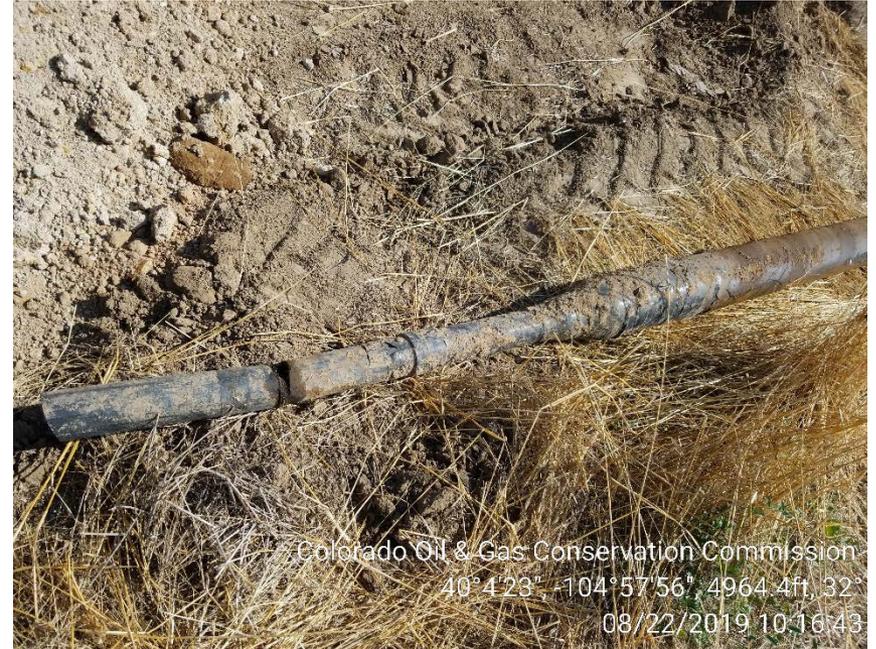
Failed section of flowline.

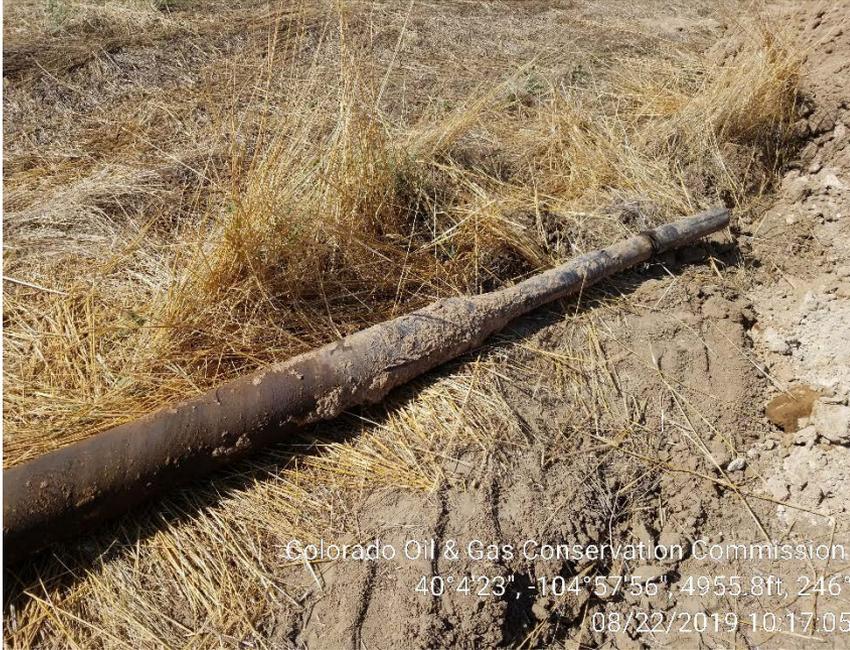
Failed section of flowline.

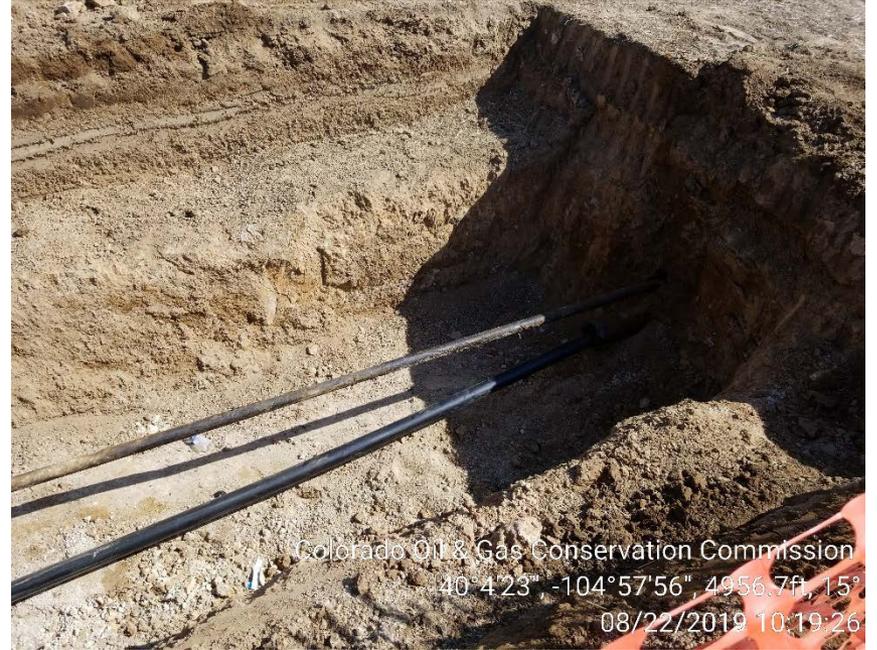
View into open excavation.
