Inspection Photos

API: 05-071-06340

Operator: TIMBER CREEK OPERATING LLC

Inspection Date: 9/12/2019

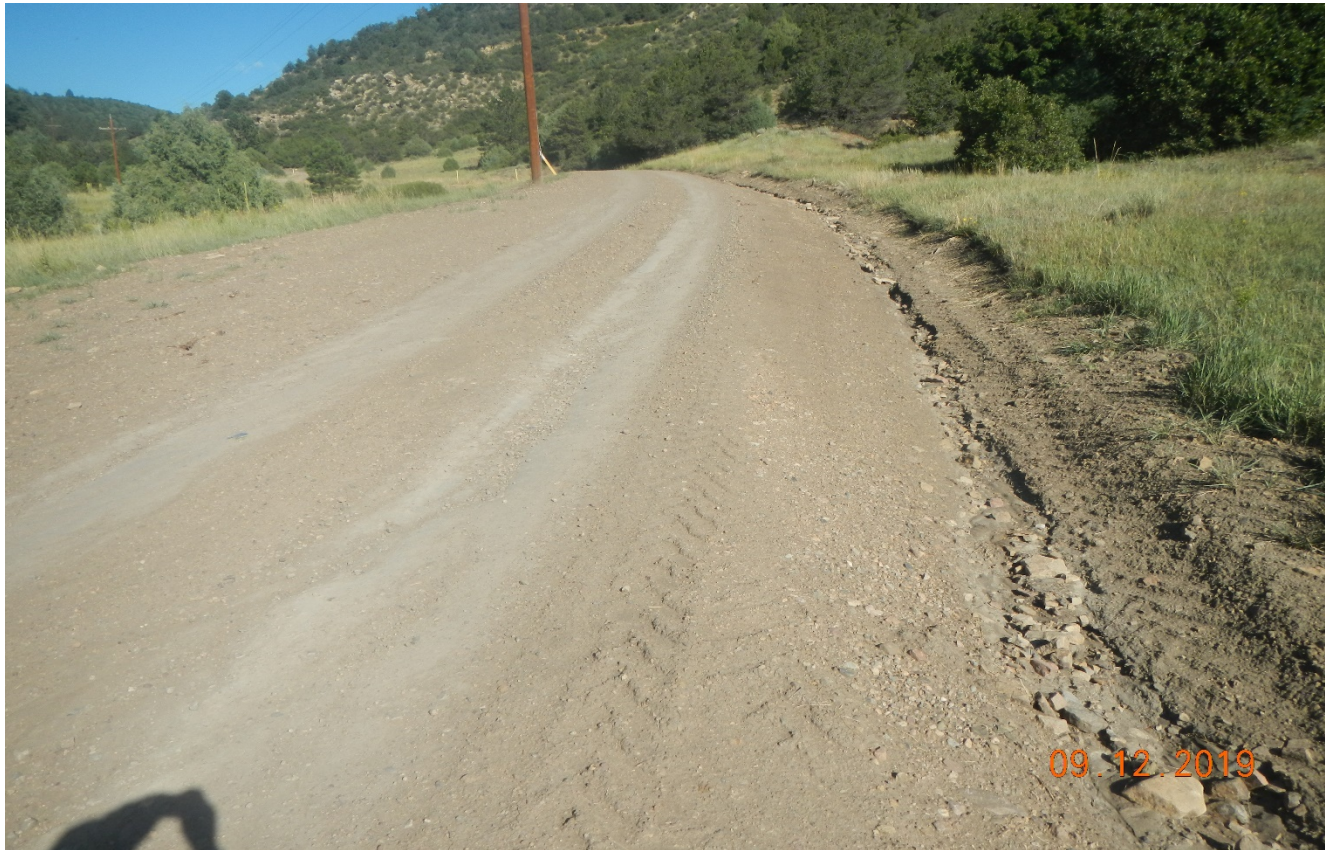
Photo 1. Facing northwest near the mouth of the canyon. The main road has recently be graded. Erosion is occurring along the side of the road.

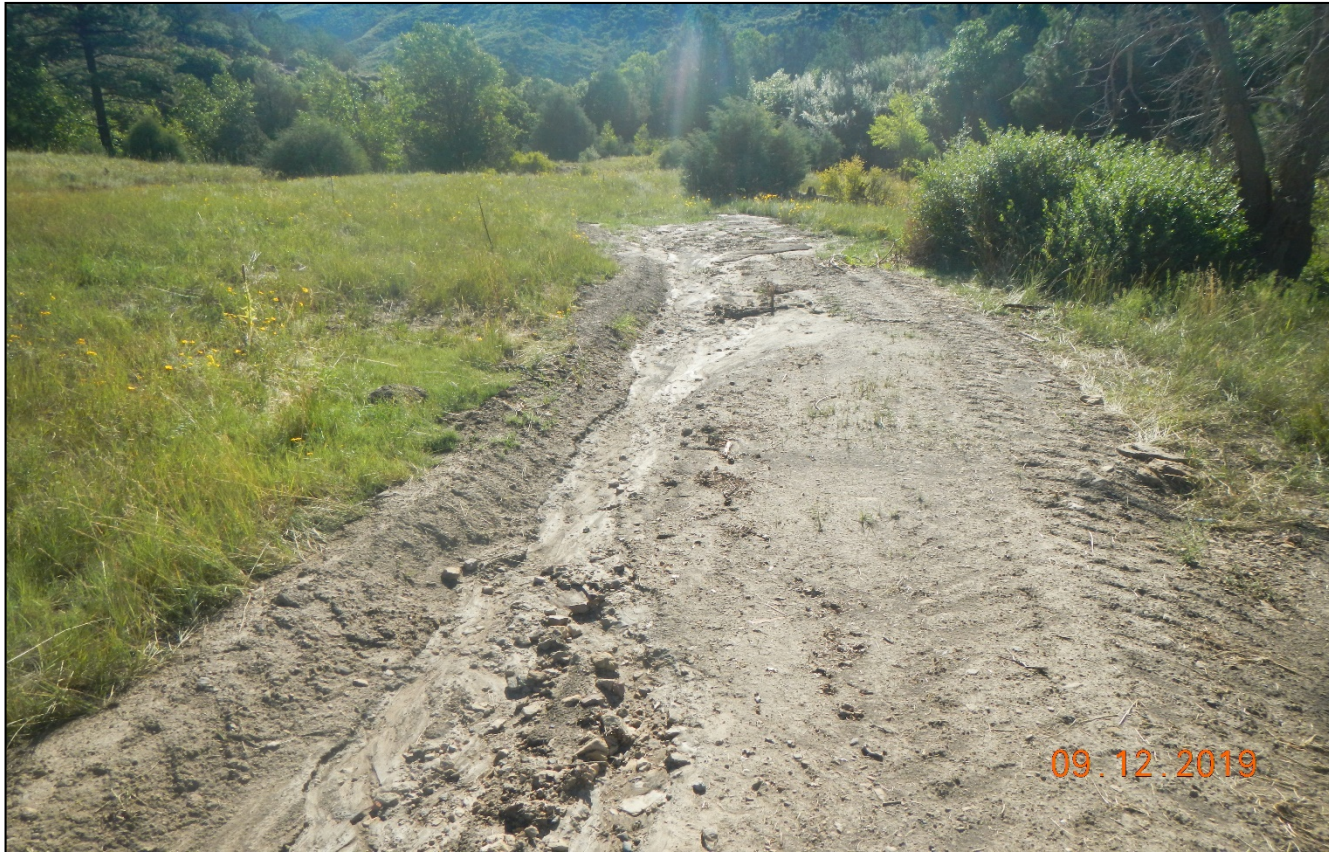
Photo 2. Sediment has already filled into the diversion ditch since grading occurred. No work has been conducted here since previous inspection. Erosion must be controlled to prevent sediment discharge. This area of disturbance needs to be seeded and stabilized.

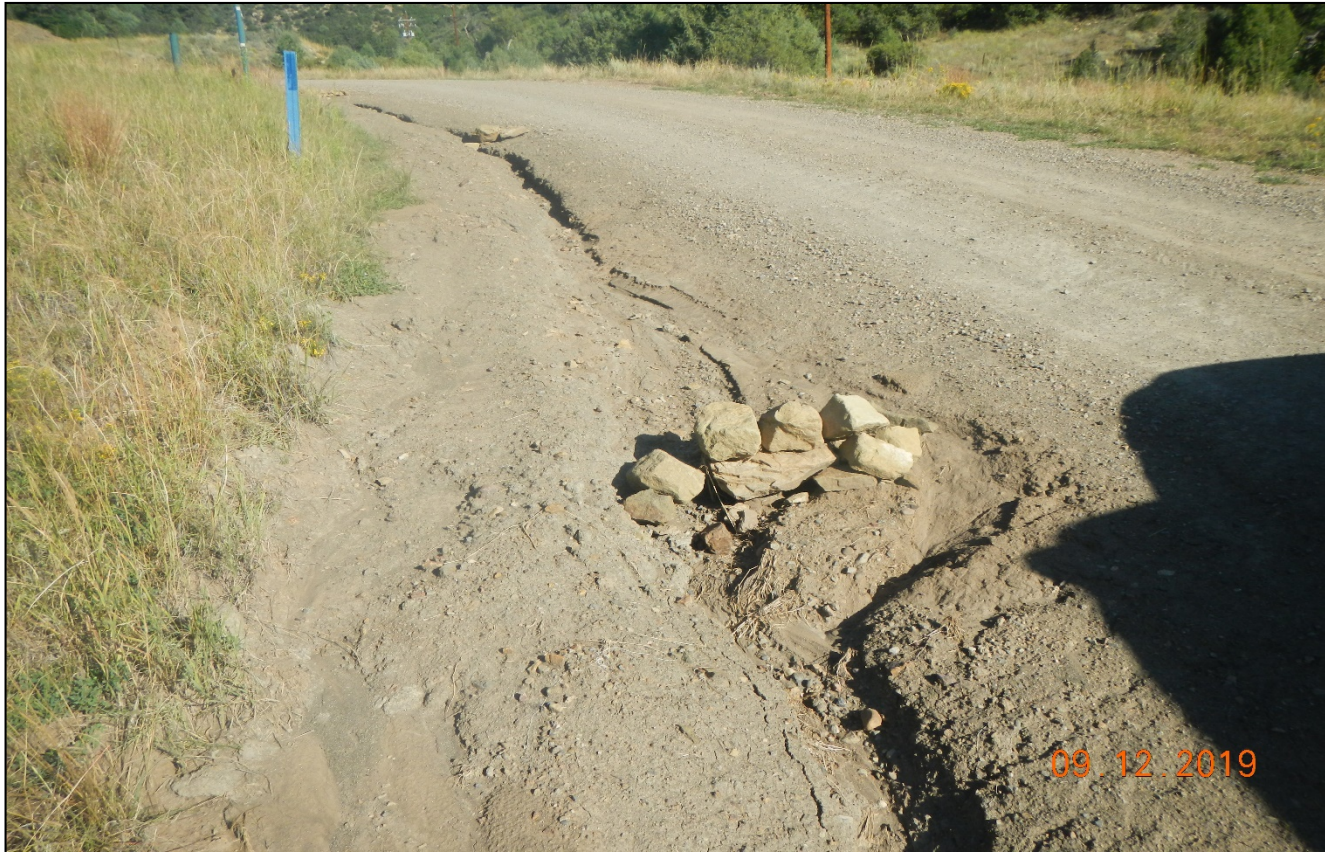
Photo 3. The rock check dams were not installed correctly. Stormwater is flowing around the checkdams causing erosion of the road.

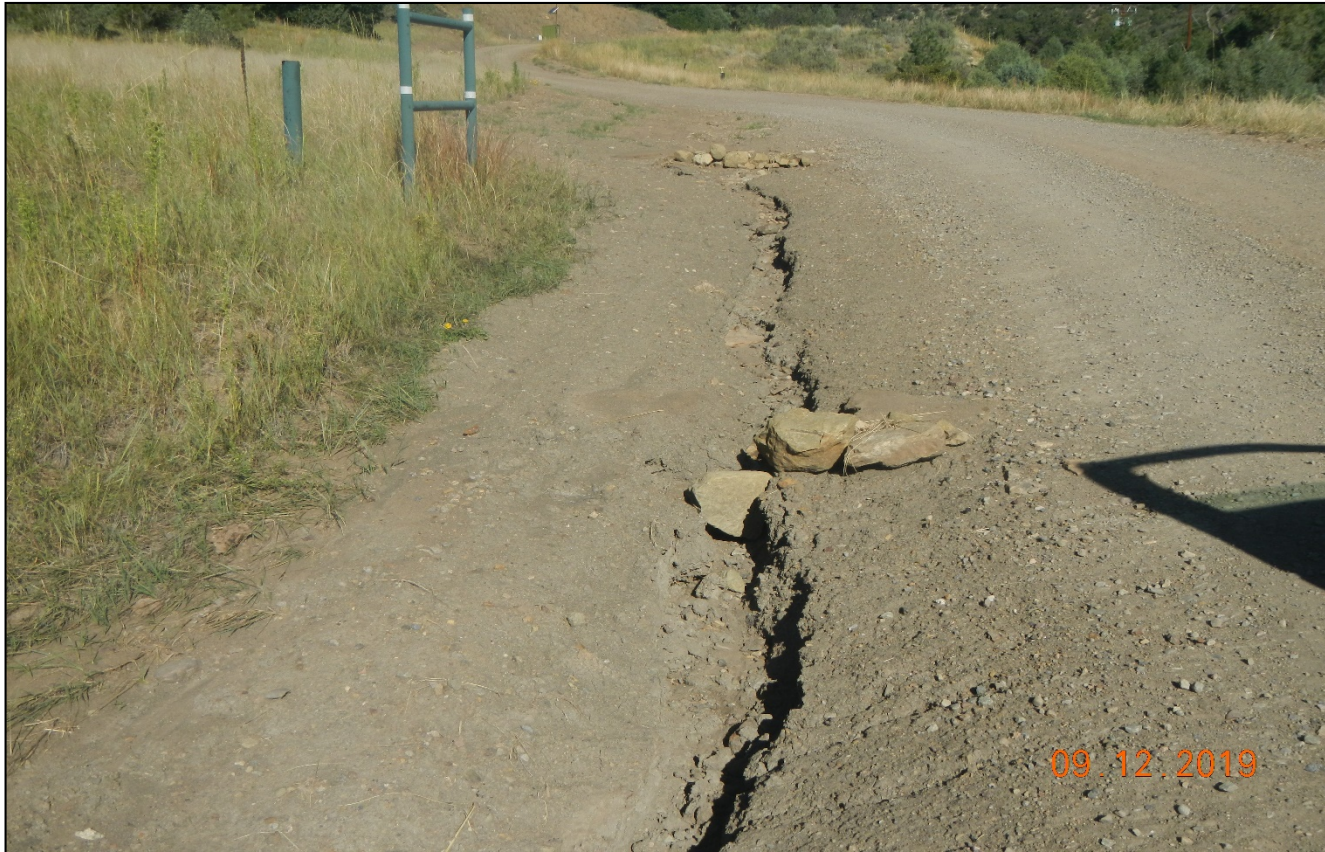
Photo 4. Photo of another checkdam further along the road. The rock check dams were not installed correctly. Stormwater is flowing around the checkdams causing erosion of the road.

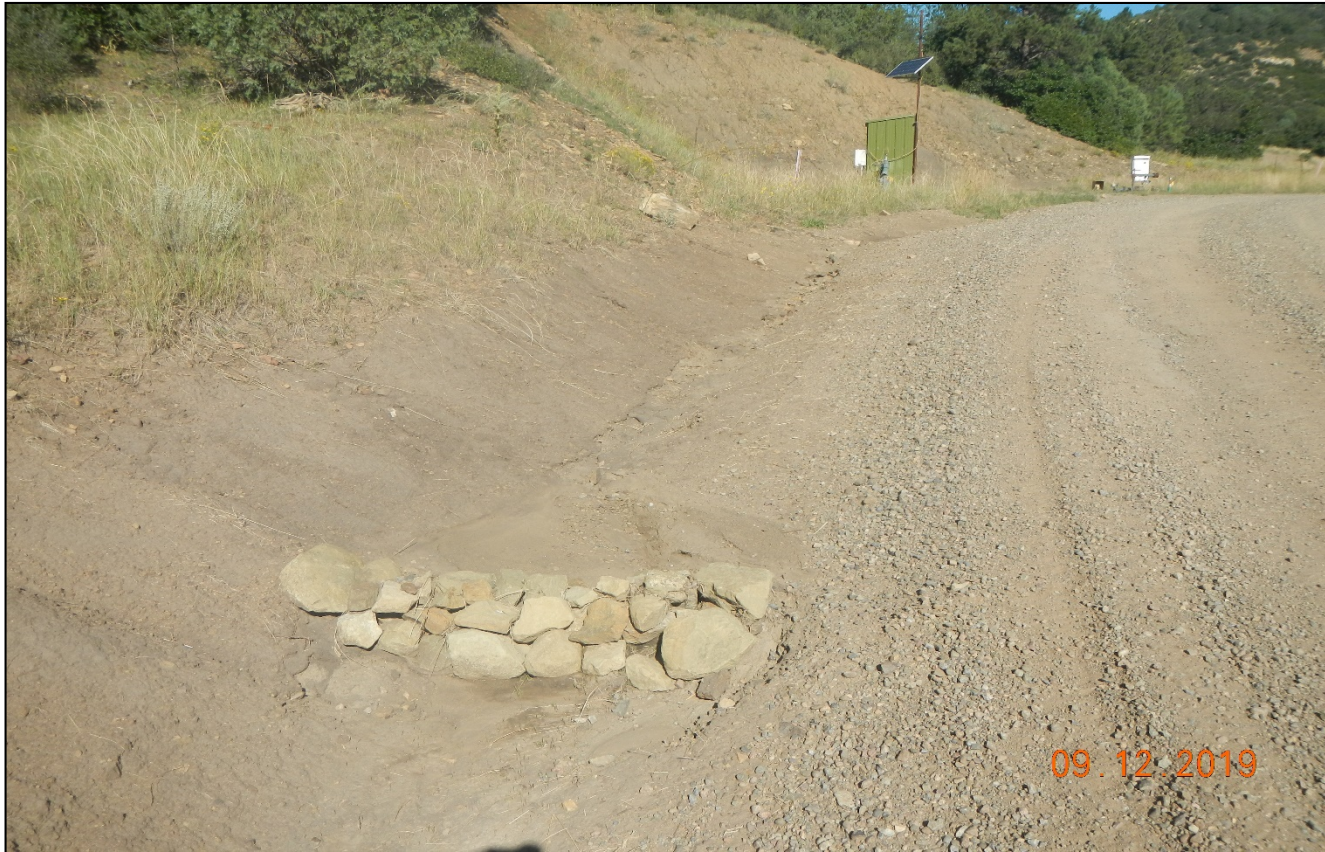
Photo 5. Photo of another checkdam further along the road. The rock check dam has filled in with sediment. Erosion needs to be controlled from the source.
