# Inspection Photos

API: 05-071-06130

Operator: TIMBER CREEK OPERATING LLC

Inspection Date: 9/12/2019

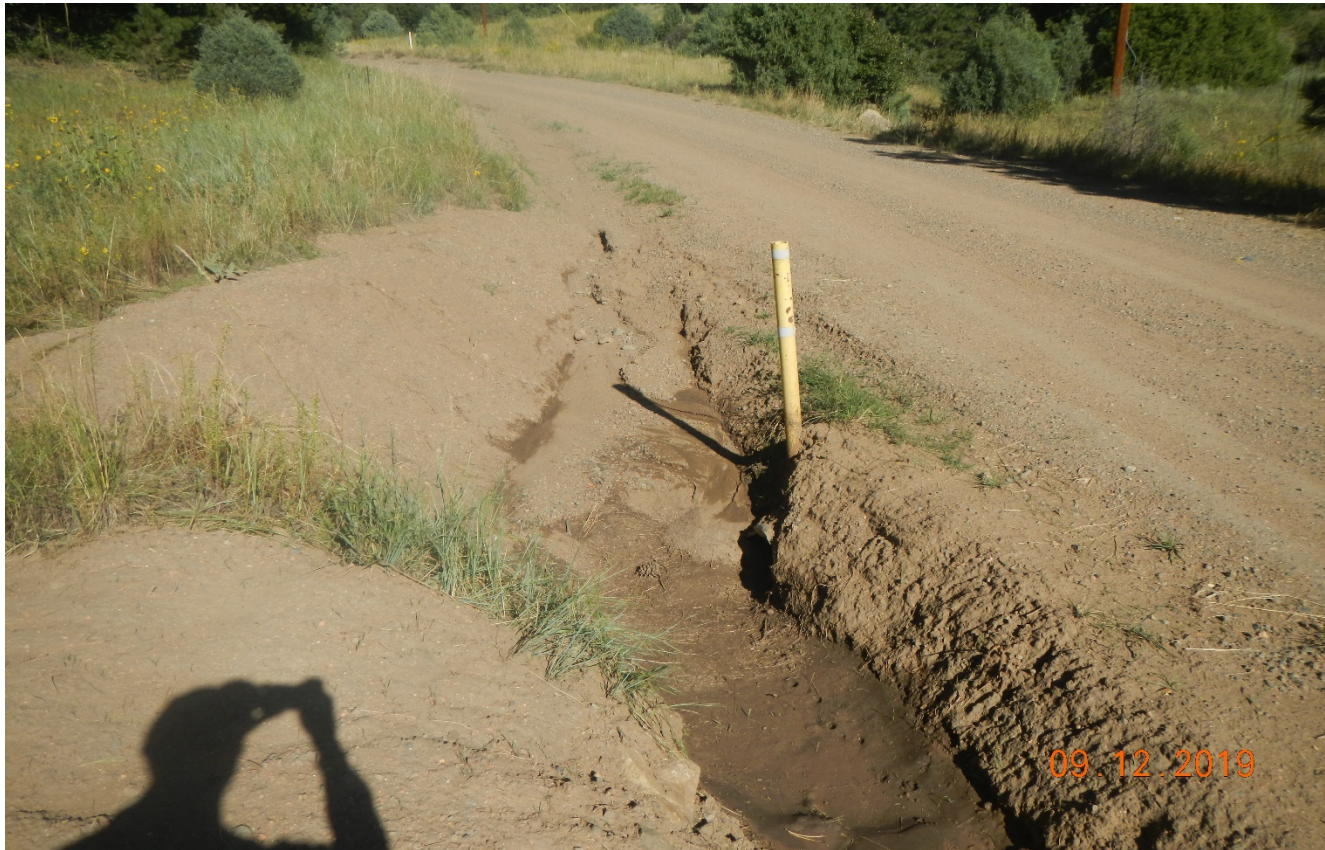
Lat/Long:37.09153/-104.93557

**Photo 1.** The culvert has filled in with sediment along the main road.

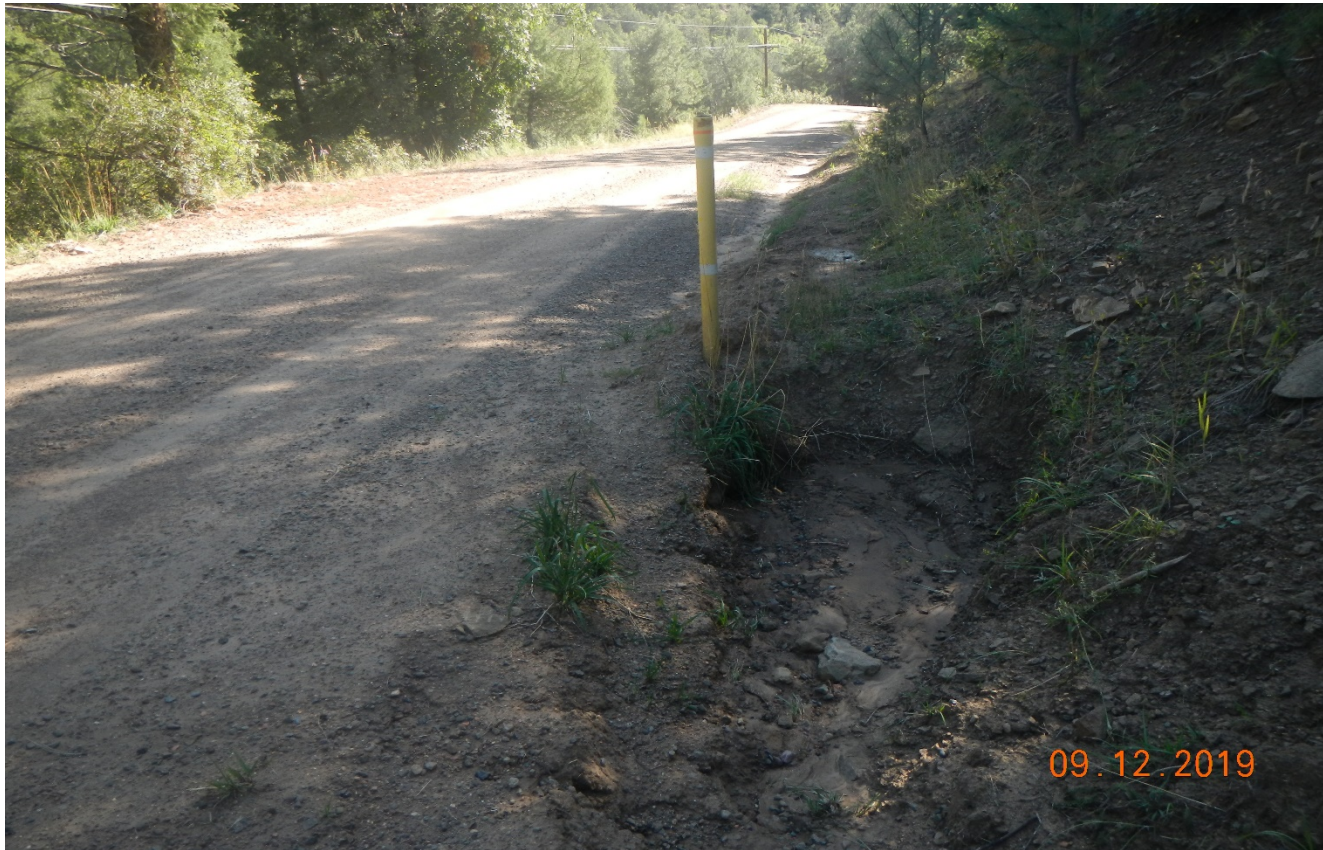
Lat/Long:37.09183/-104.93794

**Photo 2.** The culvert has filled in with sediment along the main road.

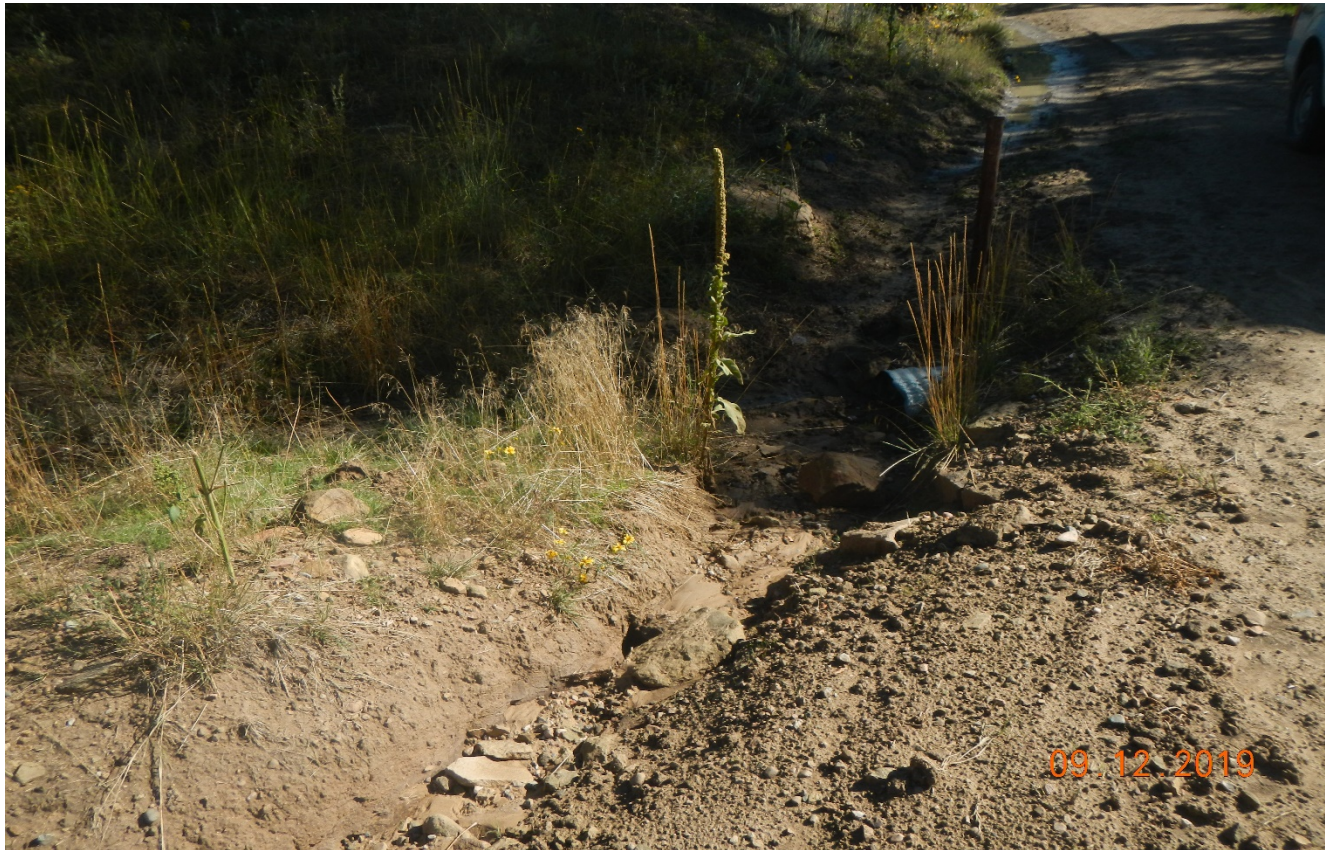
**Photo 3.** The culvert has been cleaned out since previous inspection.

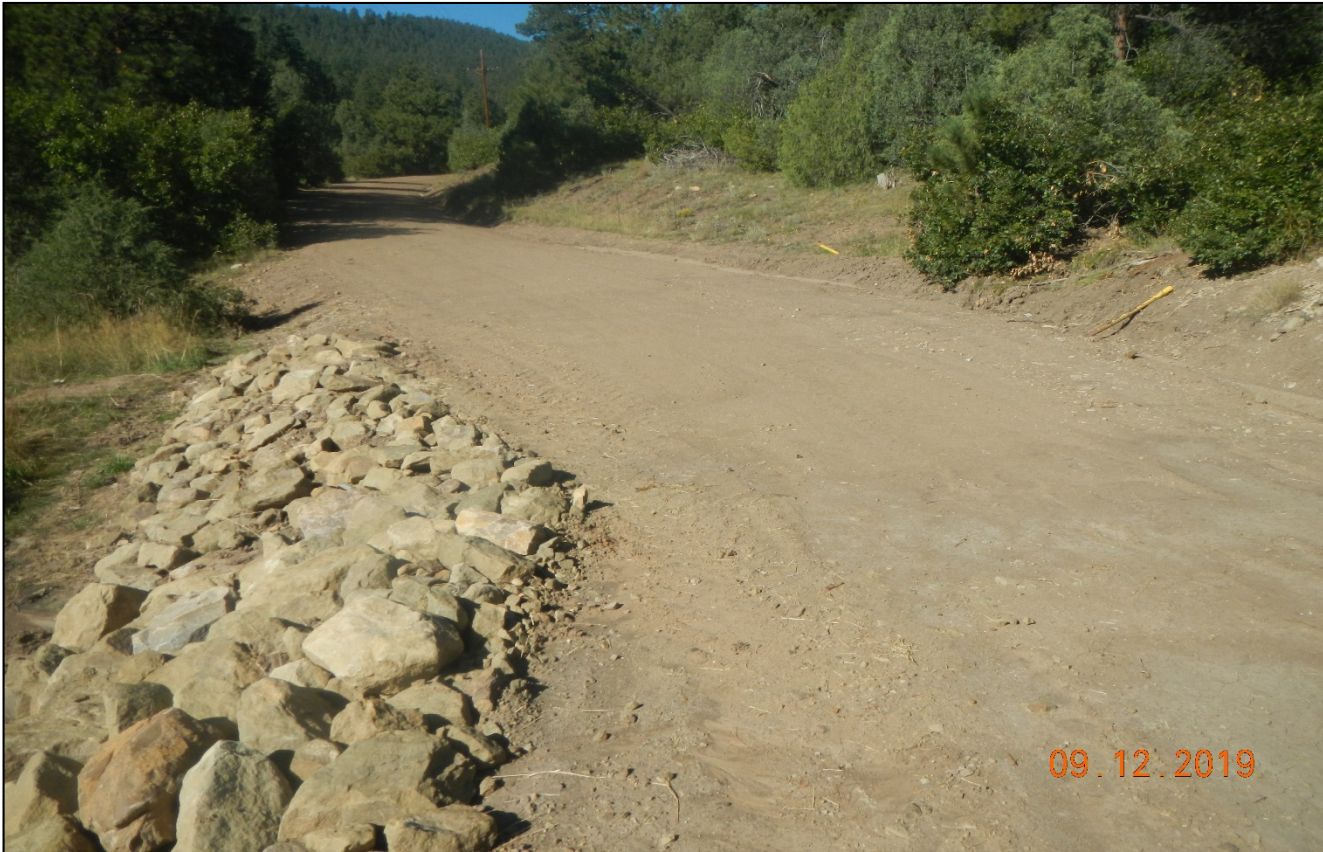
**Photo 4.** The road has been repaired and the culvert cleaned out.  
Lat/Long:37.09015/-104.94924

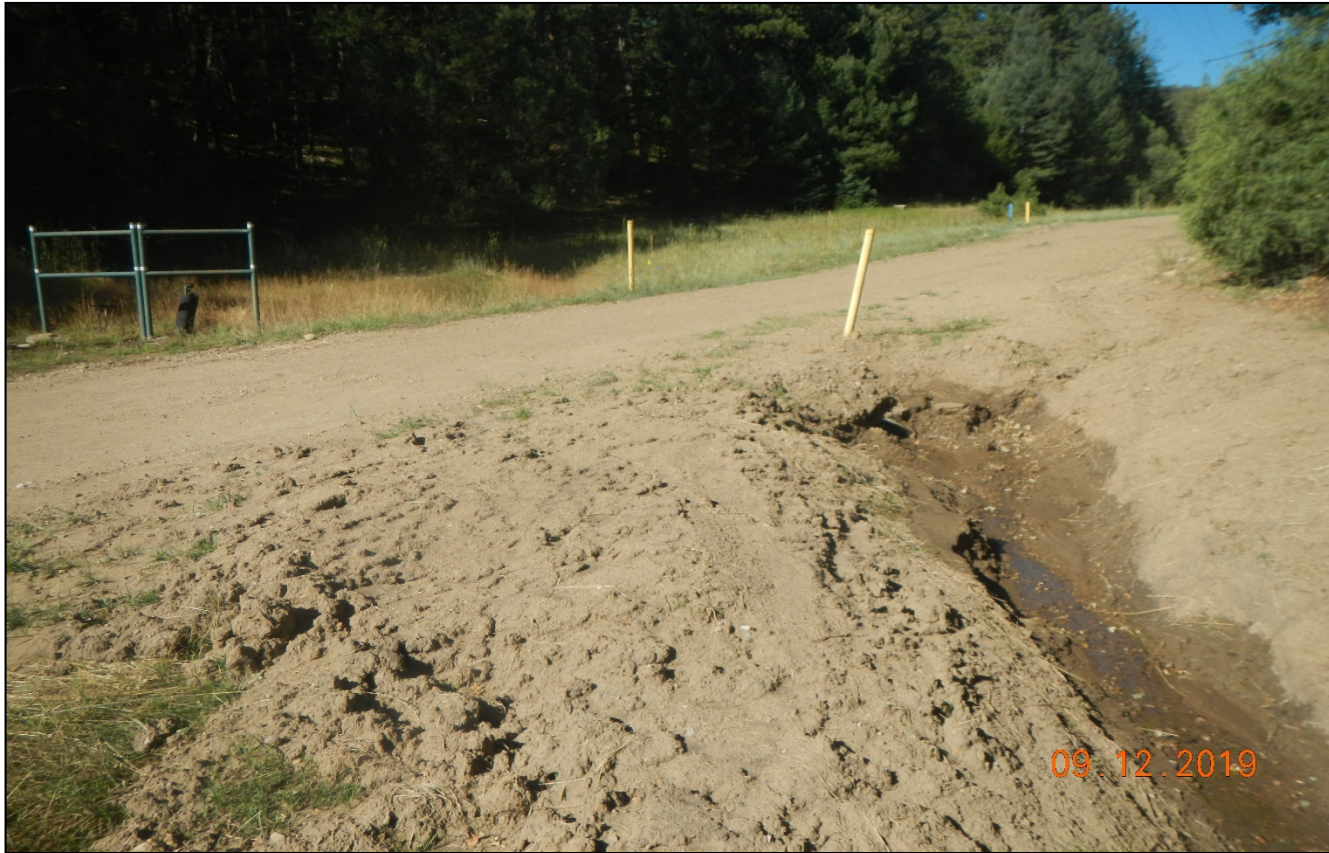
**Photo 5.** The culvert was cleaned out to allow drainage water to flow through the culvert.

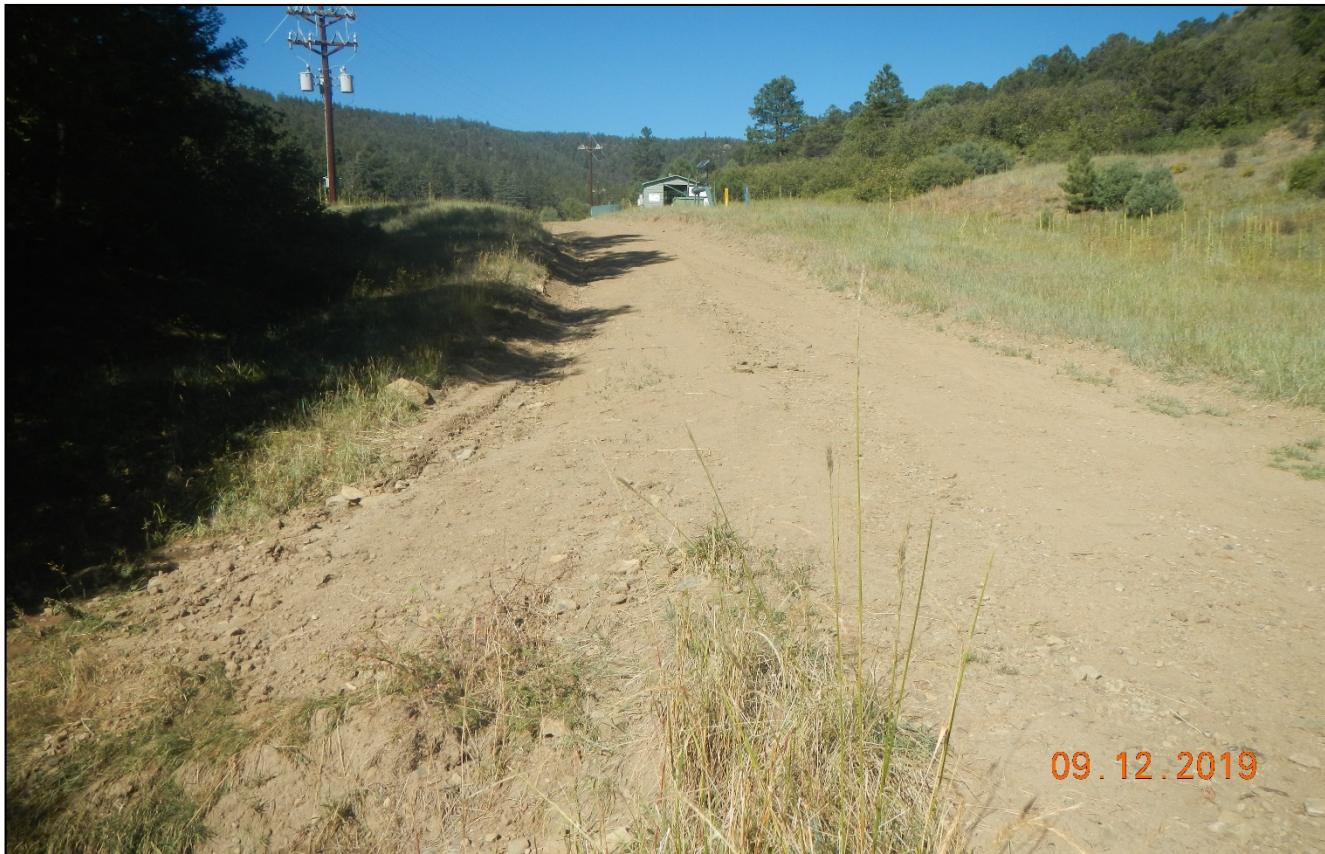
**Photo 6.** Facing west toward the location.
