Inspection Photos

API: 05-071-07186

Operator: TIMBER CREEK OPERATING LLC

Inspection Date: 9/12/2019

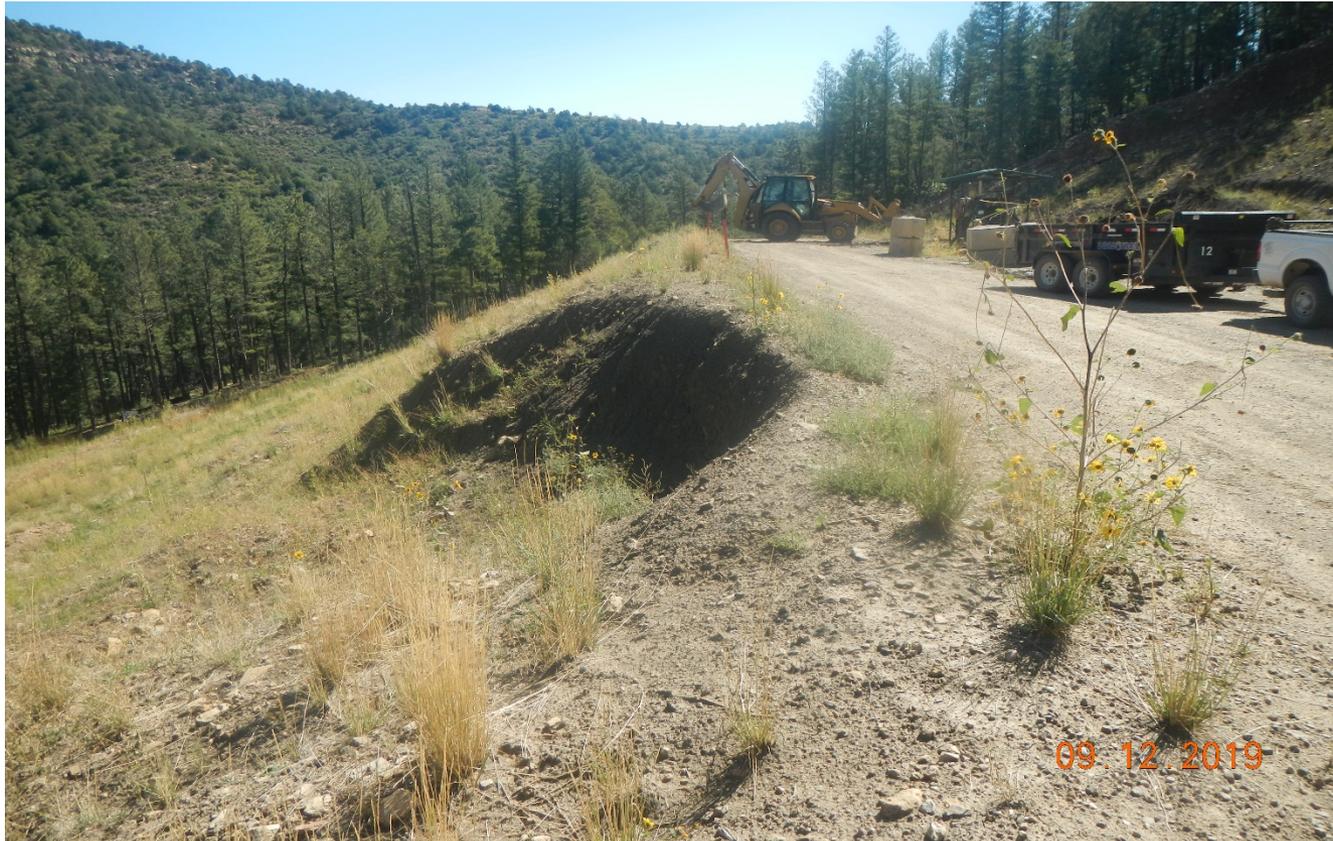
Photo 1. There is soil sloughing that occurred at the east side of the location. Corrective action of the previous inspection was not performed.

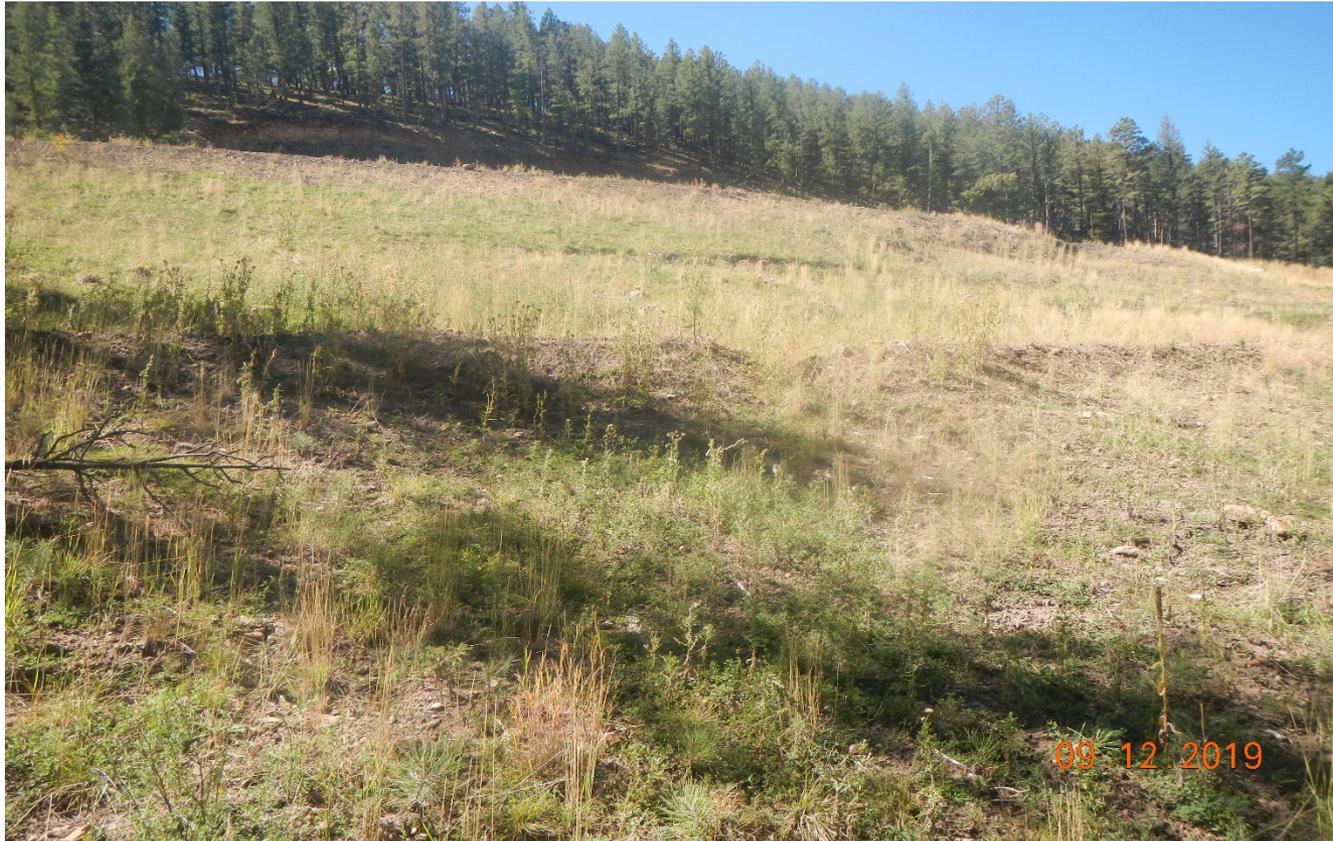
Photo 2. Facing toward the location fill slope. There are numerous noxious weeds growing in this area.

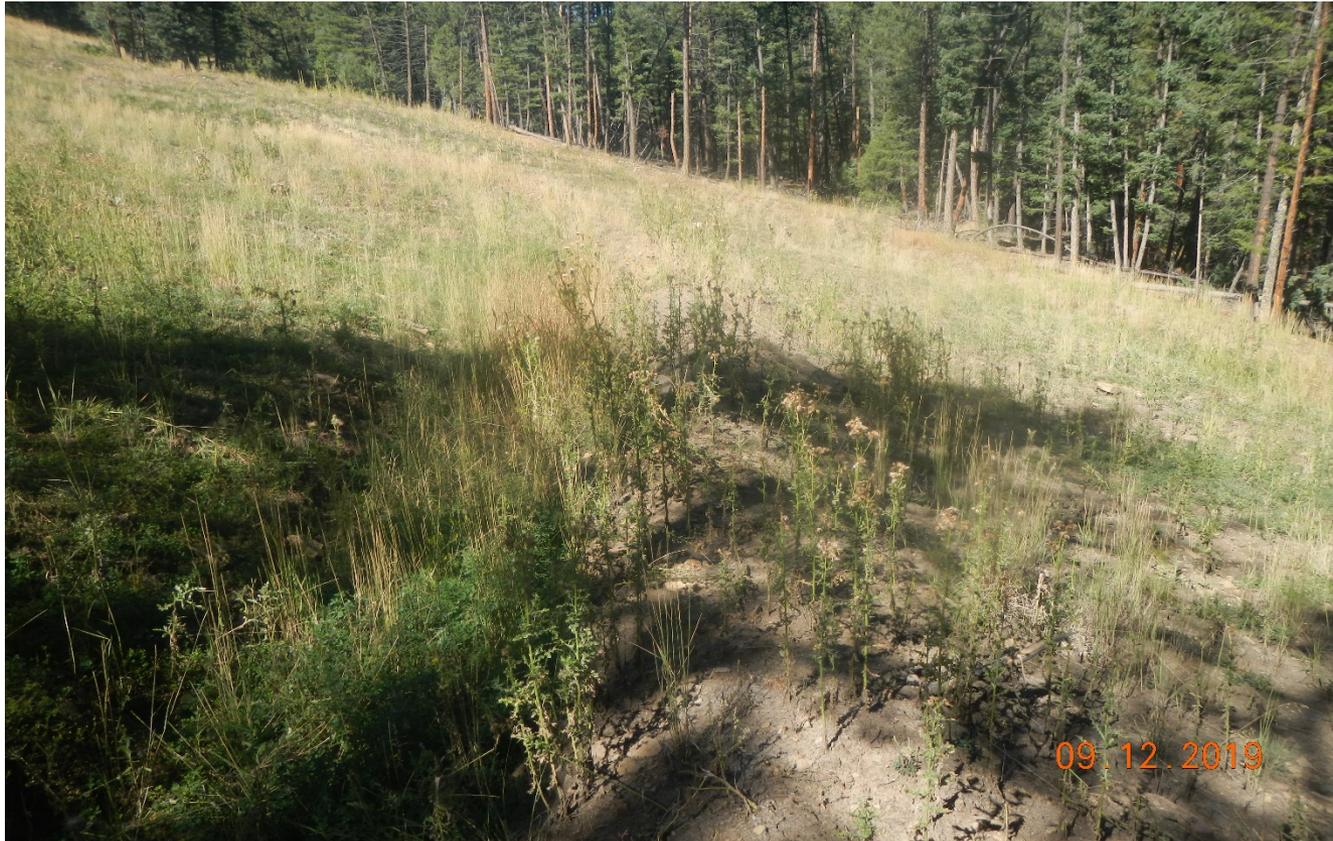
Photo 3. There are numerous noxious weeds growing in this area.
