Inspection Photos

API: 05-071-06145

Operator: MERIDIAN OIL

Inspection Date: 9/12/2019

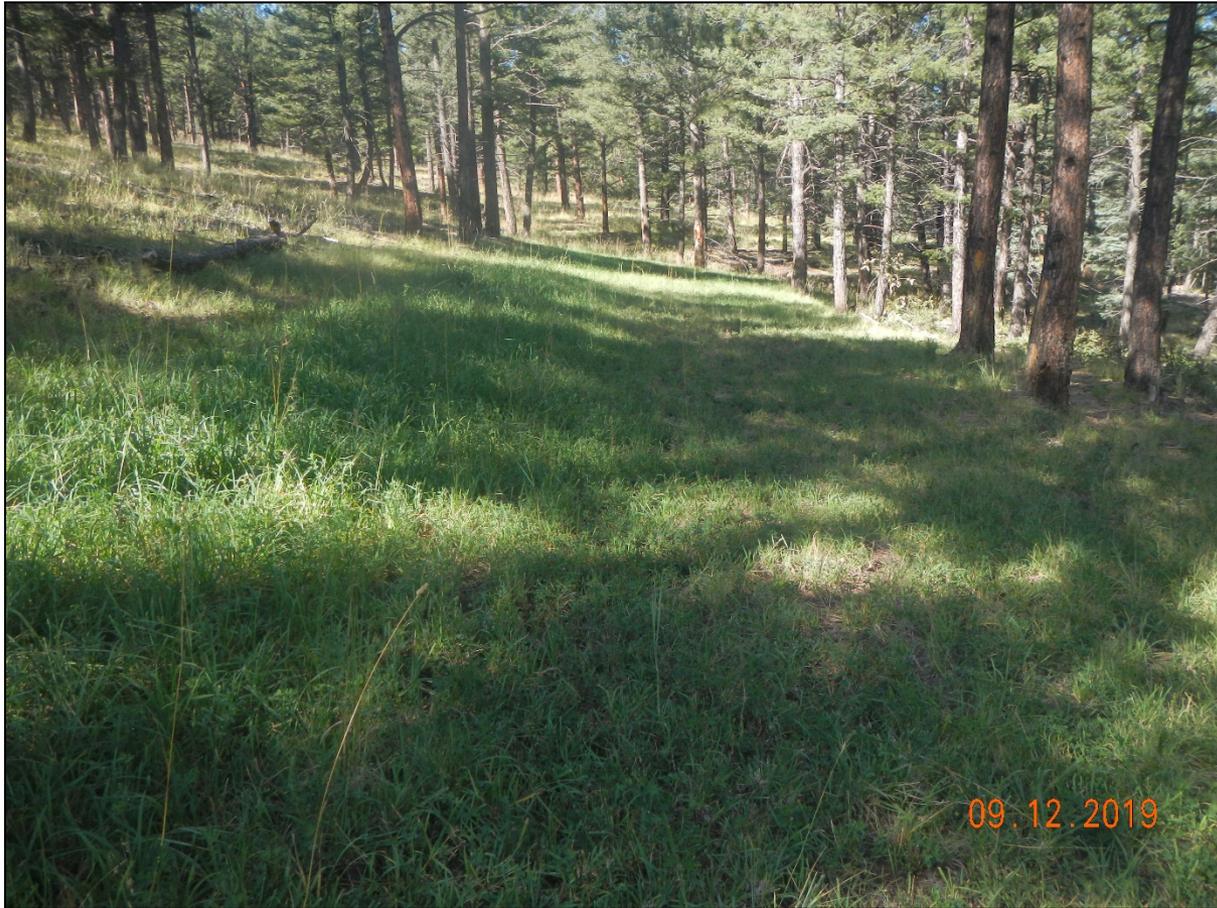
Photo 1. Facing southwest along the reclaimed access road. Perennial vegetation is uniformly established.

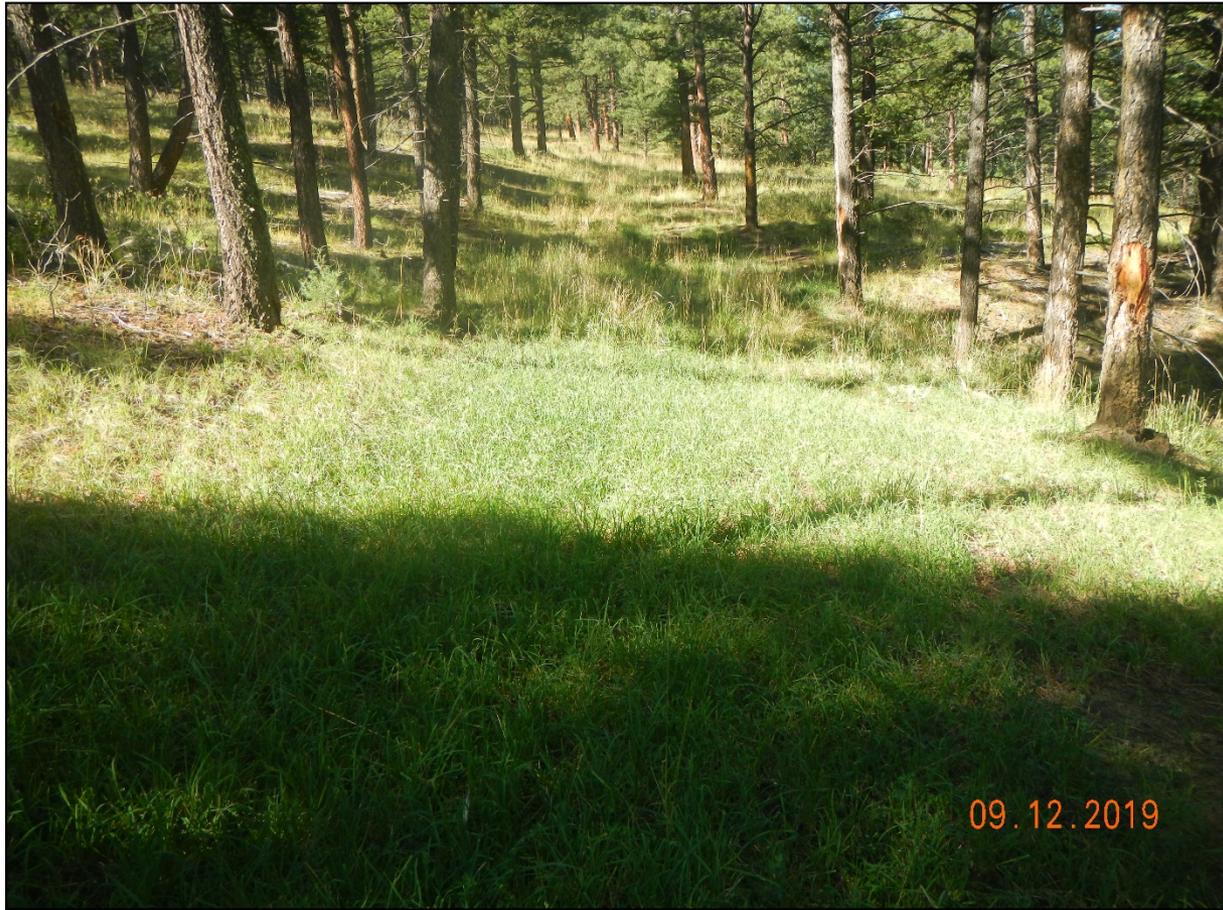
Photo 2. Facing southwest along the reclaimed access road. Perennial vegetation is uniformly established.

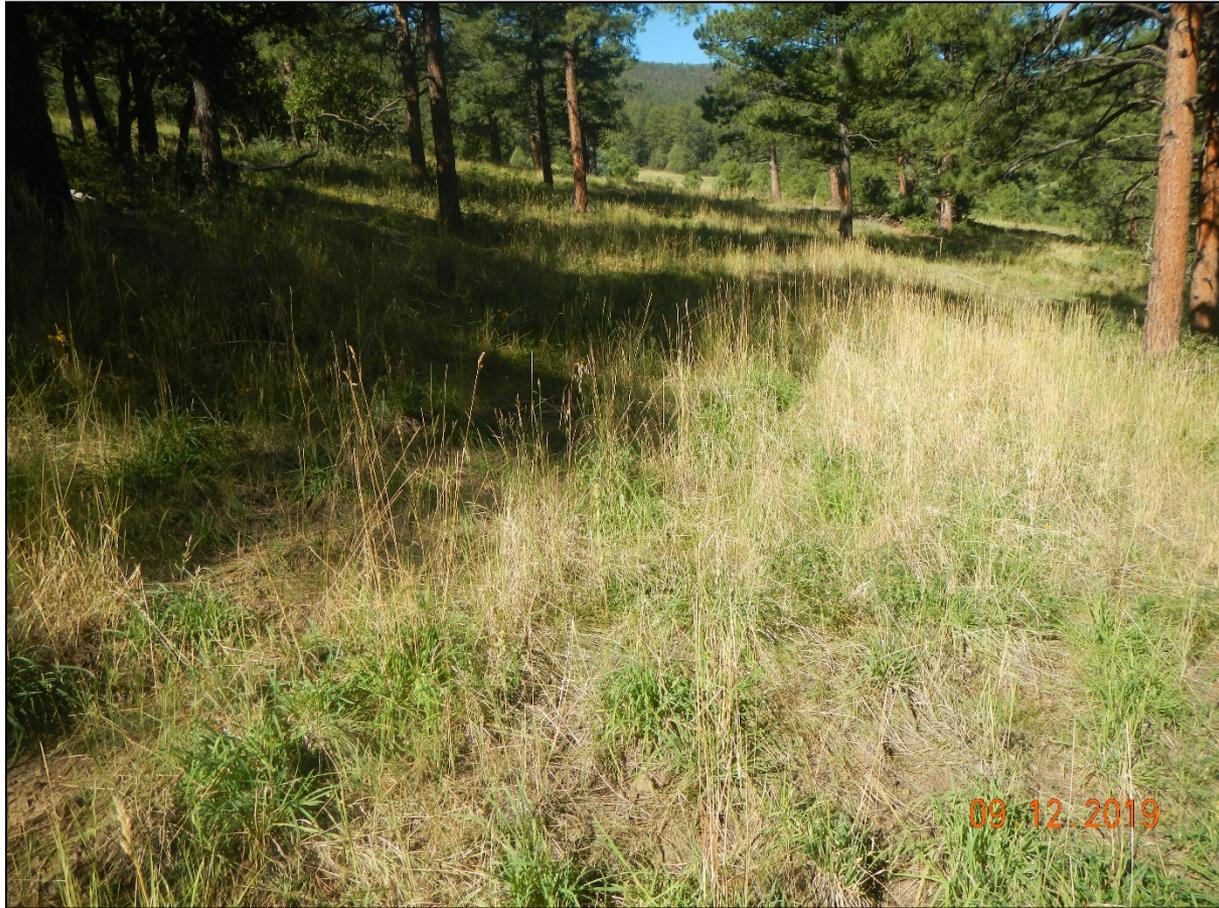
Photo 3. Facing west along the reclaimed access road. Perennial vegetation is uniformly established.

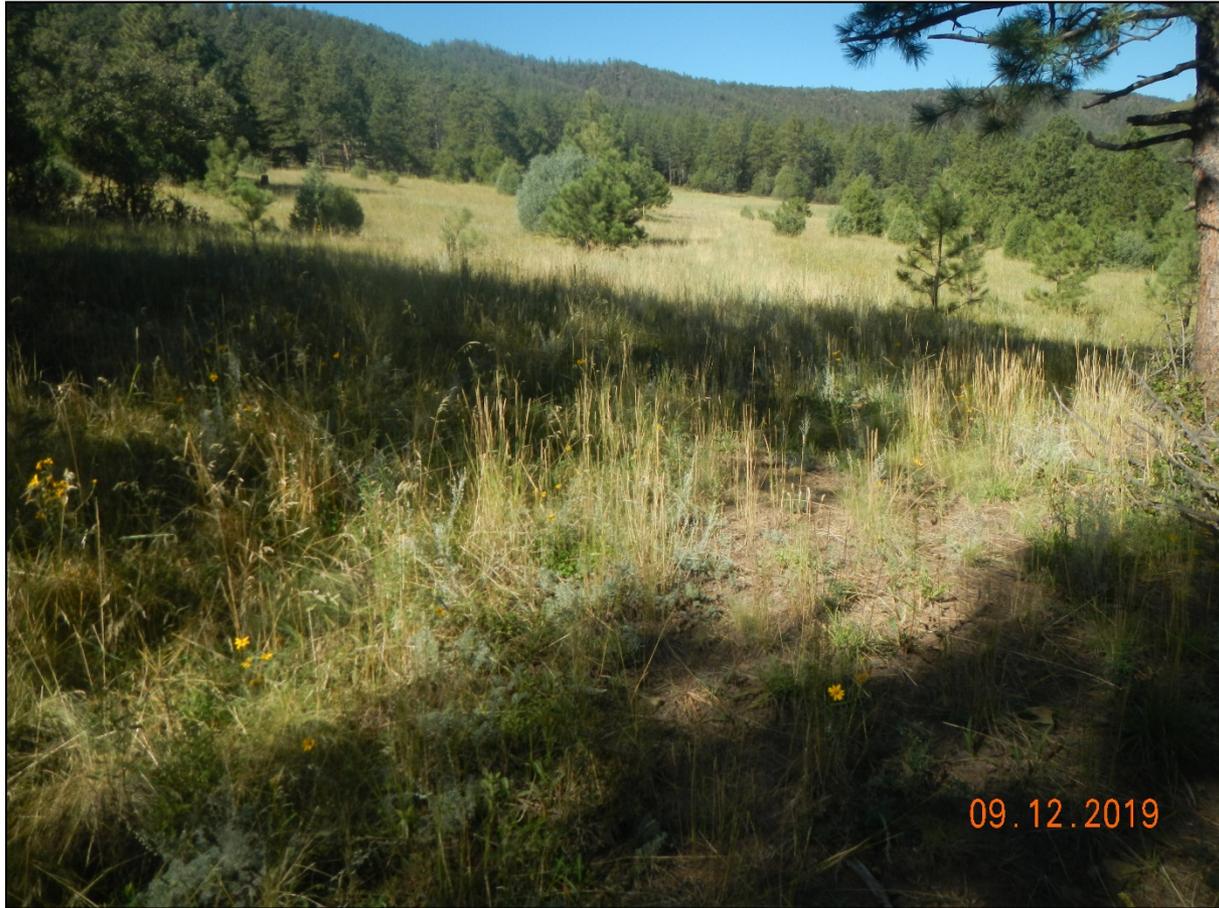
Photo 4. Facing west along the reclaimed access road. Perennial vegetation is uniformly established.

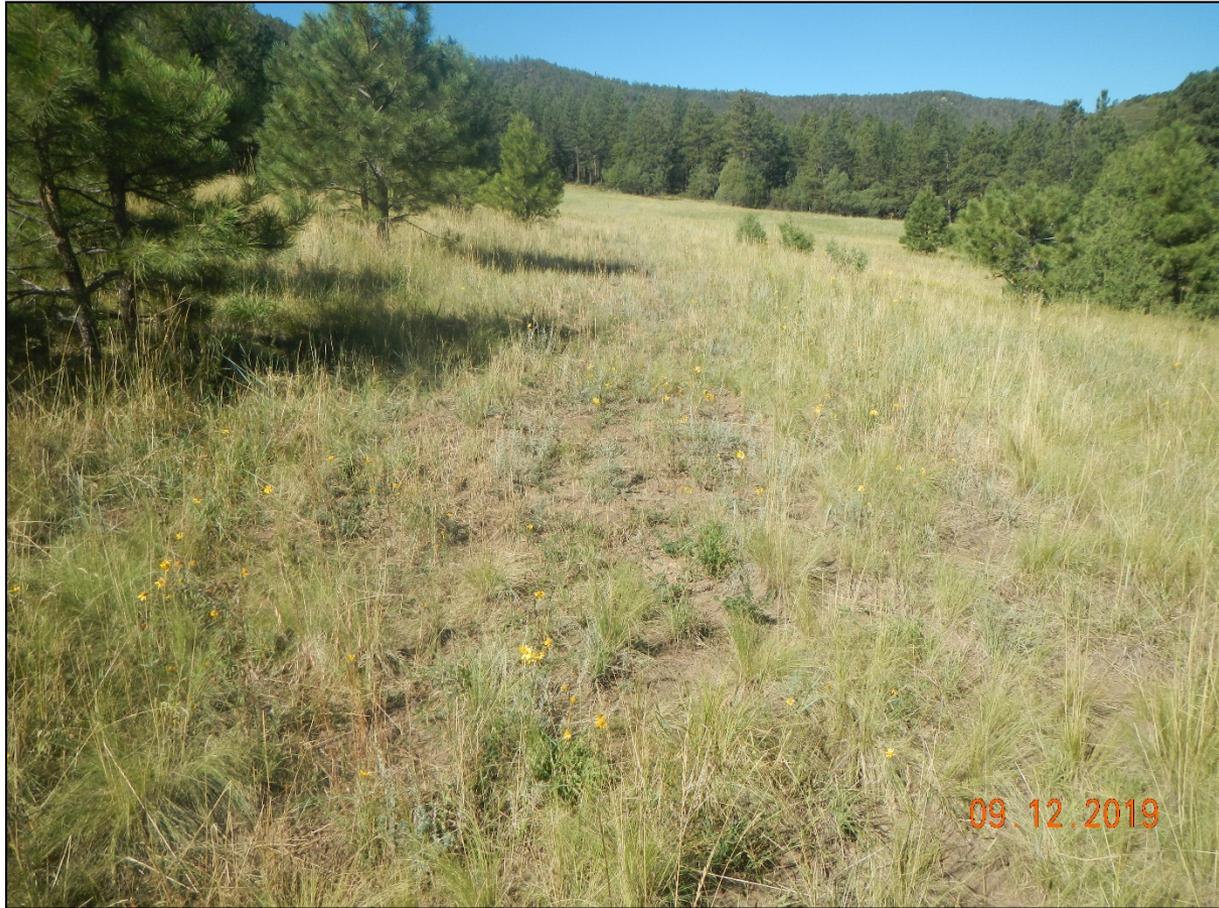
Photo 5. Facing west along the reclaimed access road. Perennial vegetation is uniformly established.

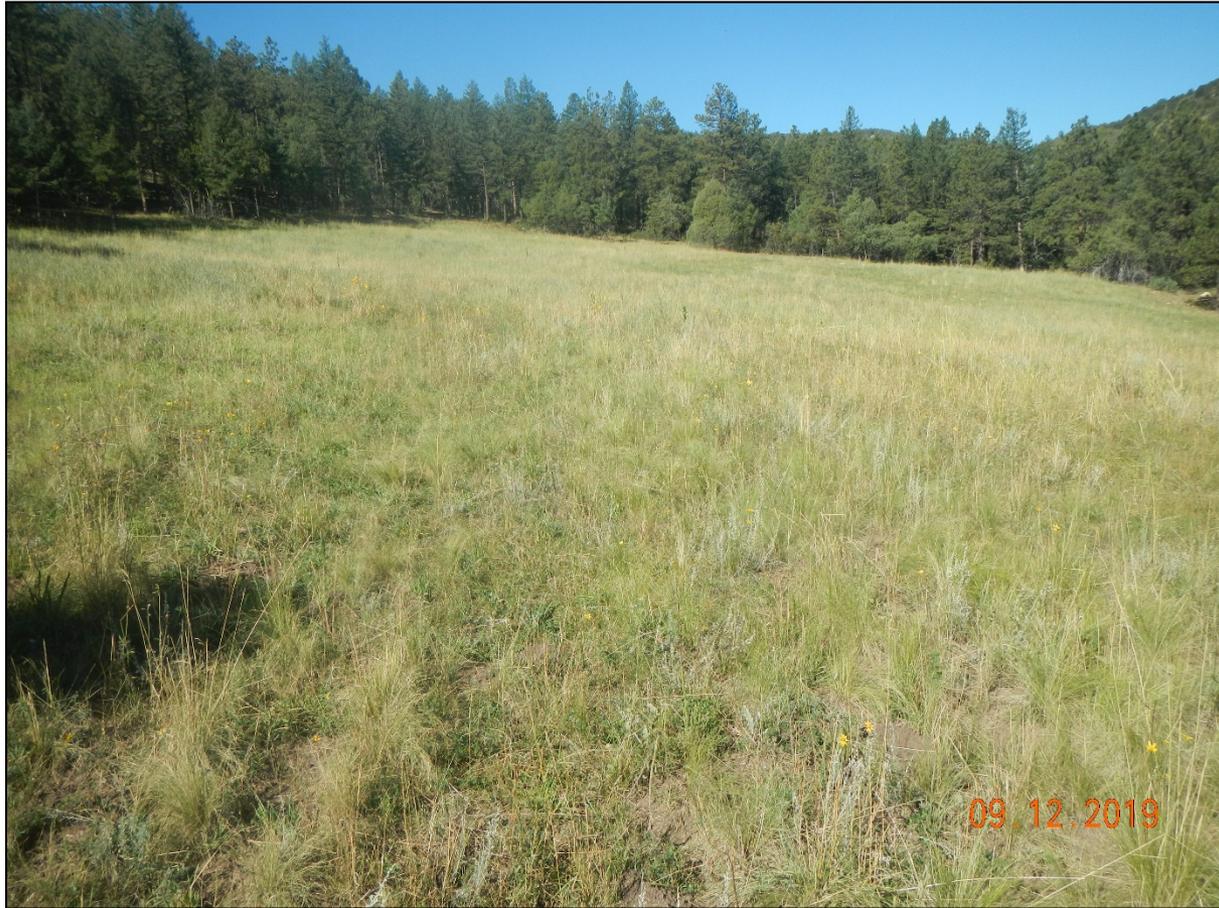
Photo 6. Facing west toward the location. Perennial vegetation is uniformly established.

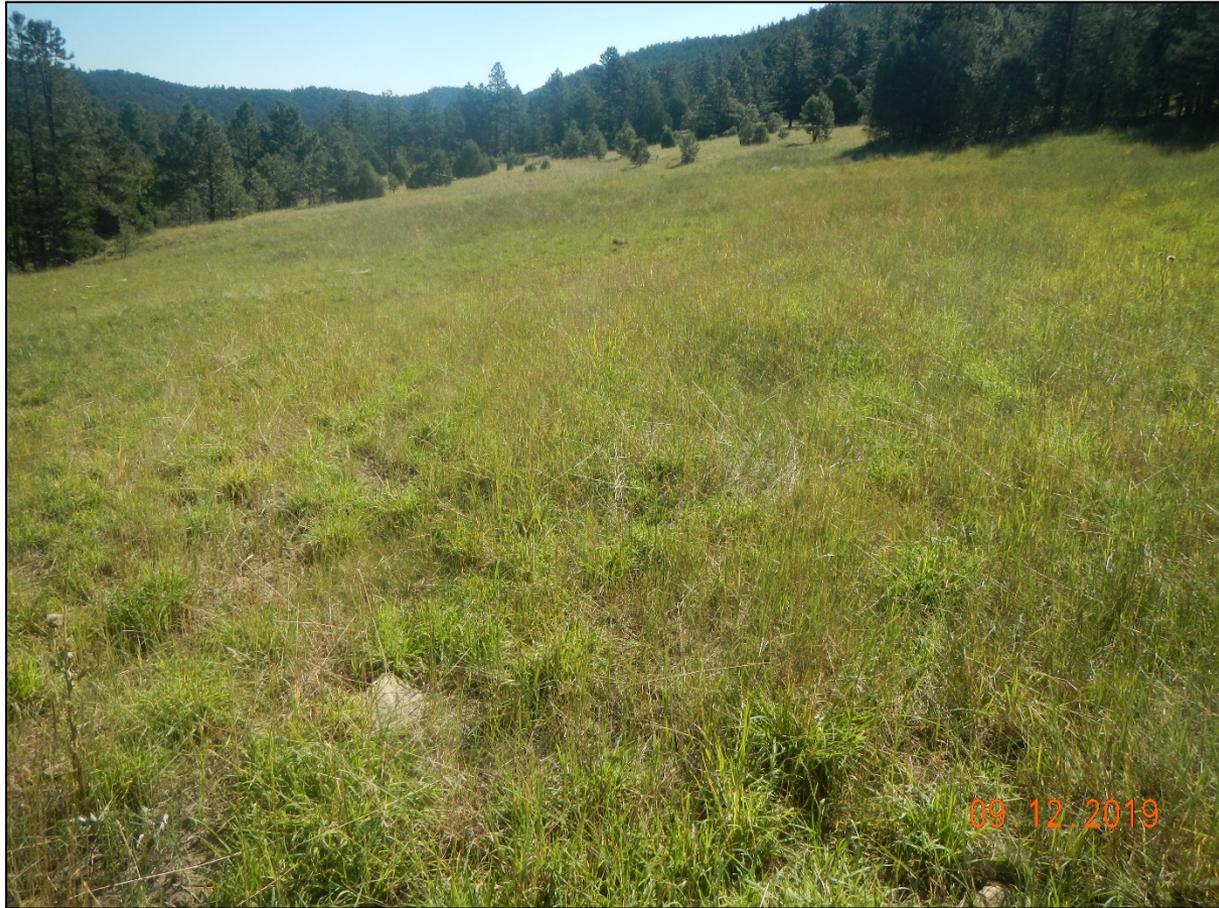
Photo 7. Facing east toward the location. Perennial vegetation is uniformly established.

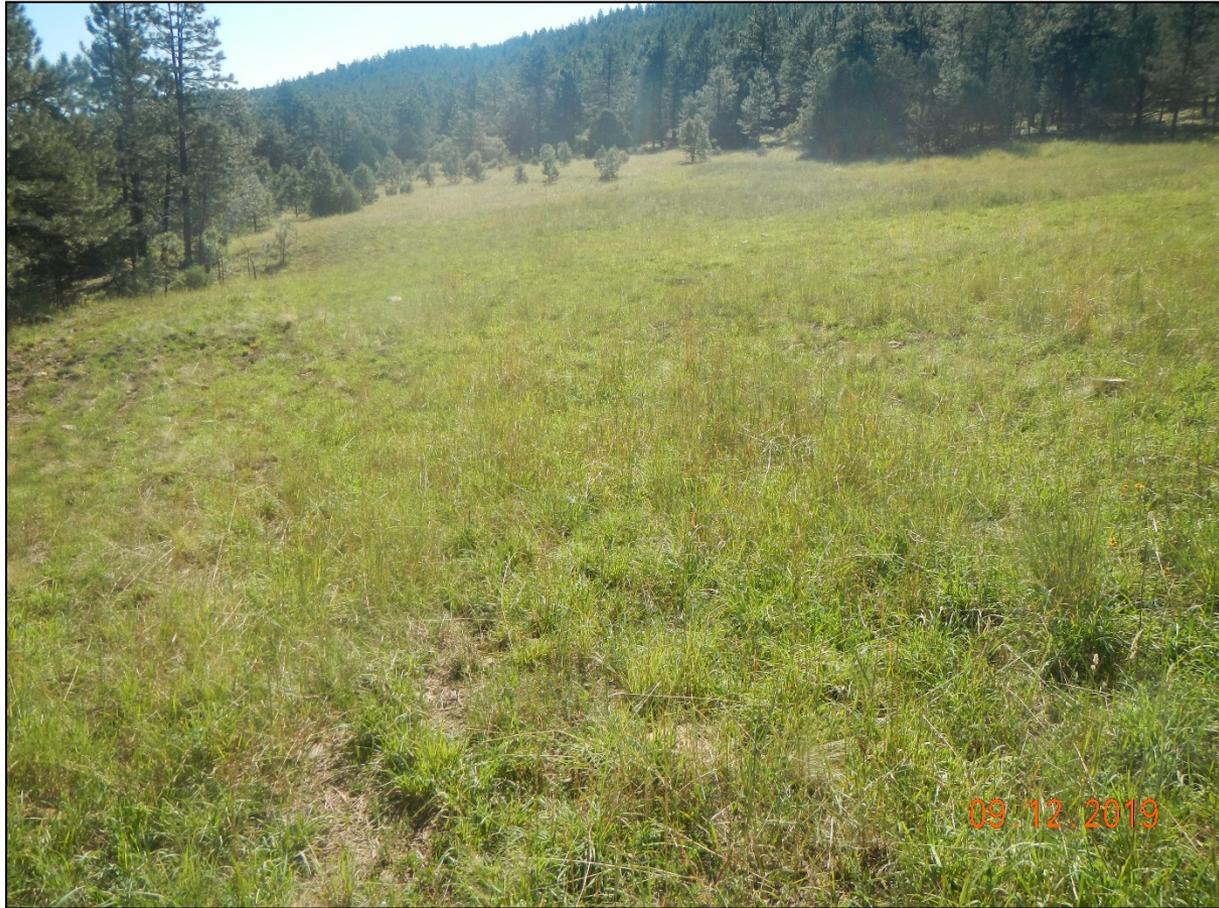
Photo 8. Northwest side of the location. Wattles have been removed. No noxious weed issues were found.

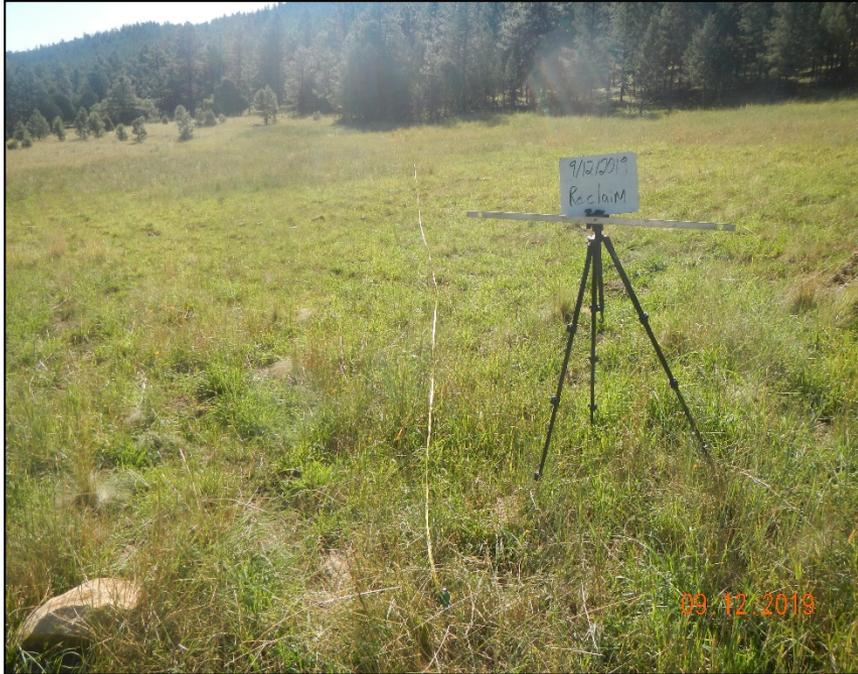
Photo 9. Transect Reclaim on location facing SE.

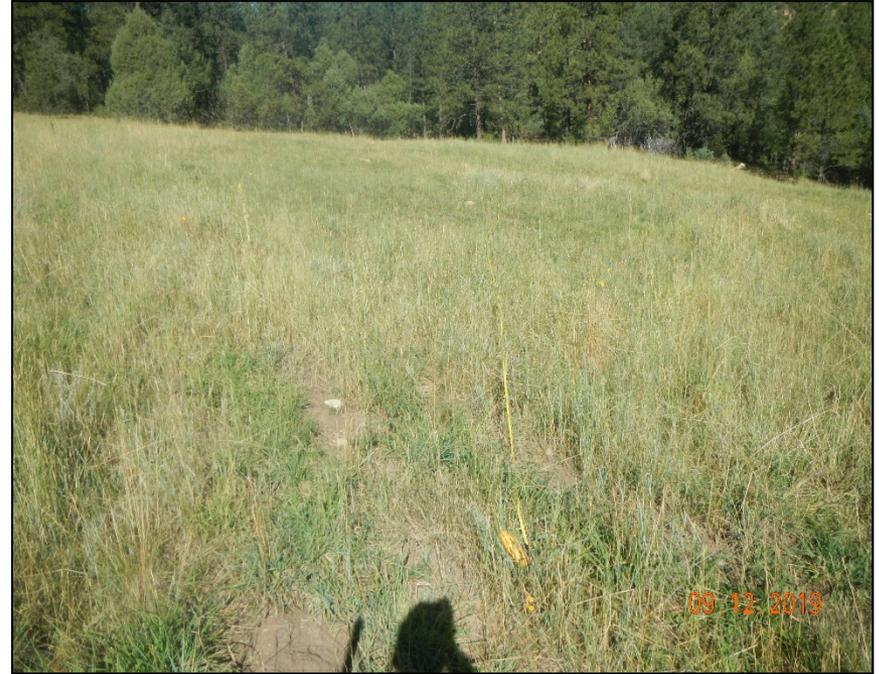
Photo 10. Transect Reclaim on location facing NW.

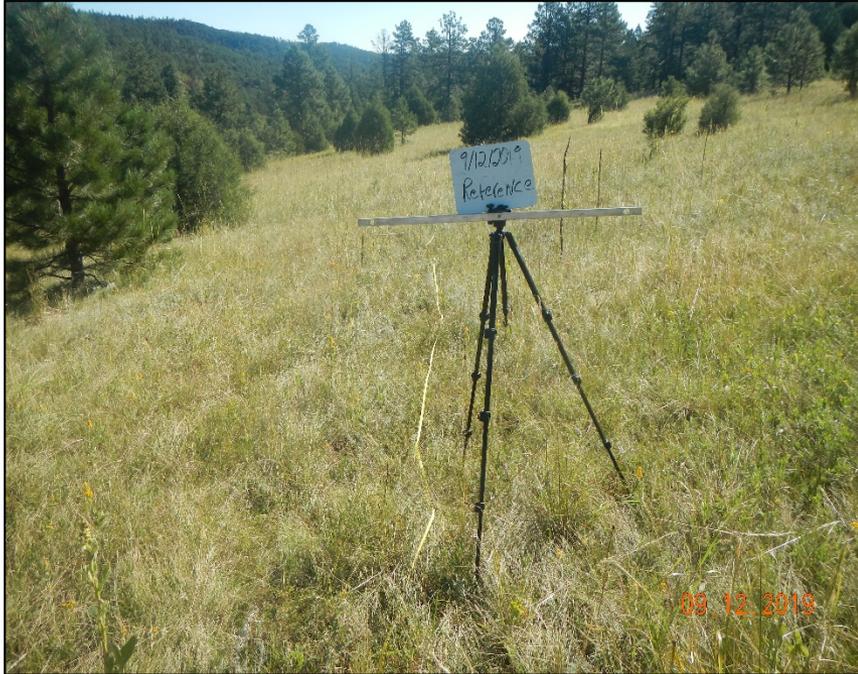
Photo 11. Transect Reference facing E.

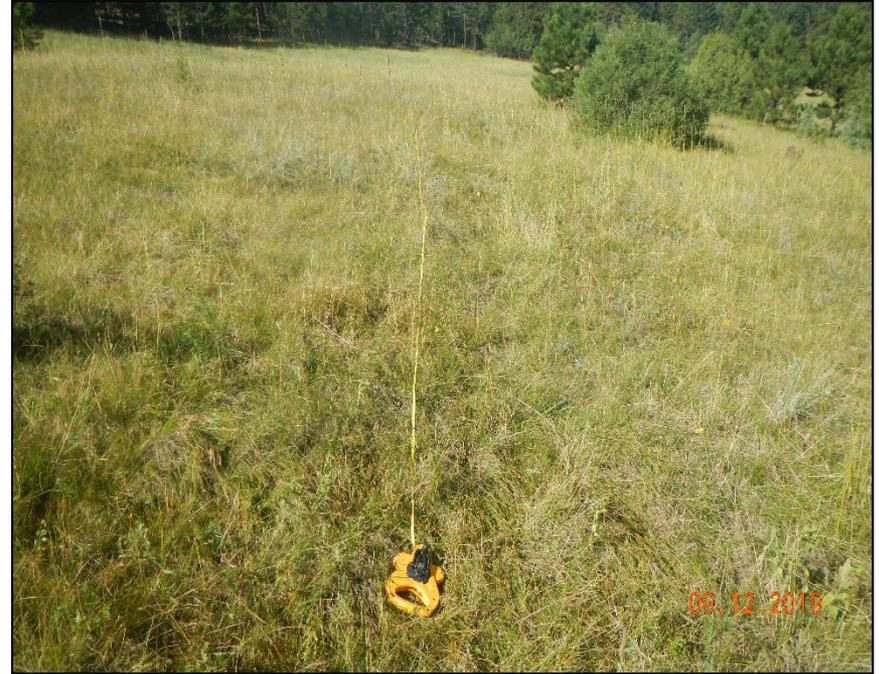
Photo 12. Transect Reference facing W.
